Asbestos Containing Material Clearance Inspection

28 April 2023

Site:	Little Bay Beach
Location:	Southern, Western and Northern Little Bay Beach

Requested by:	
Name	Joe Santangelo
Contact	0436839760
Email	joe.santangelo@randwick.nsw.gov.au
Site Details:	
Address	2 Coast Hospital Rd, Little Bay NSW 2036
Local Government Area	Randwick City Council

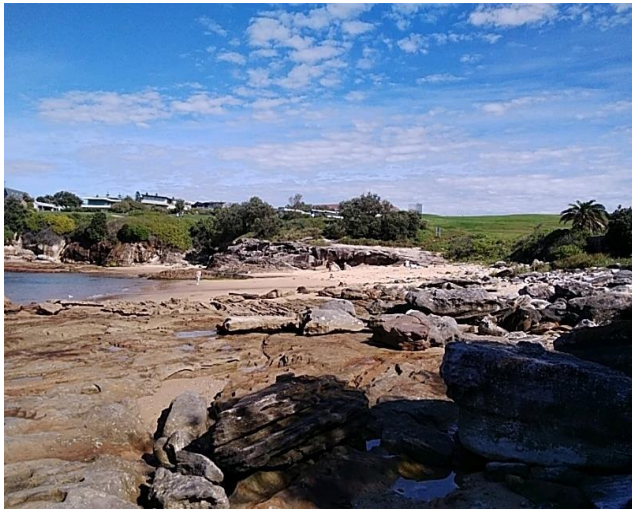
Notes: Overview of the Northern beach

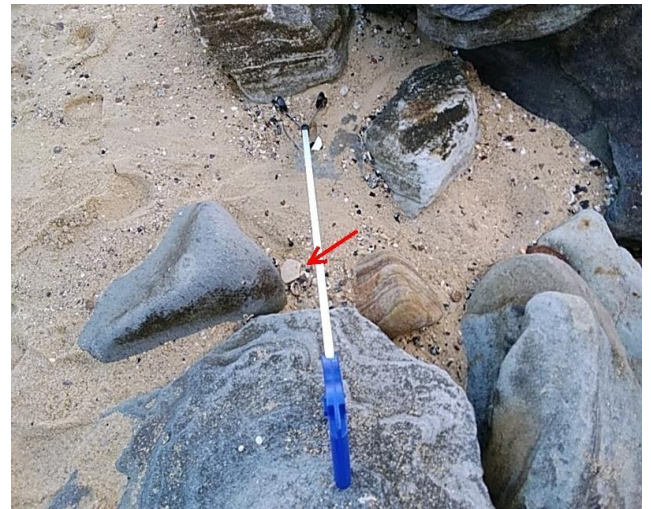
Notes: Overview of removal item within Northern beach prior to removal

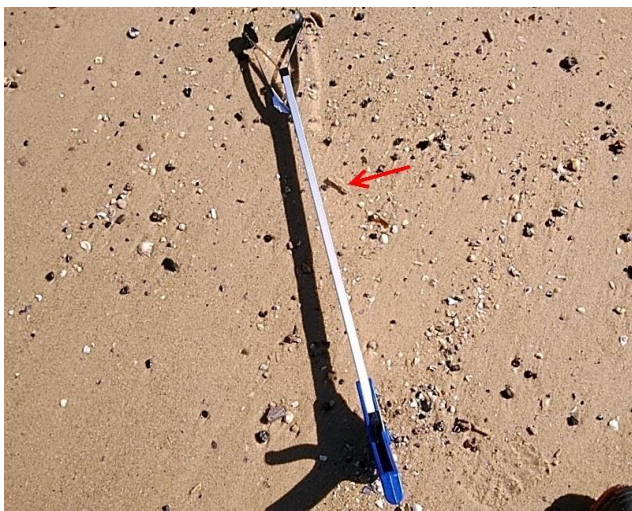
Notes: Overview of removal item within Northern beach prior to removal

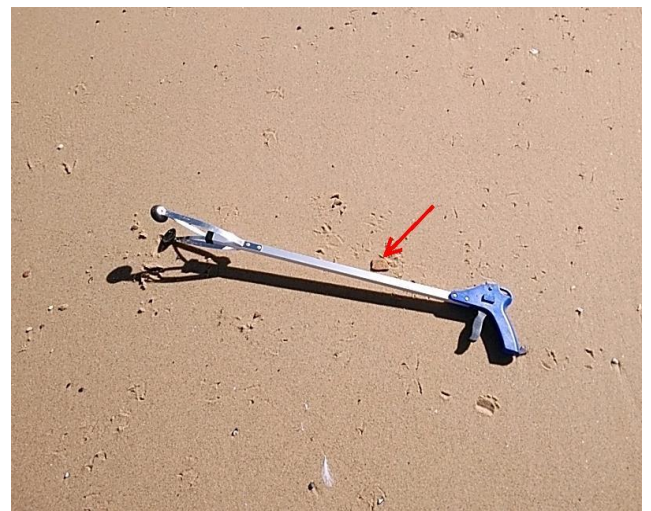
Notes: Overview of removal item within Northern beach prior to removal

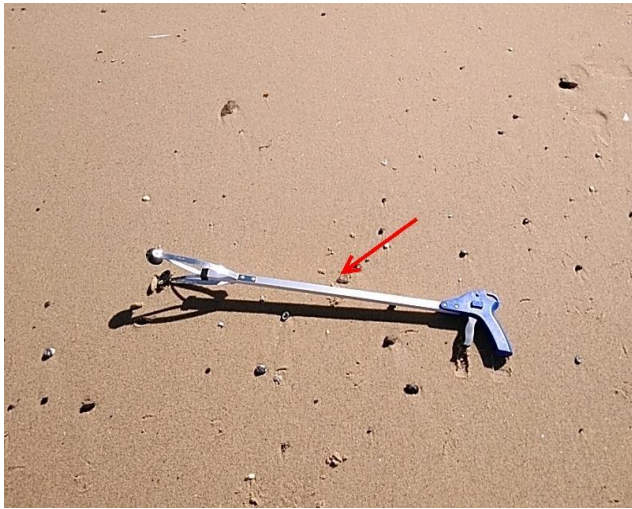
Notes: Overview of removal item within Northern beach prior to removal

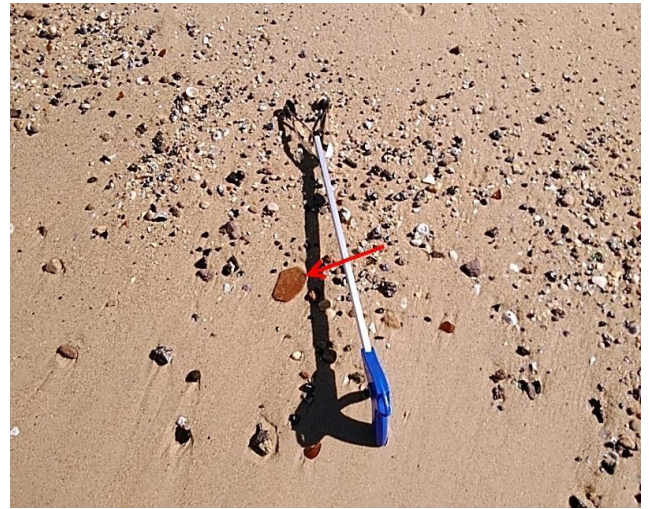
Notes: Overview of removal item within Northern beach prior to removal

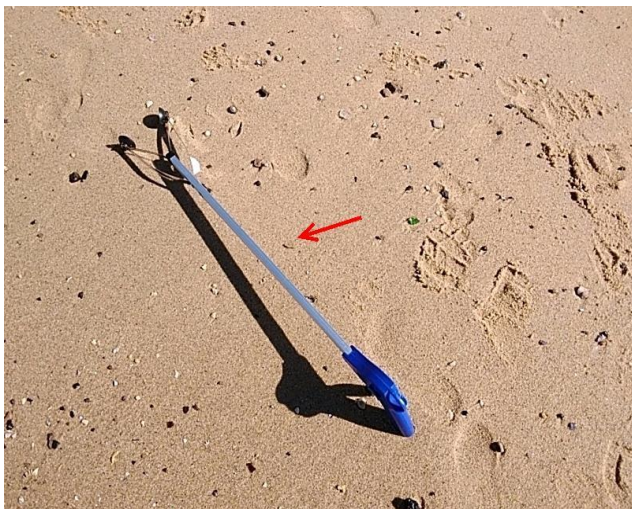
Notes: Overview of removal item within Northern beach prior to removal

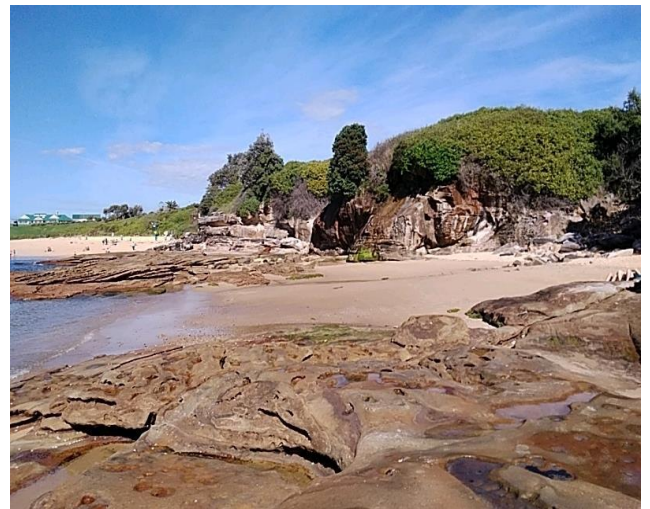
Notes: Overview of the Western beach

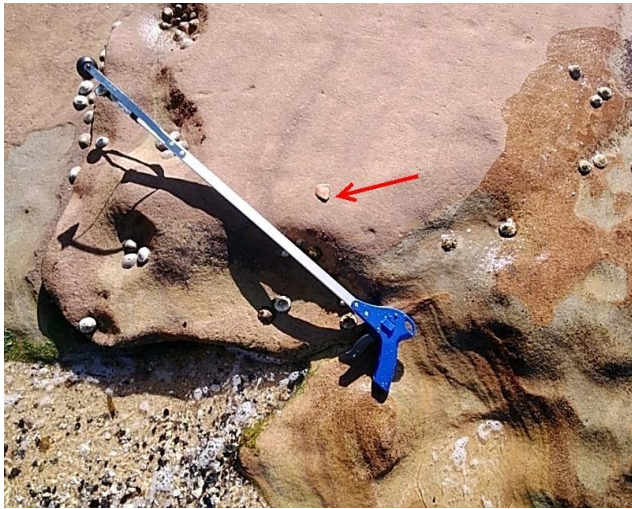
Notes: Overview of removal item within Western beach prior to removal

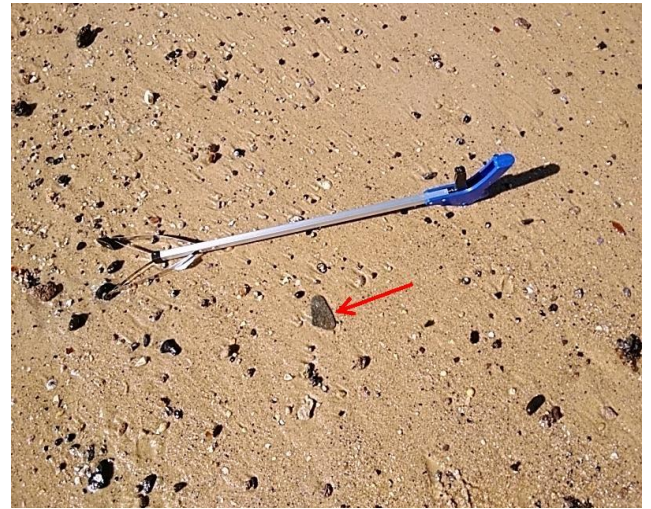
Notes: Overview of removal item within Western beach prior to removal

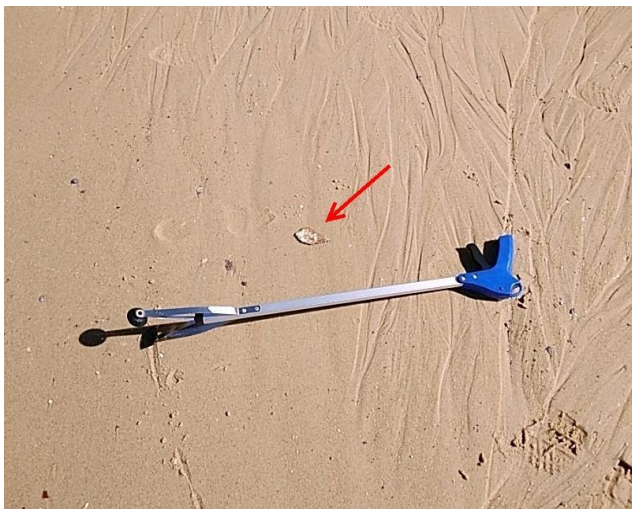
Notes: Overview of removal item within Western beach prior to removal

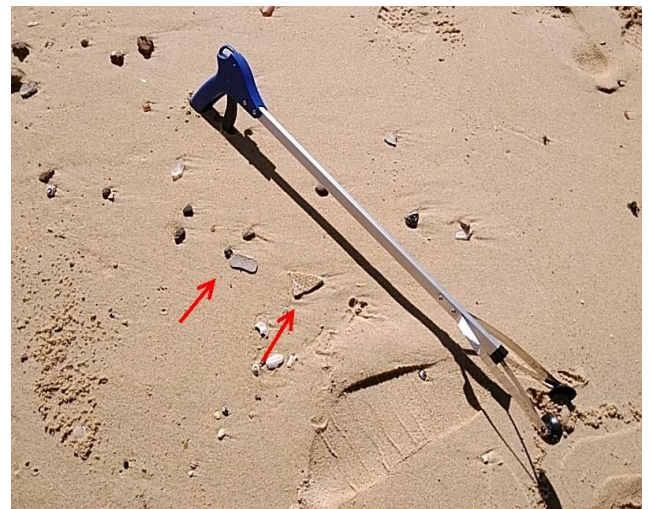
Notes: Overview of removal item within Western beach prior to removal

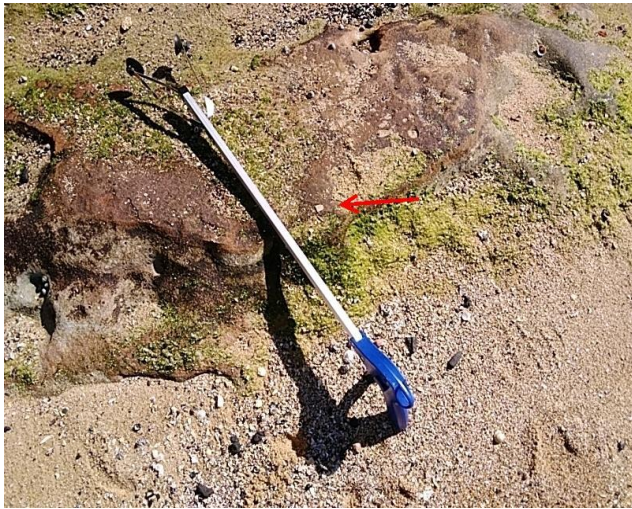
Notes: Overview of removal item within Western beach prior to removal

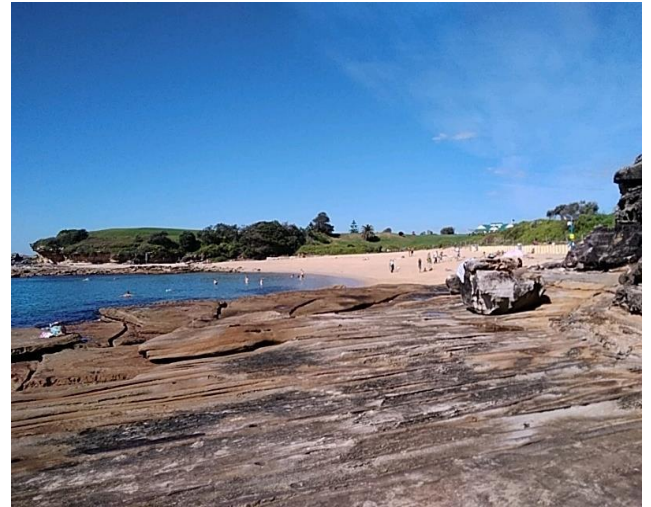
Notes: Overview of the Southern beach

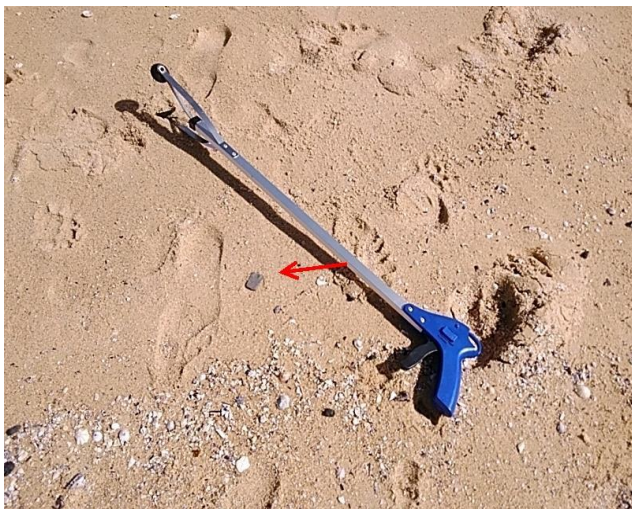
Notes: Overview of removal item within Southern beach prior to removal

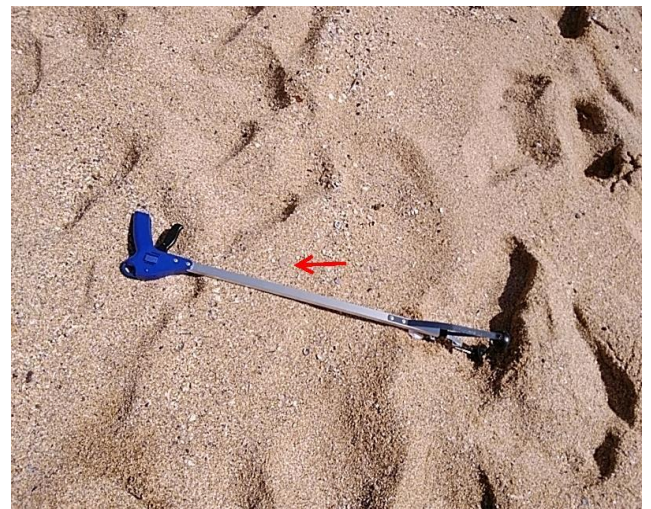
Notes: Overview of removal item within Southern beach prior to removal

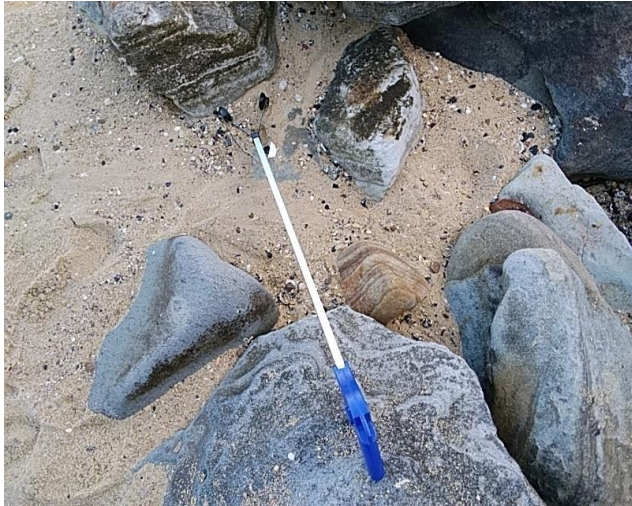
Notes: Visual inspection of removal item following removal

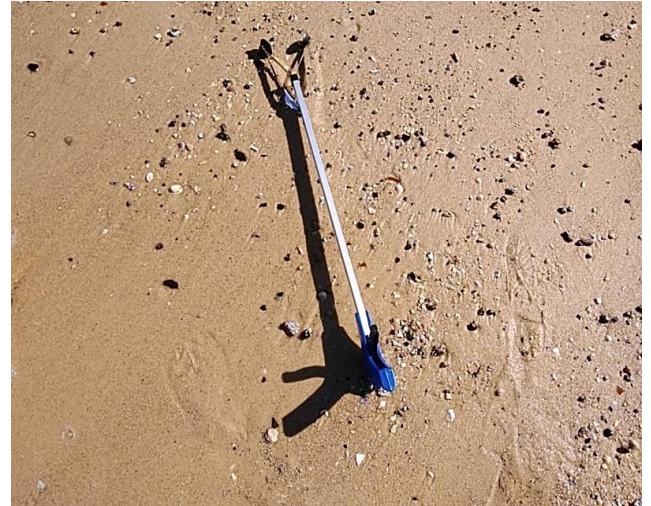
Notes: Visual inspection of removal item following removal

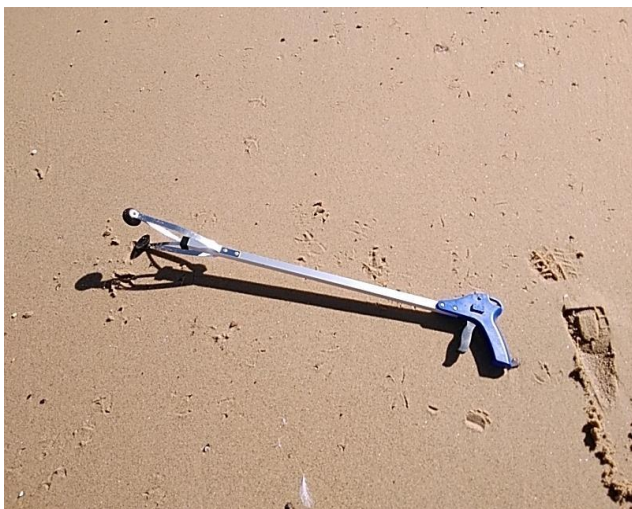
Notes: Visual inspection of removal item following removal

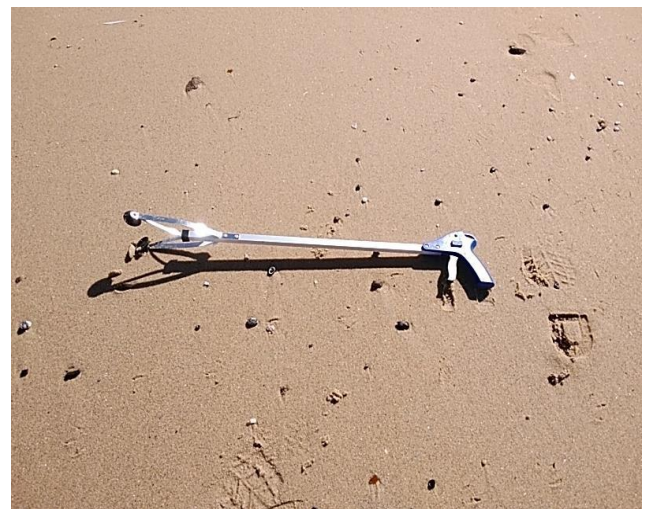
Notes: Visual inspection of removal item following removal

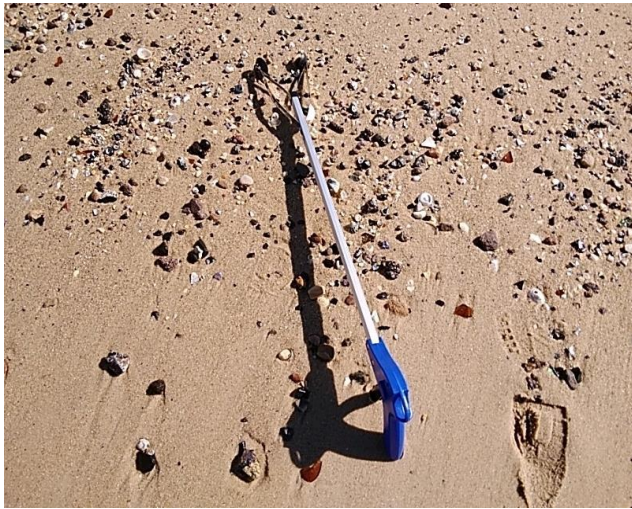
Notes: Visual inspection of removal item following removal

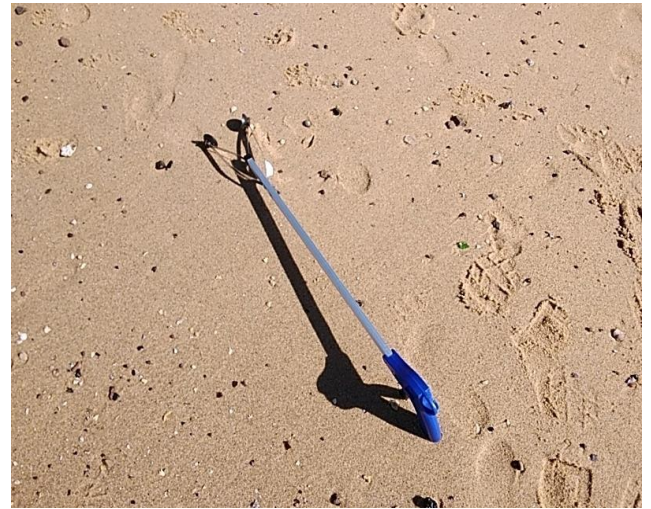
Notes: Visual inspection of removal item following removal

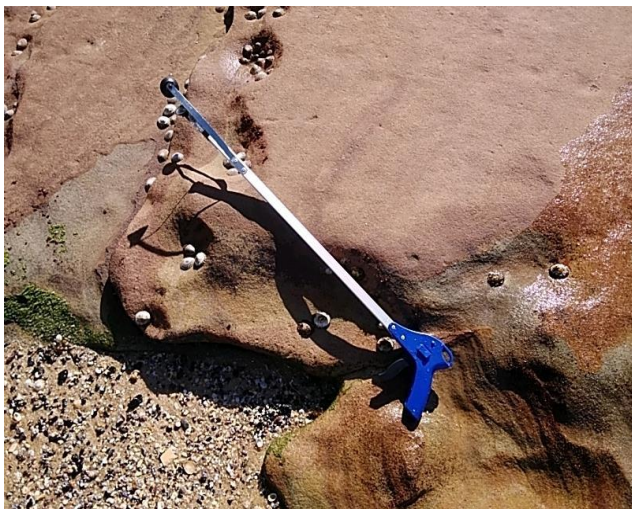
Notes: Visual inspection of removal item following removal

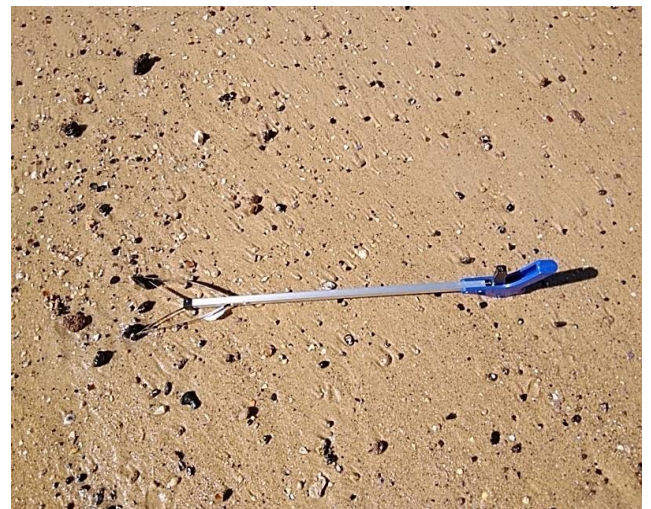
Notes: Visual inspection of removal item following removal

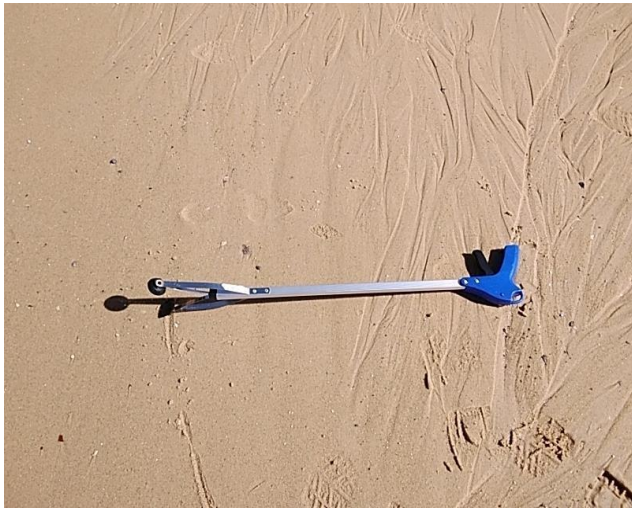
Notes: Visual inspection of removal item following removal

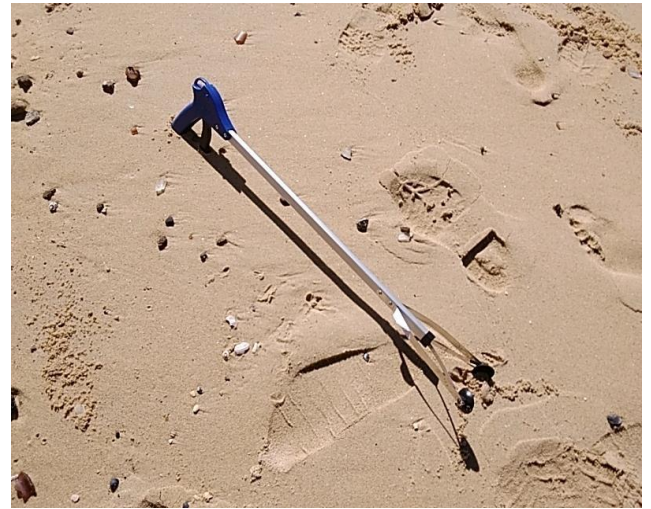
Notes: Visual inspection of removal item following removal

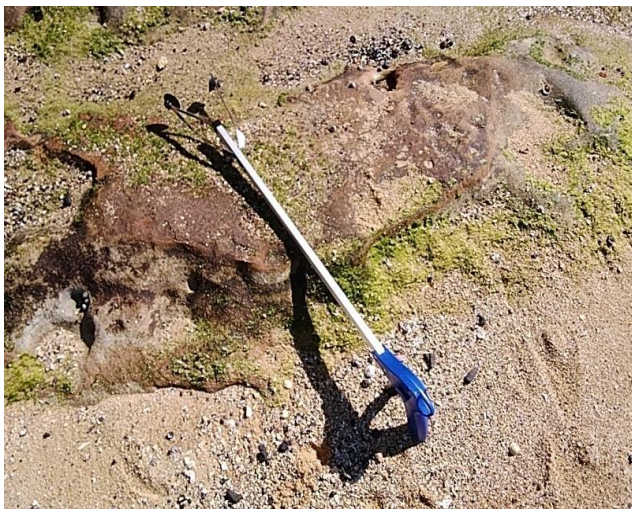
Notes: Visual inspection of removal item following removal

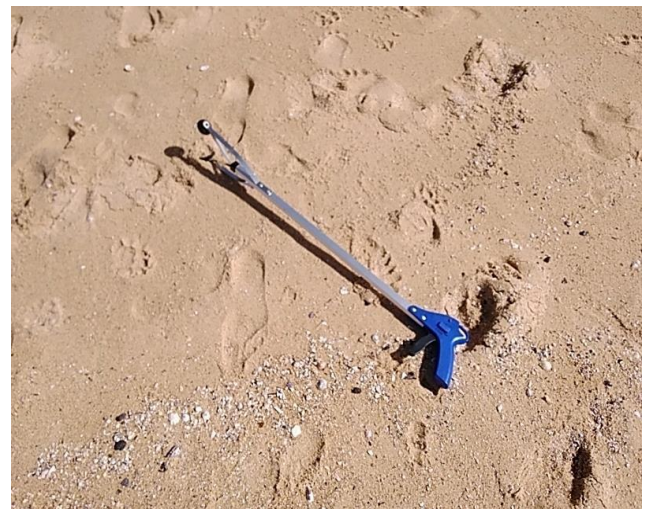
Notes: Visual inspection of removal item following removal

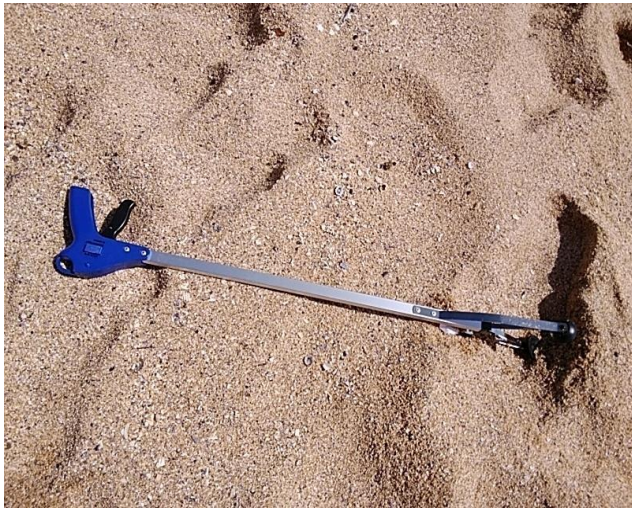
Notes: Visual inspection of removal item following removal

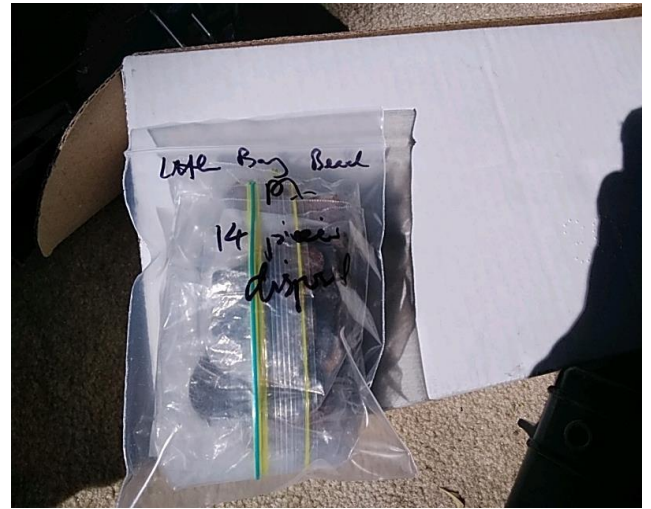
Notes: Waste disposal management (14 pieces disposed)
