Asbestos Containing Material Clearance Inspection

15 December 2022

Site:	Little Bay Beach
Location:	Southern, Western and Northern Little Bay Beach

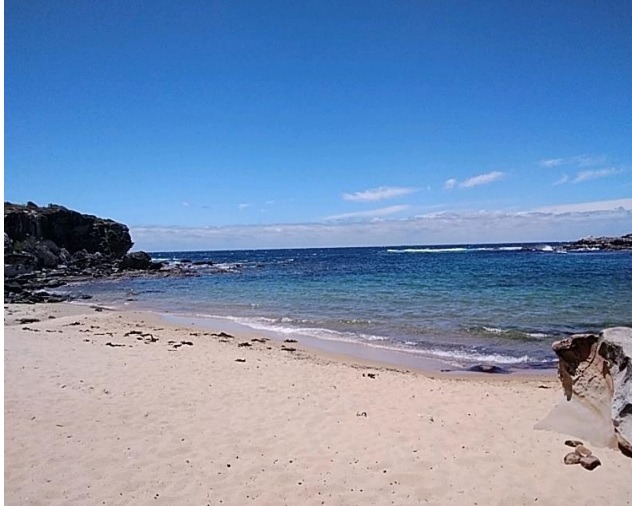
Notes: Overview of Northern beach

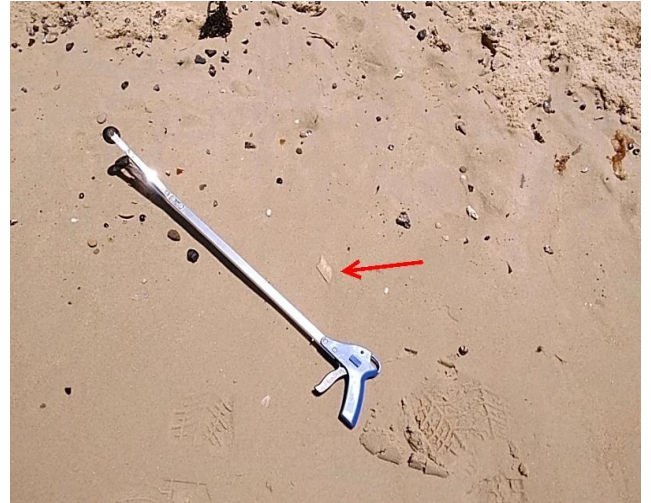
Notes: Overview of removal item within Northern beach prior to removal

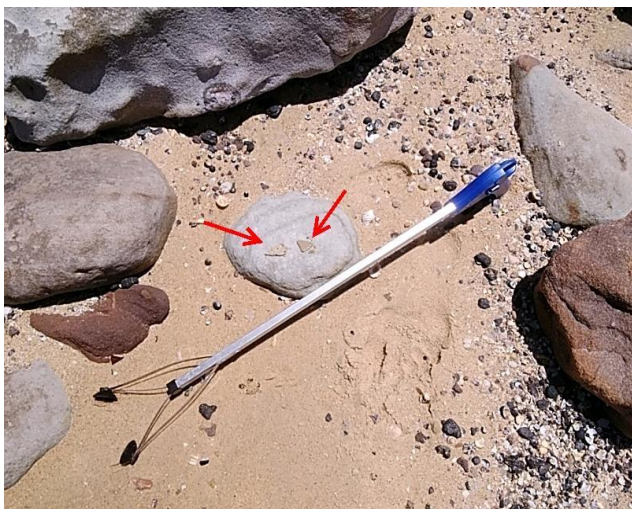
Notes: Overview of removal item within Northern beach prior to removal

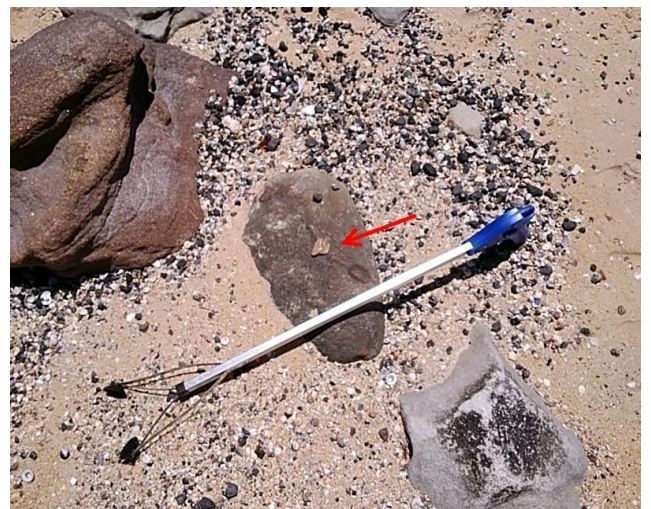
Notes: Overview of removal item within Northern beach prior to removal

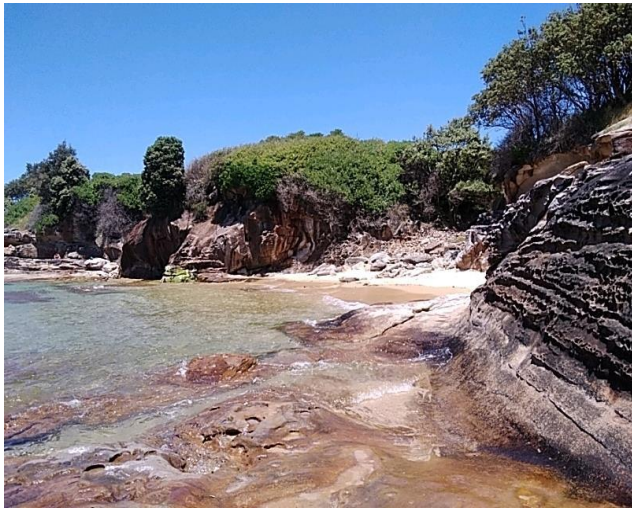
Notes: Overview of Western beach

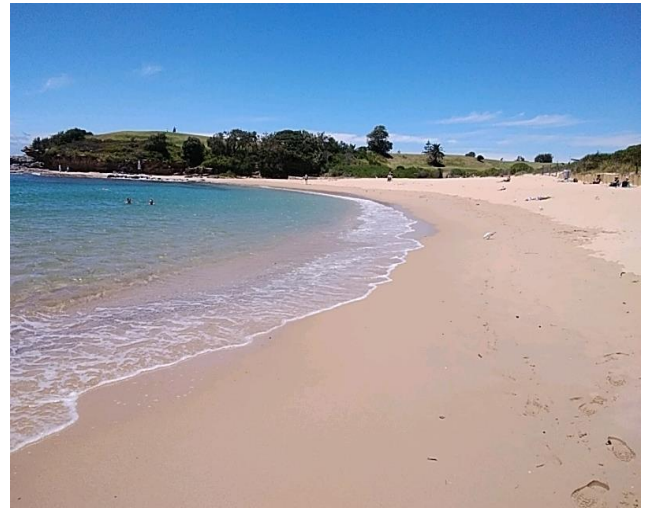
Notes: Overview of Southern beach

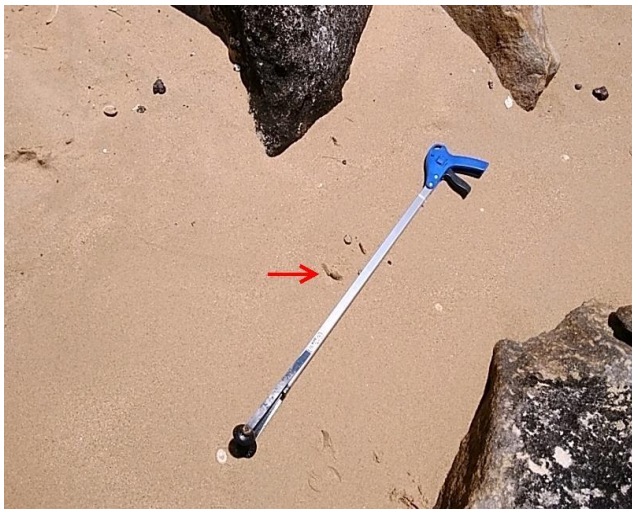
Notes: Overview of removal item within Southern beach prior to removal

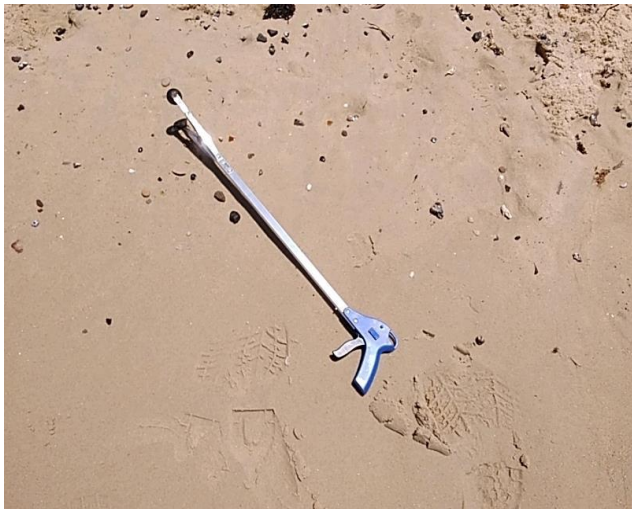
Notes: Visual inspection of removal item following removal

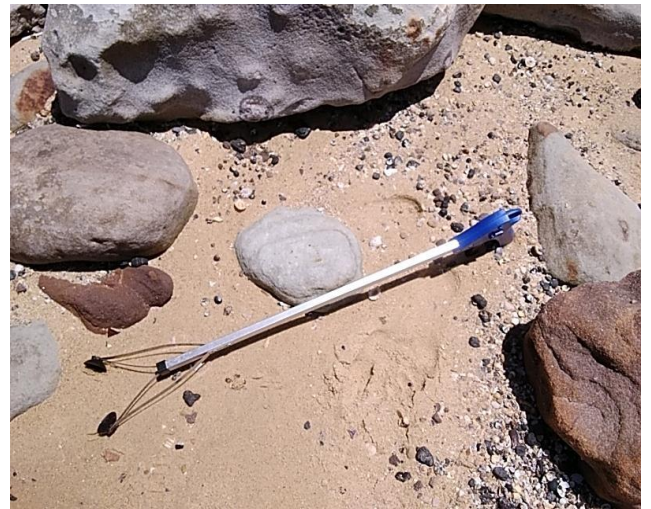
Notes: Visual inspection of removal item following removal

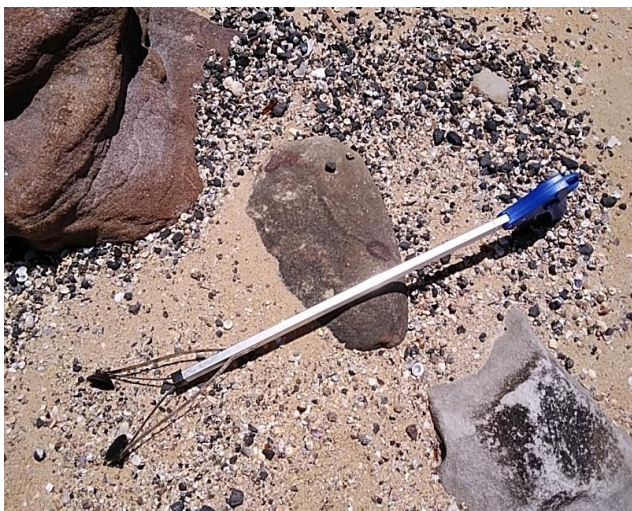
Notes: Visual inspection of removal item following removal

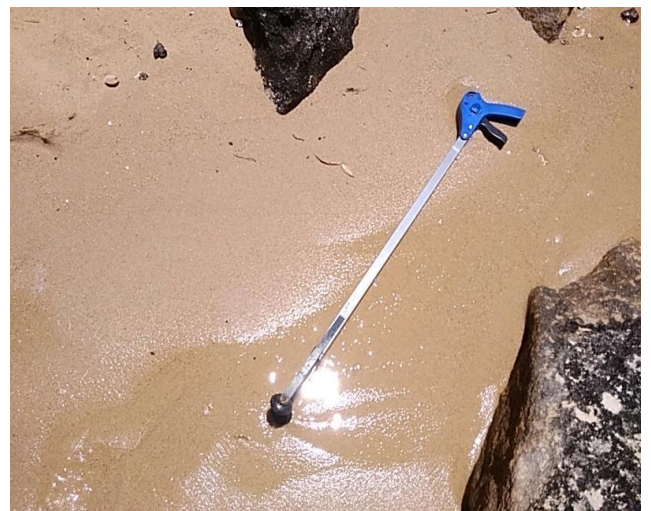
Notes: Visual inspection of removal item following removal z

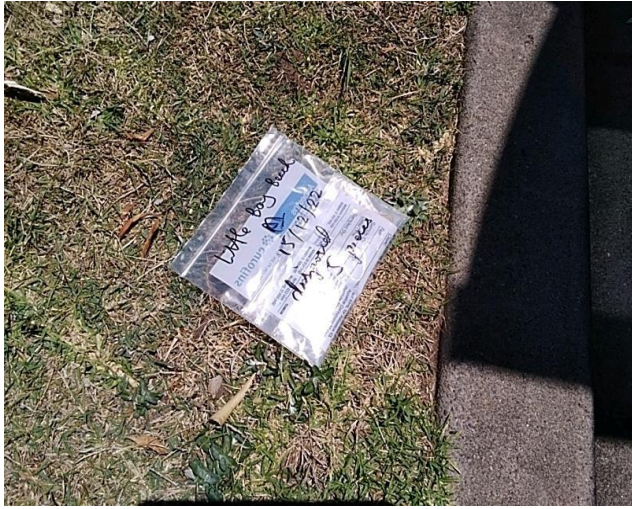
Notes: Waste disposal management (disposed 5 pieces)
