Asbestos Containing Material Clearance Inspection

9 January 2023

Site:	Little Bay Beach
Location:	Southern, Western and Northern Little Bay Beach

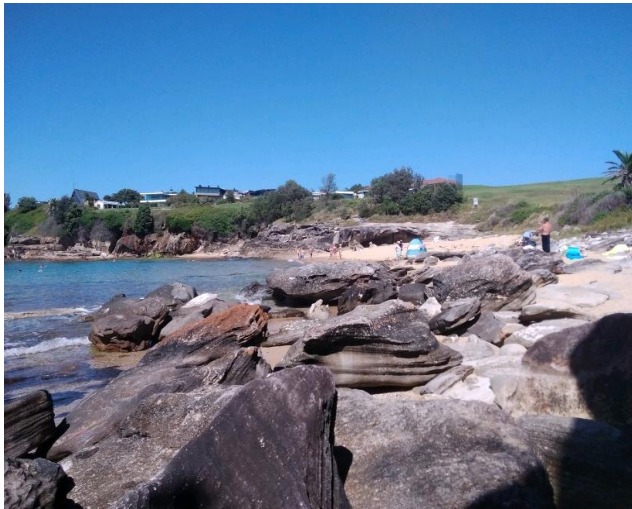
Notes: Overview of Northern beach

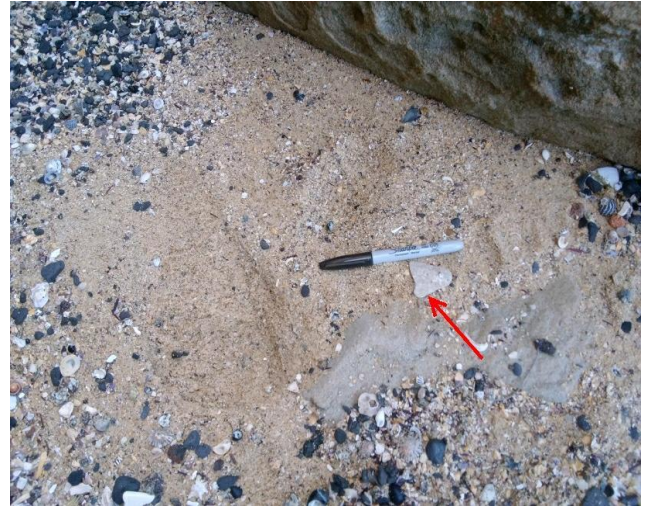
Notes: Overview of the ACM fragment prior to the removal within Northern beach.

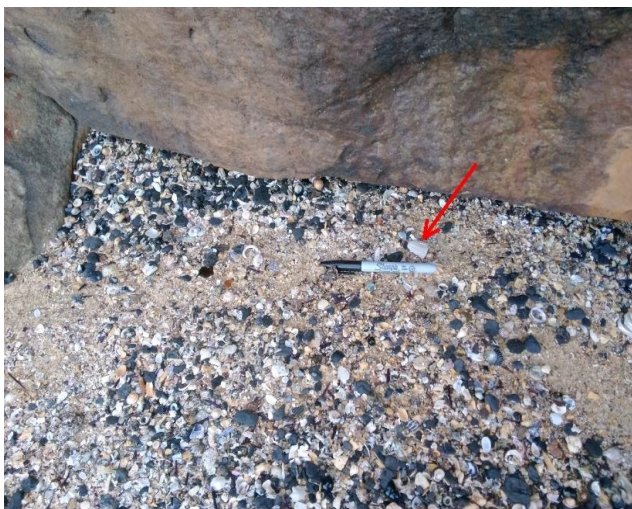
Notes: Overview of the ACM fragment prior to the removal within Northern beach.

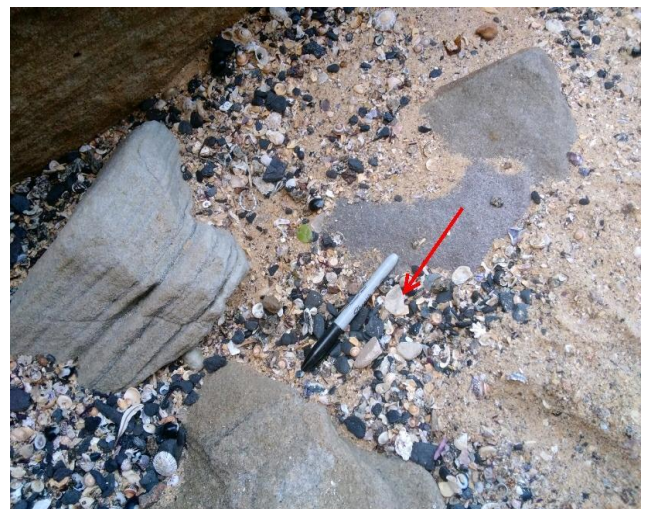
Notes: Overview of the ACM fragment prior to the removal within Northern beach.

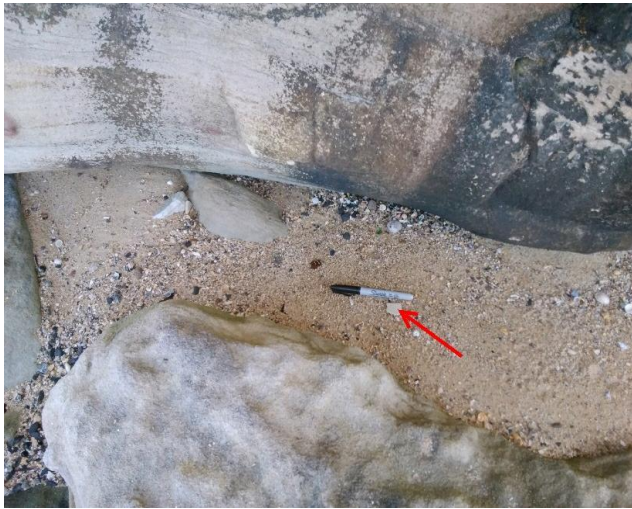
Notes: Overview of the ACM fragment prior to the removal within Northern beach.

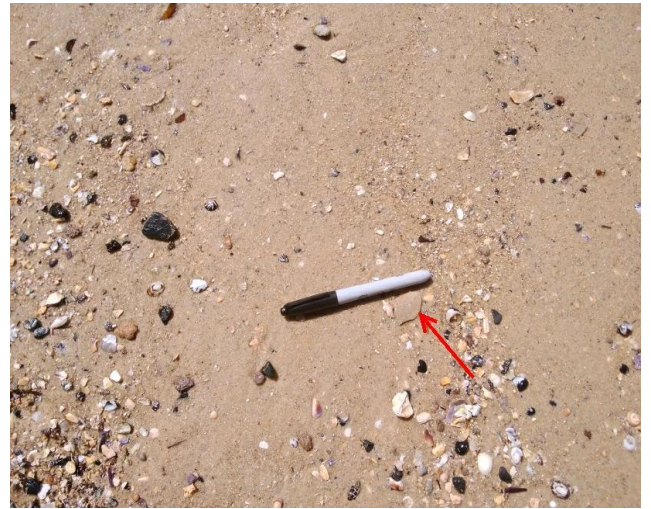
Notes: Overview of the ACM fragment prior to the removal within Northern beach.

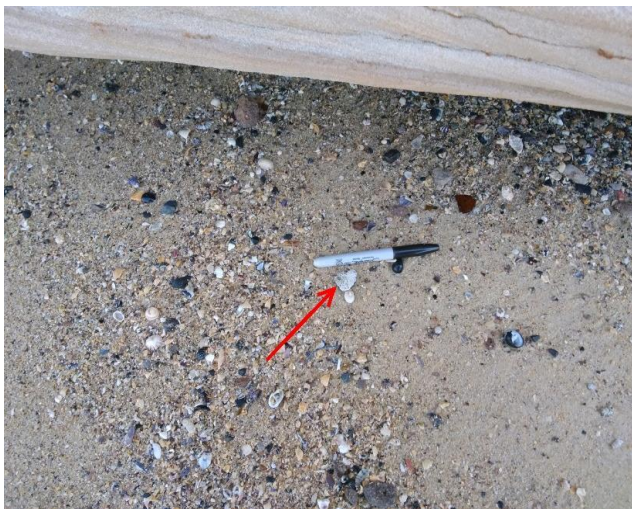
Notes: Overview of the ACM fragment prior to the removal within Northern beach.

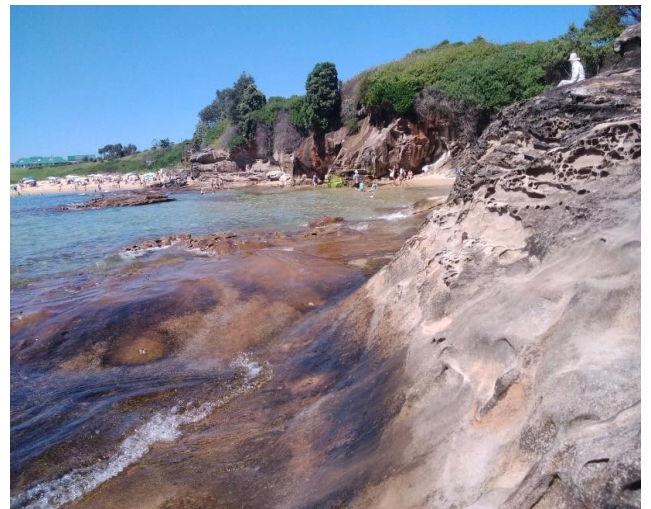
Notes: Overview of Western Beach

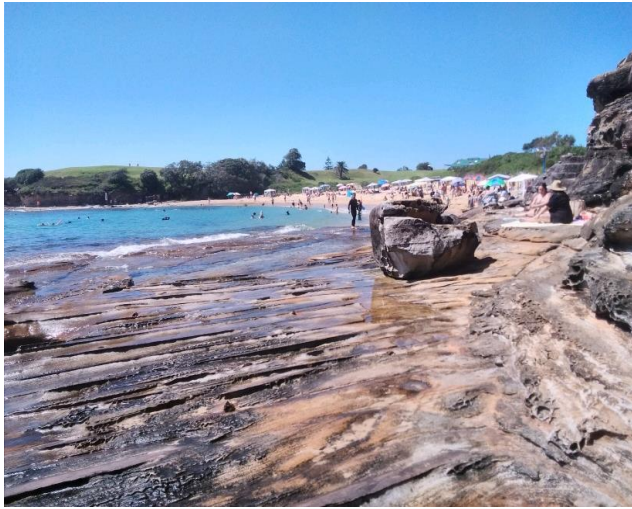
Notes: Overview of Southern Beach

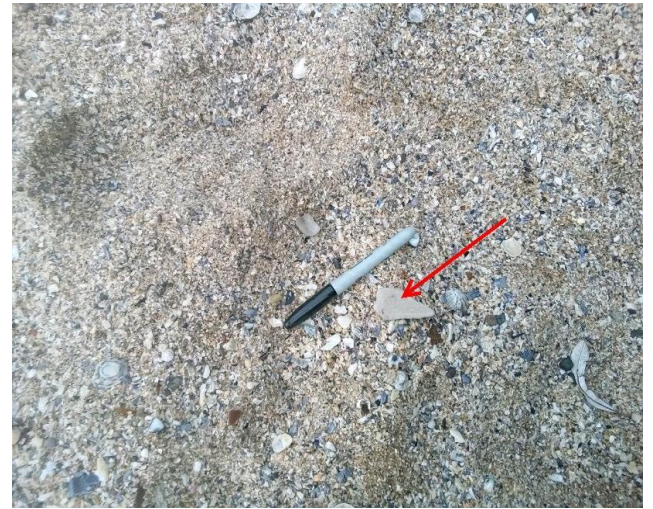
Notes: Overview of the ACM fragment prior to the removal within Southern beach.

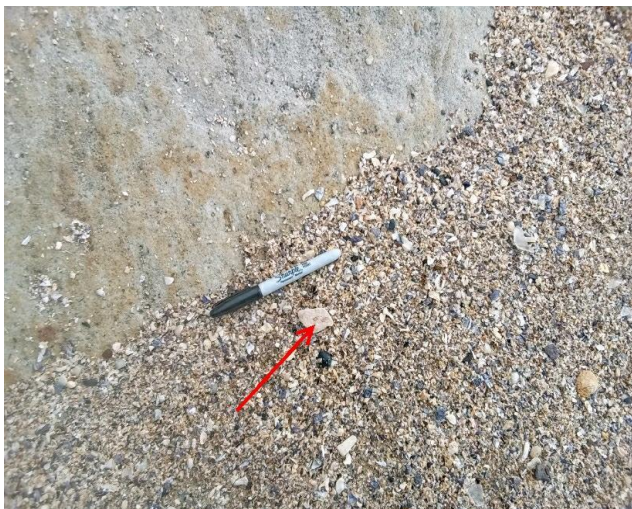
Notes: Overview of the ACM fragment prior to the removal within Southern beach.

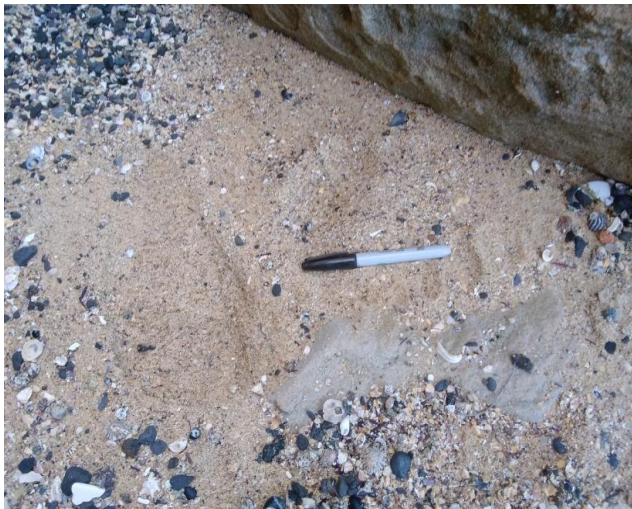
Notes: Visual surface clearance inspection following removal of ACM fragment.

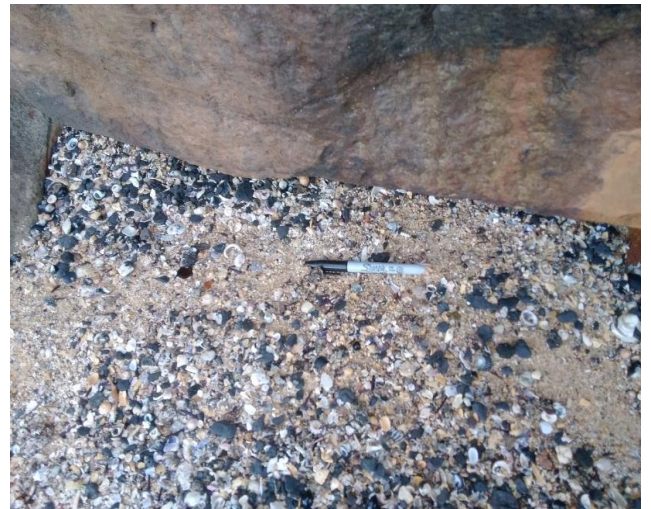
Notes: Visual surface clearance inspection following removal of ACM fragment.

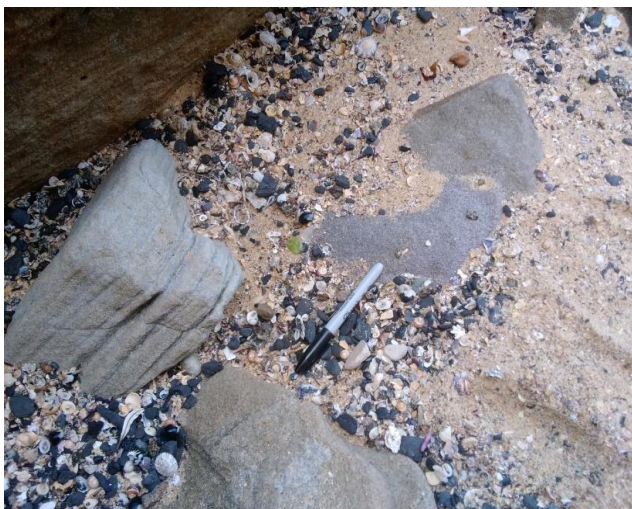
Notes: Visual surface clearance inspection following removal of ACM fragment.

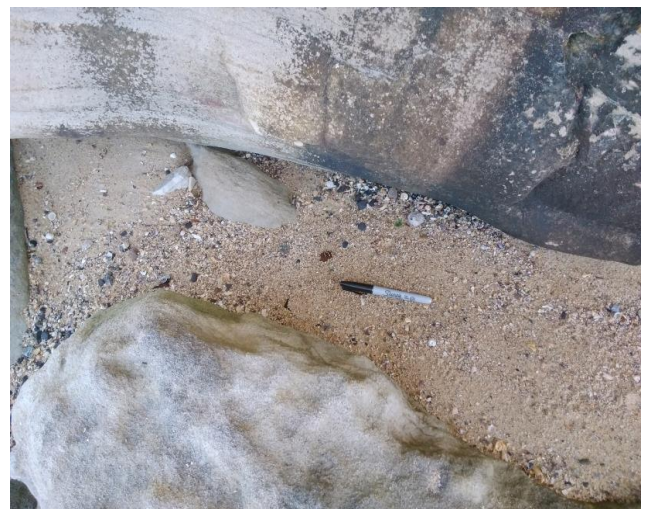
Notes: Visual surface clearance inspection following removal of ACM fragment.

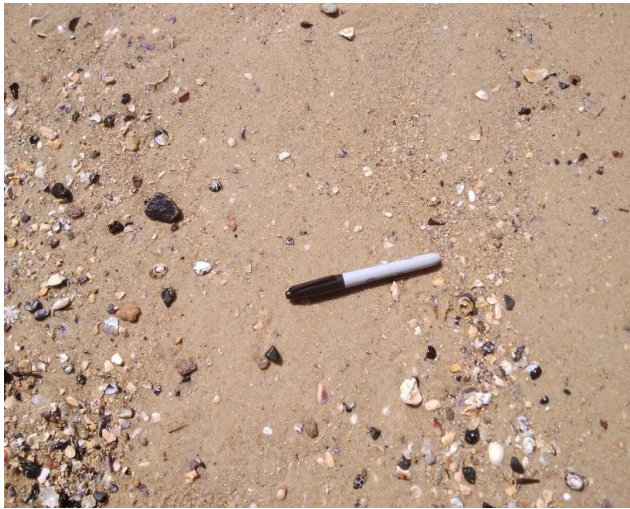
Notes: Visual surface clearance inspection following removal of ACM fragment.

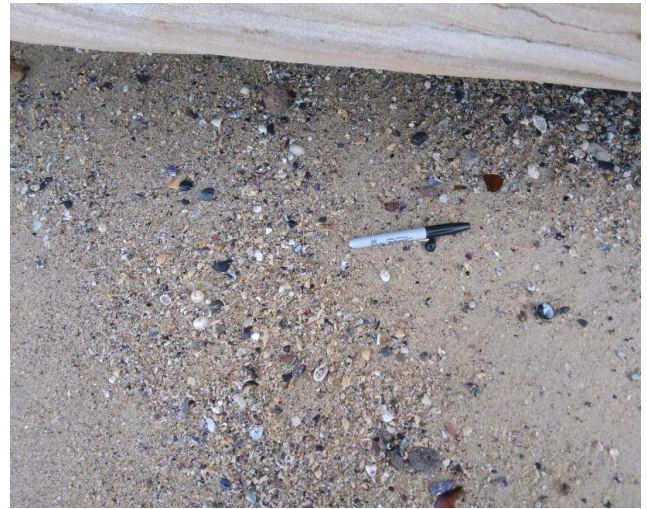
Notes: Visual surface clearance inspection following removal of ACM fragment.

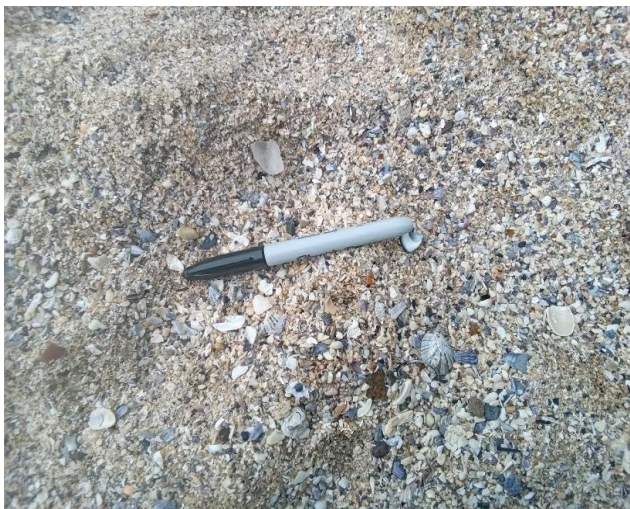
Notes: Visual surface clearance inspection following removal of ACM fragment.

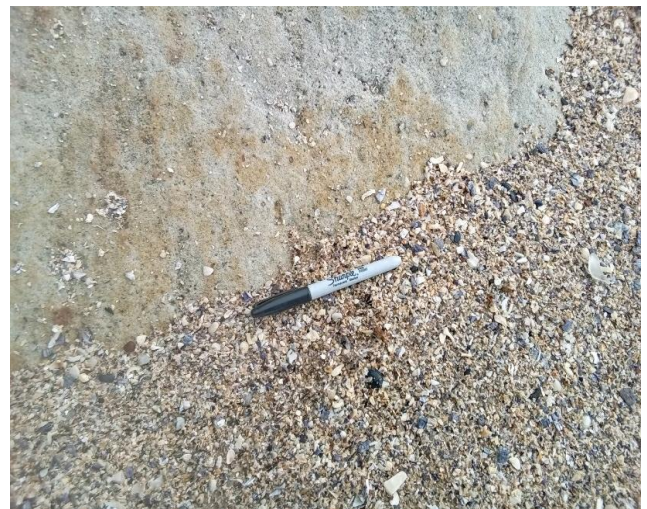
Notes: Visual surface clearance inspection following removal of ACM fragment.
