# Asbestos Containing Material Clearance Inspection

25 March 2023

<b>Site:</b>	Little Bay Beach
<b>Location:</b>	Southern, Western and Northern Little Bay Beach

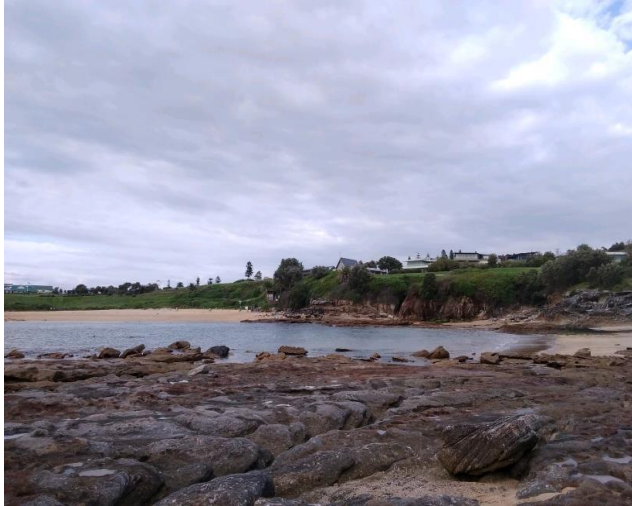
**Notes:** Overview of the Beach prior to removal works

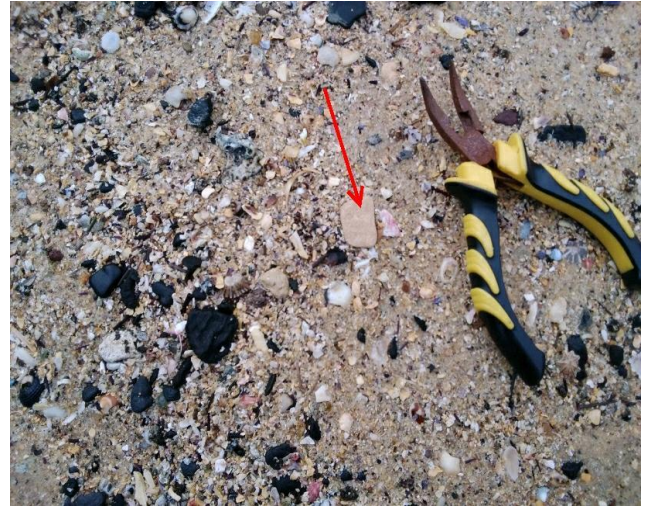
**Notes:** FC fragment identified on sand surface prior to emu pick - Northern section

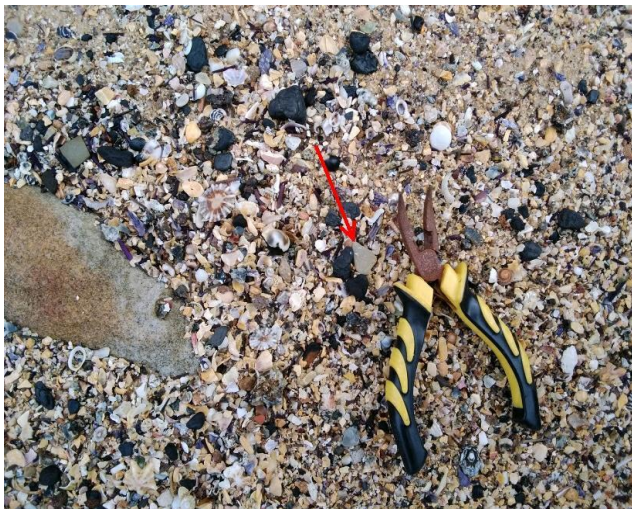
**Notes:** FC fragment identified on sand surface prior to emu pick - Northern section

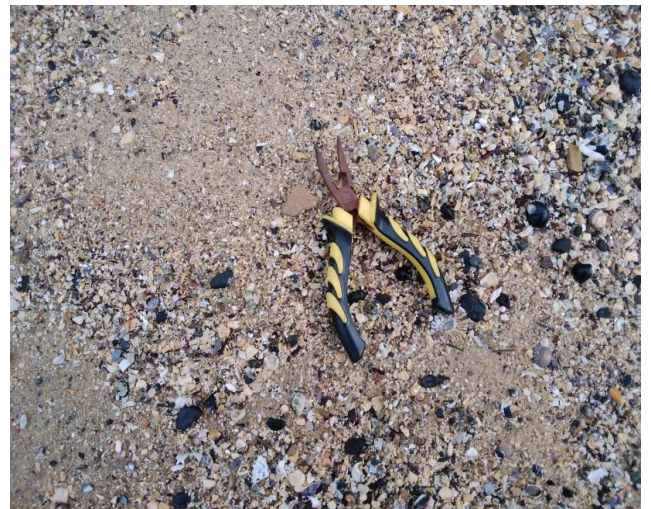
**Notes:** FC fragment identified on sand surface prior to emu pick - Northern section

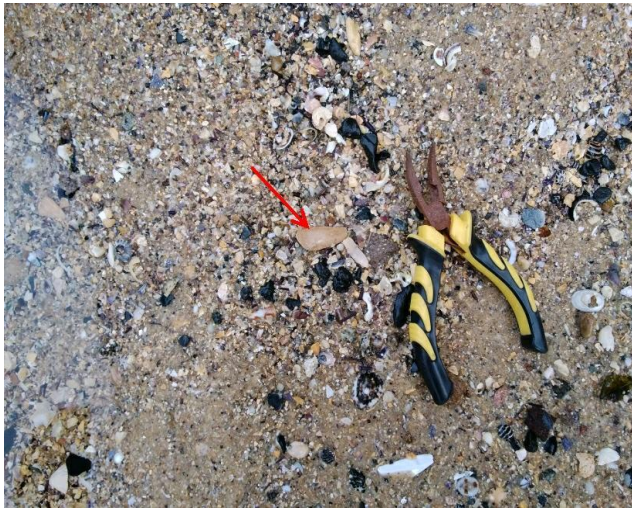
**Notes:** FC fragment identified on sand surface prior to emu pick - Northern section

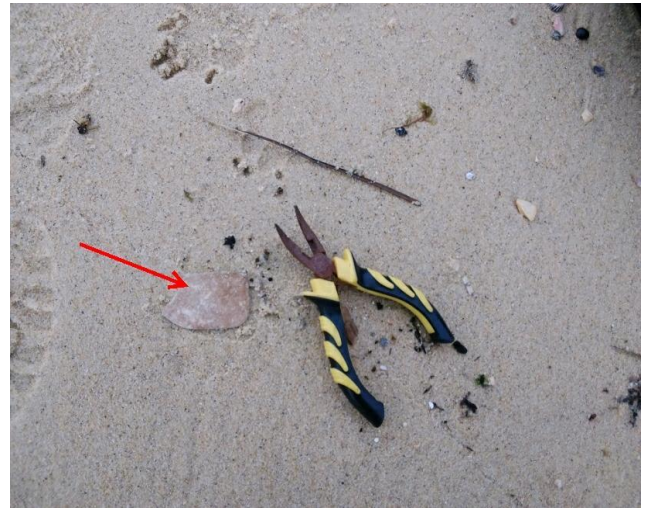
**Notes:** FC fragment identified on sand surface prior to emu pick - Northern section

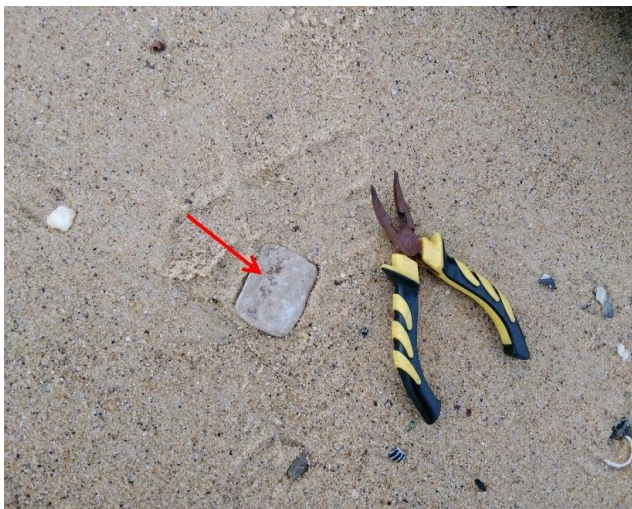
**Notes:** FC fragment identified on sand surface prior to emu pick - Northern section

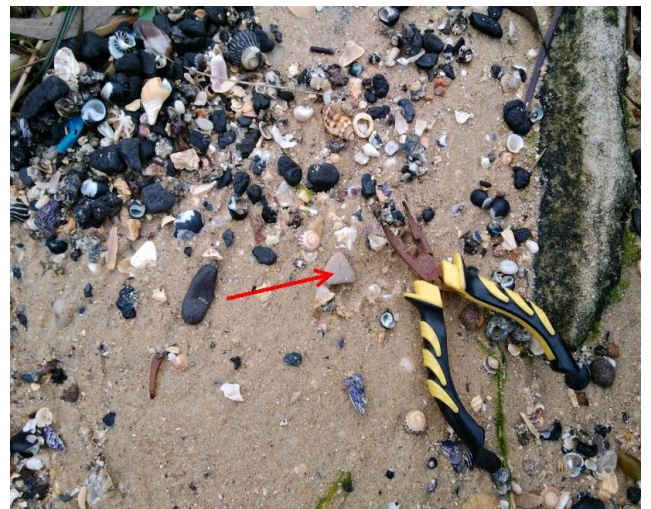
**Notes:** FC fragment identified on sand surface prior to emu pick - Northern section

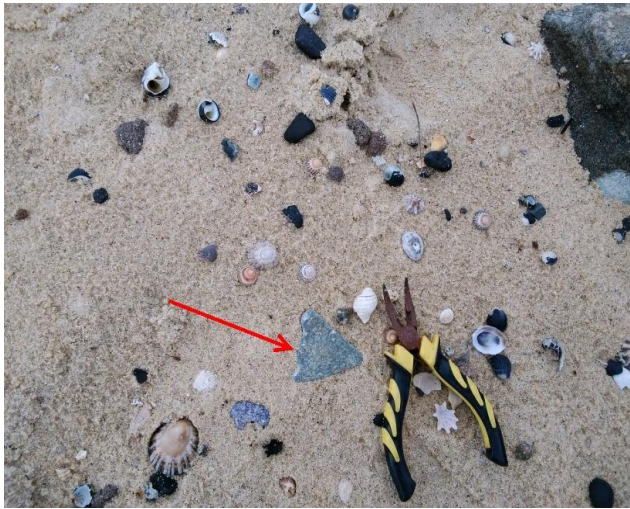
**Notes:** FC fragment identified on sand surface prior to emu pick - Northern section

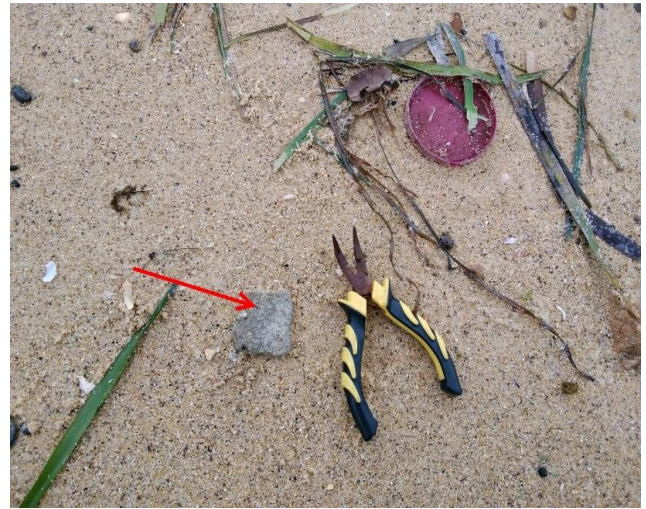
**Notes:** FC fragment identified on sand surface prior to emu pick - Western section

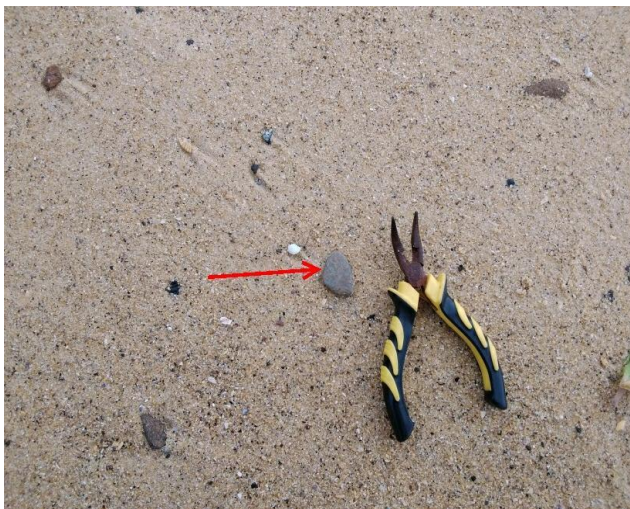
**Notes:** FC fragment identified on sand surface prior to emu pick - Western section

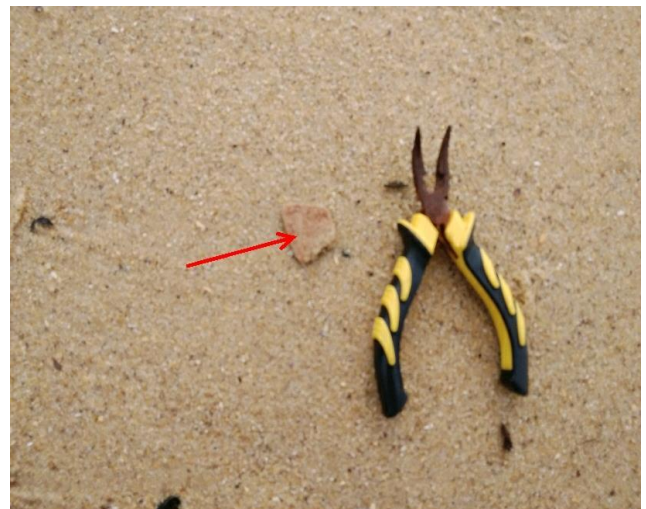
**Notes:** FC fragment identified on sand surface prior to emu pick - Western section

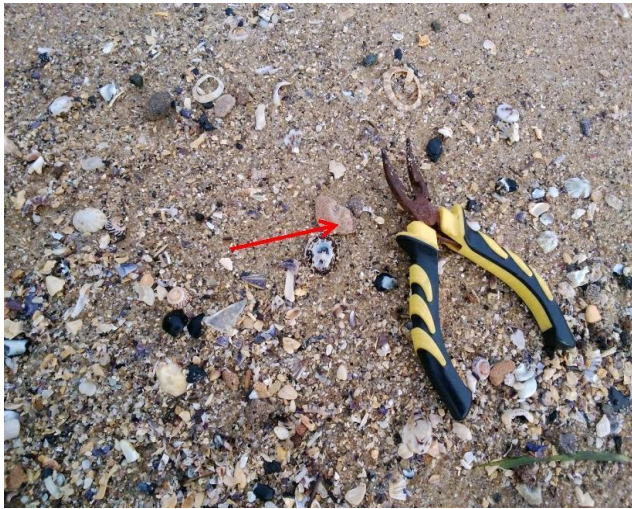
**Notes:** FC fragment identified on sand surface prior to emu pick - Western section

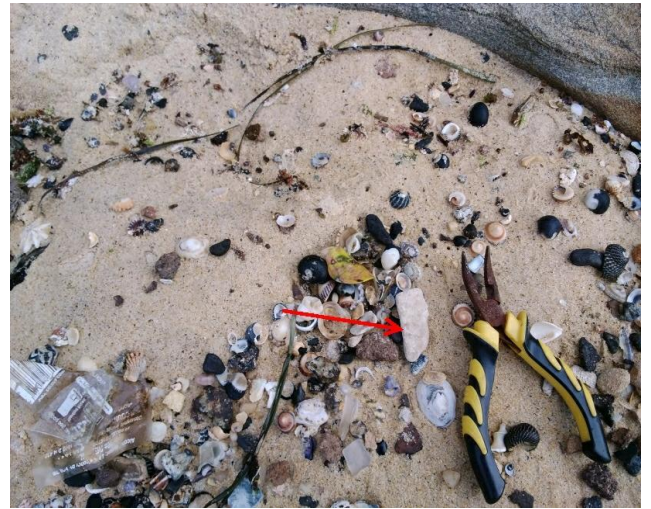
**Notes:** FC fragment identified on sand surface prior to emu pick - Southern section

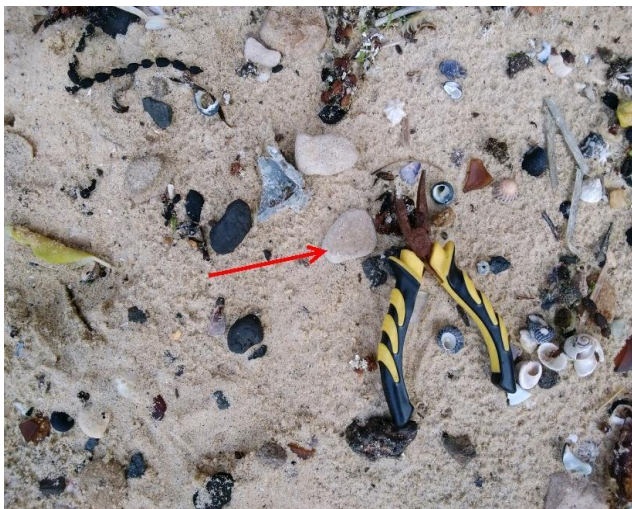
**Notes:** FC fragment identified on sand surface prior to emu pick - Southern section

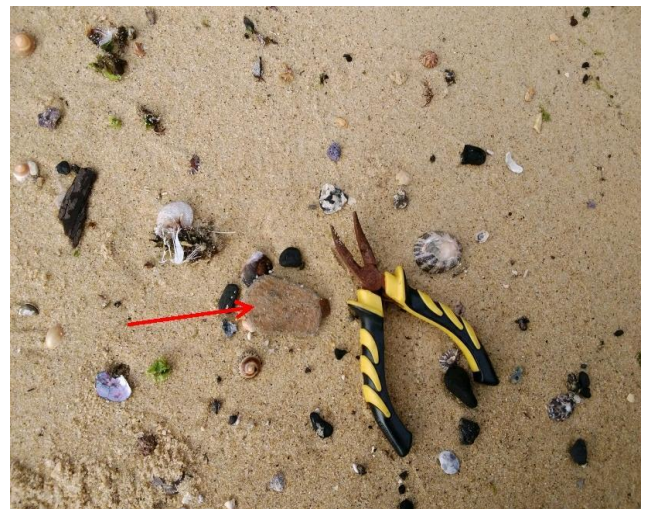
**Notes:** FC fragment identified on sand surface prior to emu pick - Southern section

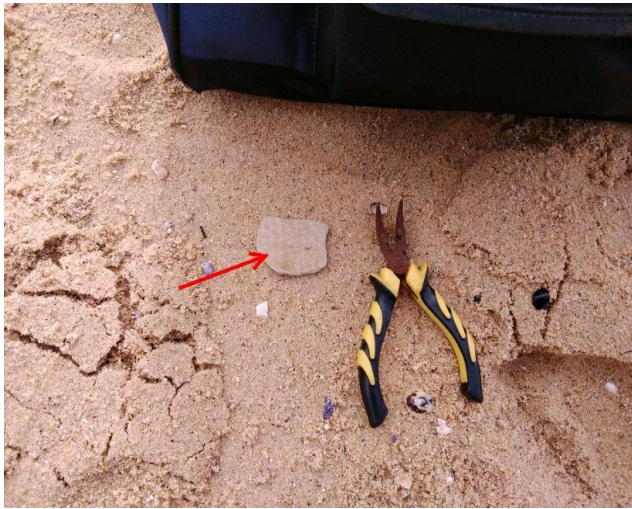
**Notes:** FC fragment identified on sand surface prior to emu pick - Southern section

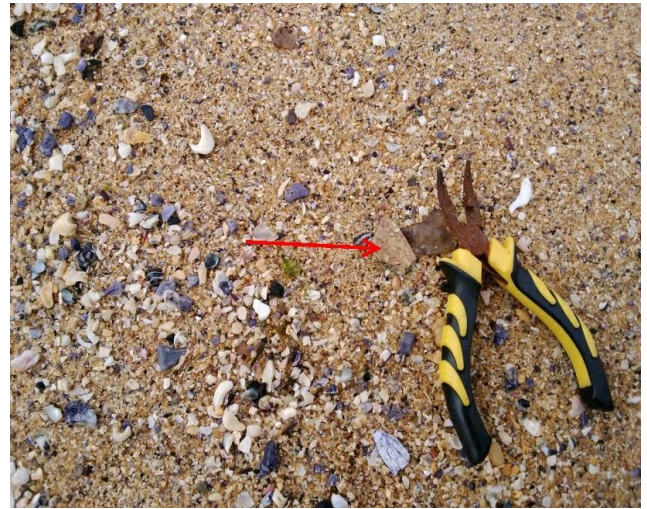
**Notes:** FC fragment identified on sand surface prior to emu pick - Southern section

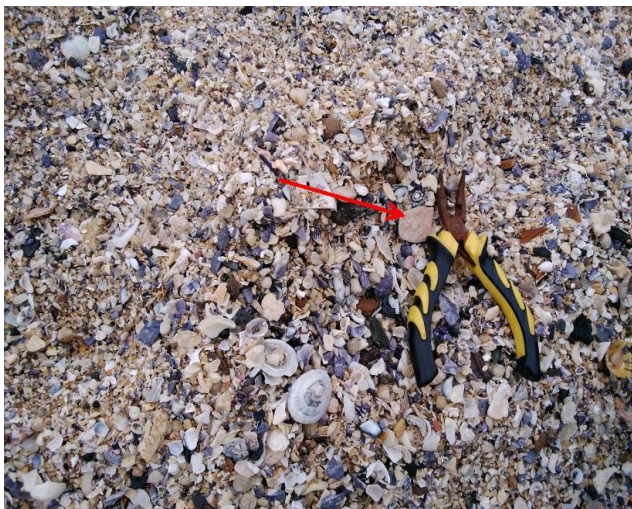
**Notes:** FC fragment identified on sand surface prior to emu pick - Southern section

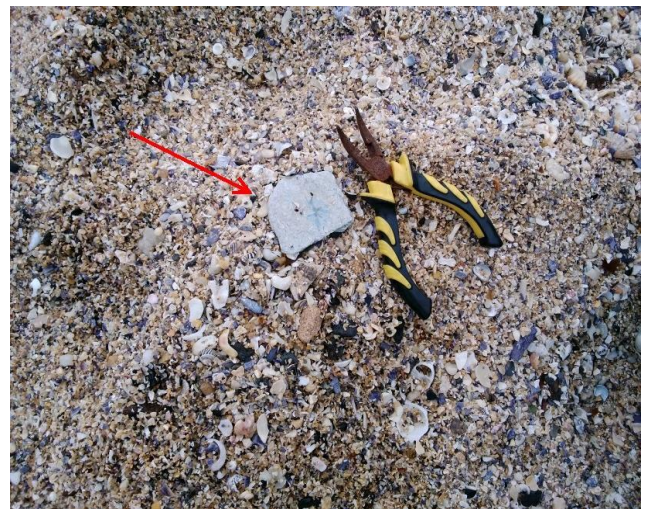
**Notes:** FC fragment identified on sand surface prior to emu pick - Southern section

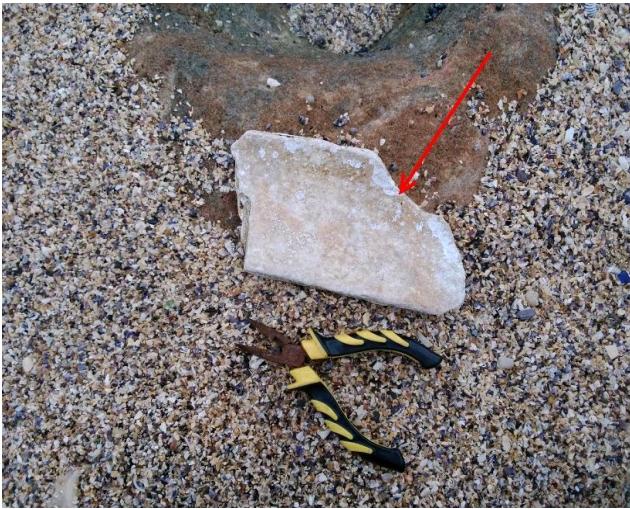
**Notes:** FC fragment identified on sand surface prior to emu pick - Southern section

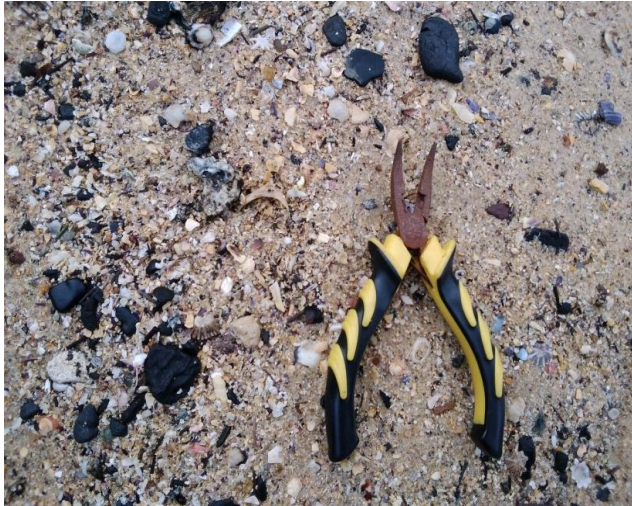
**Notes:** Sand surface following emu pick - Northern section

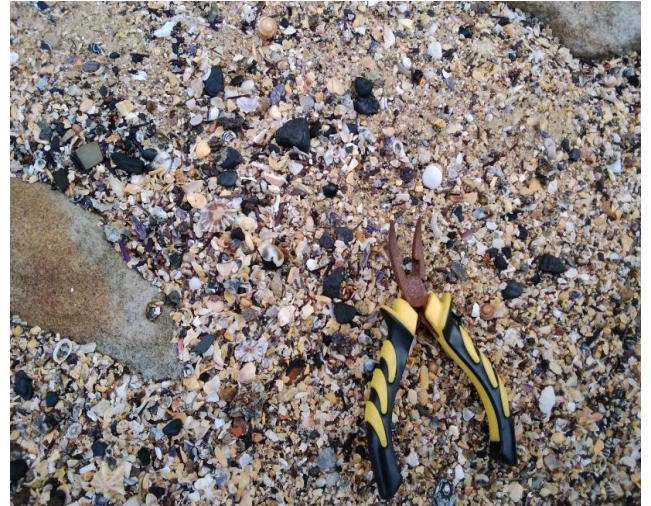
**Notes:** Sand surface following emu pick - Northern section

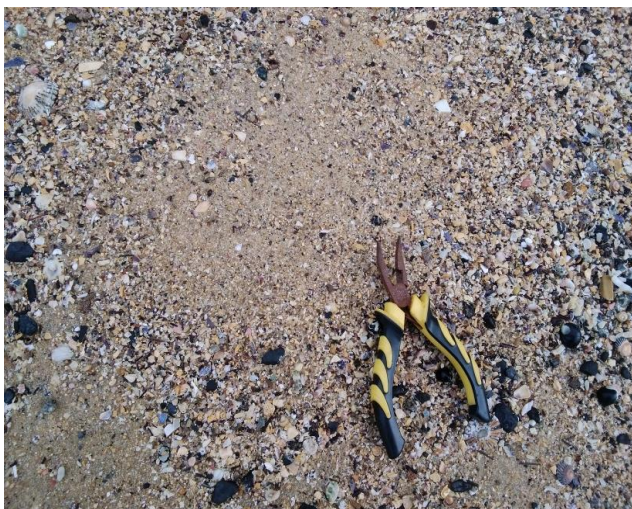
**Notes:** Sand surface following emu pick - Northern section

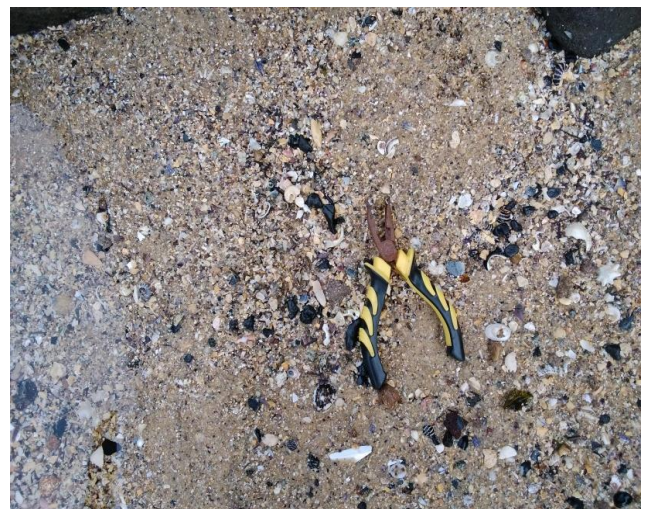
**Notes:** Sand surface following emu pick - Northern section

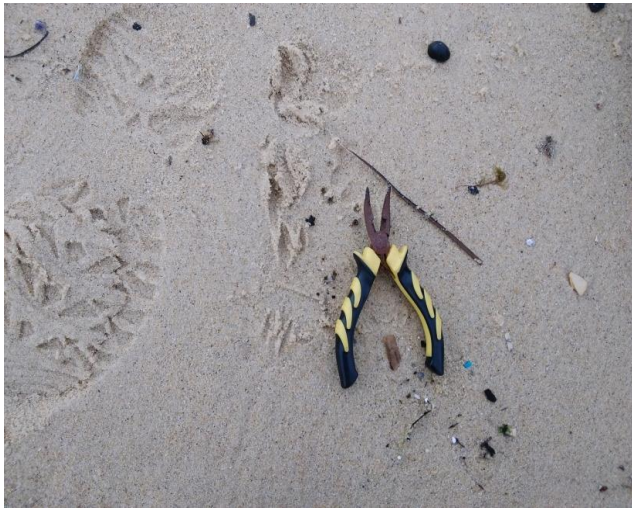
**Notes:** Sand surface following emu pick - Northern section

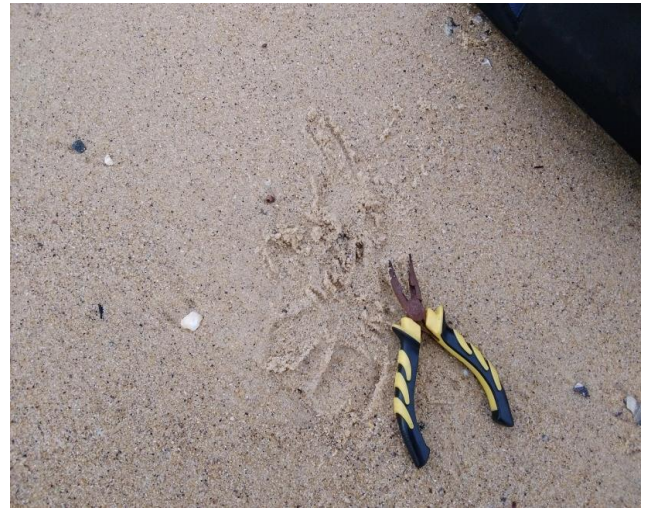
**Notes:** Sand surface following emu pick - Northern section

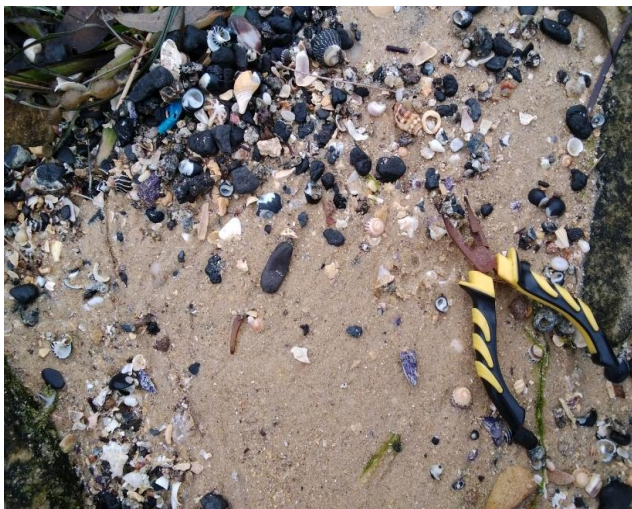
**Notes:** Sand surface following emu pick - Northern section

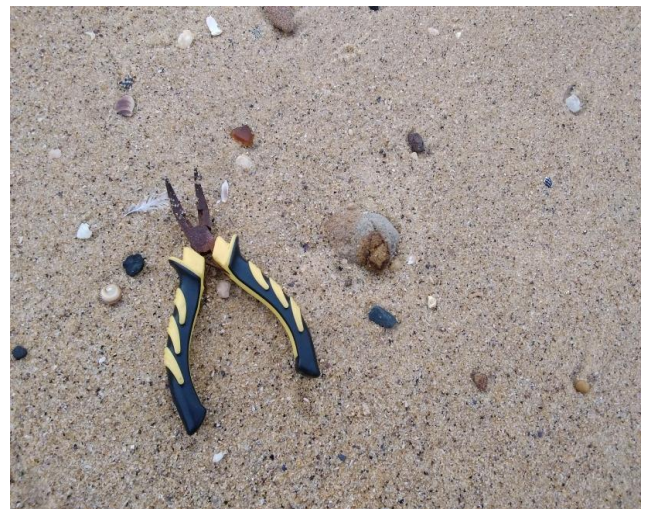
**Notes:** Sand surface following emu pick - Northern section

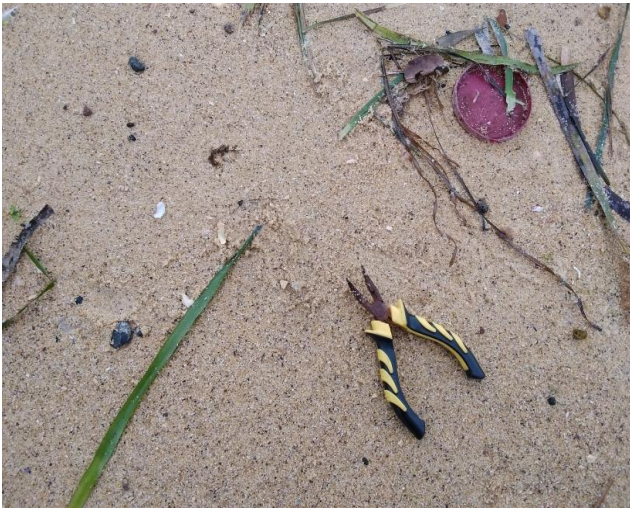
**Notes:** Sand surface following emu pick - Western section

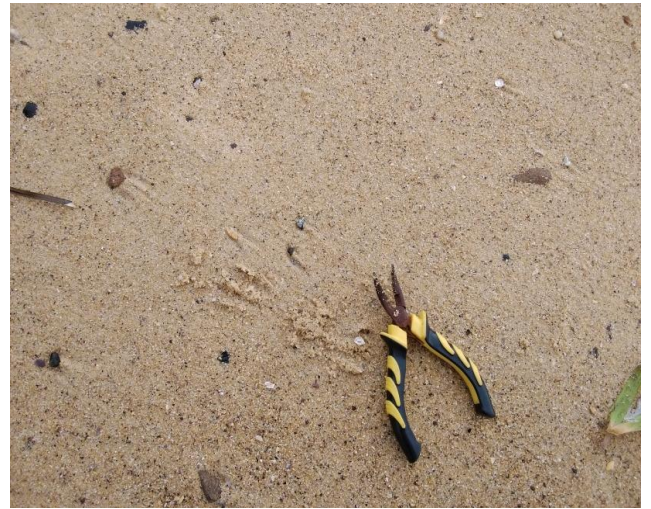
**Notes:** Sand surface following emu pick - Western section

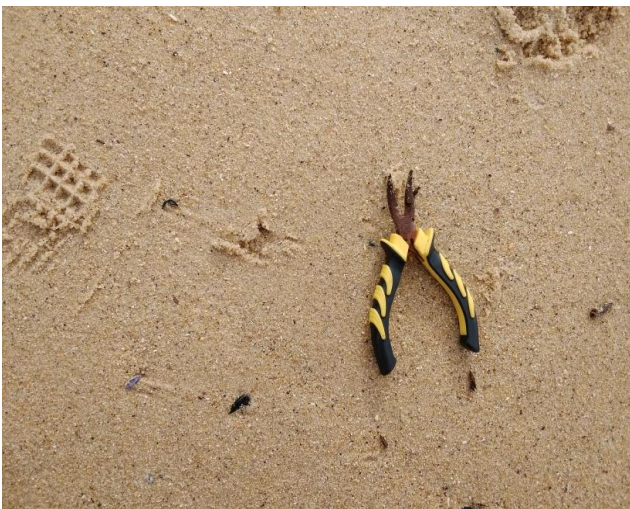
**Notes:** Sand surface following emu pick - Western section

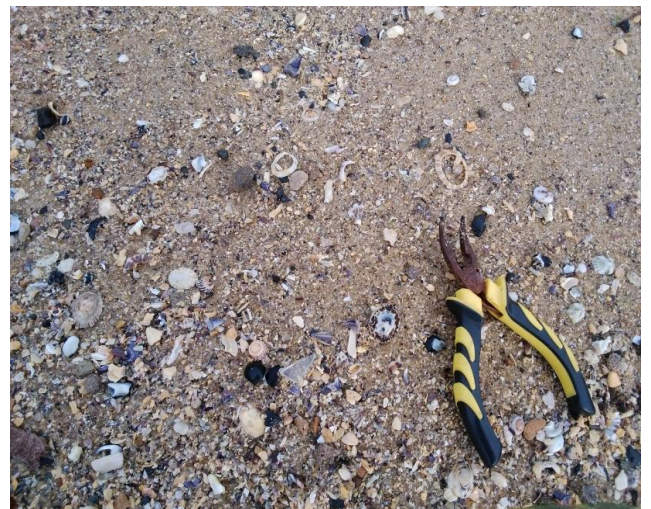
**Notes:** Sand surface following emu pick - Western section

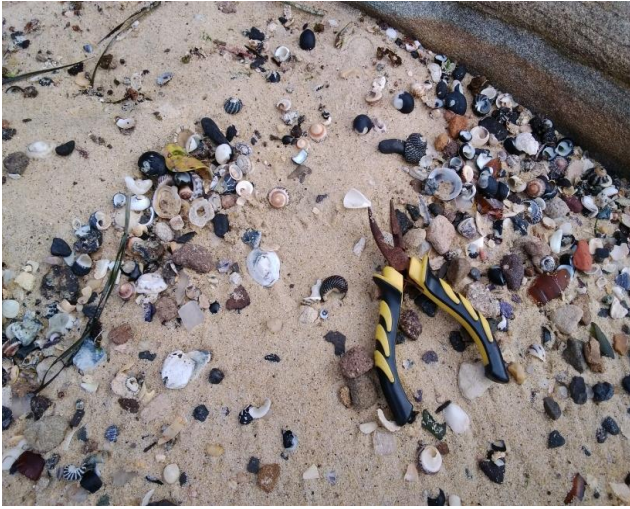
**Notes:** Sand surface following emu pick - Southern section

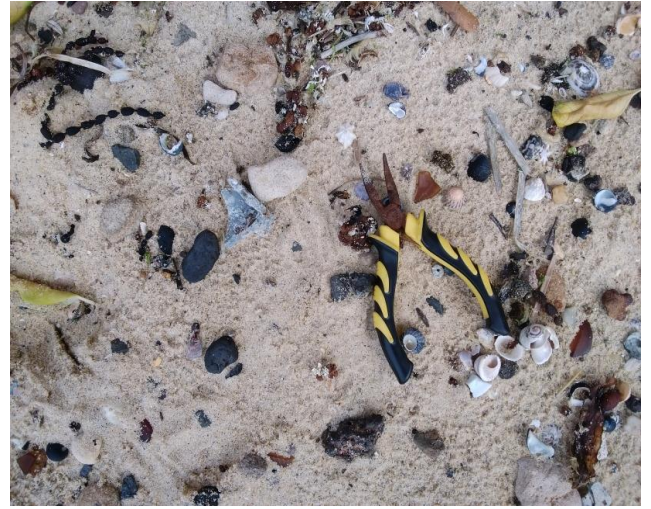
**Notes:** Sand surface following emu pick - Southern section

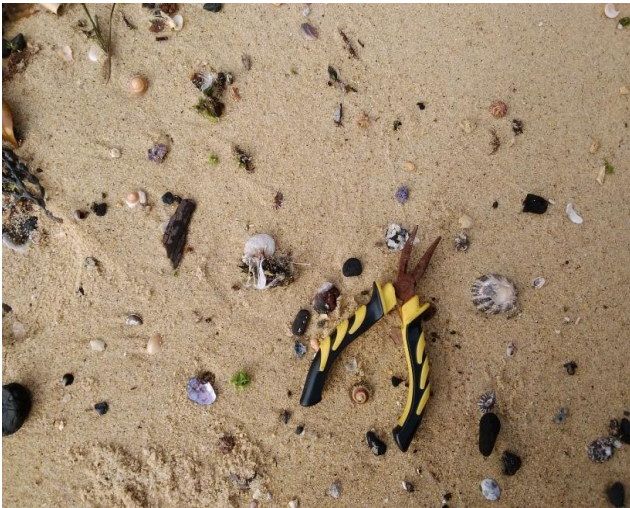
**Notes:** Sand surface following emu pick - Southern section

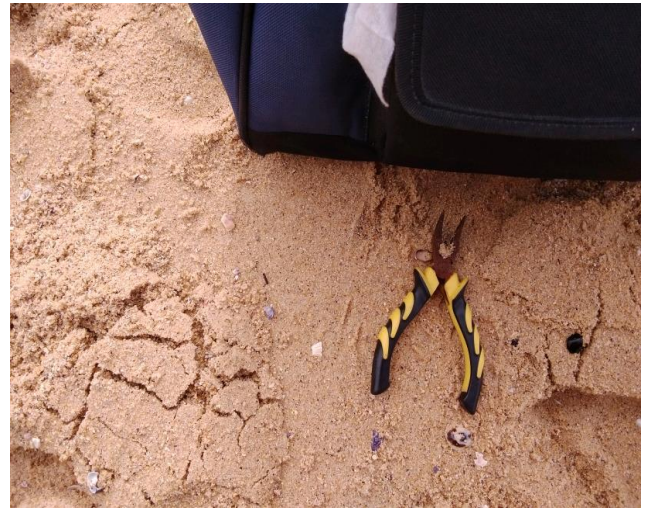
**Notes:** Sand surface following emu pick - Southern section

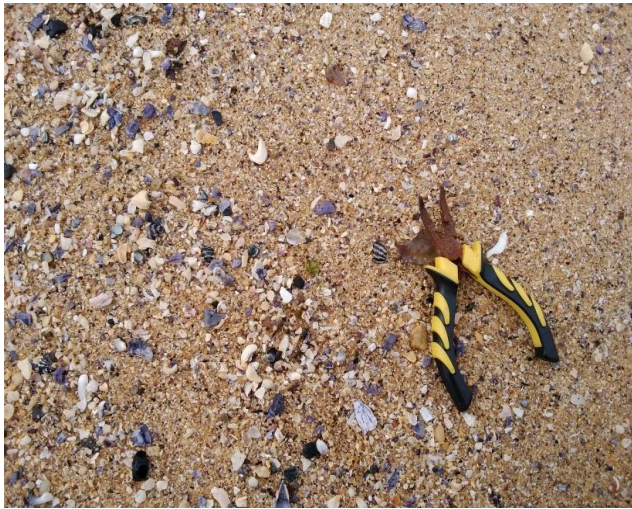
**Notes:** Sand surface following emu pick - Southern section

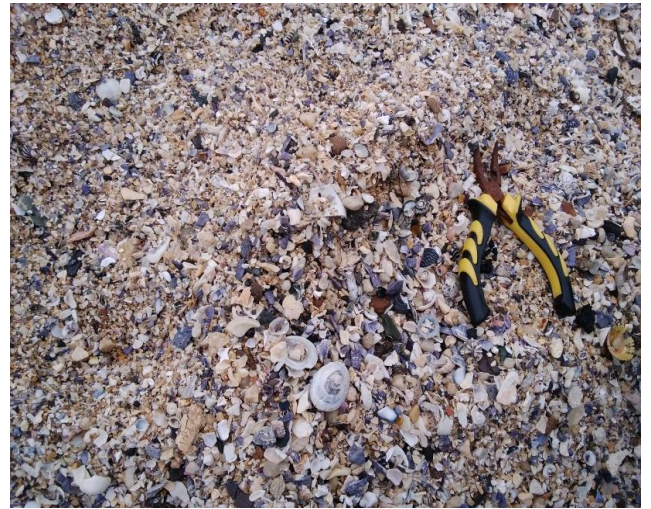
**Notes:** Sand surface following emu pick - Southern section

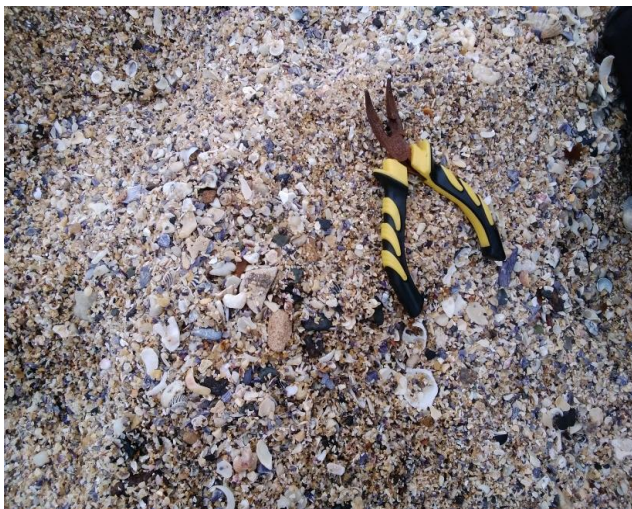
**Notes:** Sand surface following emu pick - Southern section

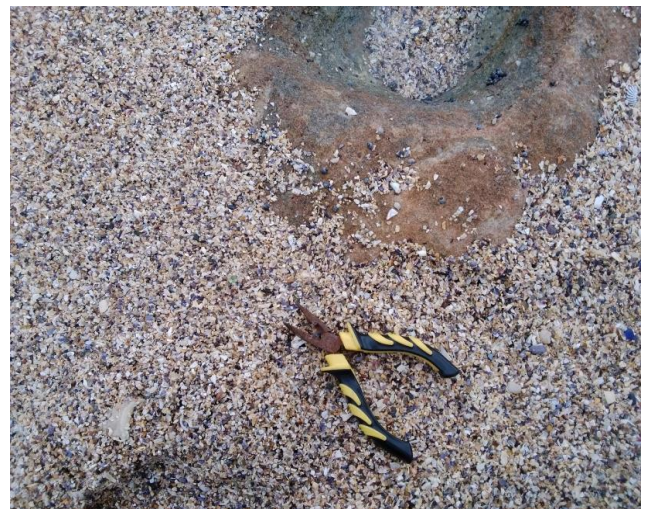
**Notes:** Sand surface following emu pick - Southern section
