RE: Asbestos Containing Material Clearance Inspection

Site:	Little Bay Beach		
Location:	Southern, Western and Northern Little Bay Beach

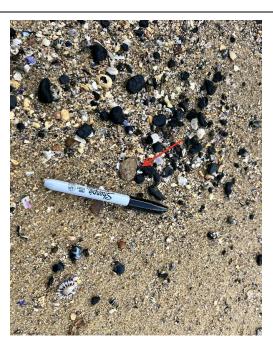
Notes: Overview of suspected FC Sheeting fragment within Northern Beach.

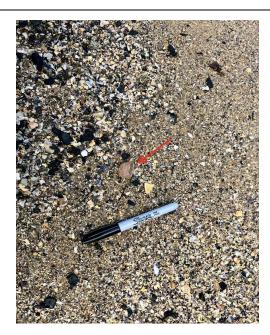
Notes: Overview of suspected FC Sheeting fragment within Northern Beach.

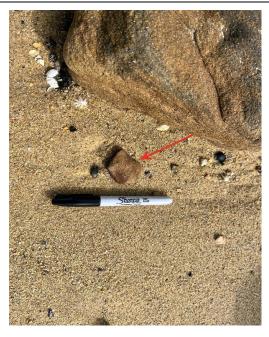
Notes: Overview of suspected FC Sheeting fragment within Northern Beach.

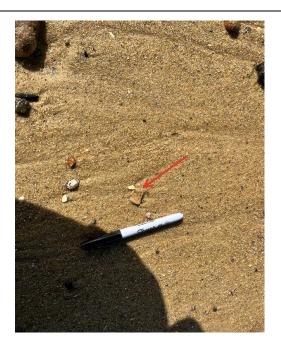
Notes: Overview of suspected FC Sheeting fragment within Western Beach.

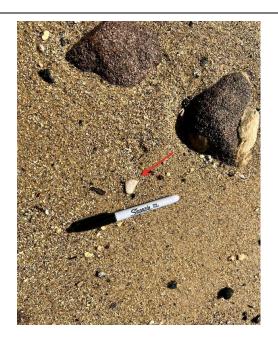
Notes: Overview of suspected FC Sheeting fragment within Western Beach.

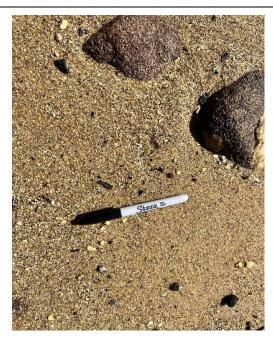
Notes: Visual surface clearance inspection following emu picking of suspected FC Sheeting fragment within Western Beach.

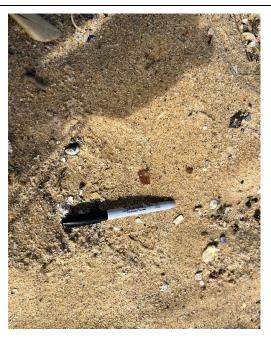
Notes: Visual surface clearance inspection following emu picking of suspected FC Sheeting fragment within Western Beach.
