Asbestos Containing Material Clearance Inspection

2 June 2023

Site:	Little Bay Beach
Location:	Southern, Western and Northern Little Bay Beach

Requested by:	
Name	Ryan Zammit
Contact	90936744
Email	ryan.zammit@randwick.nsw.gov.au
Site Details:	
Address	2 Coast Hospital Rd, Little Bay NSW 2036
Local Government Area	Randwick City Council

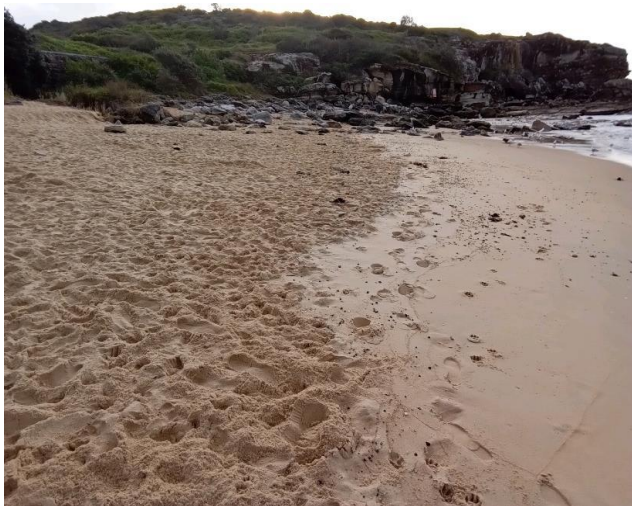
Notes: Overview of the Northern Beach prior to the emu picking of suspected asbestos containing FC fragments.

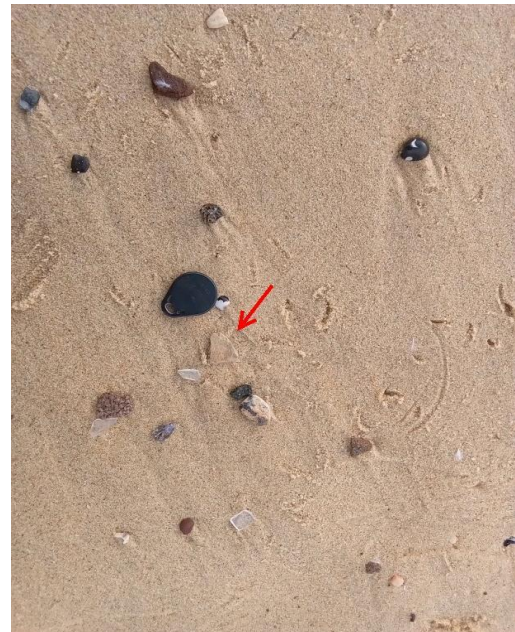
Notes: Overview of the FC fragment prior to the emu picking within Northern Beach.

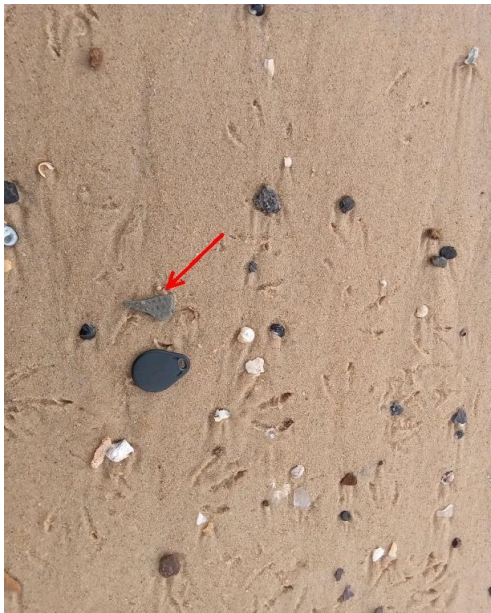
Notes: Overview of the FC fragment prior to the emu picking within Northern Beach.

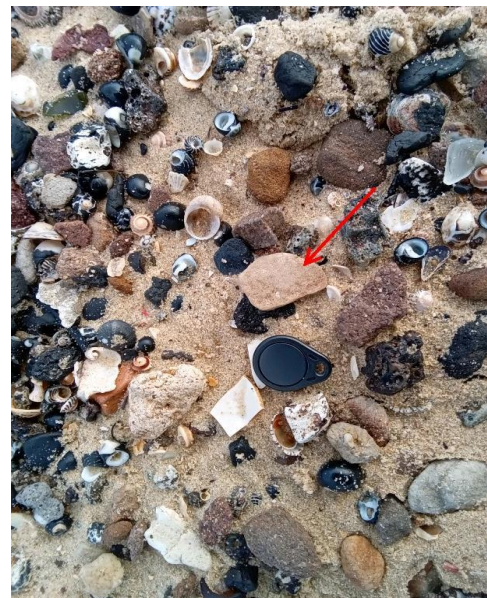
Notes: Overview of the FC fragment prior to the emu picking within Northern Beach.

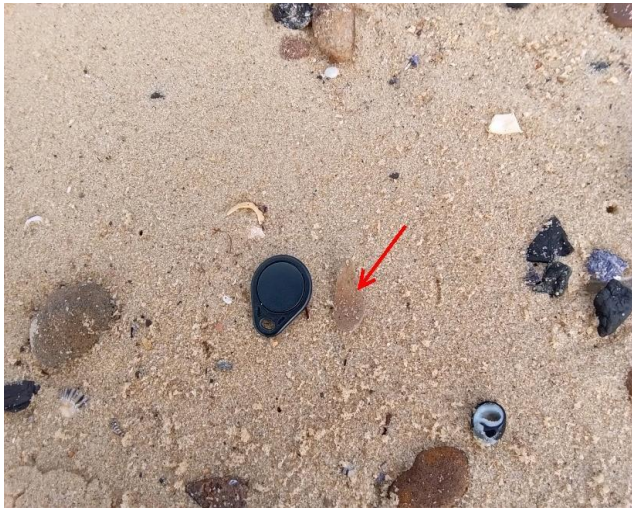
Notes: Overview of the FC fragment prior to the emu picking within Northern Beach.

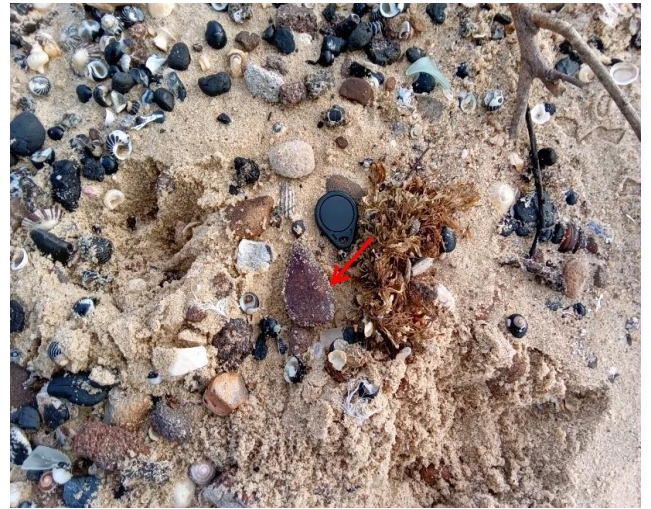
Notes: Overview of the FC fragment prior to the emu picking within Northern Beach.

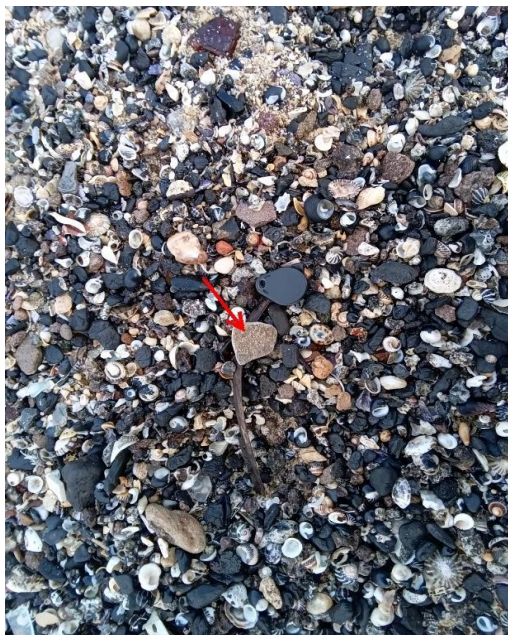
Notes: Overview of the FC fragment prior to the emu picking within Northern Beach.

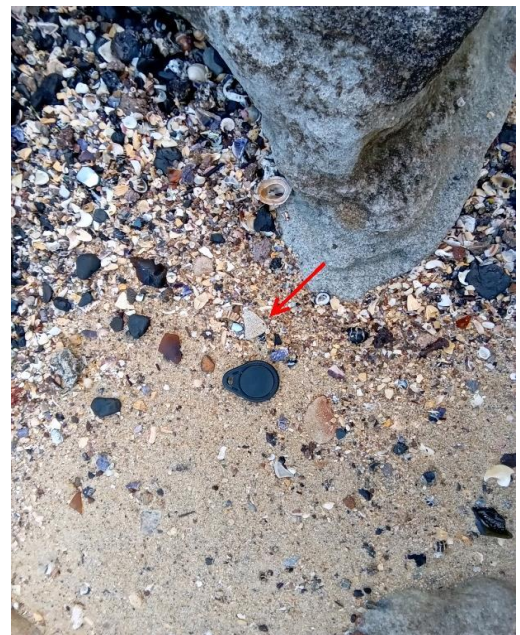
Notes: Overview of the FC fragment prior to the emu picking within Northern Beach.

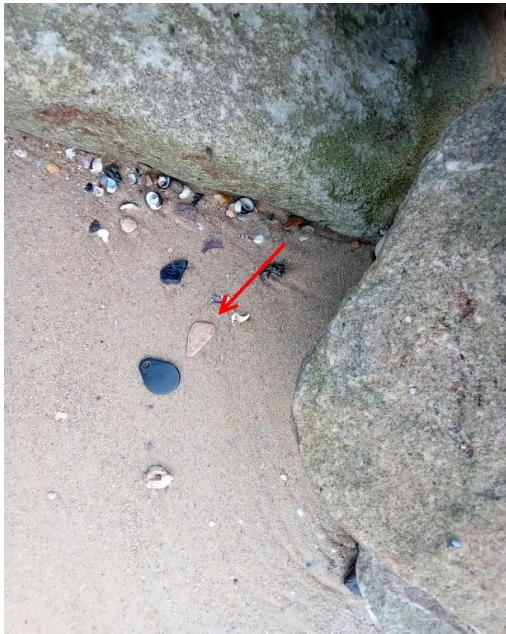
Notes: Overview of the FC fragment prior to the emu picking within Northern Beach.

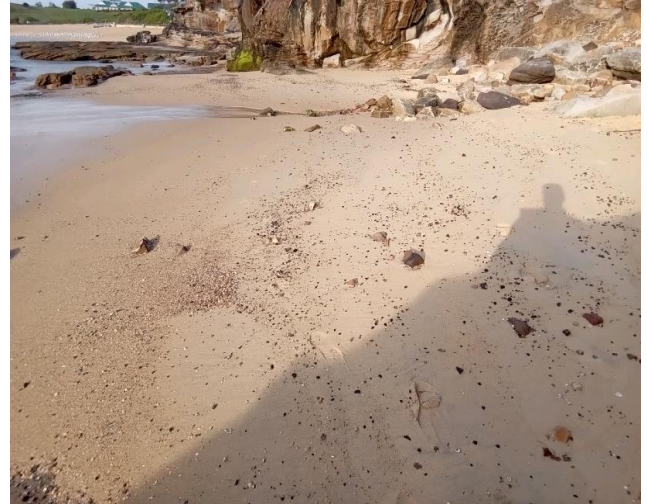
Notes: Overview of the Western Beach prior to the emu picking of suspected asbestos containing FC fragments.

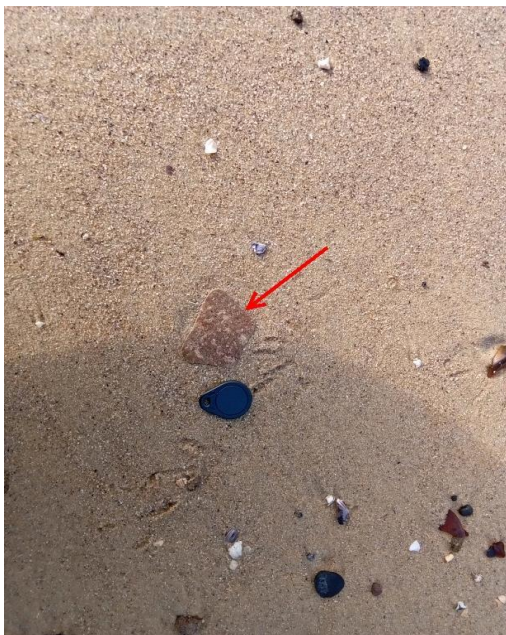
Notes: Overview of the FC fragment prior to the emu picking within Western Beach.

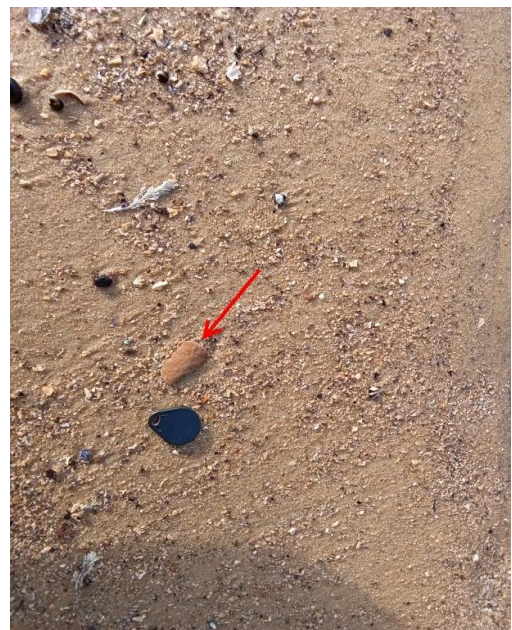
Notes: Overview of the FC fragment prior to the emu picking within Western Beach.

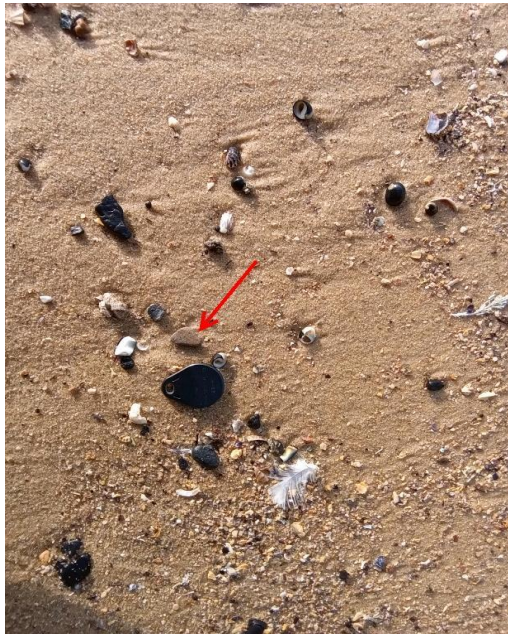
Notes: Overview of the FC fragment prior to the emu picking within Western Beach.

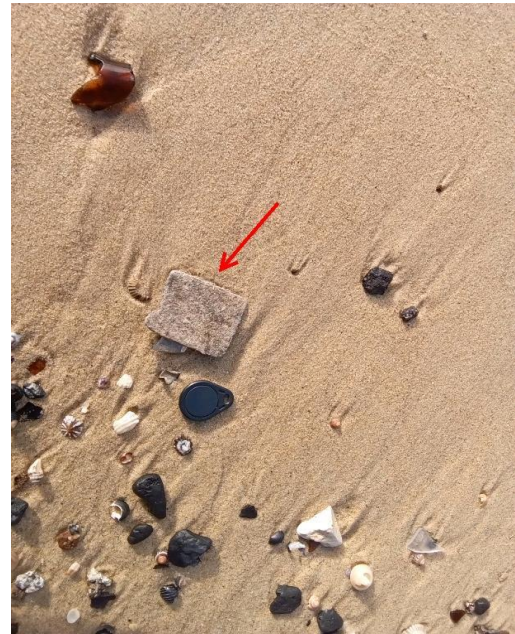
Notes: Overview of the FC fragment prior to the emu picking within Western Beach.

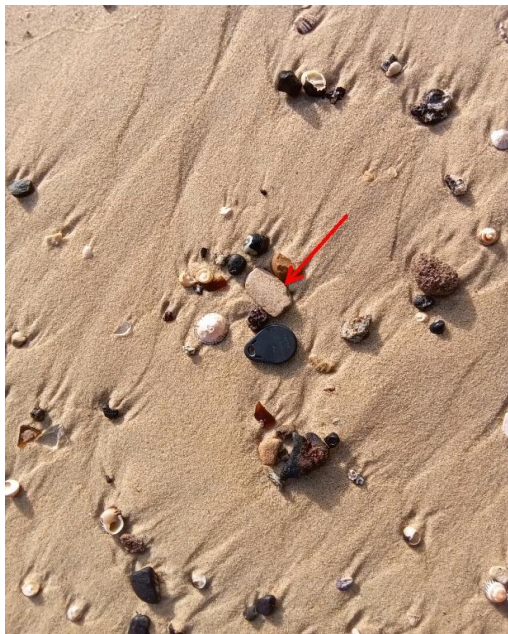
Notes: Overview of the FC fragment prior to the emu picking within Western Beach.

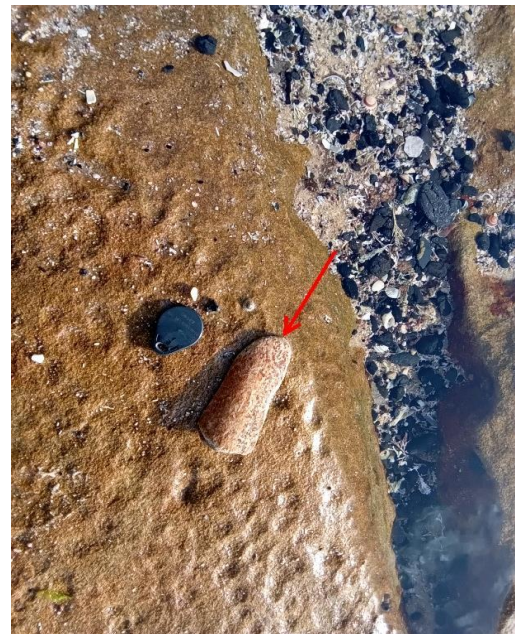
Notes: Overview of the FC fragment prior to the emu picking within Western Beach.

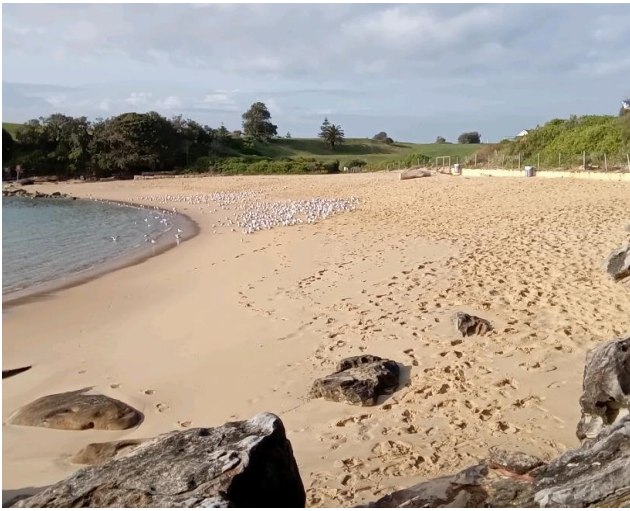
Notes: Overview of the Southern Beach prior to the emu picking of suspected asbestos containing FC fragments.

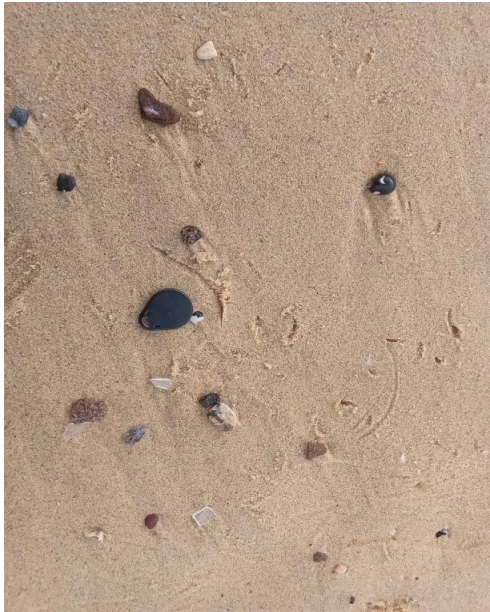
Notes: Visual surface clearance inspection following removal of suspected asbestos containing fragment.

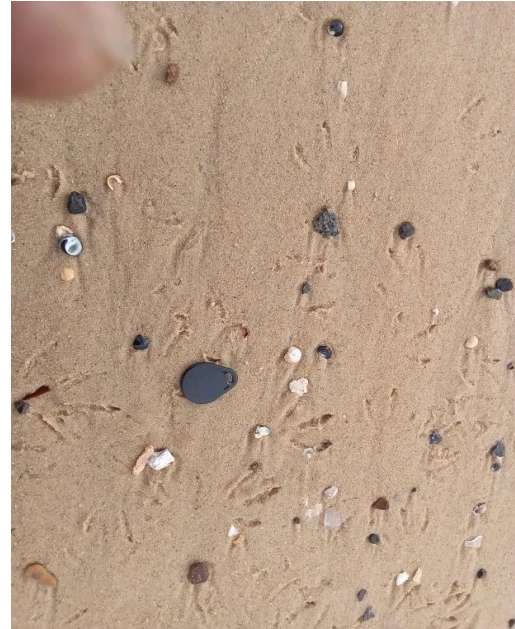
Notes: Visual surface clearance inspection following removal of suspected asbestos containing fragment

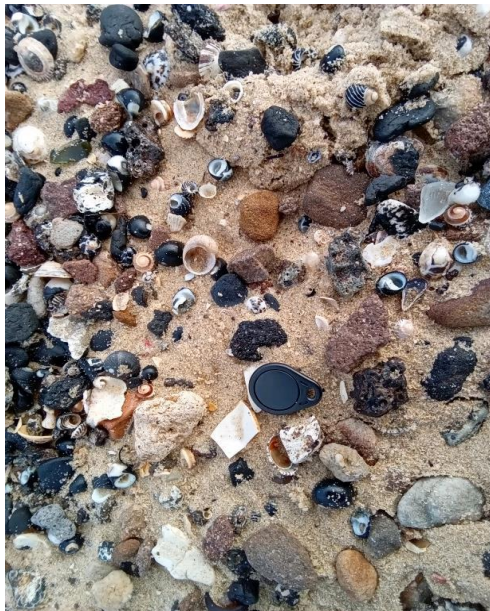
Notes: Visual surface clearance inspection following removal of suspected asbestos containing fragment

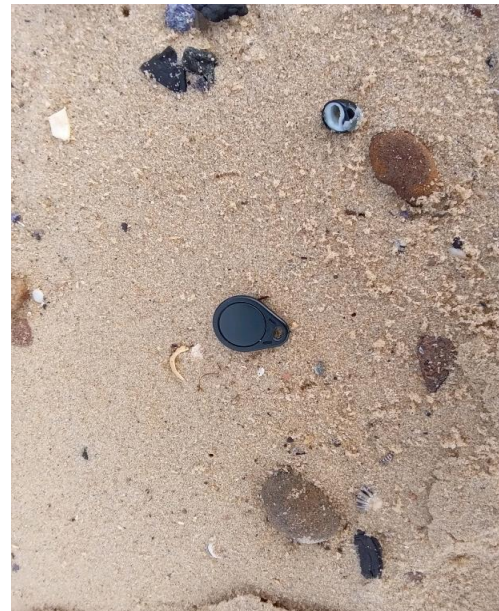
Notes: Visual surface clearance inspection following removal of suspected asbestos containing fragment

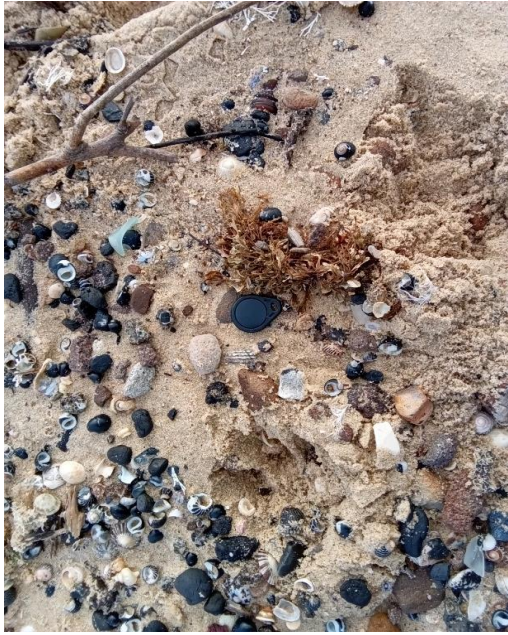
Notes: Visual surface clearance inspection following removal of suspected asbestos containing fragment

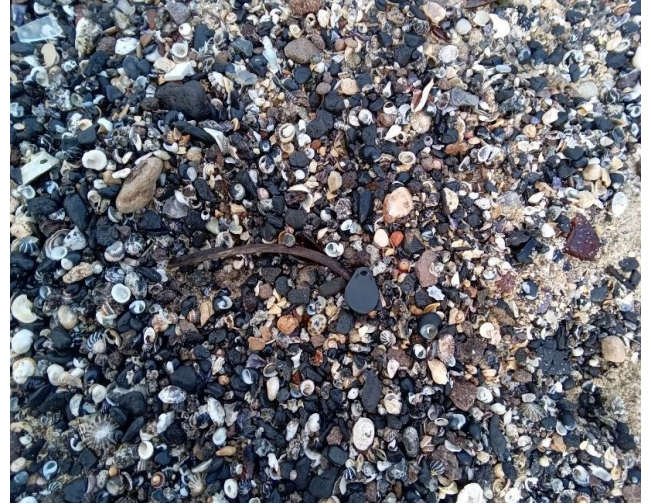
Notes: Visual surface clearance inspection following removal of suspected asbestos containing fragment

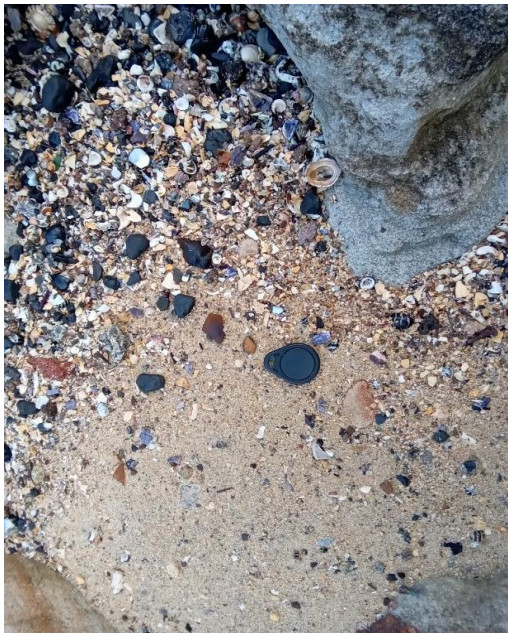
Notes: Visual surface clearance inspection following removal of suspected asbestos containing fragment

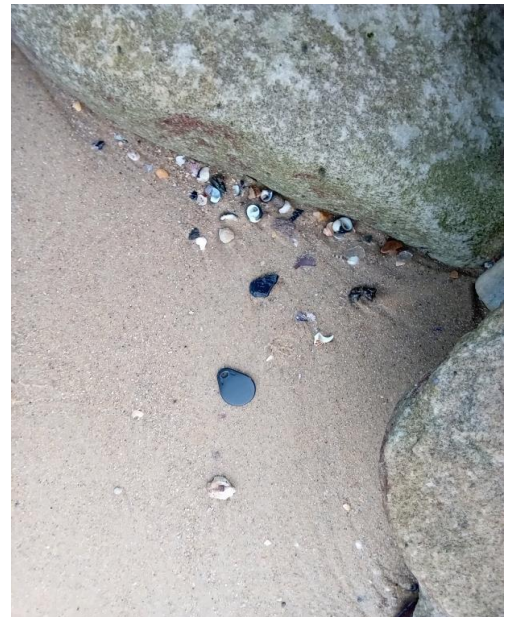
Notes: Visual surface clearance inspection following removal of suspected asbestos containing fragment

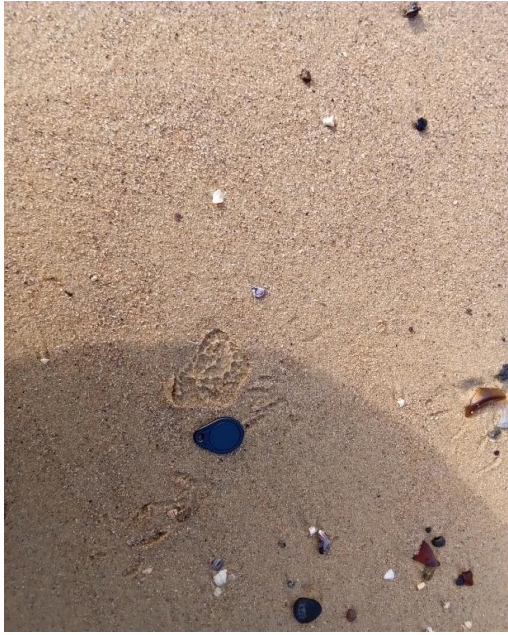
Notes: Visual surface clearance inspection following removal of suspected asbestos containing fragment

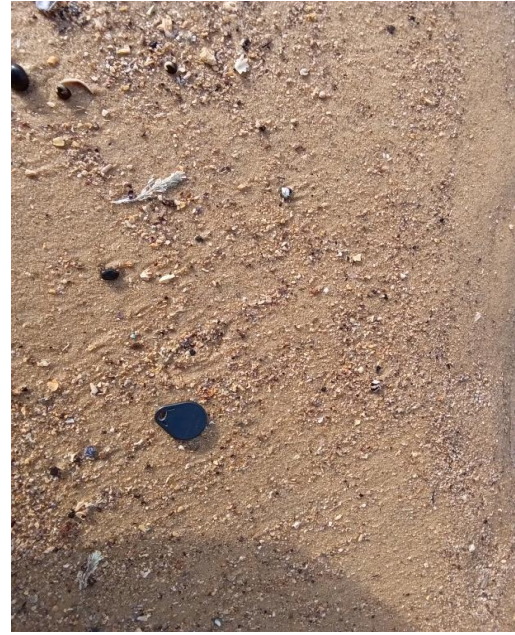
Notes: Visual surface clearance inspection following removal of suspected asbestos containing fragment

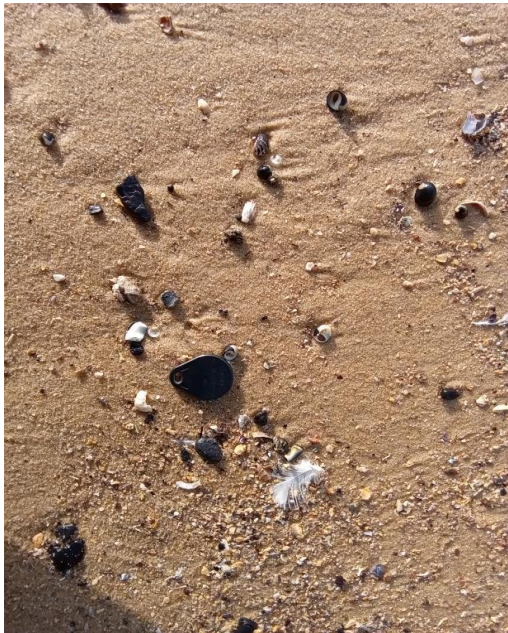
Notes: Visual surface clearance inspection following removal of suspected asbestos containing fragment

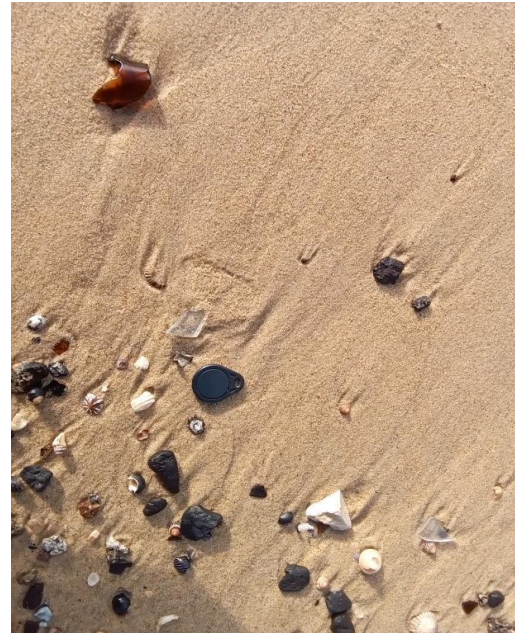
Notes: Visual surface clearance inspection following removal of suspected asbestos containing fragment

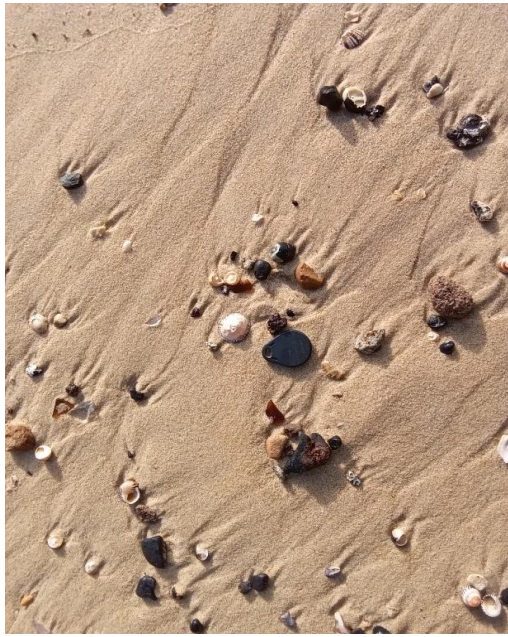
Notes: Visual surface clearance inspection following removal of suspected asbestos containing fragment

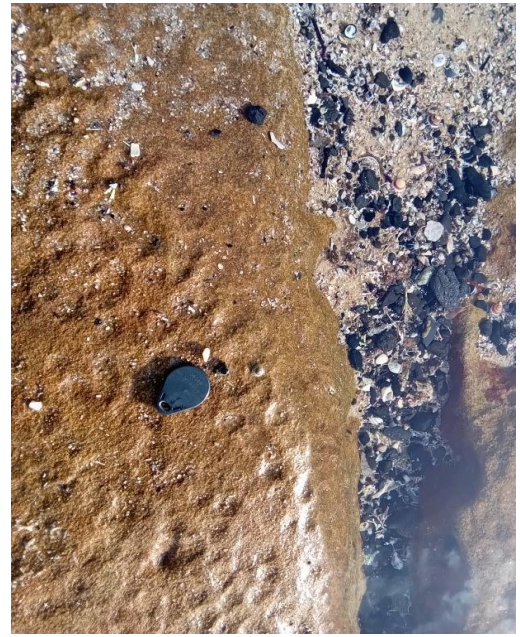
Notes: Visual surface clearance inspection following removal of suspected asbestos containing fragment
