Asbestos Containing Material Clearance Inspection

24 June 2023

Site:	Little Bay Beach
Location:	Southern, Western and Northern Little Bay Beach

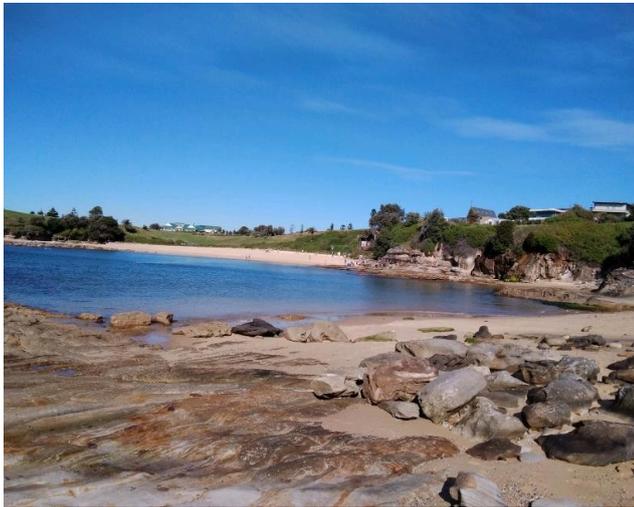
Notes: Overview of the Beach during the inspection

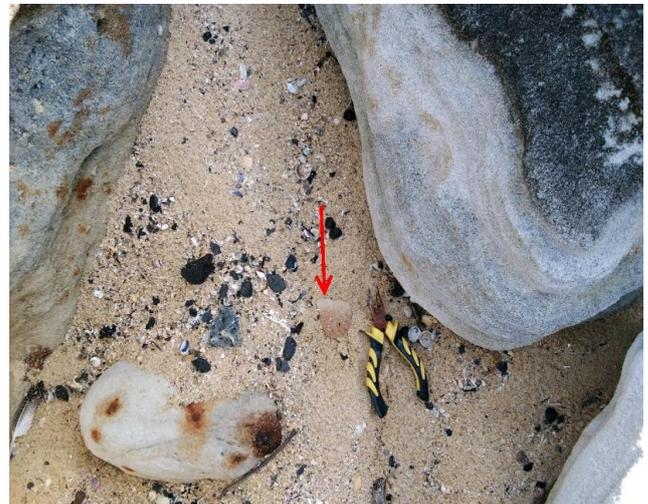
Notes: FC fragment identified on sand surface prior to emu pick - Northern section

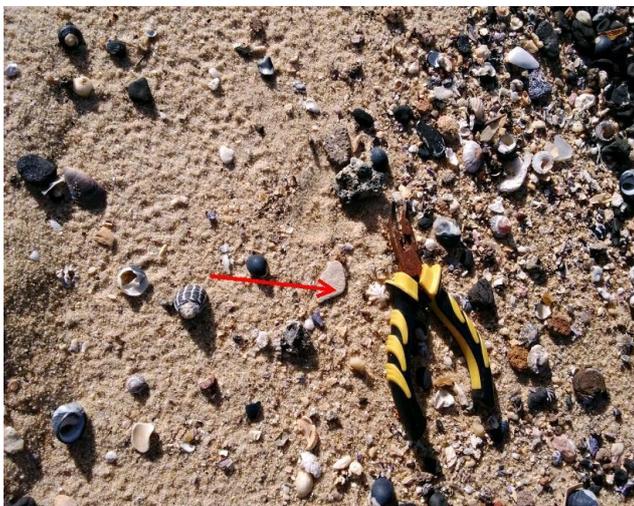
Notes: FC fragment identified on sand surface prior to emu pick - Northern section

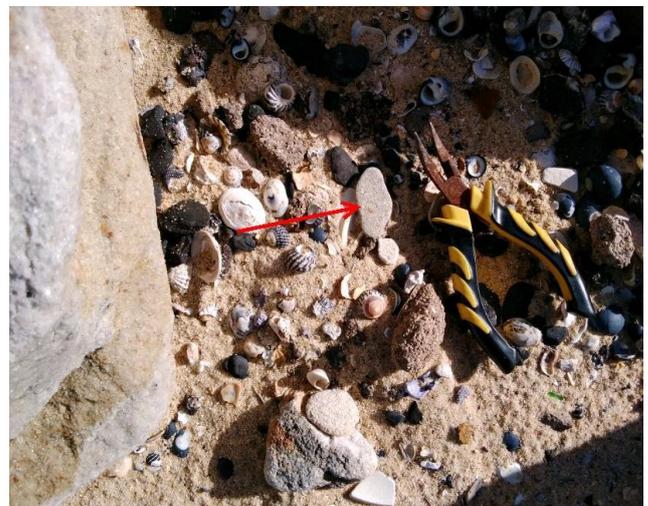
Notes: FC fragment identified on sand surface prior to emu pick - Northern section

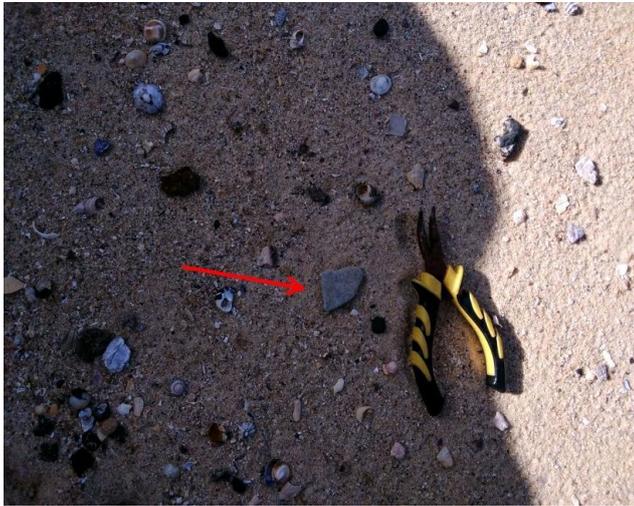
Notes: FC fragment identified on sand surface prior to emu pick - Northern section

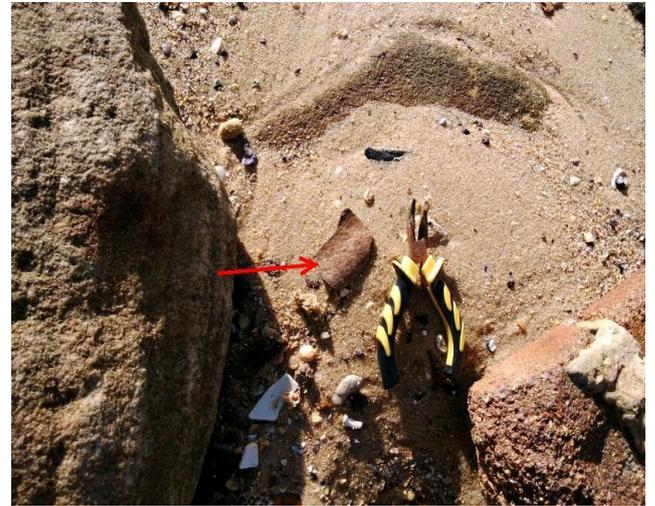
Notes: FC fragment identified on sand surface prior to emu pick - Northern section

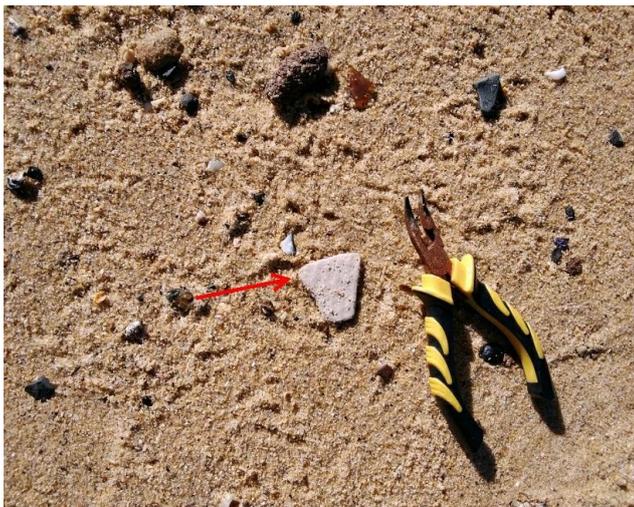
Notes: FC fragment identified on sand surface prior to emu pick - Northern section

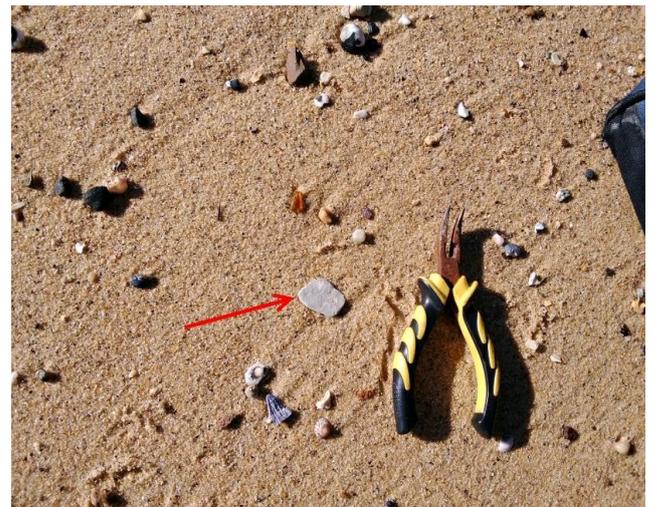
Notes: FC fragment identified on sand surface prior to emu pick - Northern section

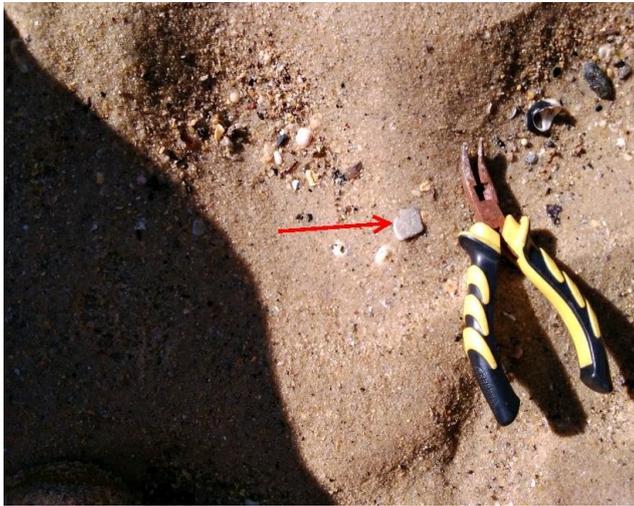
Notes: FC fragment identified on sand surface prior to emu pick - Northern section

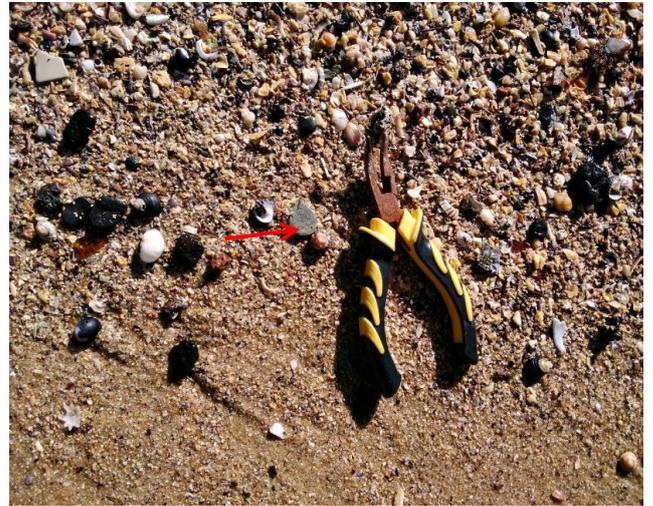
Notes: FC fragment identified on sand surface prior to emu pick - Western section

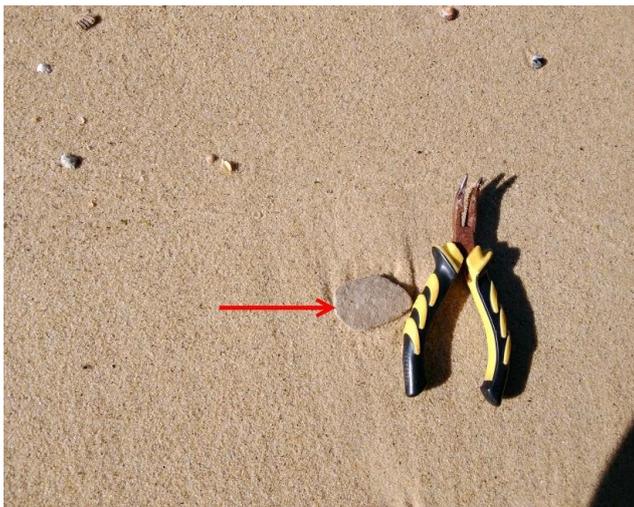
Notes: FC fragment identified on sand surface prior to emu pick - Western section

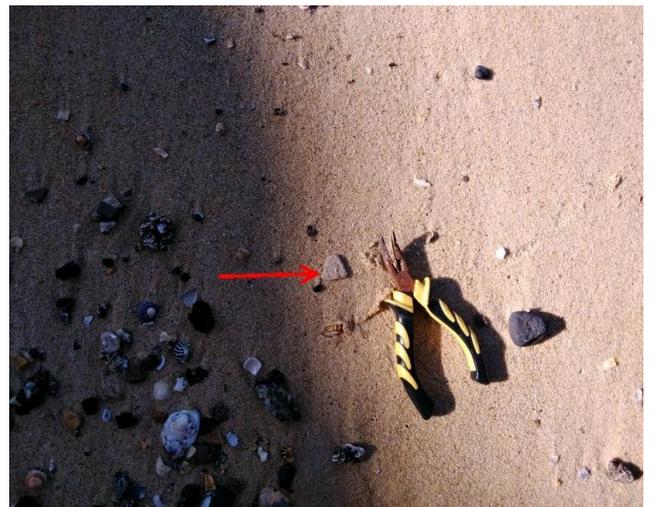
Notes: FC fragment identified on sand surface prior to emu pick - Western section

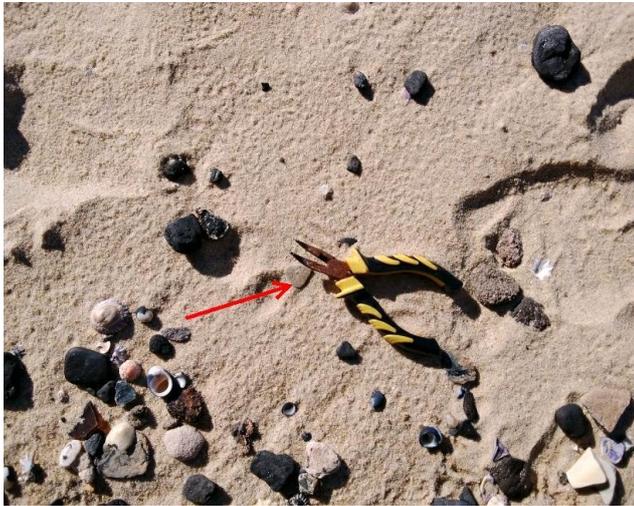
Notes: FC fragment identified on sand surface prior to emu pick - Western section

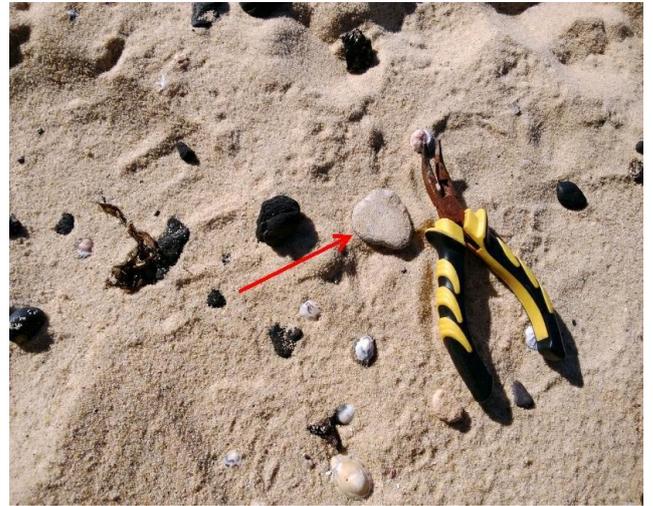
Notes: FC fragment identified on sand surface prior to emu pick - Western section

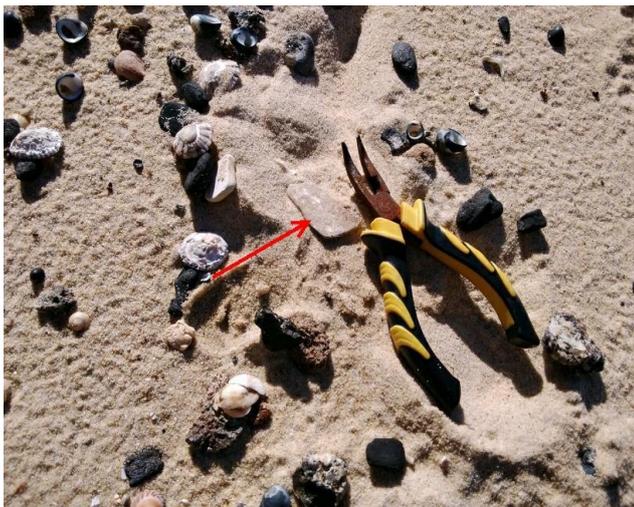
Notes: FC fragment identified on sand surface prior to emu pick - Western section

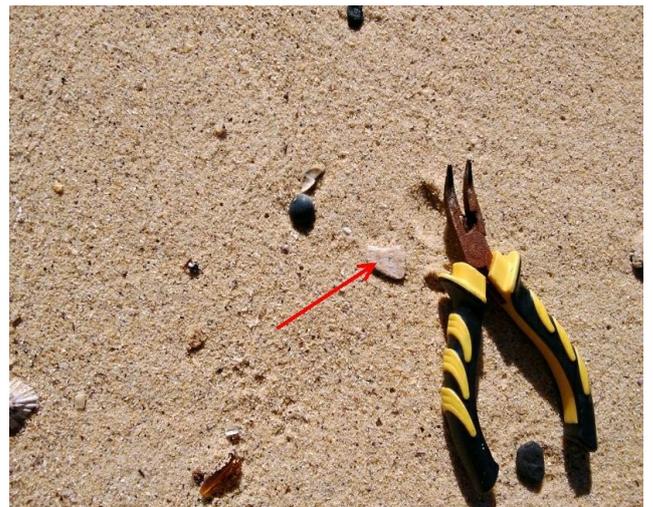
Notes: FC fragment identified on sand surface prior to emu pick - Southern section

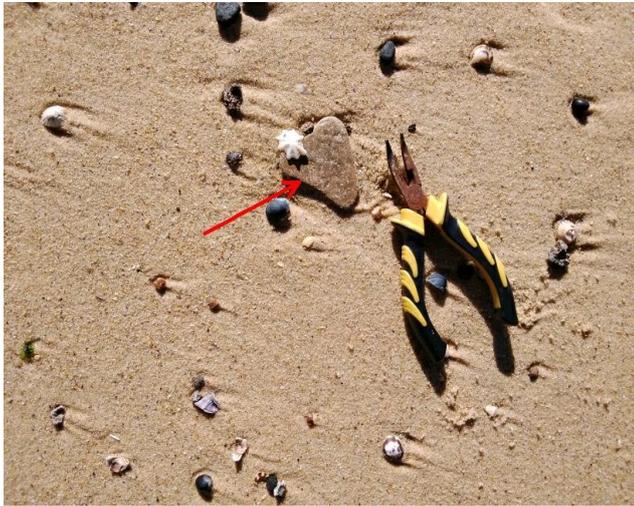
Notes: FC fragment identified on sand surface prior to emu pick - Southern section

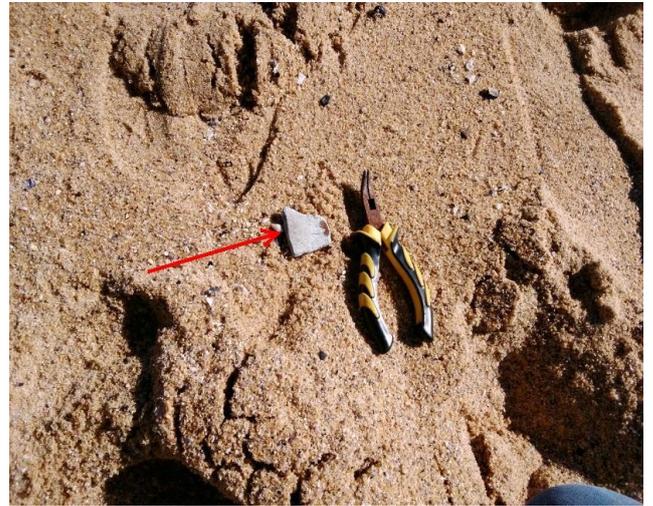
Notes: FC fragment identified on sand surface prior to emu pick - Southern section

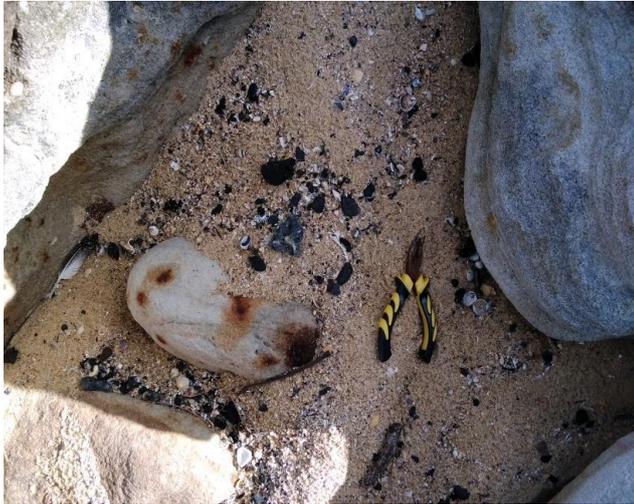
Notes: Sand surface following emu pick - Northern section

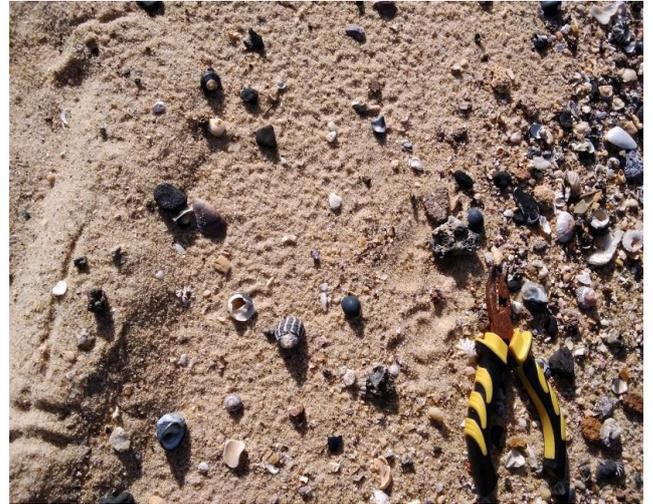
Notes: Sand surface following emu pick - Northern section

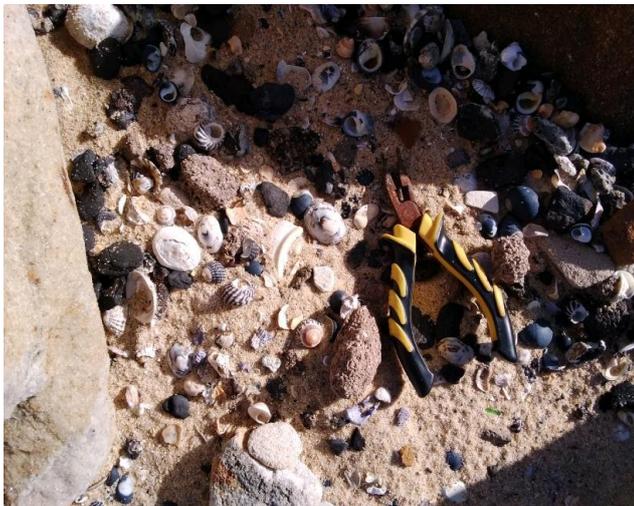
Notes: Sand surface following emu pick - Northern section

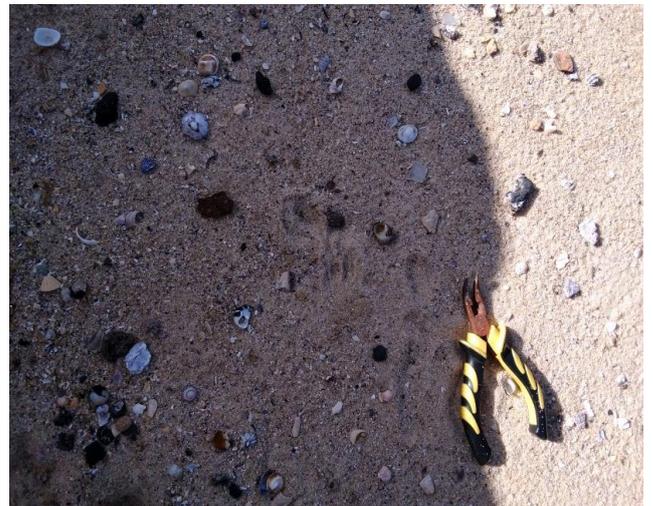
Notes: Sand surface following emu pick - Northern section

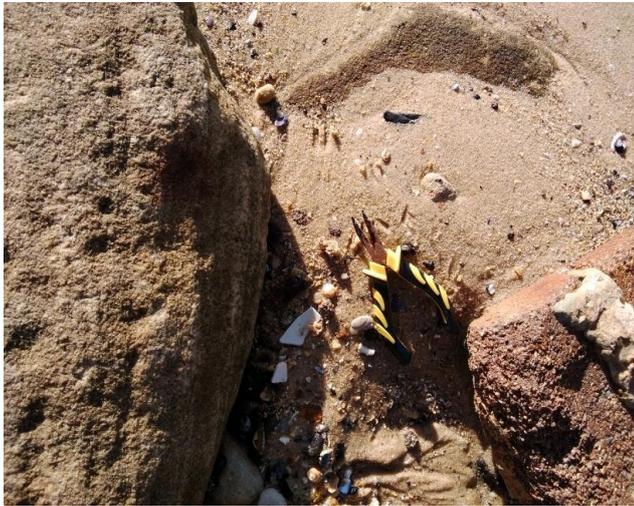
Notes: Sand surface following emu pick - Northern section

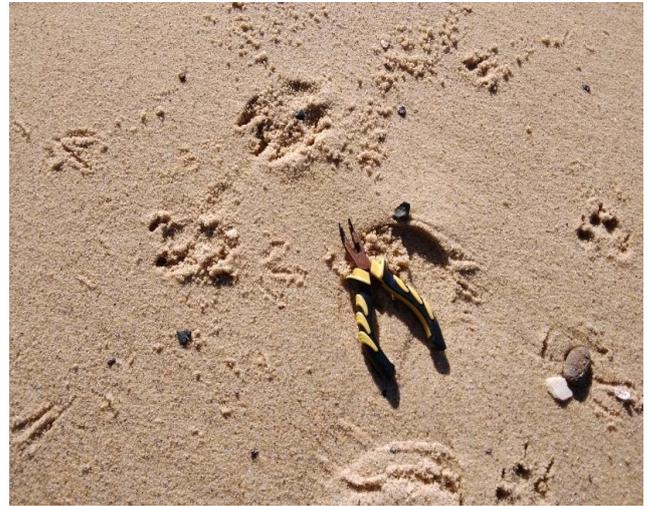
Notes: Sand surface following emu pick - Northern section

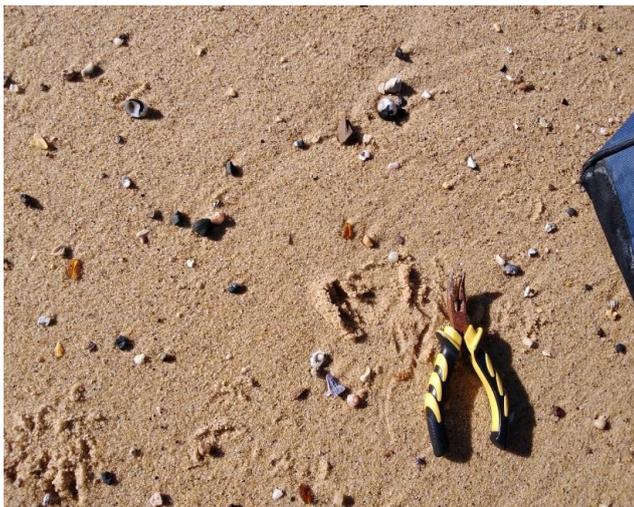
Notes: Sand surface following emu pick - Northern section

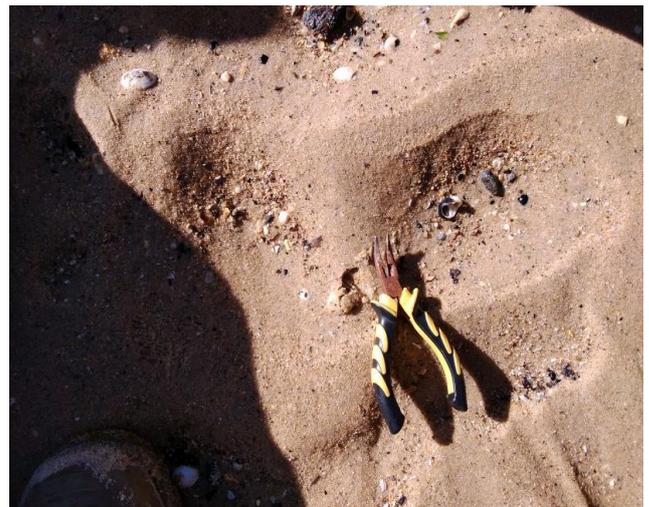
Notes: Sand surface following emu pick - Western section

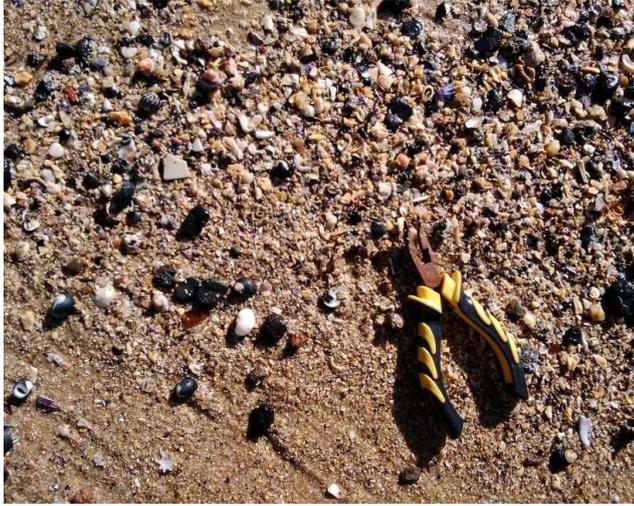
Notes: Sand surface following emu pick - Western section

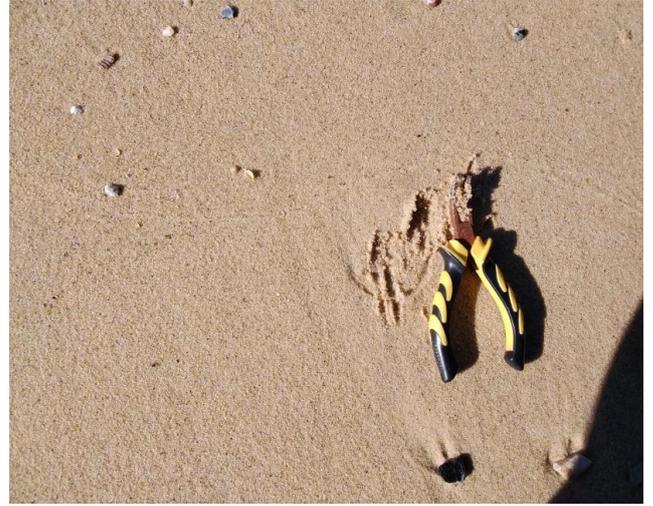
Notes: Sand surface following emu pick - Western section

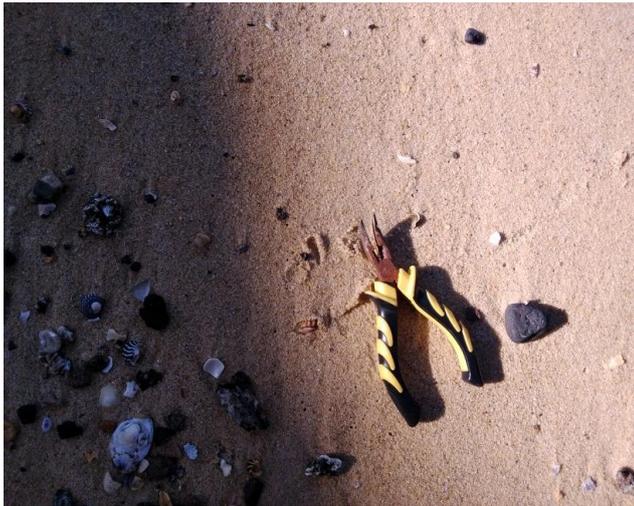
Notes: Sand surface following emu pick - Western section

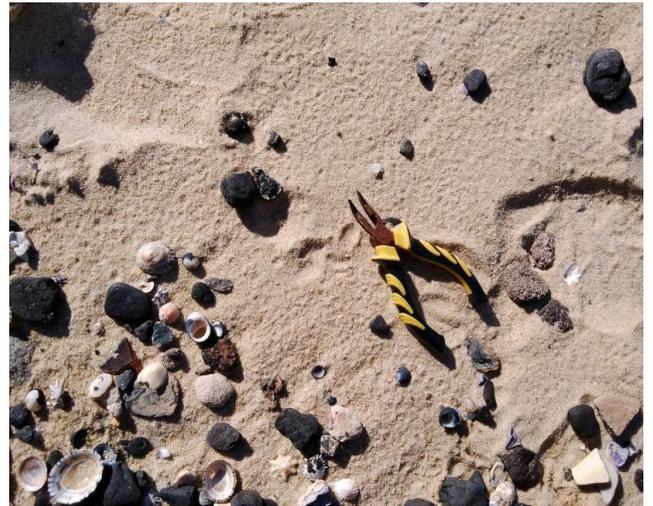
Notes: Sand surface following emu pick - Western section

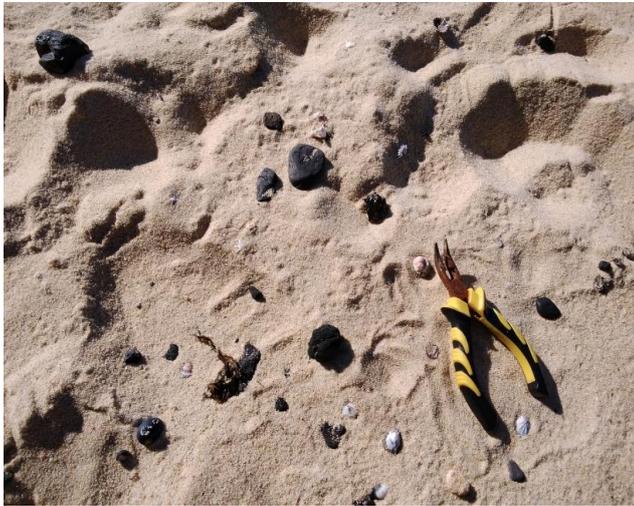
Notes: Sand surface following emu pick - Western section

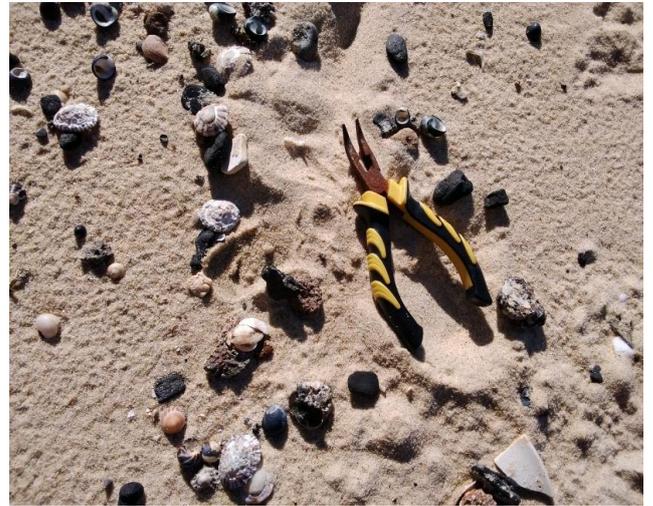
Notes: Sand surface following emu pick - Western section

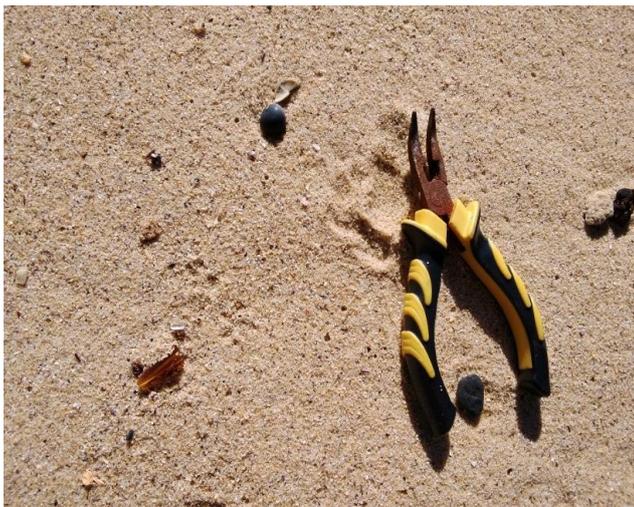
Notes: Sand surface following emu pick - Southern section

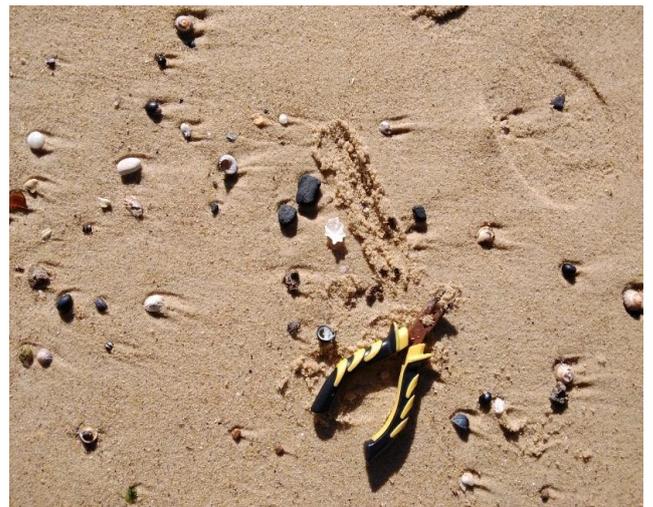
Notes: Sand surface following emu pick - Southern section

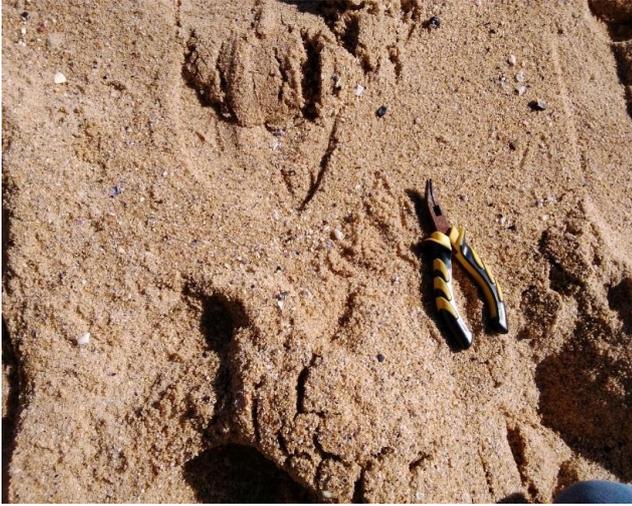
Notes: Sand surface following emu pick - Southern section
