Asbestos Containing Material Clearance Inspection

6 February 2023

Randwick City Council
30 Frances Street
Randwick NSW 2031

Site:	Little Bay Beach
Location:	Southern, Western and Northern Little Bay Beach

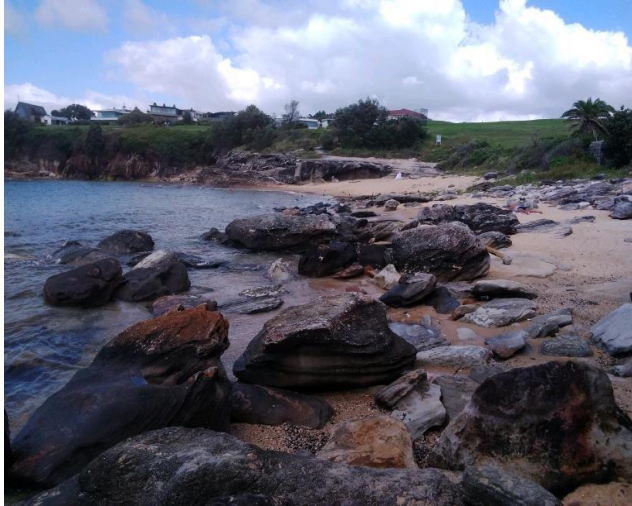
Notes: Overview of Northern beach

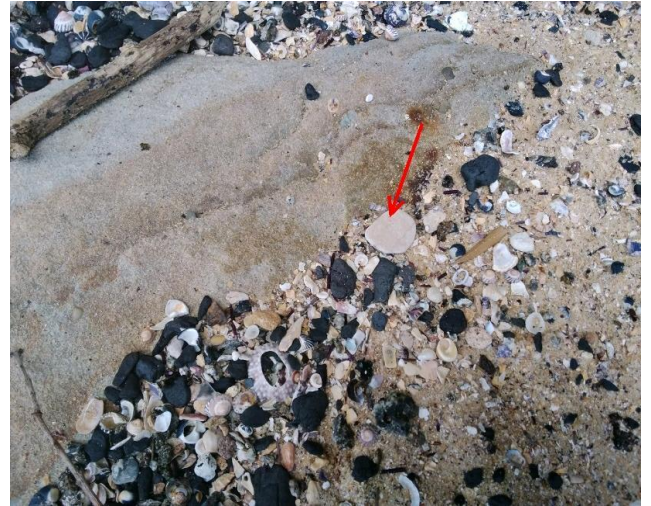
Notes: Overview of the ACM fragment prior to the removal within Northern beach.

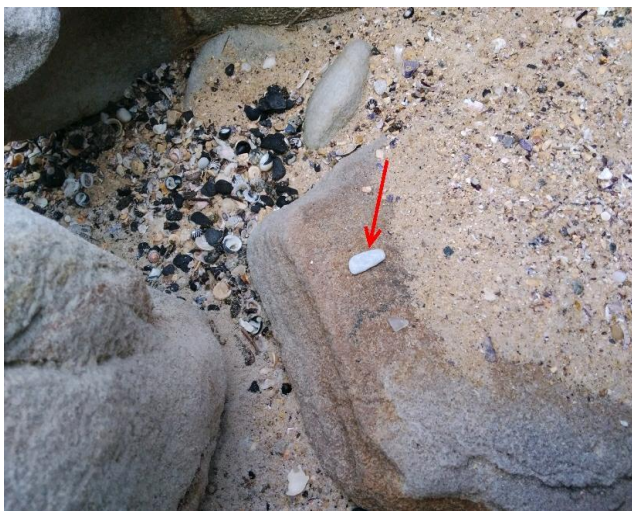
Notes: Overview of the ACM fragment prior to the removal within Northern beach.

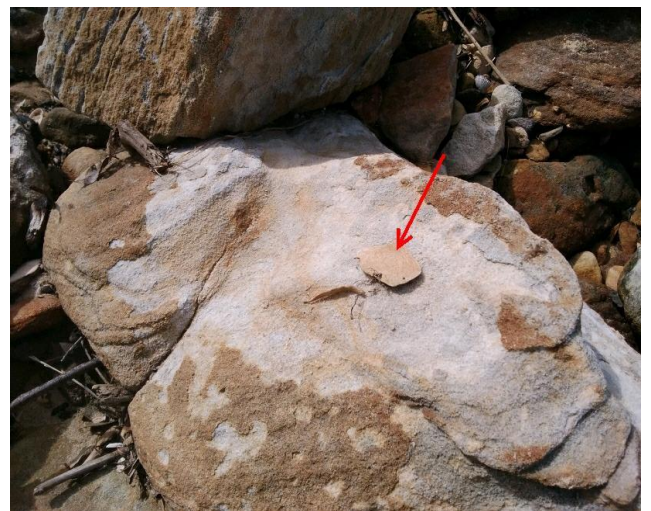
Notes: Overview of the ACM fragment prior to the removal within Northern beach.

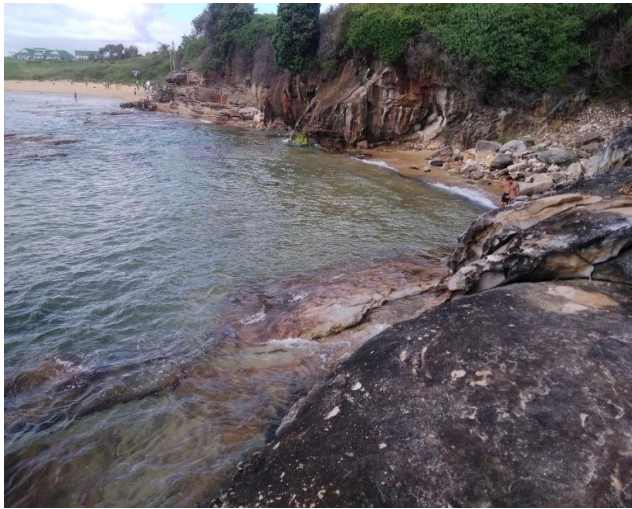
Notes: Overview of Western beach

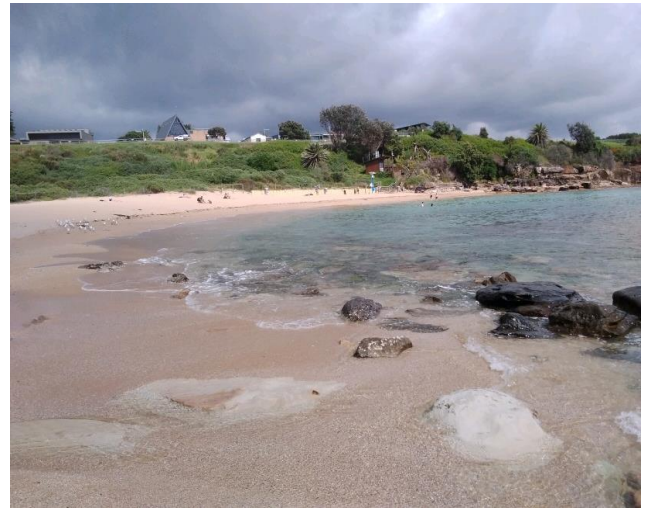
Notes: Overview of Southern beach

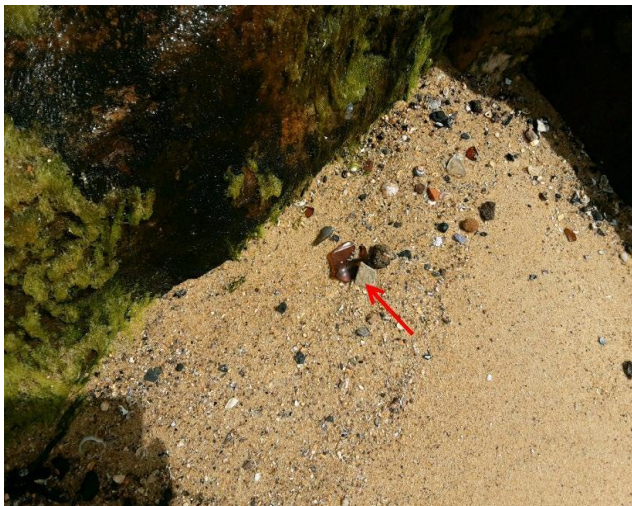
Notes: Overview of the ACM fragment prior to the removal within Southern beach.

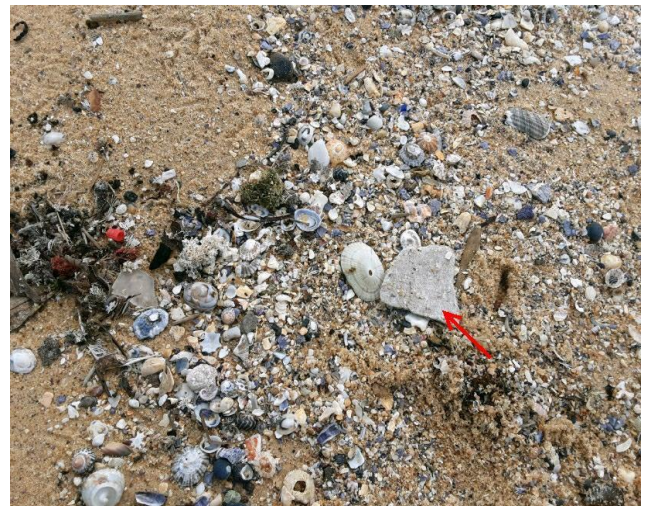
Notes: Overview of the ACM fragment prior to the removal within Southern beach.

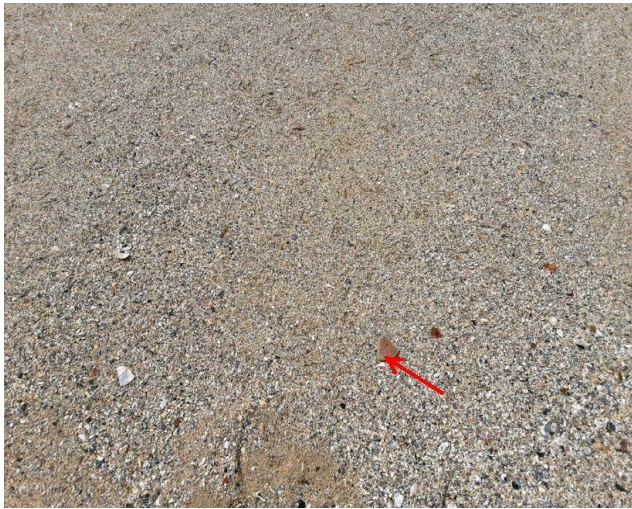
Notes: Overview of the ACM fragment prior to the removal within Southern beach.

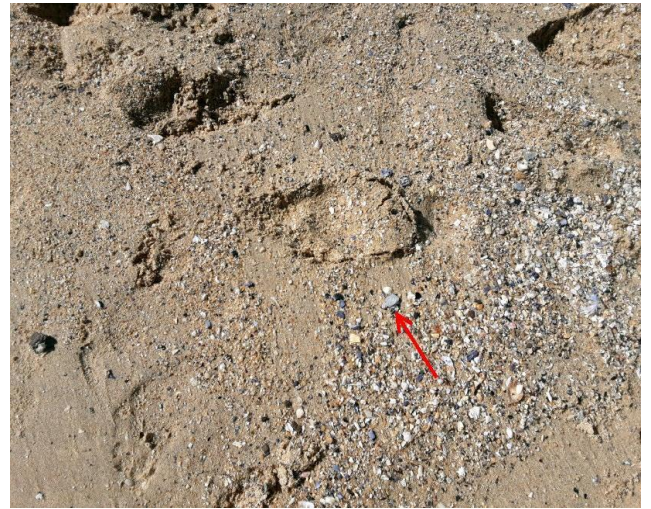
Notes: Overview of the ACM fragment prior to the removal within Southern beach.

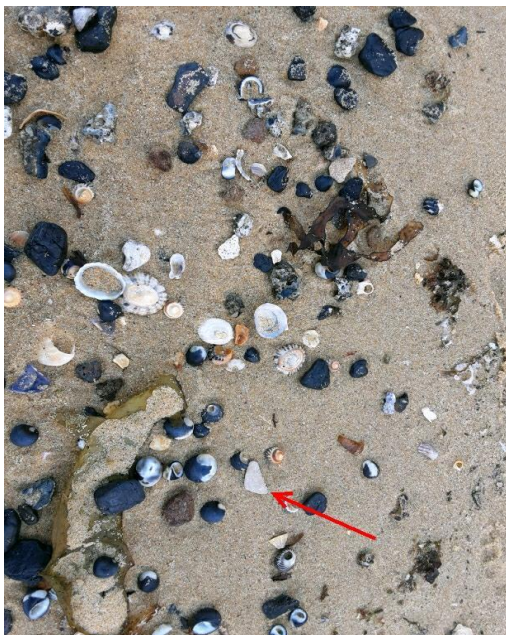
Notes: Overview of the ACM fragment prior to the removal within Southern beach.

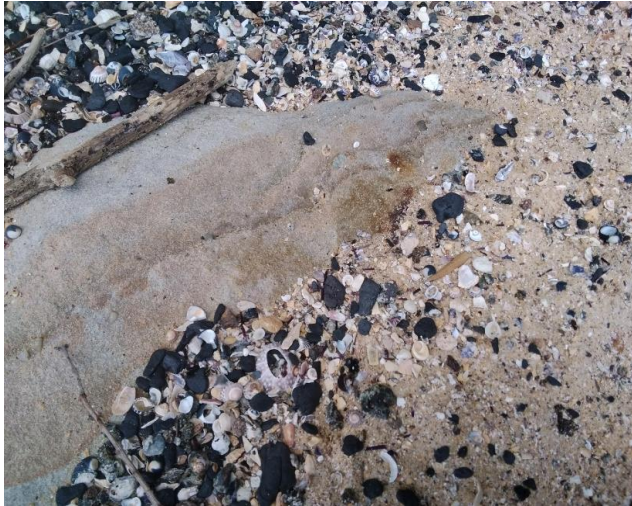
Notes: Visual surface clearance inspection following removal of ACM fragment.

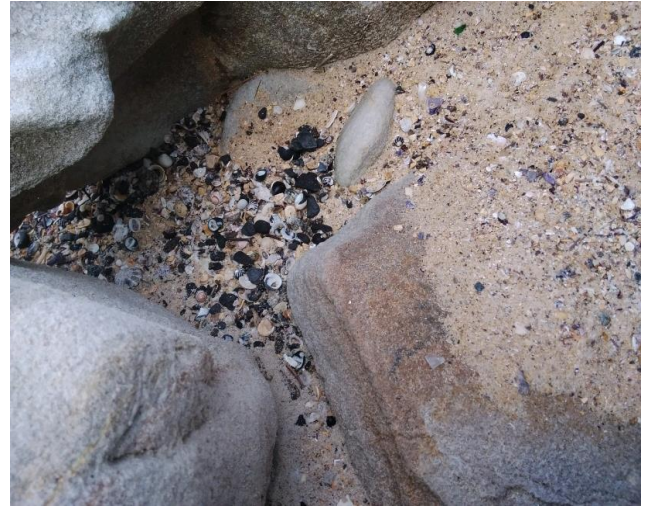
Notes: Visual surface clearance inspection following removal of ACM fragment.

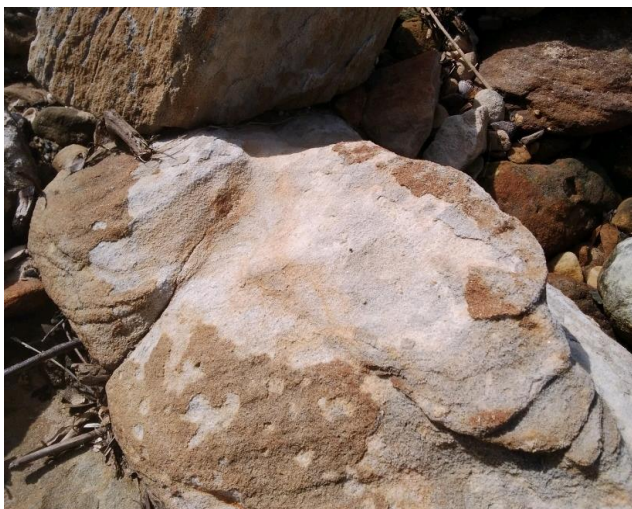
Notes: Visual surface clearance inspection following removal of ACM fragment.

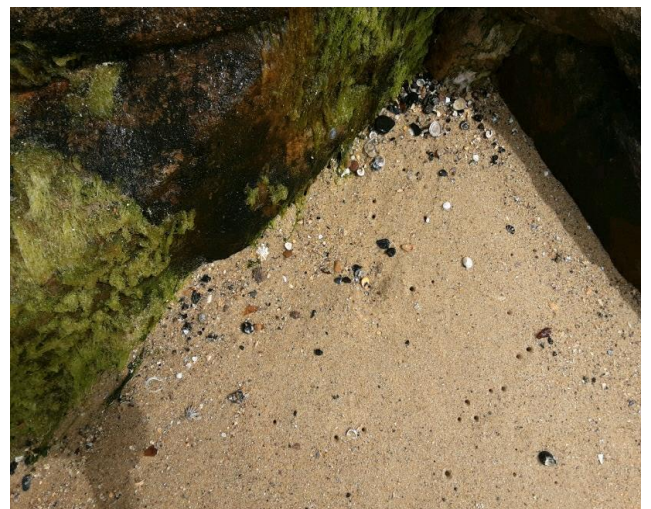
Notes: Visual surface clearance inspection following removal of ACM fragment.

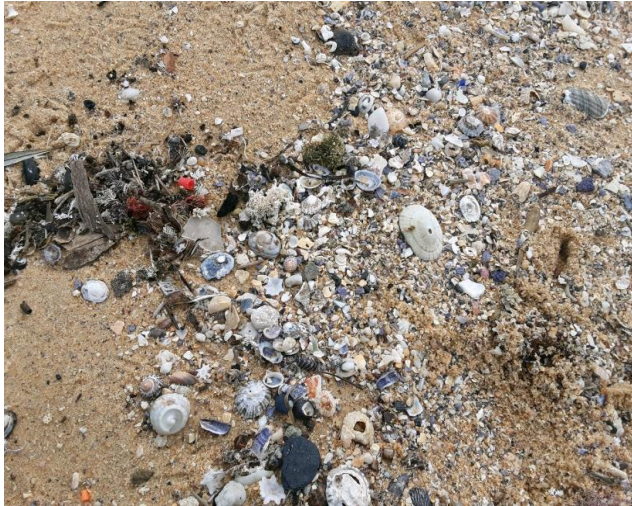
Notes: Visual surface clearance inspection following removal of ACM fragment.

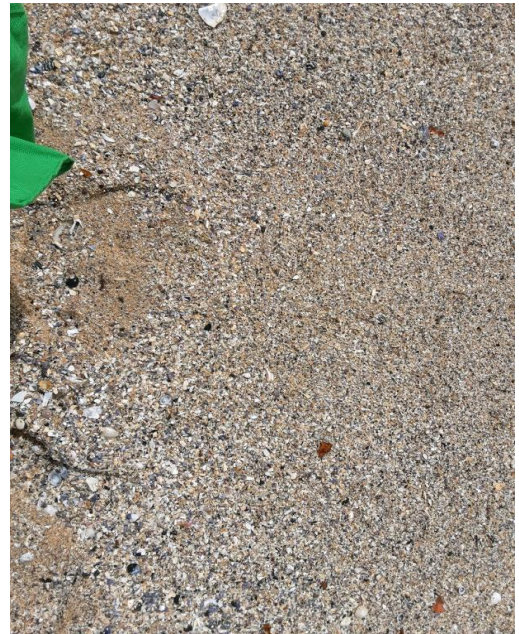
Notes: Visual surface clearance inspection following removal of ACM fragment.

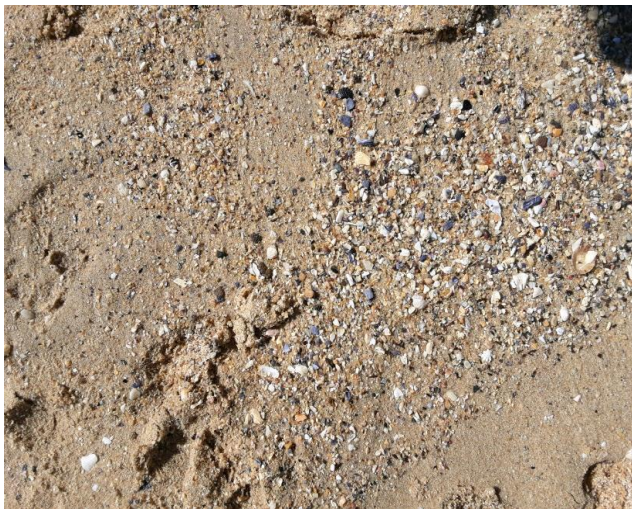
Notes: Visual surface clearance inspection following removal of ACM fragment.

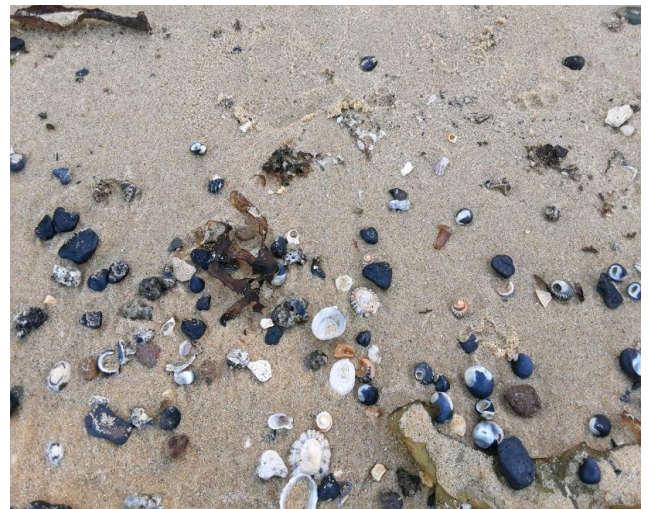
Notes: Visual surface clearance inspection following removal of ACM fragment.
