Asbestos Containing Material Clearance Inspection

3 July 2023

Site:	Little Bay Beach
Location:	Southern, Western and Northern Little Bay Beach

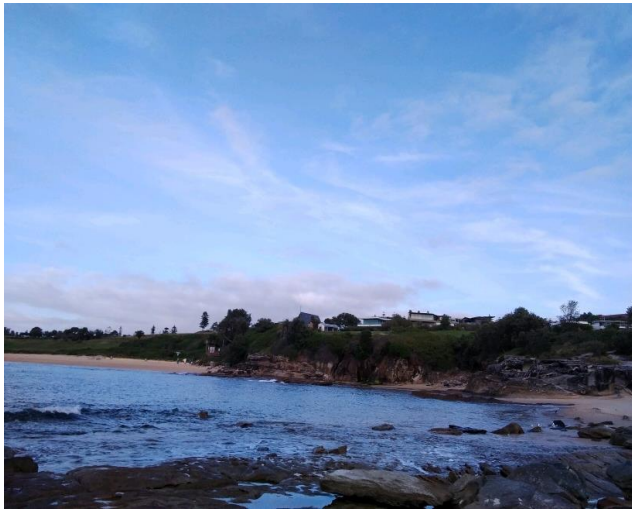
Notes: Overview of the Beach during the inspection

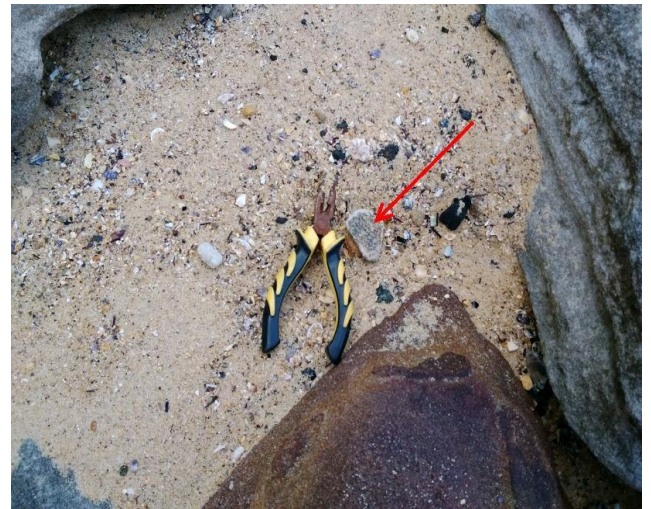
Notes: FC fragment identified on sand surface prior to emu pick - Northern section

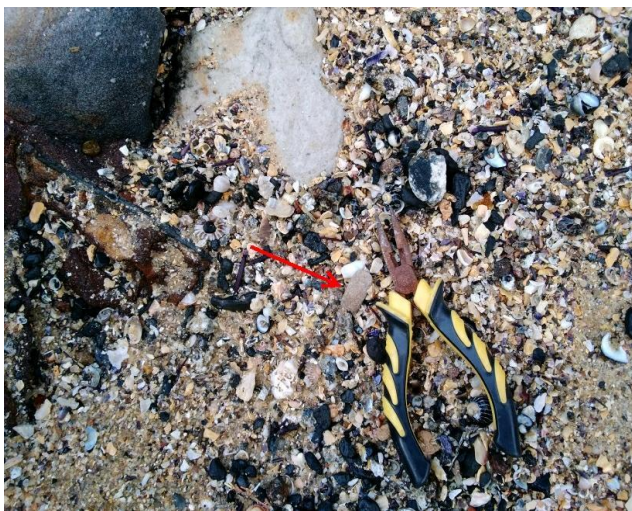
Notes: FC fragment identified on sand surface prior to emu pick - Northern section

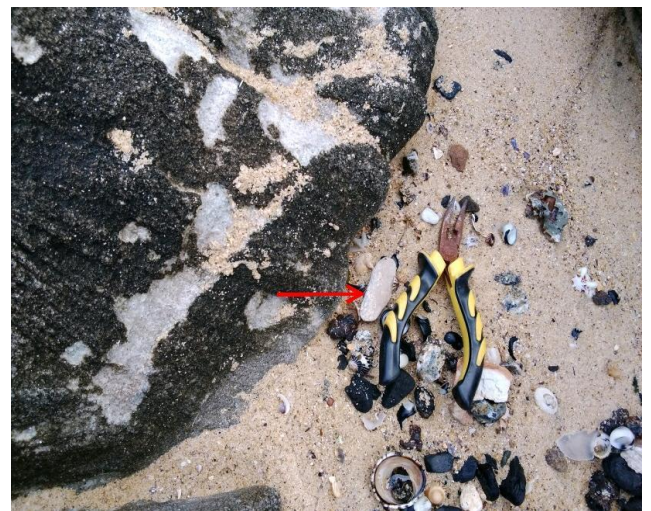
Notes: FC fragment identified on sand surface prior to emu pick - Northern section

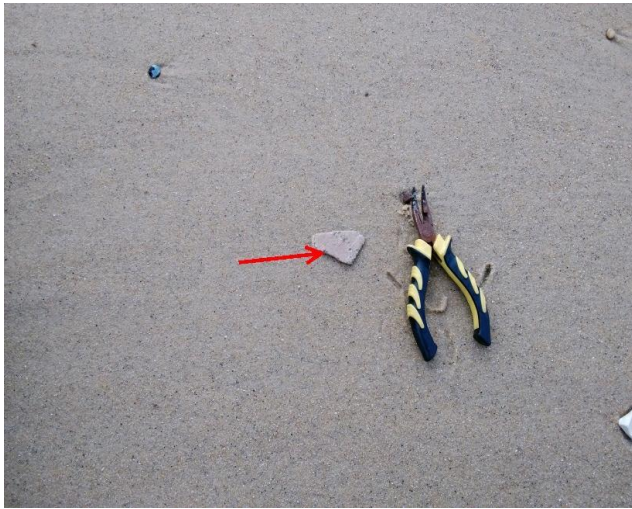
Notes: FC fragment identified on sand surface prior to emu pick - Northern section

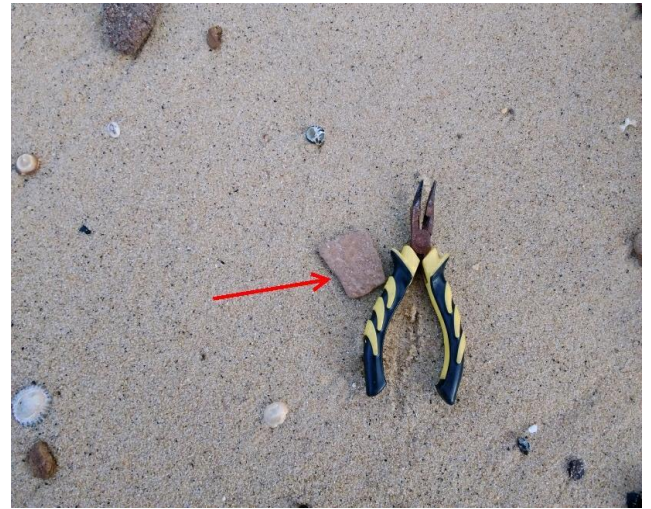
Notes: FC fragment identified on sand surface prior to emu pick - Northern section

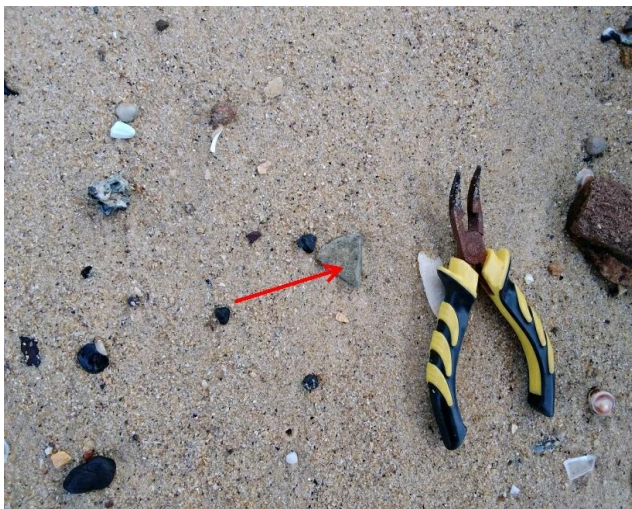
Notes: FC fragment identified on sand surface prior to emu pick - Northern section

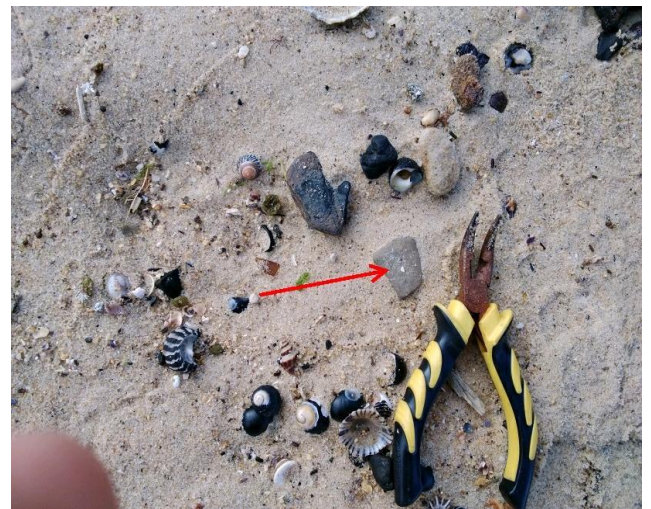
Notes: FC fragment identified on sand surface prior to emu pick - Western section

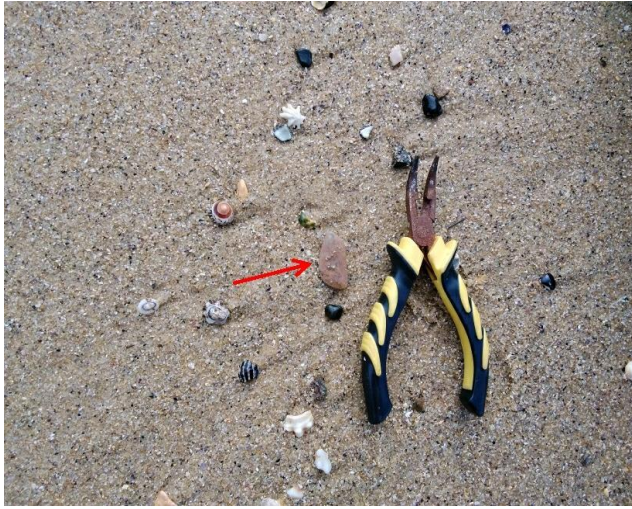
Notes: FC fragment identified on sand surface prior to emu pick - Southern section

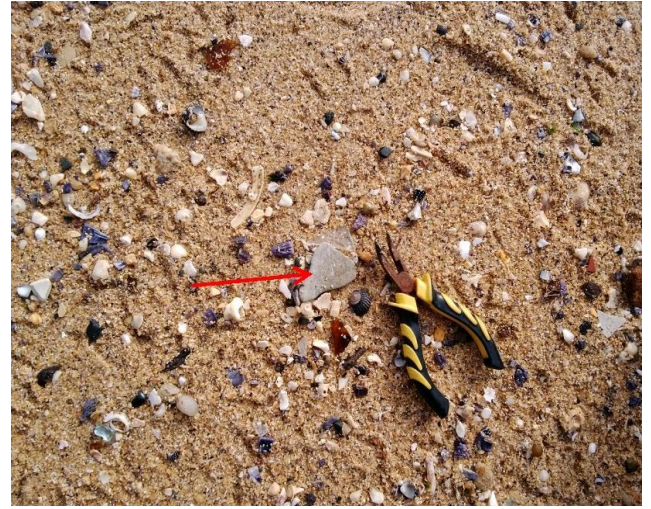
Notes: FC fragment identified on sand surface prior to emu pick - Southern section

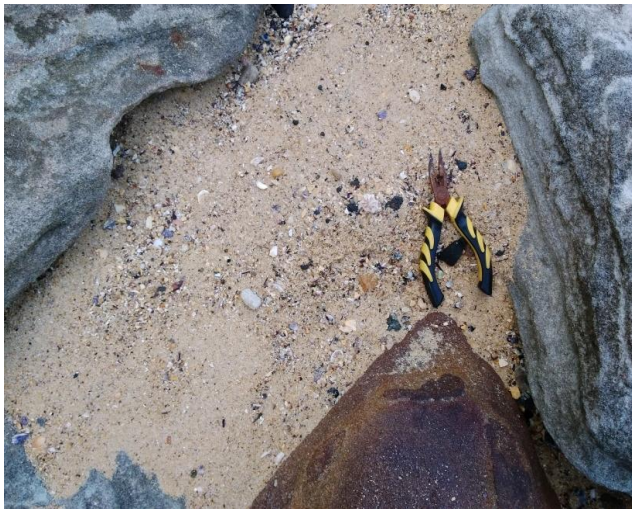
Notes: Sand surface following emu pick - Northern section

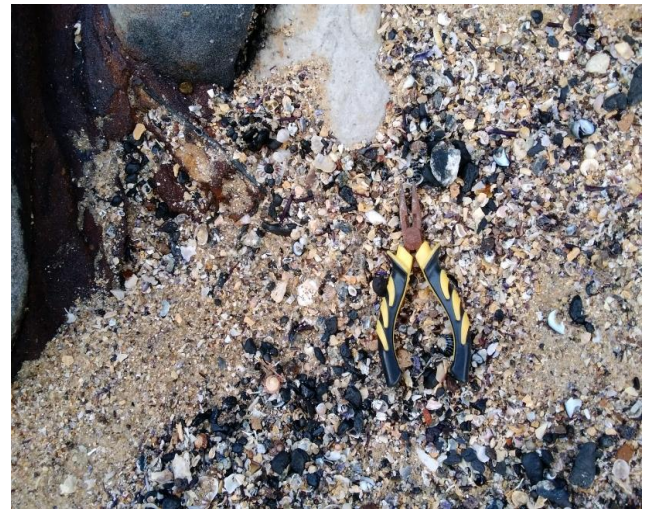
Notes: Sand surface following emu pick - Northern section

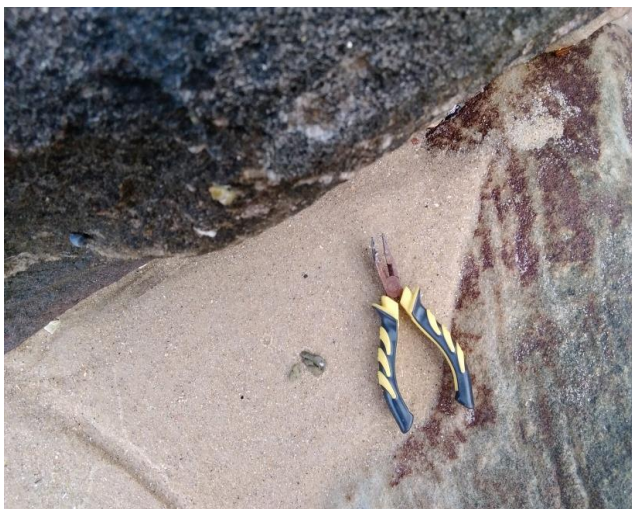
Notes: Sand surface following emu pick - Northern section

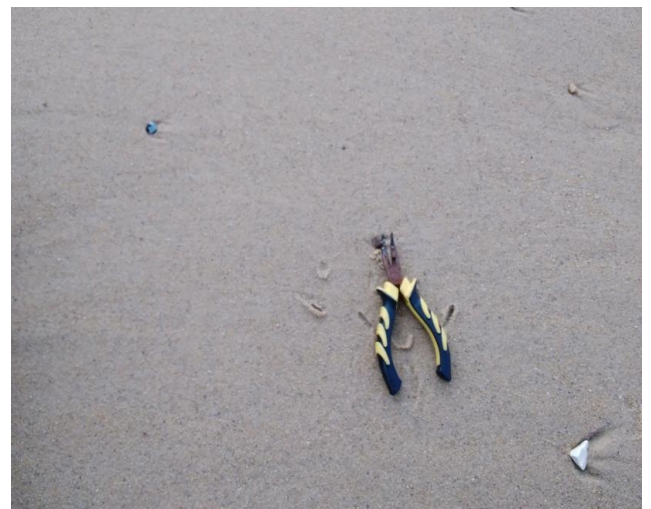
Notes: Sand surface following emu pick - Northern section

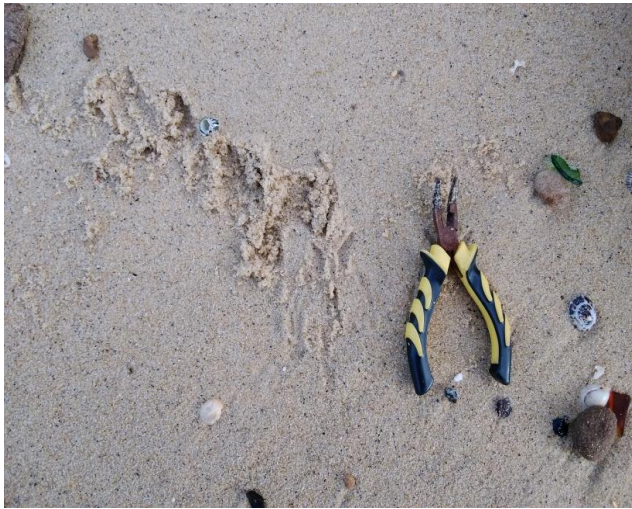
Notes: Sand surface following emu pick - Northern section

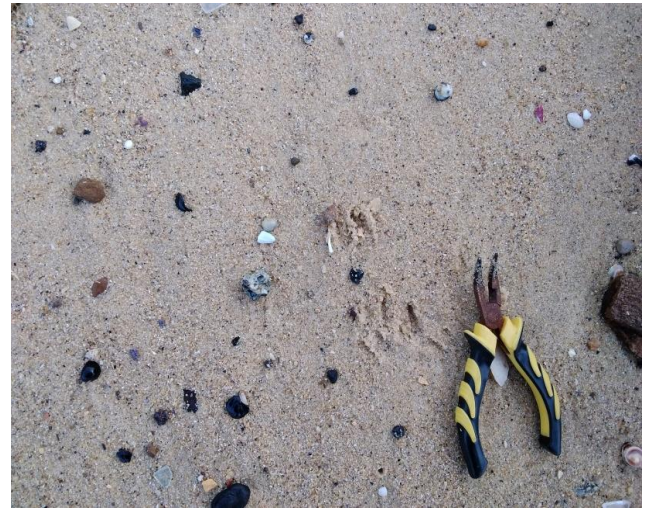
Notes: Sand surface following emu pick - Northern section

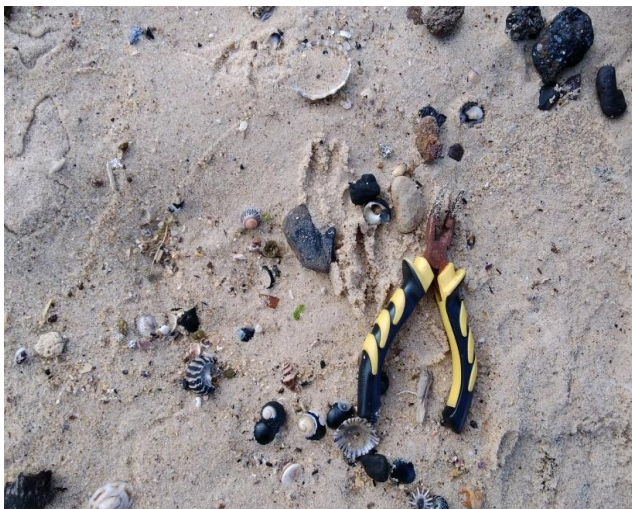
Notes: Sand surface following emu pick - Western section

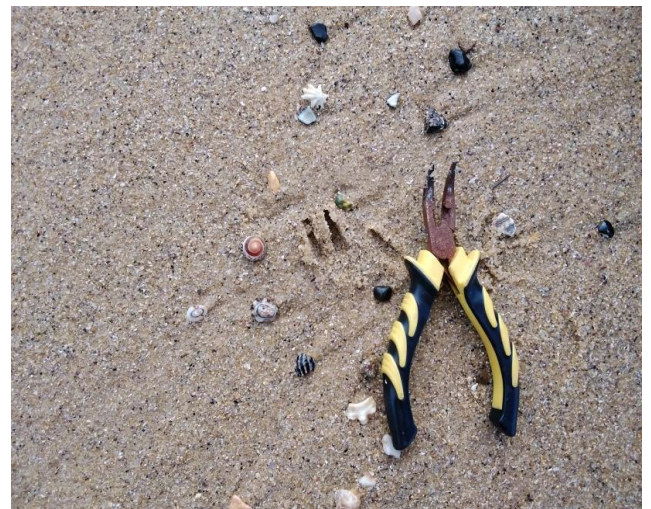
Notes: Sand surface following emu pick - Southern section

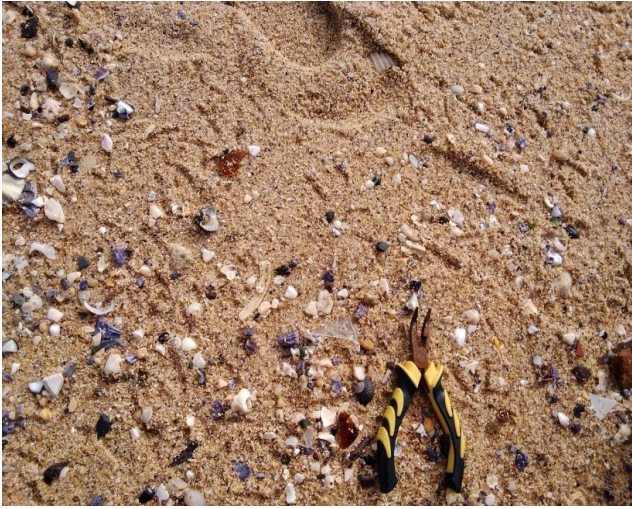
Notes: Sand surface following emu pick - Southern section
