Detailed Site Investigation (DSI) of Potential Asbestos Contamination at Little Bay Beach, Little Bay NSW

Prepared for:	Randwick City Council	
Site	Little Bay Beach	
Location	4R Coast Hospital Rd, Little Bay NSW	
Field Work Date	26 th – 30 th April 2021	
Report Date	17 th September 2021	
Report Version	v6 final	
	Jeffrey Yu	
Prepared by:	 Senior Environmental Consultant Licensed Asbestos Assessor (001366) PhD in Environmental Engineering PhD in Medicinal Chemistry

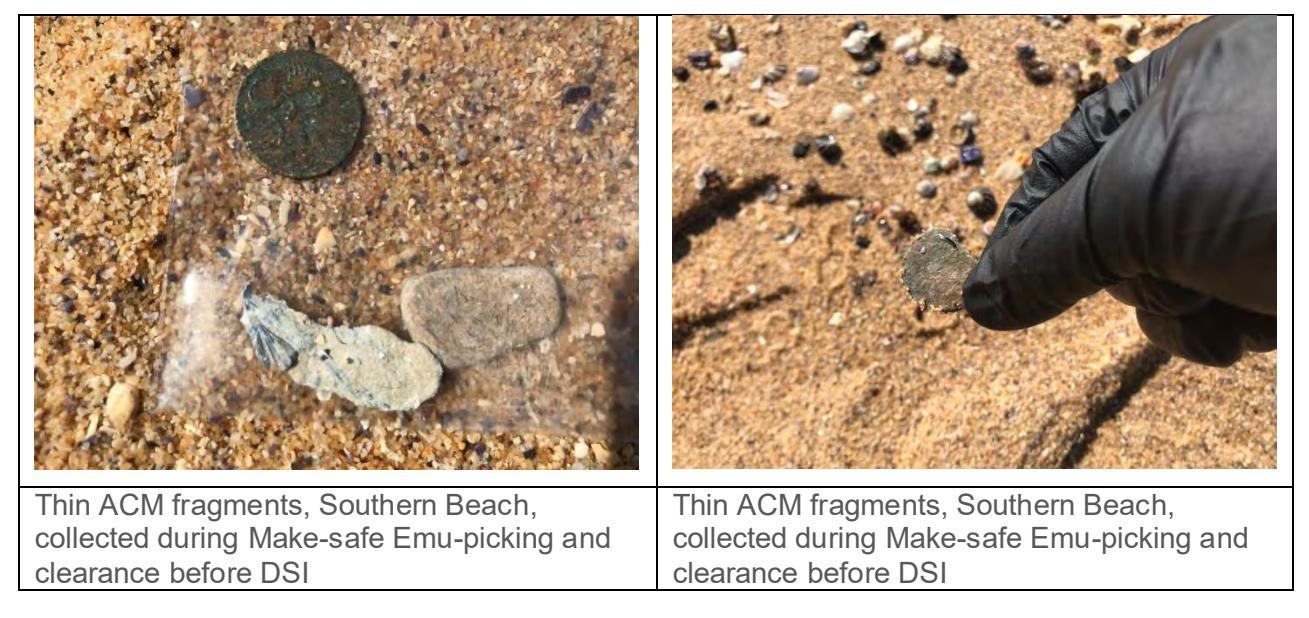
Table 11 Photos – Thin Bonded ACM fragments

- Several bonded ACM fragments were observed at Southern Beach (Table 11)
- ACM fragments were observed in Crown Gully 2 (Table 17)
- Significant amount of ACM fragments (>1 Kg) was collected adjacent to the outlet of stormwater pipe at Crown Gully 3 and then all the way to the rocky area in the bay.

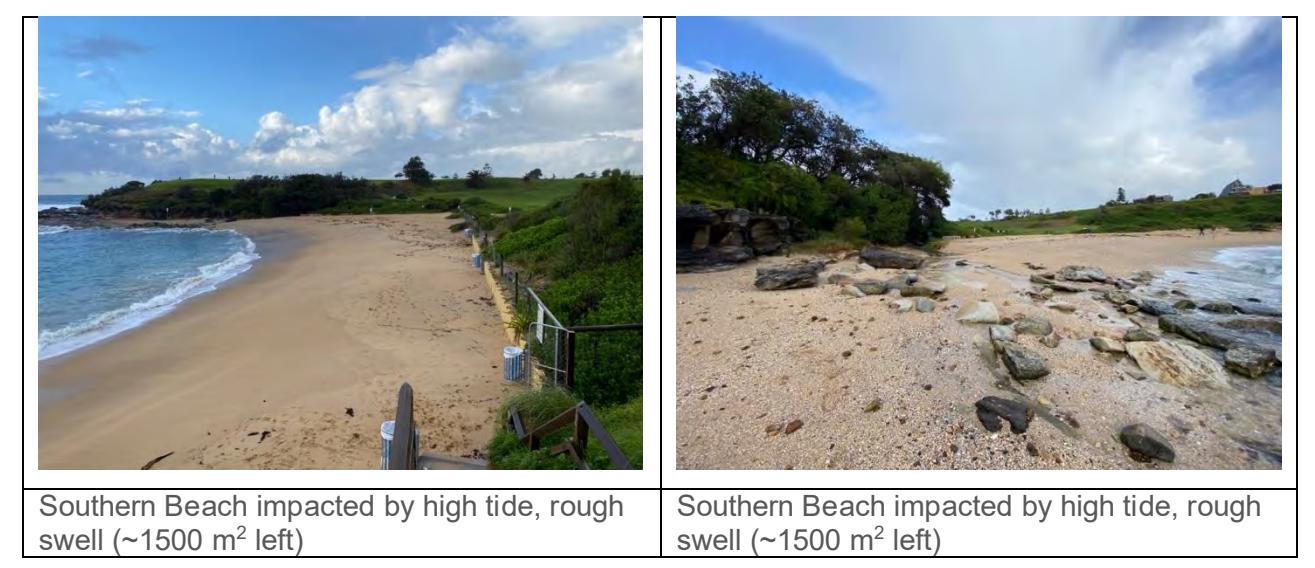
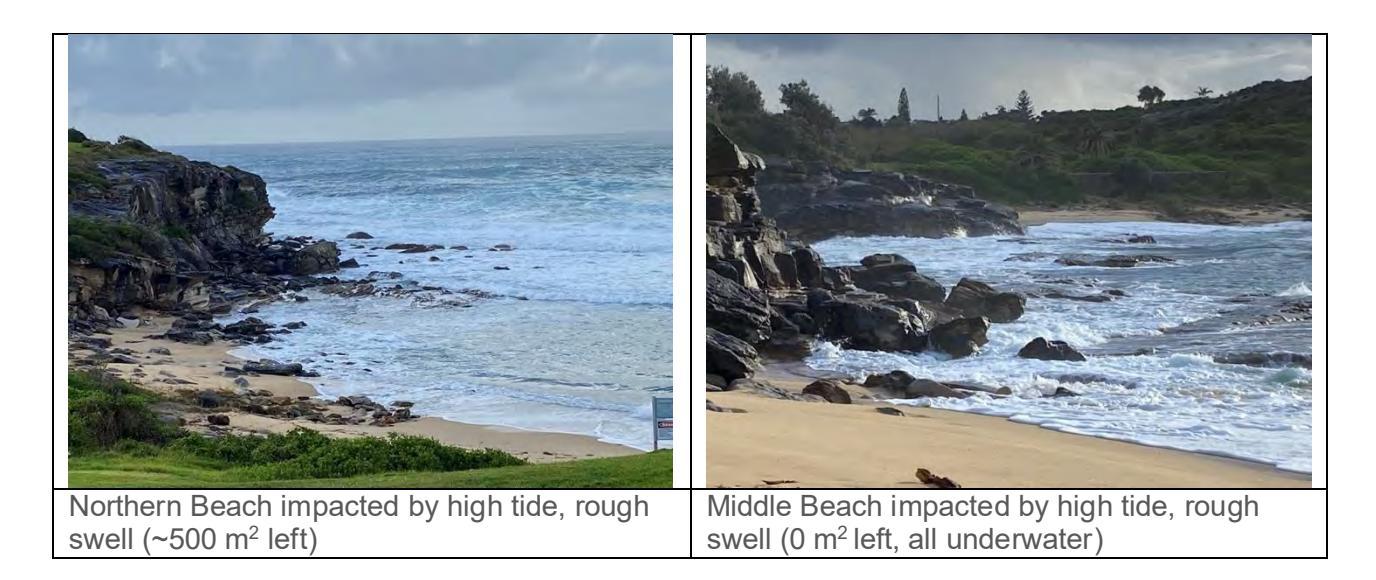
Table 12 Photos – Three beaches impacted by high tide and rough swell

While Underwater Sand Area (~10000 m²) in the bay was out of the scope of work, ACM fragments have been observed between or under rocks/boulders in the water during the lowest tide period (~0.2 m). During high tide period (~2 m), the whole Middle Beach, most of the Northern Beach and half of the Southern Beach are under water or impacted by strong tides.

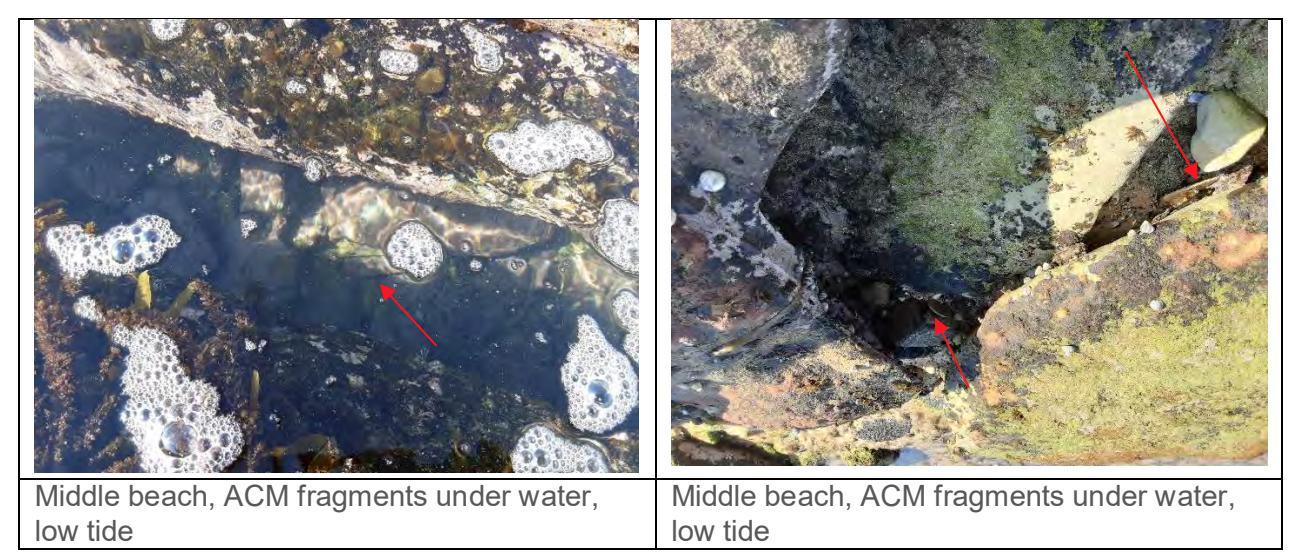
Table 16 Photos - Representative Photos of Asbestos observed in Rock Area or Unknown Underwater Areas at Middle Beach

Rock outcrops separate the Middle Beach and Southern Beach. However, there is no apparent physical boundary between the Northern Beach and Middle Beach. Abundant ACM fragments (super 6 corrugated sheeting chunks, flat ACM sheeting) were observed, during the bi-weekly visual inspections undertaken prior to the DSI, within these rocky areas.

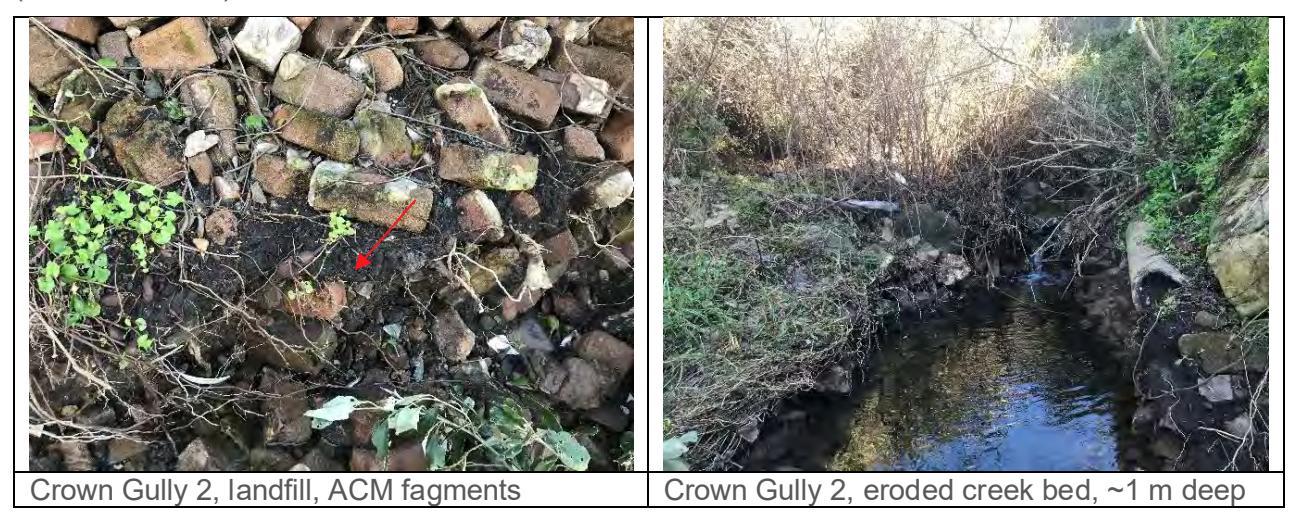
Table 17 Photos - Representative Photos of Asbestos observed in Crown Gully 2, Middle Beach (Western Beach)

- Fill material was observed throughout the Crown Gully 2 and a stockpile of old bricks and concrete were stacked on the outlet of the gully.
- ACM fragments were identified and confirmed in the gully surface and buried within demolition material (only halfway towards the overpass was accessible at the time of inspection).
- ACM fragments are constantly being pushed up and down the sand area with tidal movements
- Hundreds of ACM fragments (super 6 corrugated sheeting chunks, flat ACM sheeting) have been collected since 21 August 2020.
- Crown Gully 2 has limited access.
- Visible ACM fragments were identified under the rock platform immediately adjacent to the low tide water line.
- Fill materials such as building rubbles and solid waste (including plastic, tiles, rubber, tyre, bricks) were observed along the edge of the hill slope.

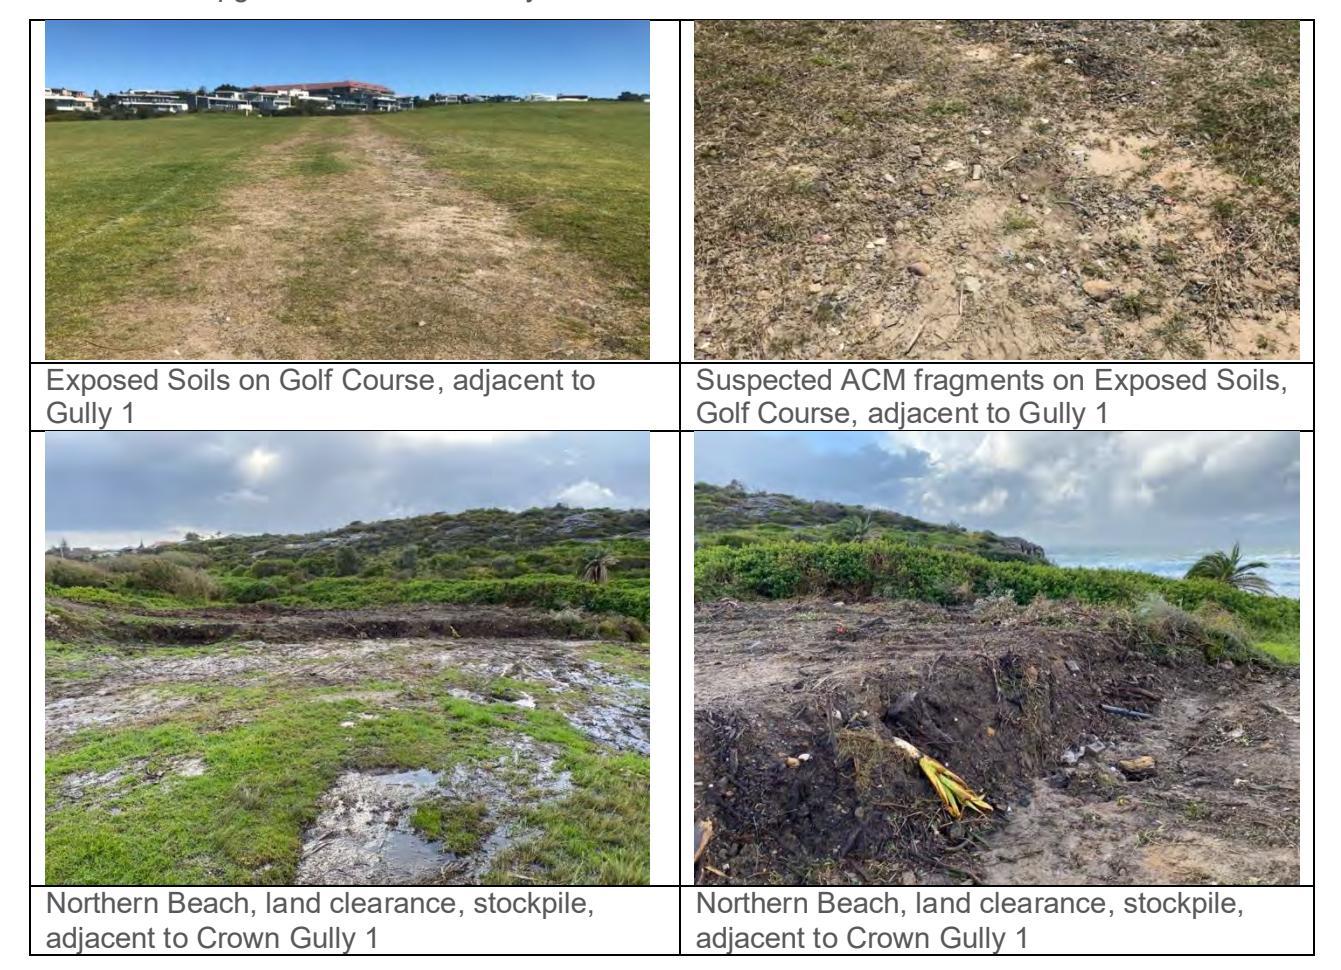
Table 20 Photos – Representative Photos of Asbestos Observed, Stockpiles, Exposed Soils on Golf Course, upgradient of Crown Gully 1, Northern Beach

- ACM fragments were observed up to the Golf Course between Crown Gully 1 and Crown Gully 2, wherever soil is stockpiled, has been disturbed and/or eroded (land bush clearance, golf car drive path, stormwater runoff channels, fill slopes), asbestos fragments were scattered significantly below and above the plastic mesh material (Table 20)
