Coogee Bay Floodplain Risk
Management Study & Plan

APPENDIX

COMMUNITY NEWSLETTER

Newsletter

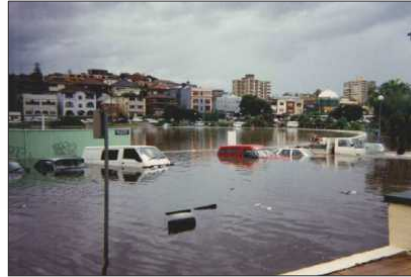
Flooding at Coogee Oval, 24 January 1999.

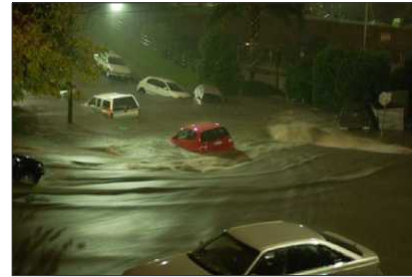
Flooding in Dolphin Street, 2 May 2009.

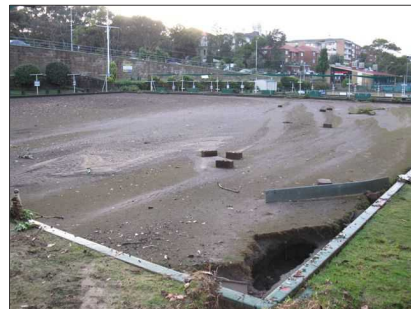
Flooding at Randwick Bowling Club, 3 May 2009

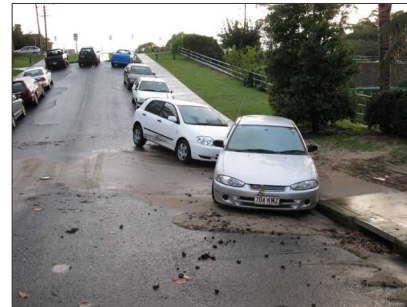
Flooding in Dolphin Street, 2 May 2009.
