# Detailed Site Investigation, Finucane Reserve, 1 Finucane Crescent, Matraville NSW

Randwick City Council

Report

5 March 2025

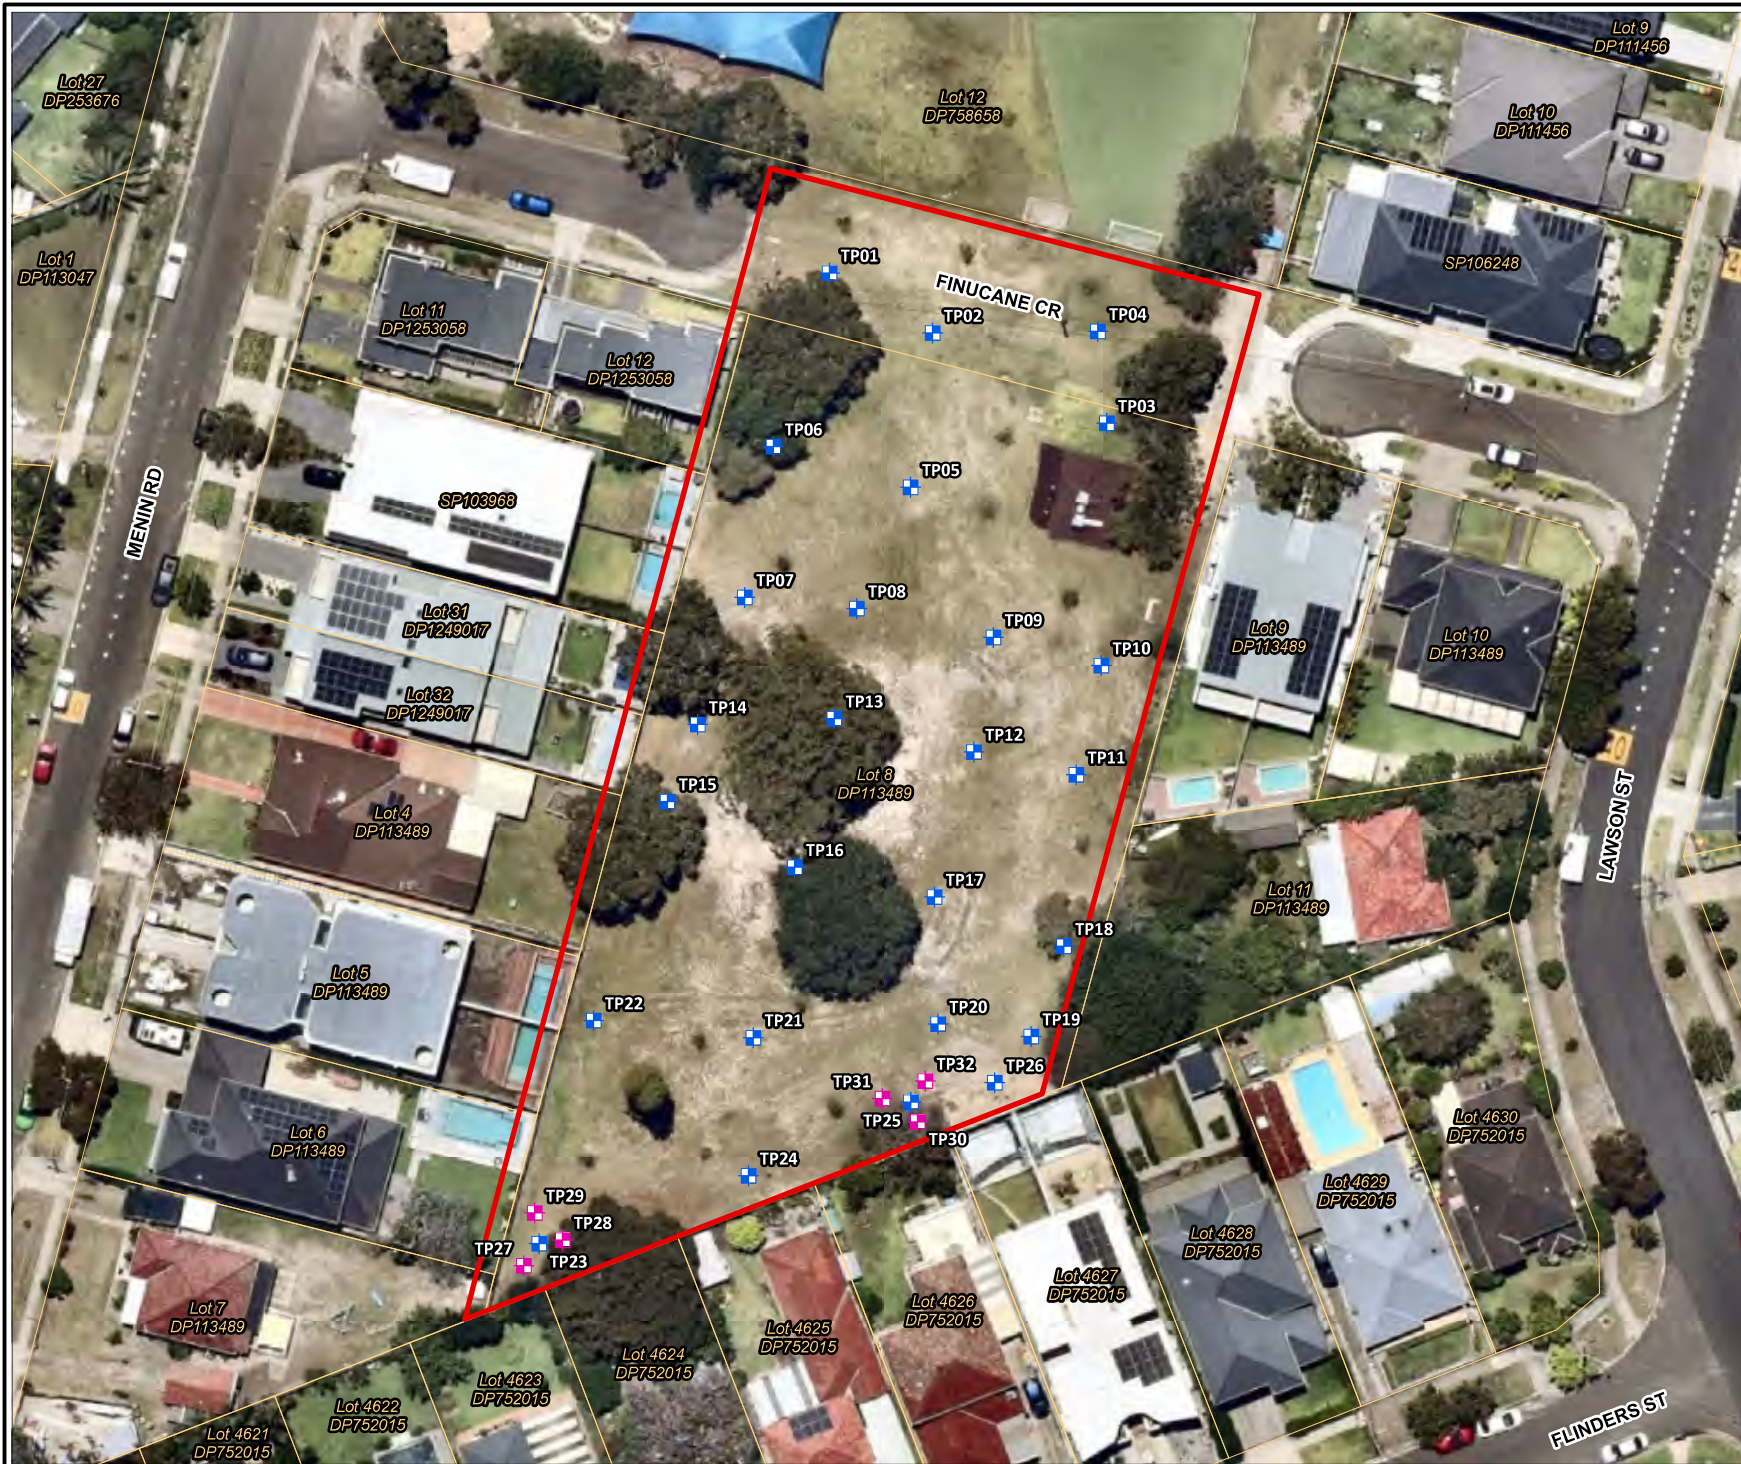
**SAMPLE LOCATIONS**

The lithology encountered at the site during the field works is summarised below. Detailed test pit logs are included in **Appendix F**. A total of 26 soil sample locations (TP01 to TP26) were advanced across the accessible site with an additional six observational test pits (TP27 to TP32) advanced in the southern portion of the site adjacent to test pits where ACM and anthropogenic inclusions were observed. See **Figure 2** for sample locations.

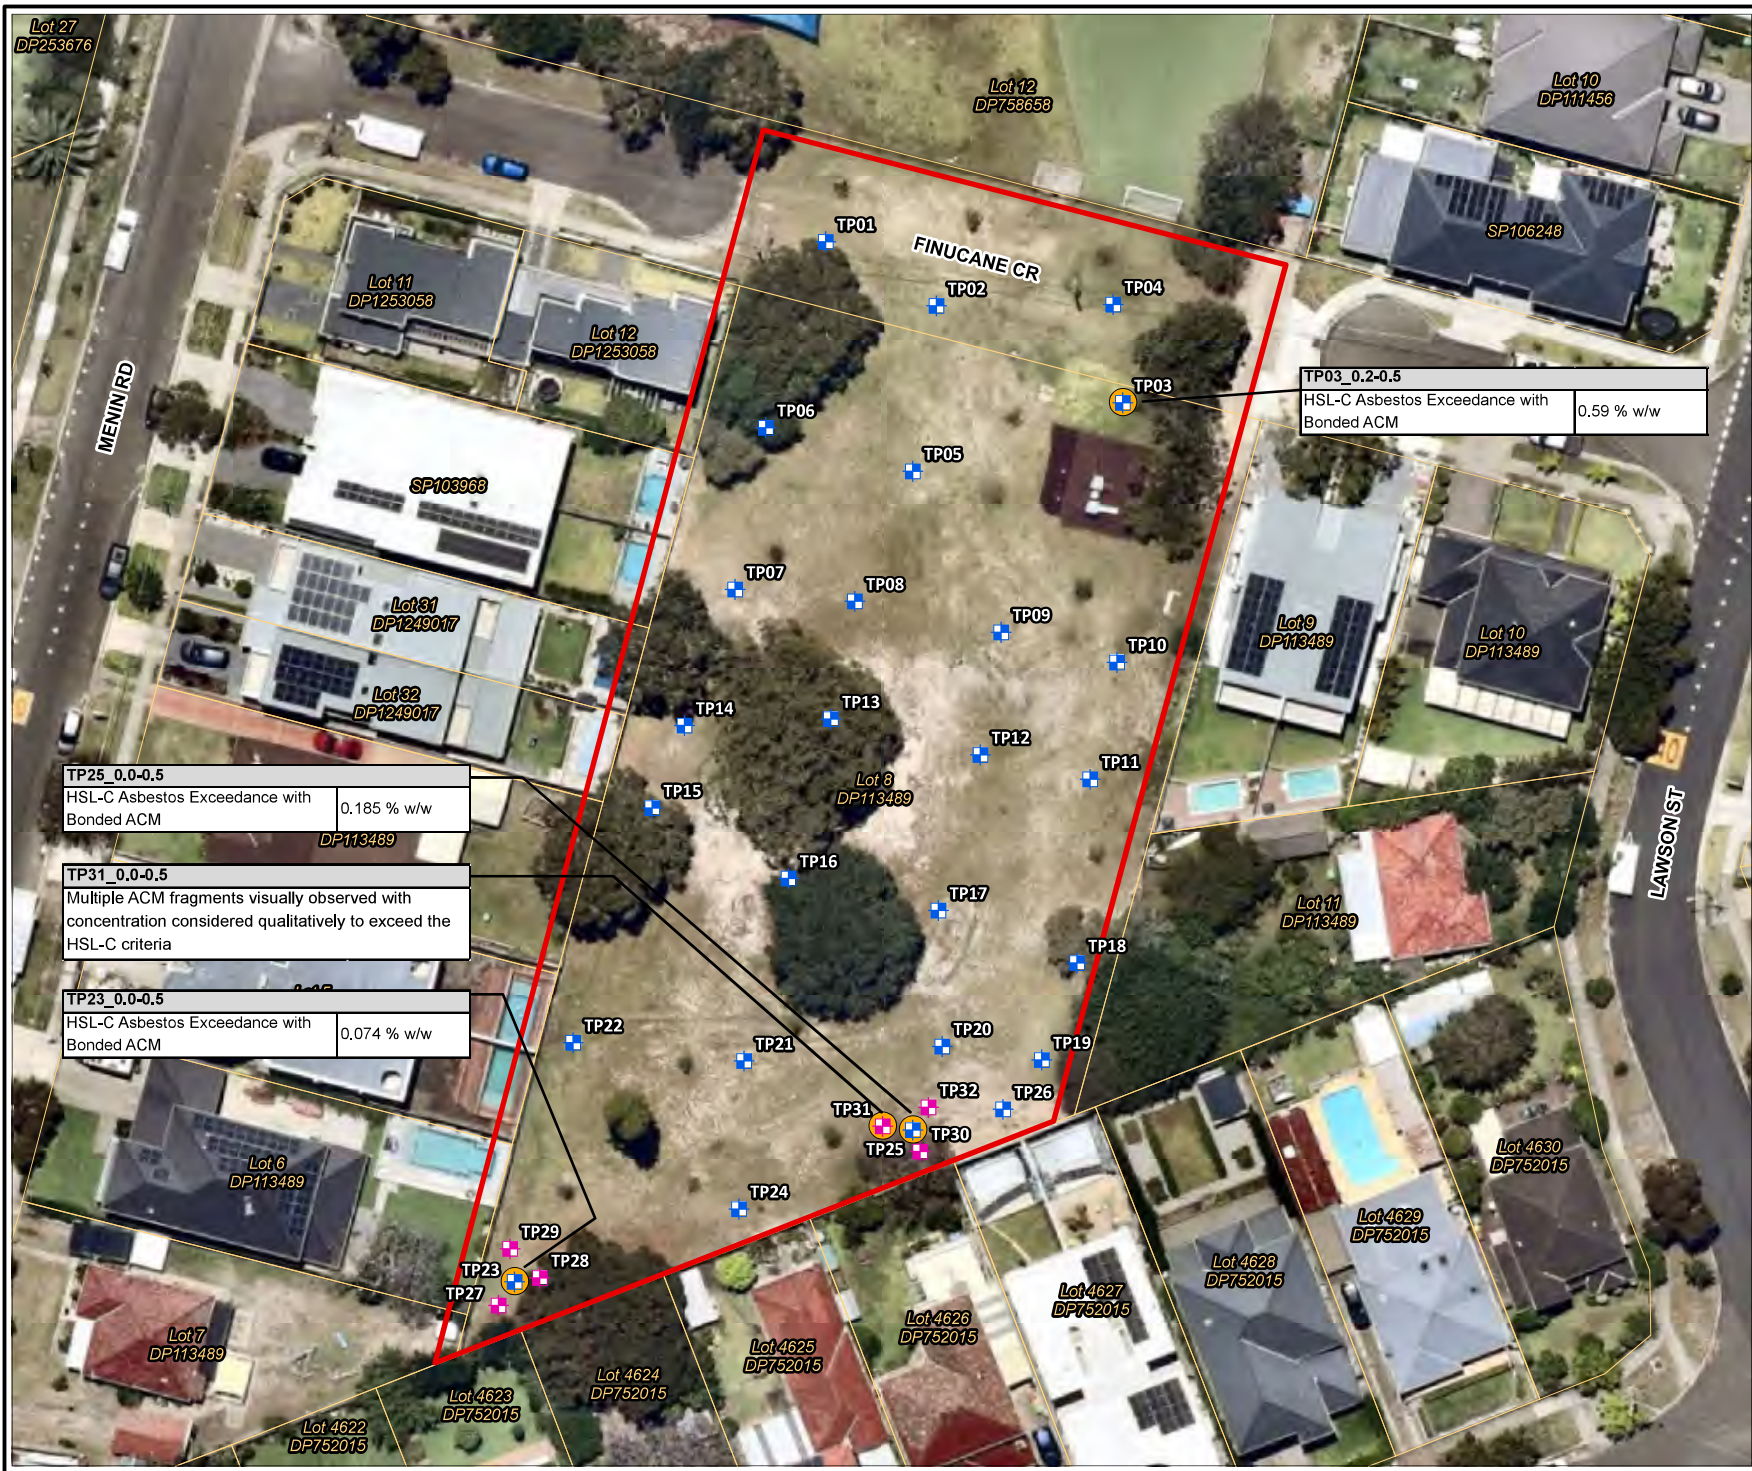
Bonded ACM was observed in four test pits (TP03, TP23, TP25 and TP31) with three of these noted to be in the southern portion and within an area that has had patches of sand (TP25 and TP31), and a single location (TP03) in the proposed works area near the playground. Locations where visible asbestos was observed are shown on **Figure 3**.

Bonded ACM was observed within fill material at three test pit locations (TP03 0.2-0.5, TP23 0-0.5 and TP25 0-0.5) where samples were collected and analysed. In addition, ACM was observed in one (TP31 0-0.5) of the additional six test pits (TP27-TP32) advanced for visual inspections.

- TP23\_0-0.5 exceeded a the adopted HSL-C (0.02%) for bonded asbestos (ACM) in soil with a concentration of 0.074 %w/w;
- TP25\_0-0.5 exceeded a the adopted HSL-C (0.02%) for bonded asbestos (ACM) in soil with a concentration of 0.185 %w/w; and
- TP31: Asbestos quantification was not conducted at this location due to the size of ACM fragments observed, with concentration considered qualitatively to exceed the adopted criteria.
