**Southern Metropolitan Cemeteries Trust  
12 Military Road  
Matraville NSW 2036**

Project 86050.01  
14 May 2018  
R.001.Rev0  
SCP:cm

**Preliminary Geotechnical Investigation  
Proposed Extension of Existing Cemetery  
Prince of Wales Drive, Matraville**

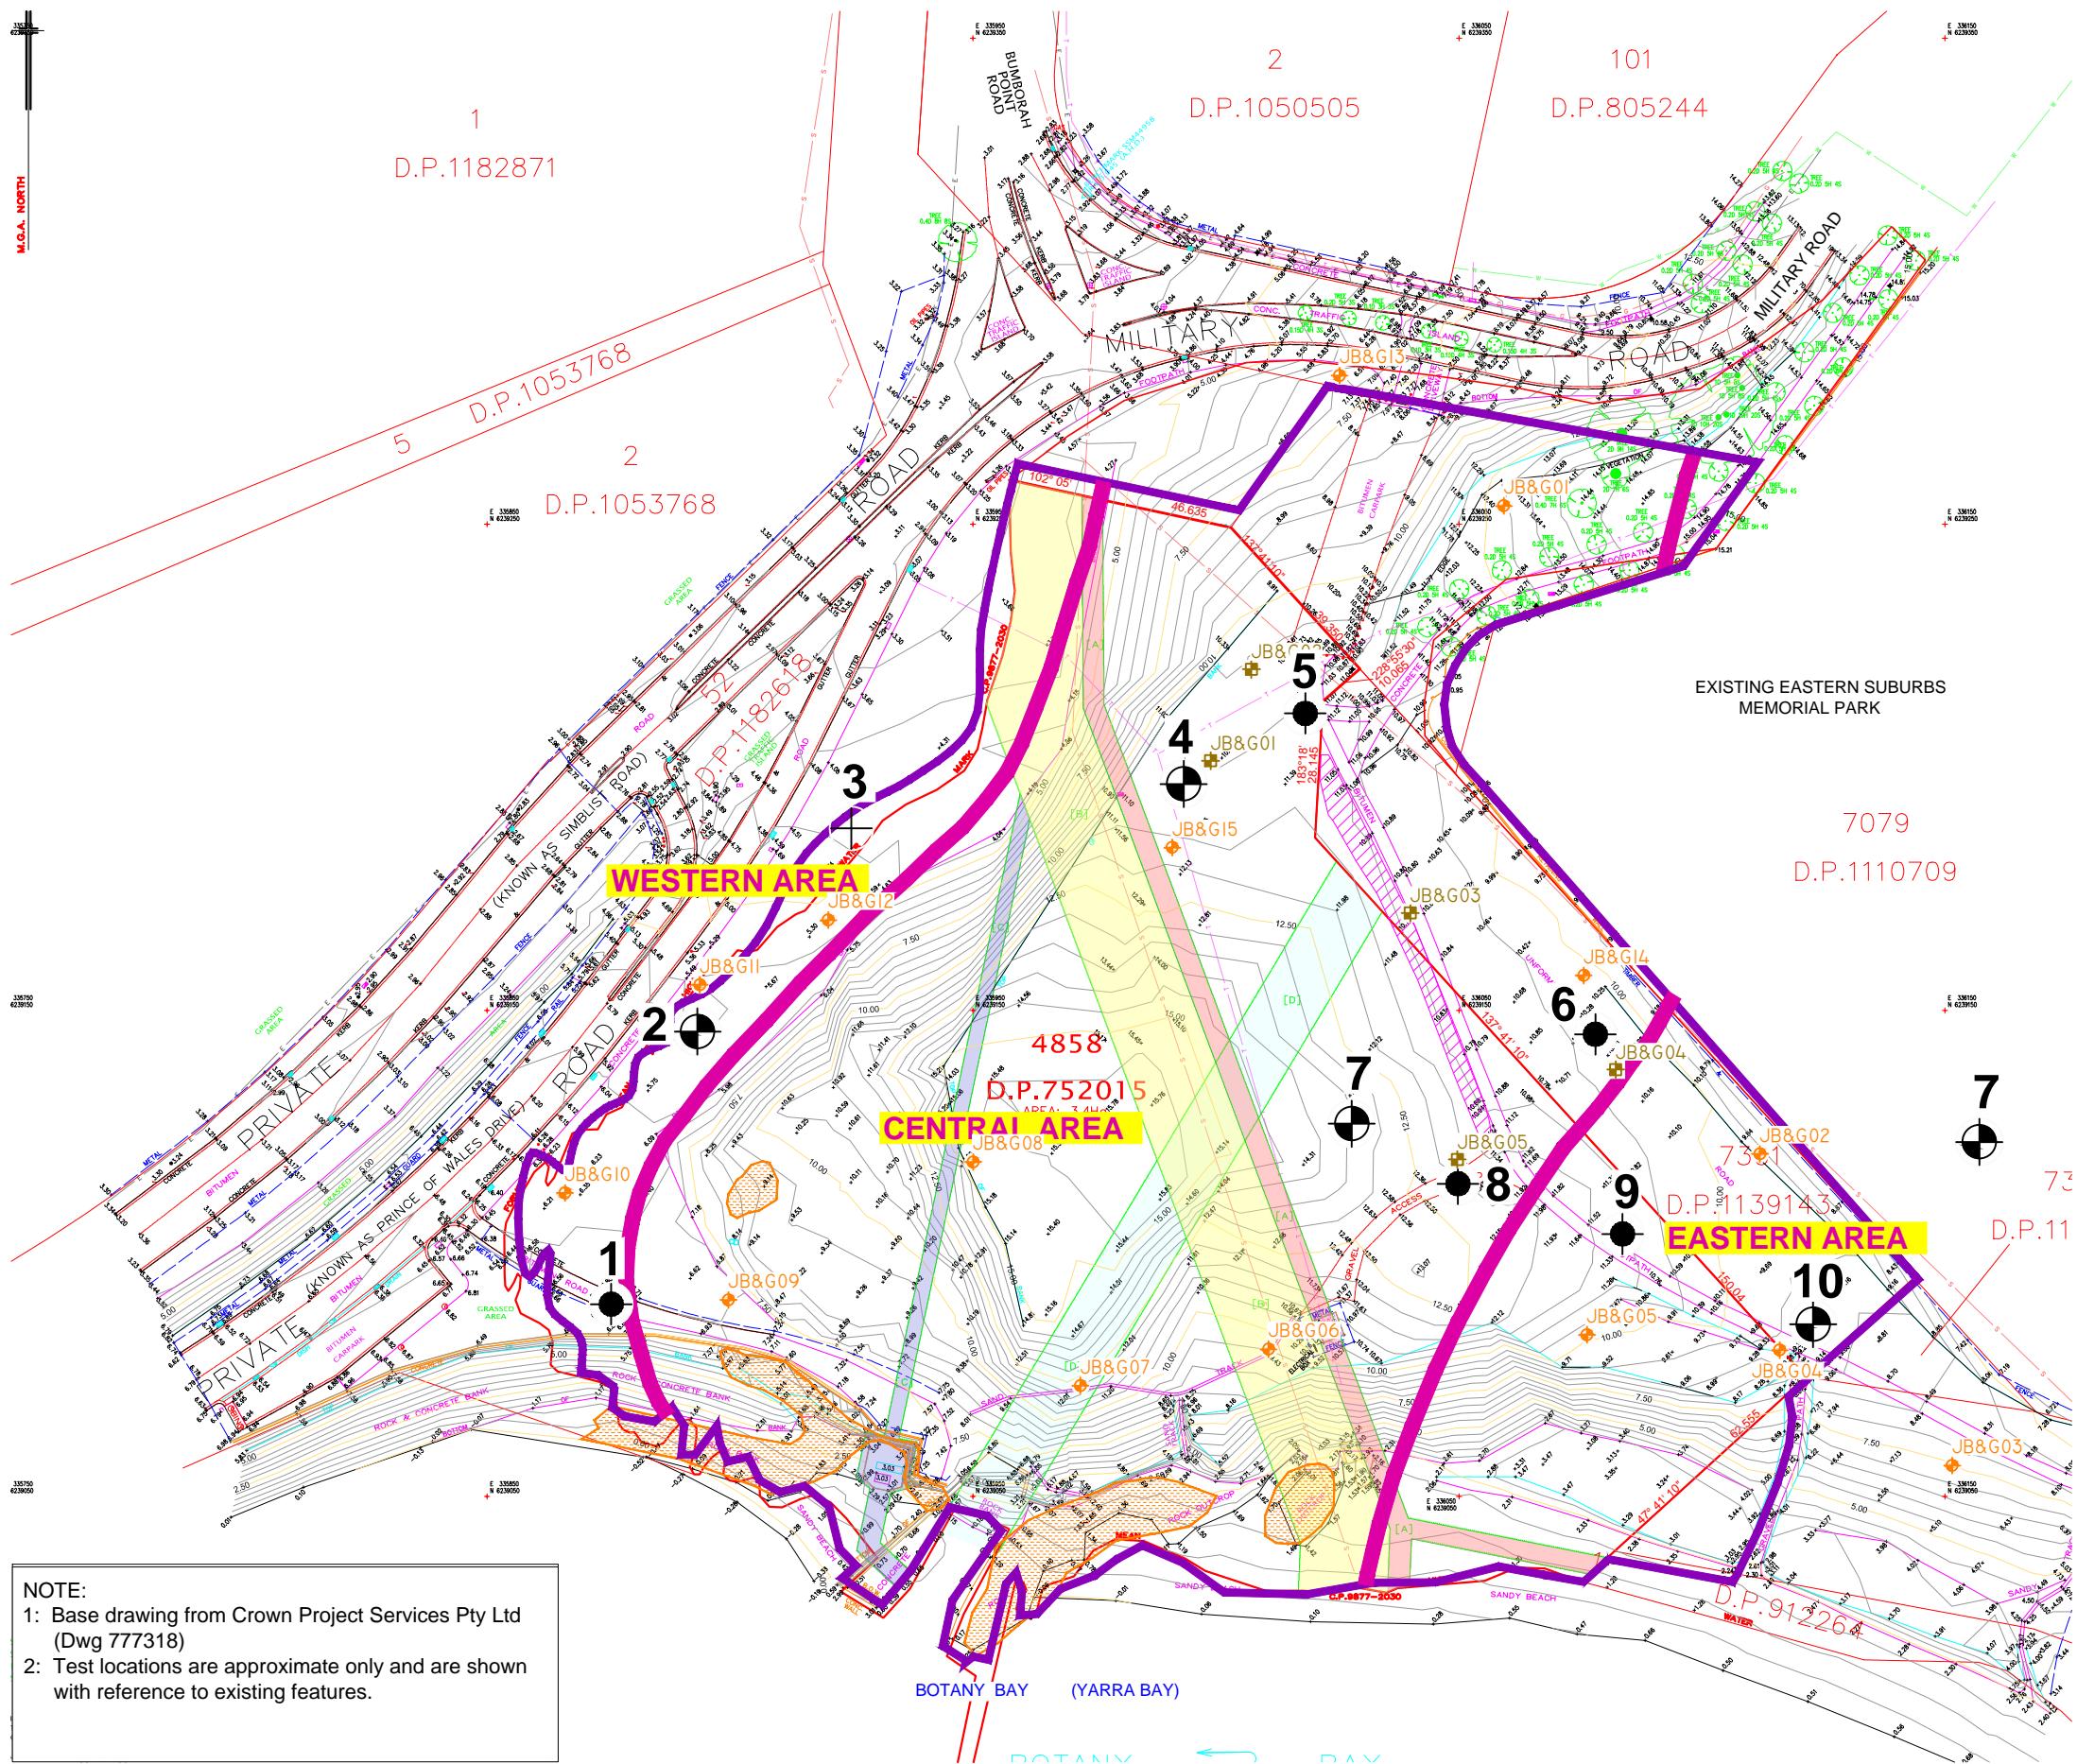
- Site Boundary
- ▨ Stockpile
- ▨ Sandstone outcrop
- Approximate model area boundary
- ◆ CPT location
- ◆ Shallow borehole location
- + DPT location
- ◆ Environmental borehole (JBS&G) location
- ▨ Environmental test pit (JBS&G) location

A preliminary contamination site investigation for the site was undertaken in March 2018, and the resulting report (Report 54725/114752 Rev0, dated 4 May 2018, by JBS&G Australia Pty Ltd (JBS&G)) was provided to DP by Urbis to assist with the current report. Test locations from that investigation have been superimposed on Drawing 1, attached.

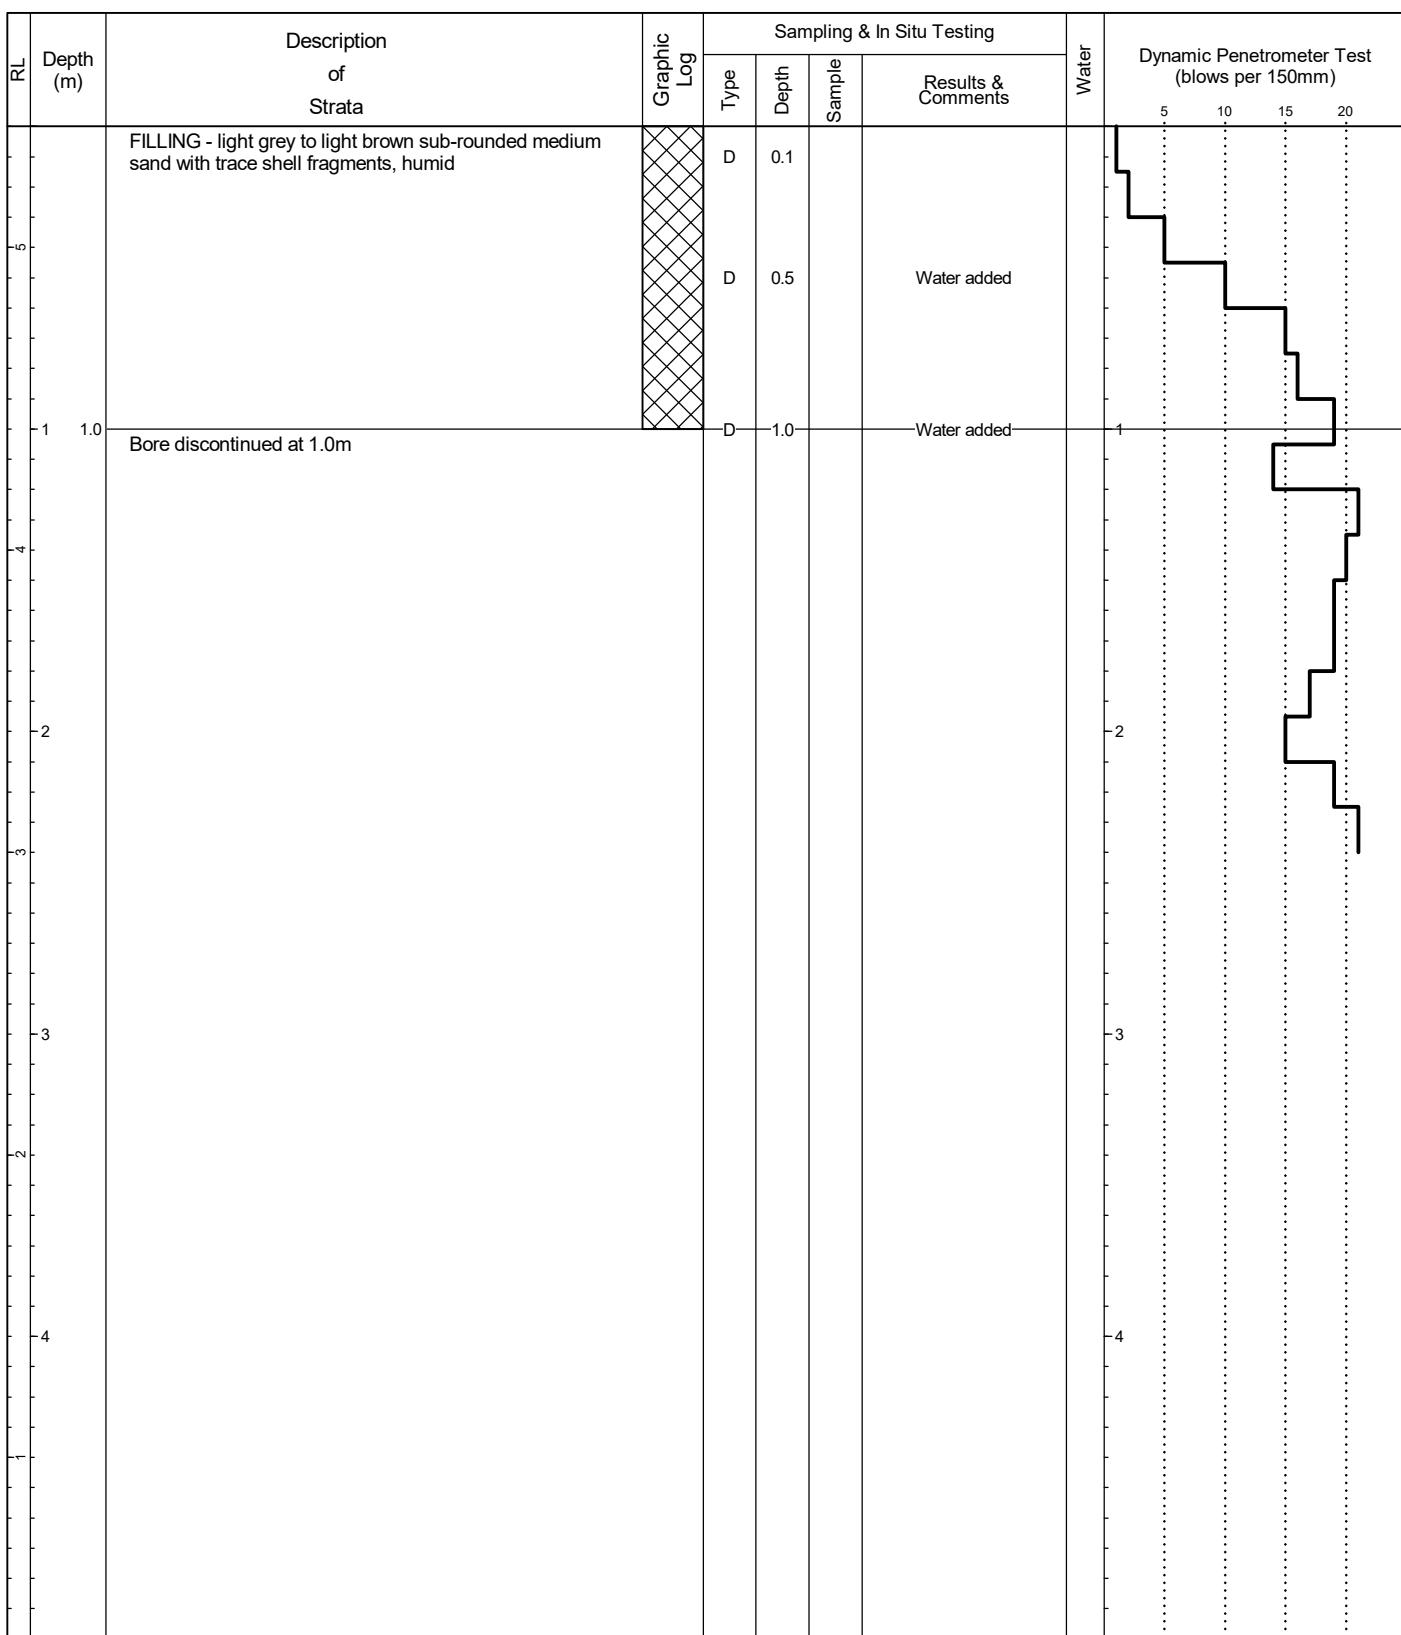
**BORE No:** 2  
**PROJECT No:** 86050.01  
**DATE:** 12/4/2018  
**SHEET** 1 OF 1

**WATER OBSERVATIONS:** No free groundwater observed whilst augering

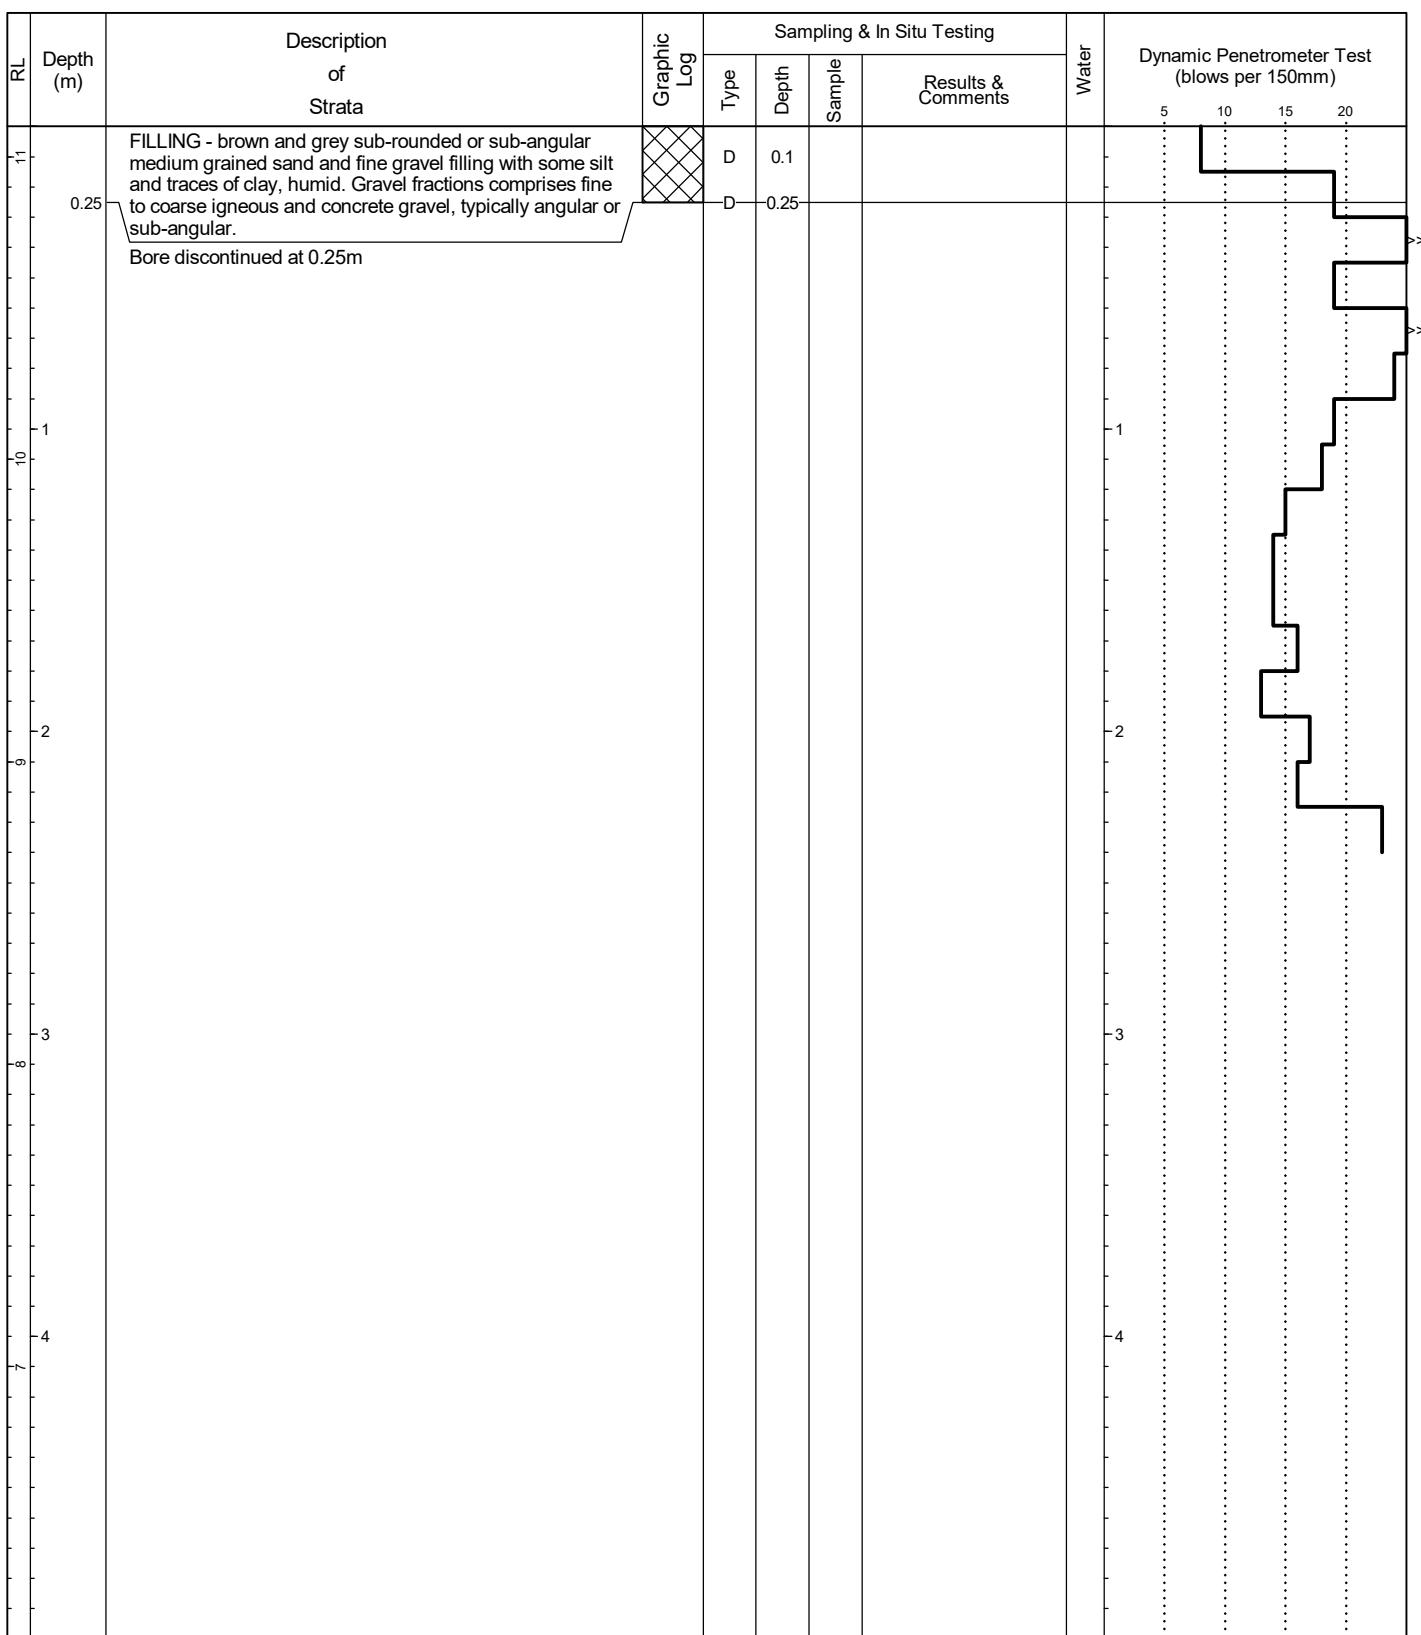
**BORE No:** 4  
**PROJECT No:** 86050.01  
**DATE:** 12/4/2018  
**SHEET** 1 OF 1

**WATER OBSERVATIONS:** No free groundwater observed whilst augering

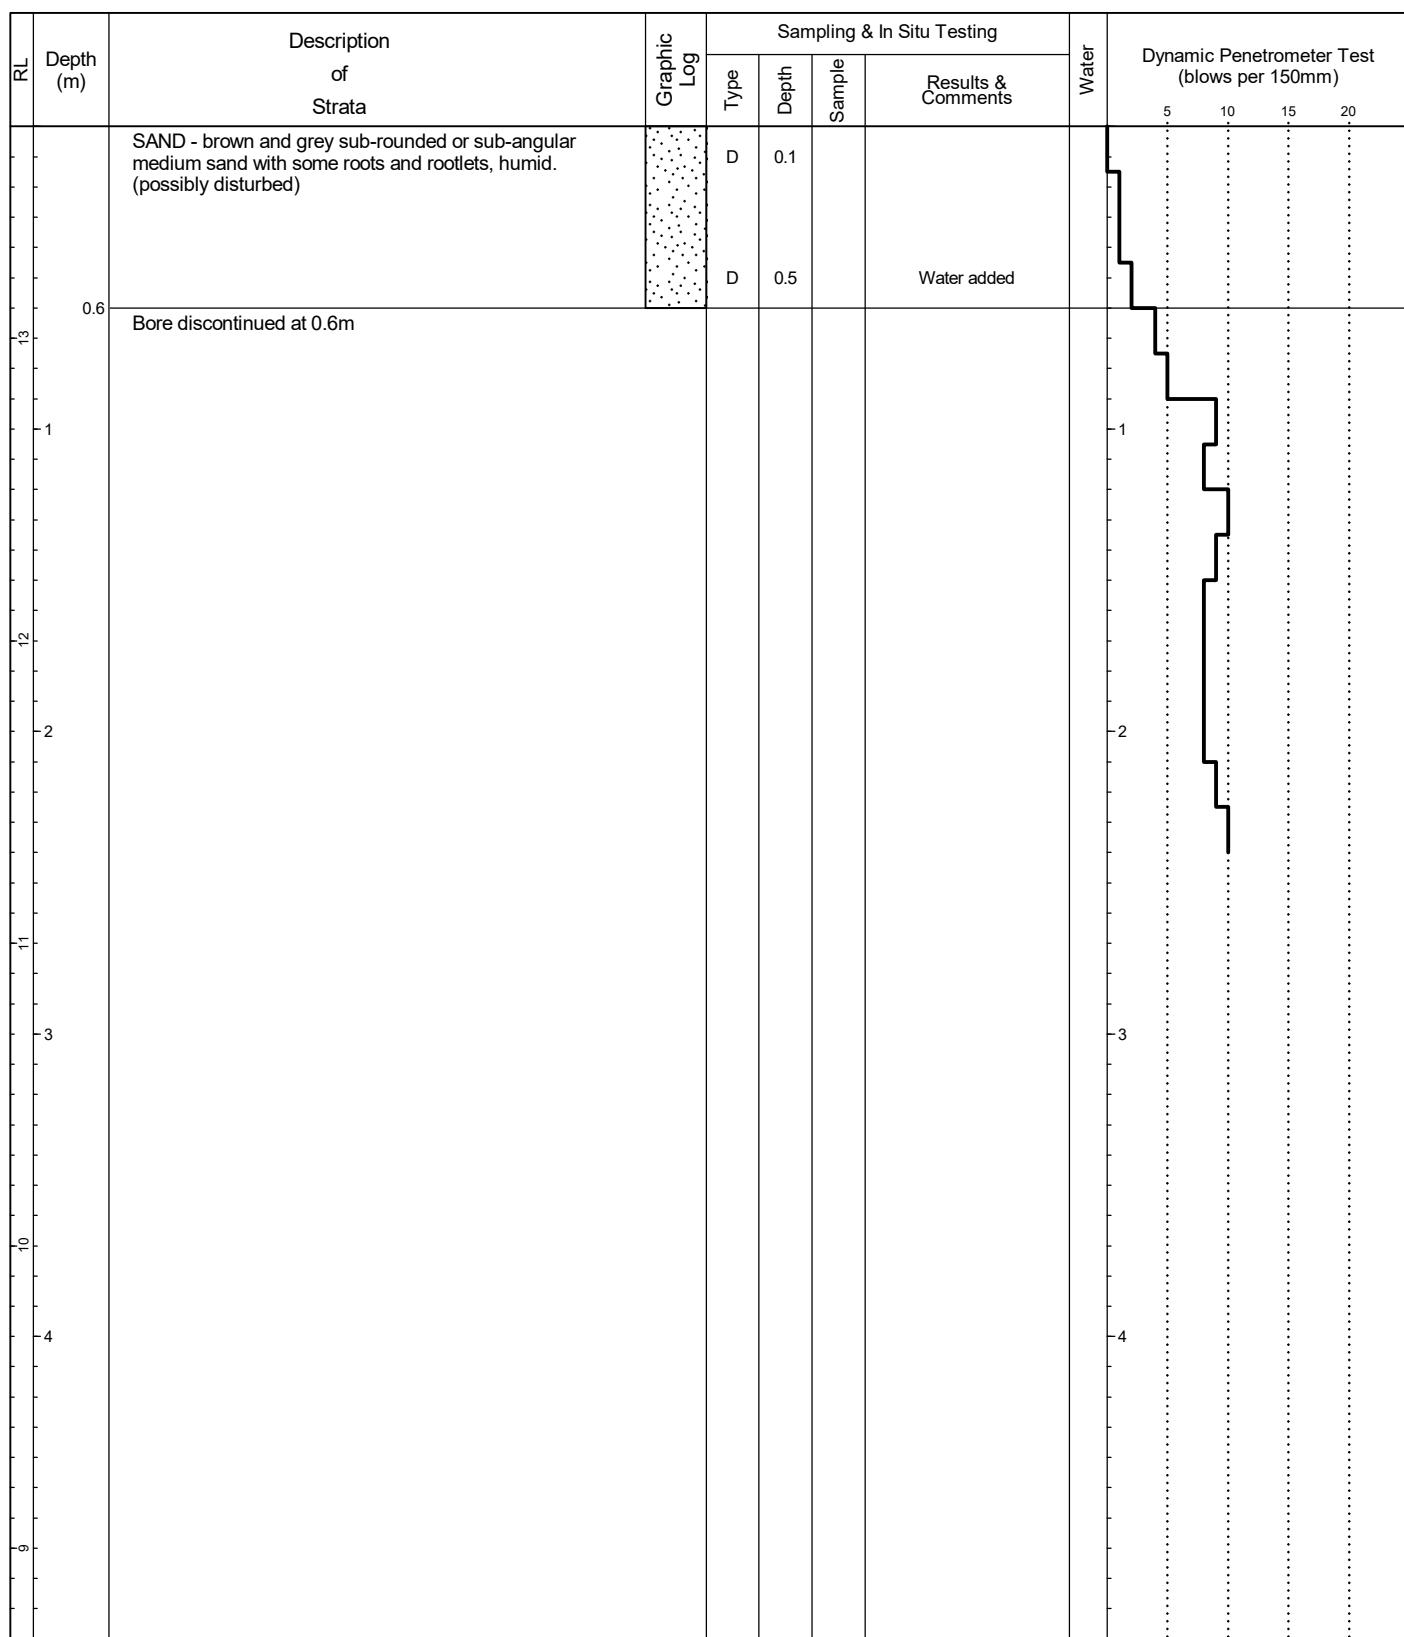
**BORE No:** 7  
**PROJECT No:** 86050.01  
**DATE:** 12/4/2018  
**SHEET** 1 OF 1

**WATER OBSERVATIONS:** No free groundwater observed whils augering

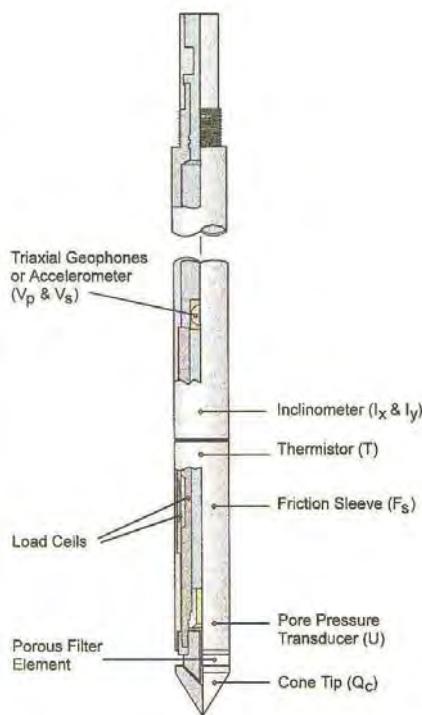
Figure 1: Cone Diagram

- Cone tip resistance  $q_c$
- Sleeve friction  $f_s$
- Inclination (from vertical)  $i$
- Depth below ground  $z$

The inclinometer in the cone enables the verticality of the test to be confirmed and, if required, the vertical depth can be corrected.

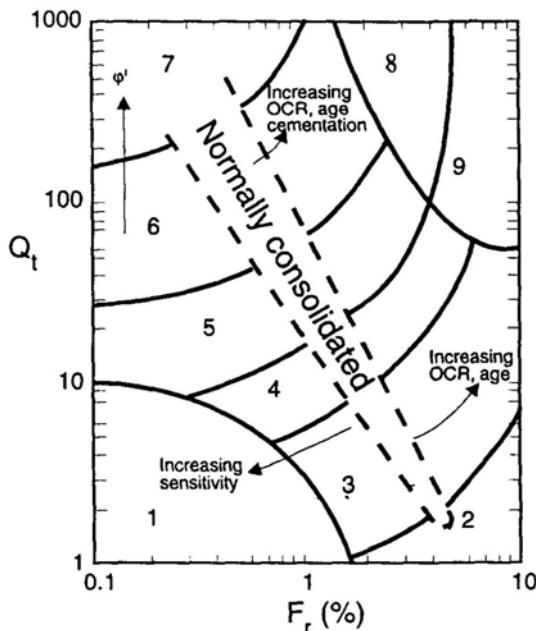
Figure 3: Soil Classification Chart

DP's in-house CPT software provides computer aided interpretation of soil strata, generating soil descriptions and strengths for each layer. The software can also produce plots of estimated soil parameters, including modulus, friction angle, relative density, shear strength and over consolidation ratio.

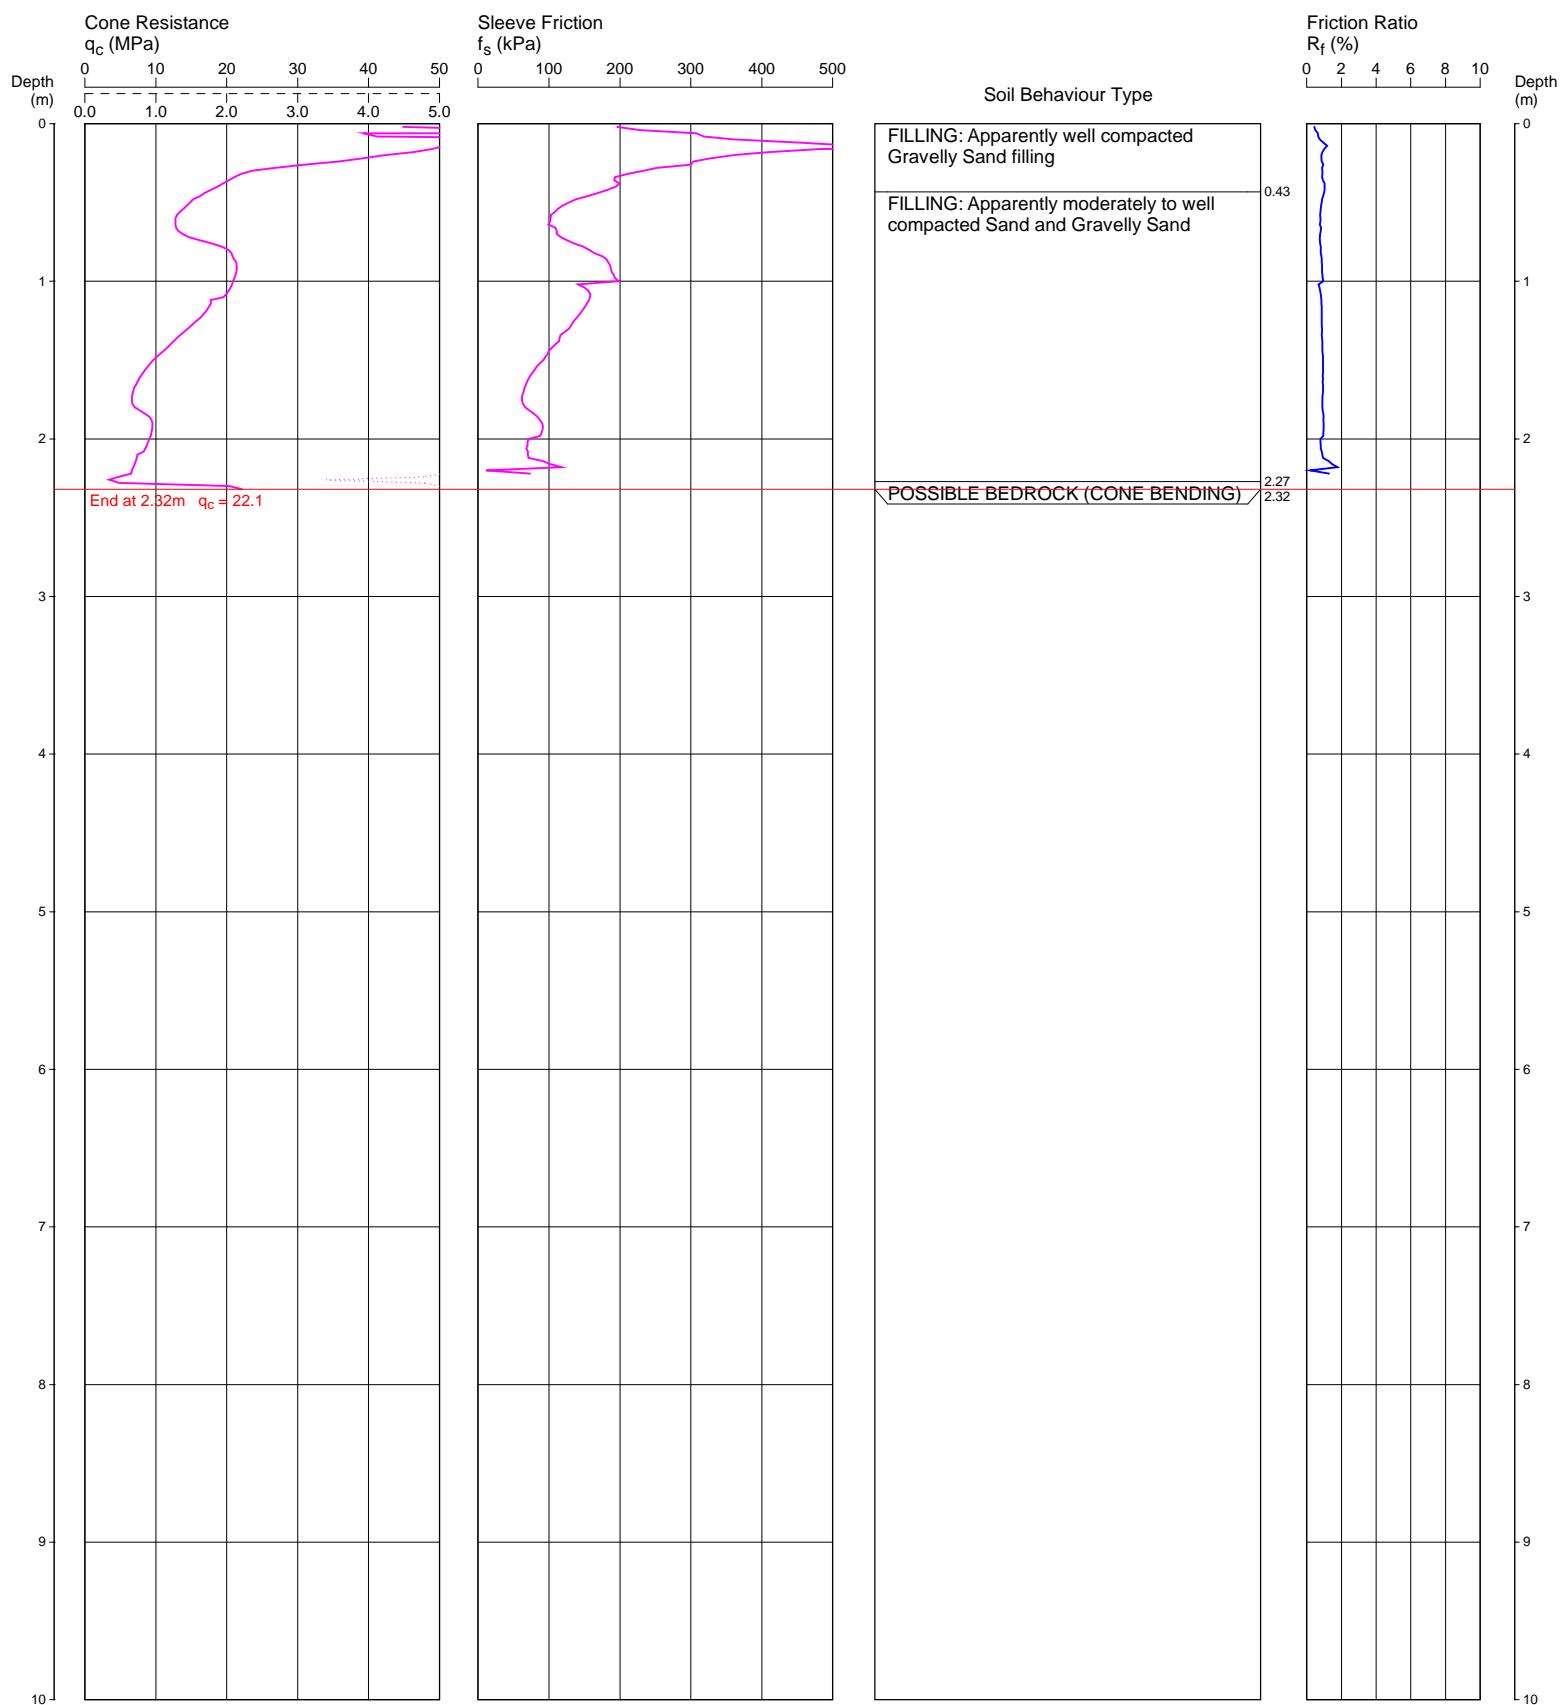
**REMARKS:** TEST DISCONTINUED DUE TO SUDDEN BEND ON PROBABLE ROCK  
HOLE COLLAPSED AT 1.9 m DEPTH AFTER WITHDRAWAL OF RODS

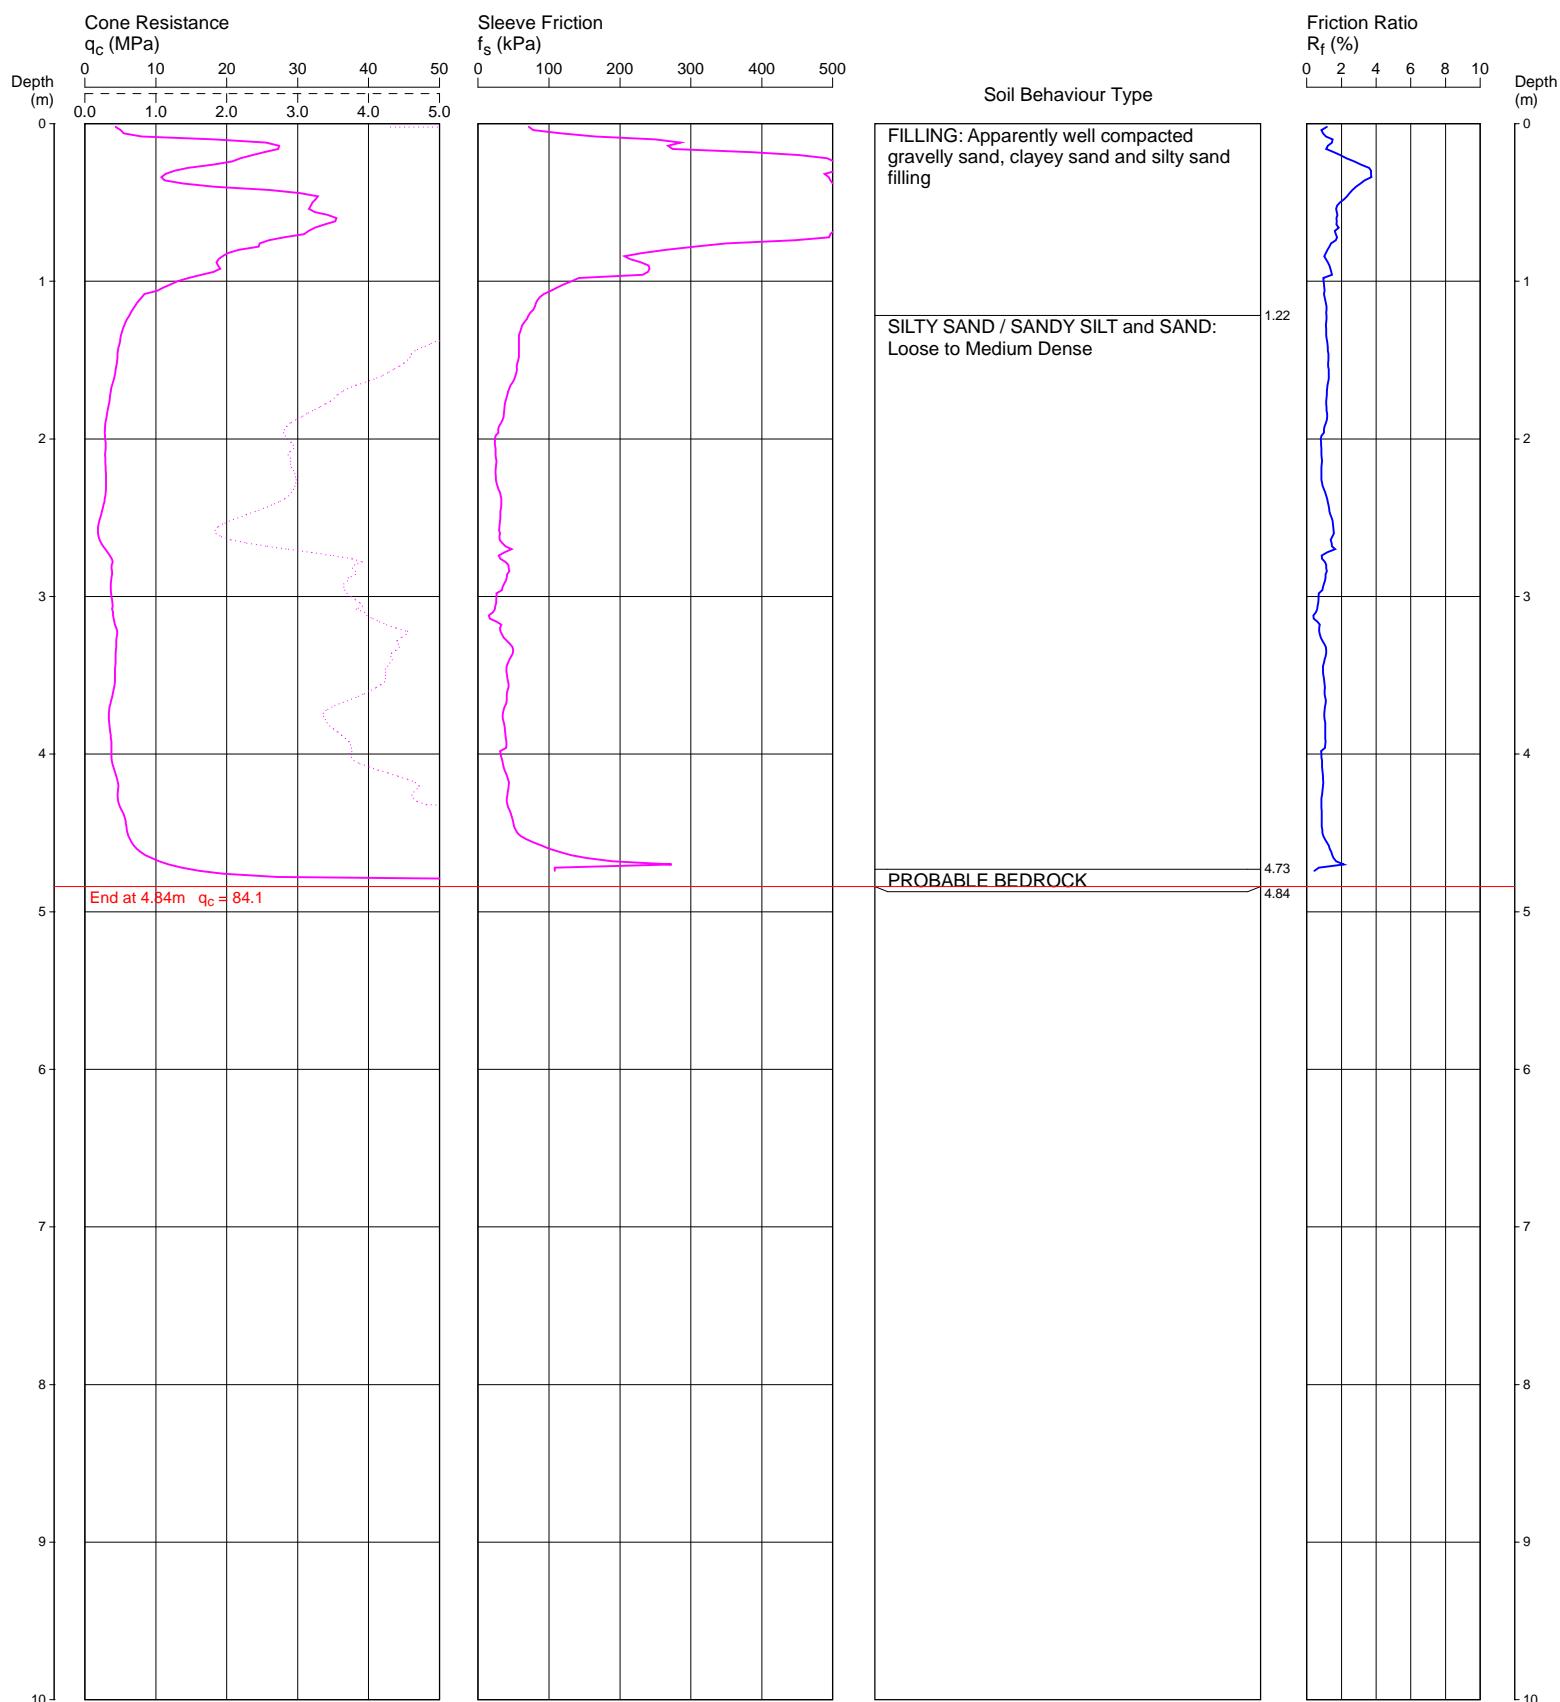
**REMARKS:** TEST DISCONTINUED AT REFUSAL  
HOLE COLLAPSED AT 0.3 m DEPTH AFTER WITHDRAWAL OF RODS

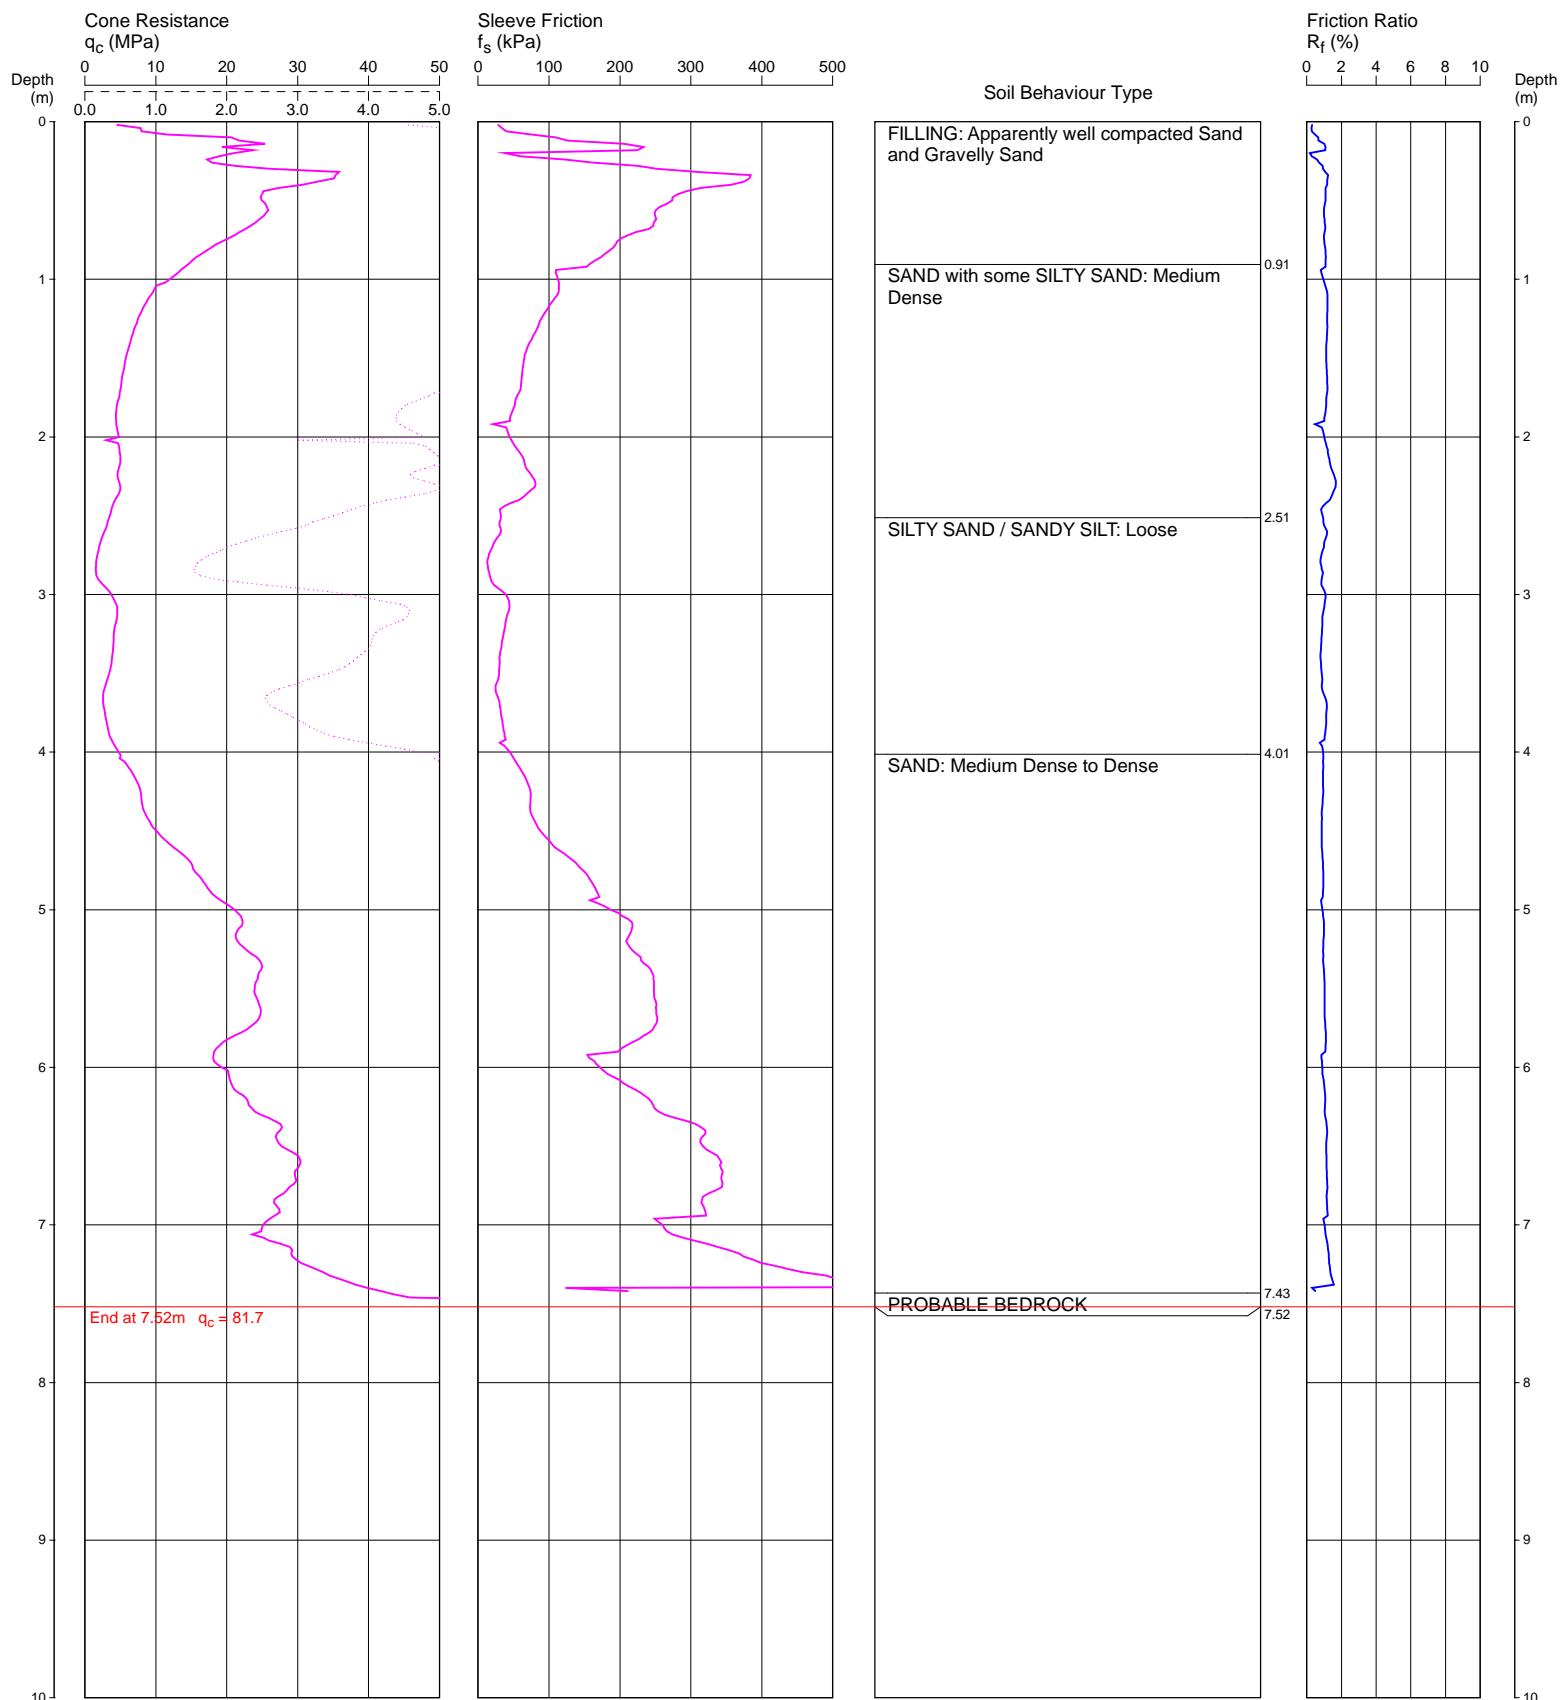
**REMARKS:** TEST DISCONTINUED AT REFUSAL  
HOLE COLLAPSED AT 4.9 m DEPTH AFTER WITHDRAWAL OF RODS

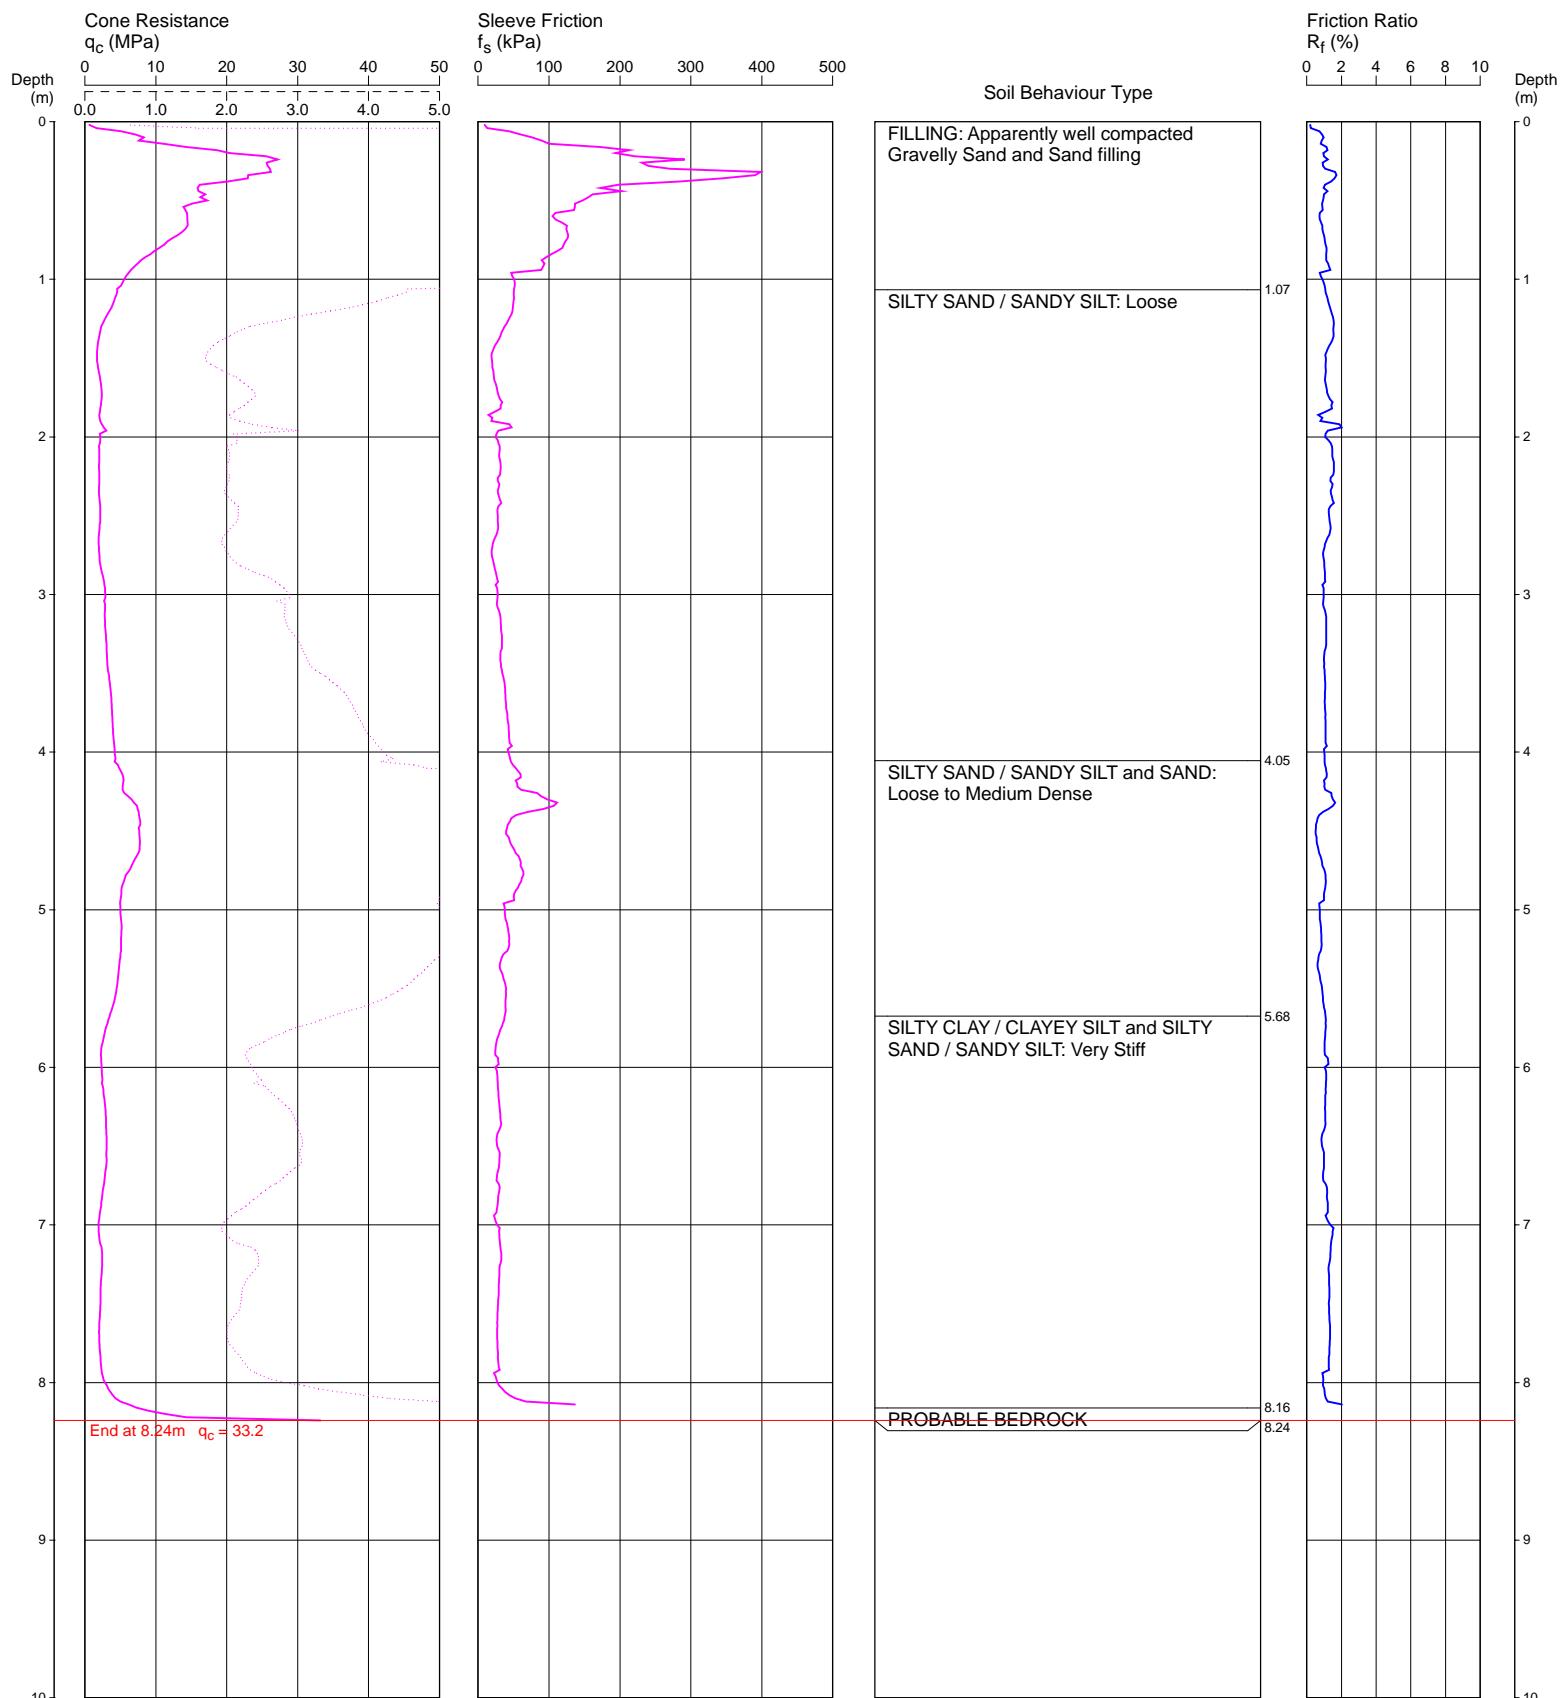
**REMARKS:** TEST DISCONTINUED DUE TO SUDDEN BENDING ON PROBABLE ROCK  
HOLE COLLAPSED AT 7.8 m DEPTH AFTER WITHDRAWAL OF RODS
