**Southern Metropolitan Cemeteries Trust  
12 Military Road  
Matraville NSW 2036**

Project 86050.01  
14 May 2018  
R.001.Rev0  
SCP:cm

**Preliminary Geotechnical Investigation  
Proposed Extension of Existing Cemetery  
Prince of Wales Drive, Matraville**

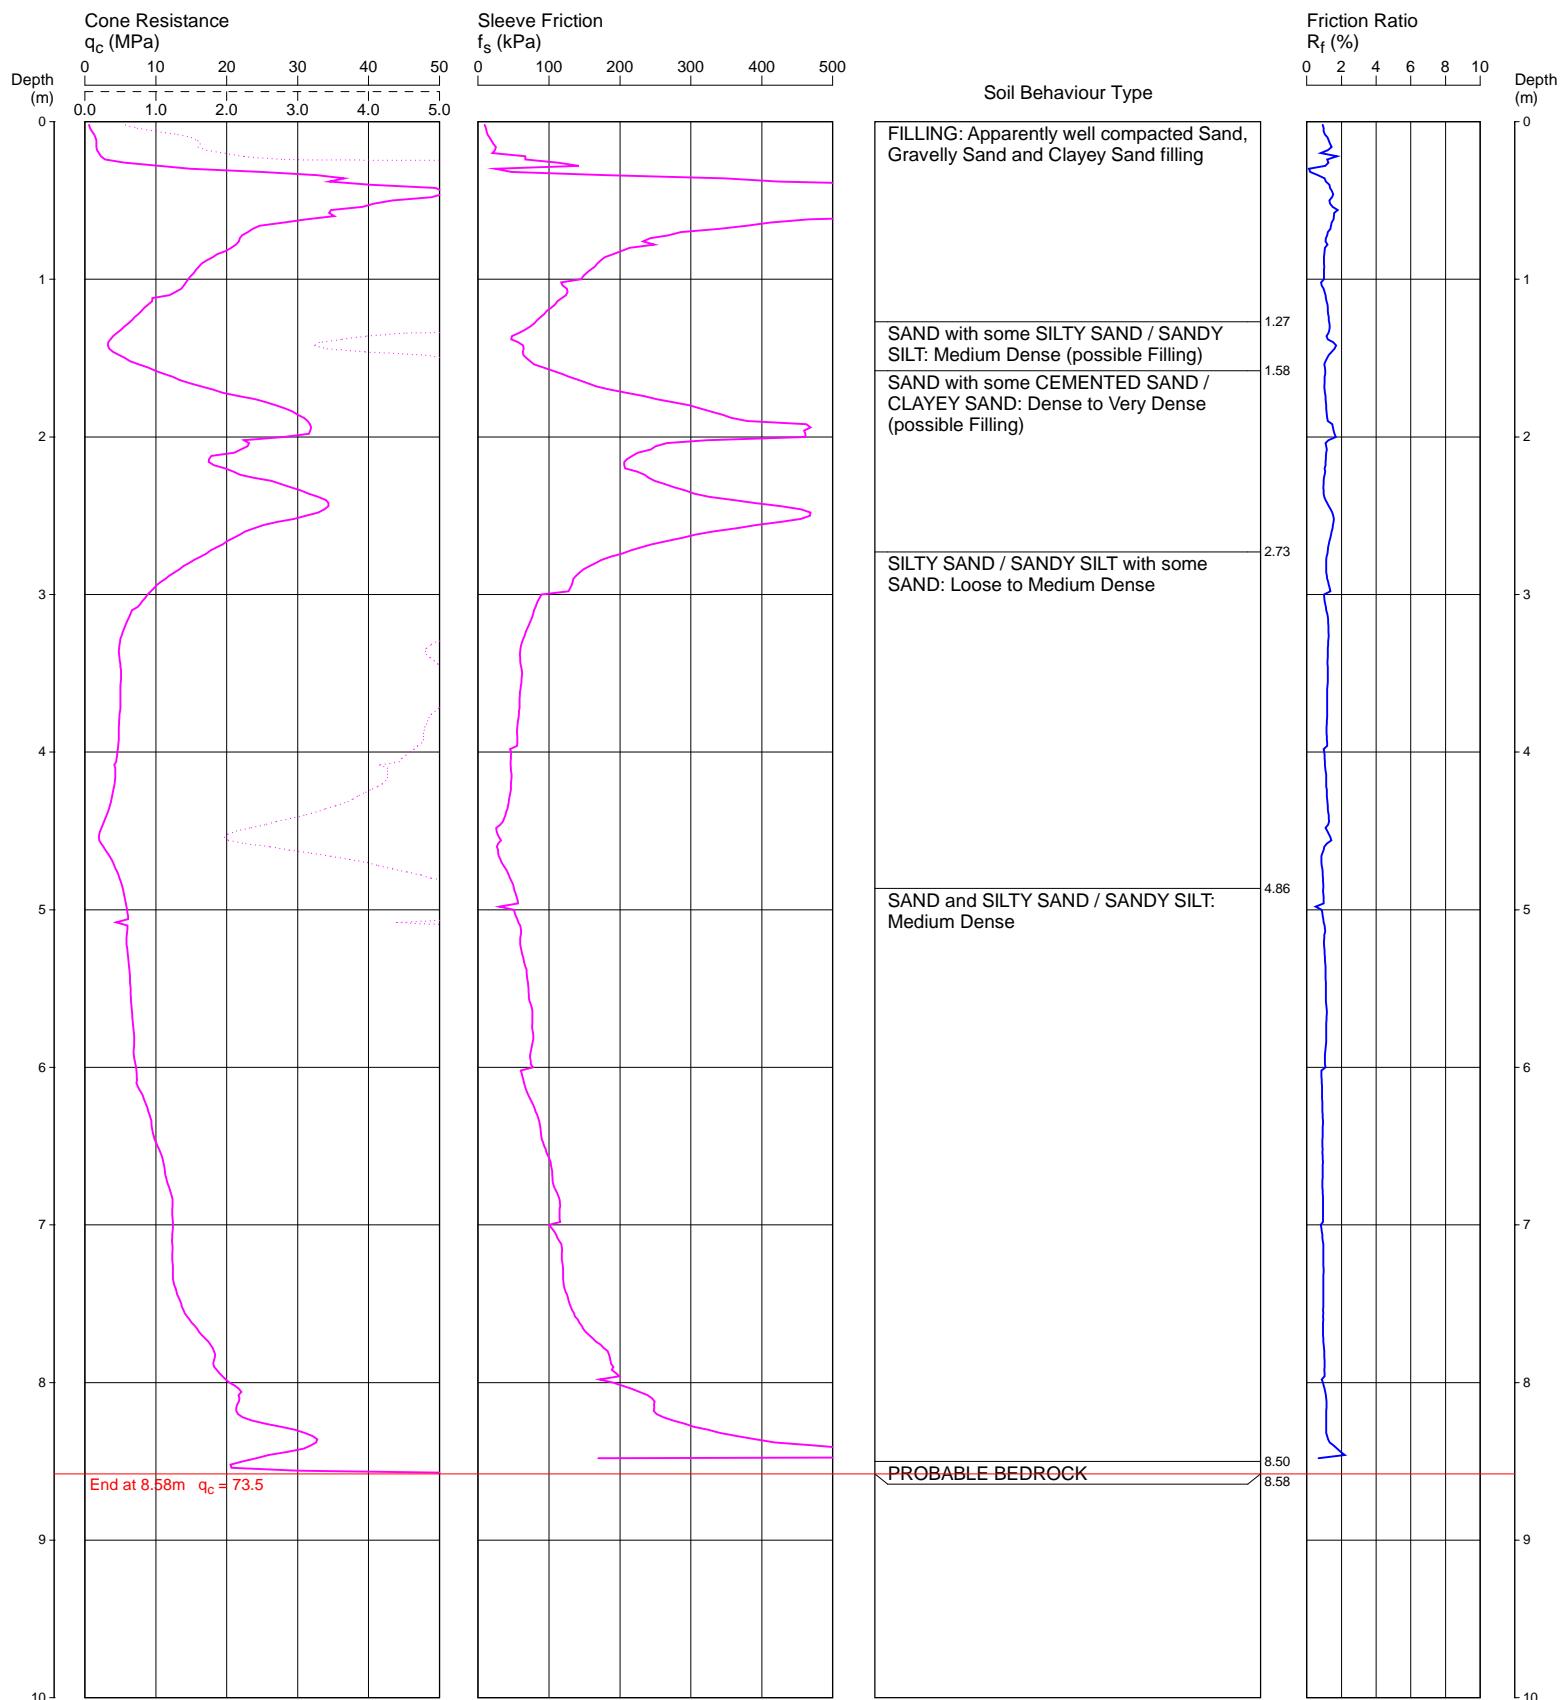
**REMARKS:** TEST DISCONTINUED DUE TO REFUSAL  
HOLE COLLAPSED AT 7.1 m DEPTH AFTER WITHDRAWAL OF RODS

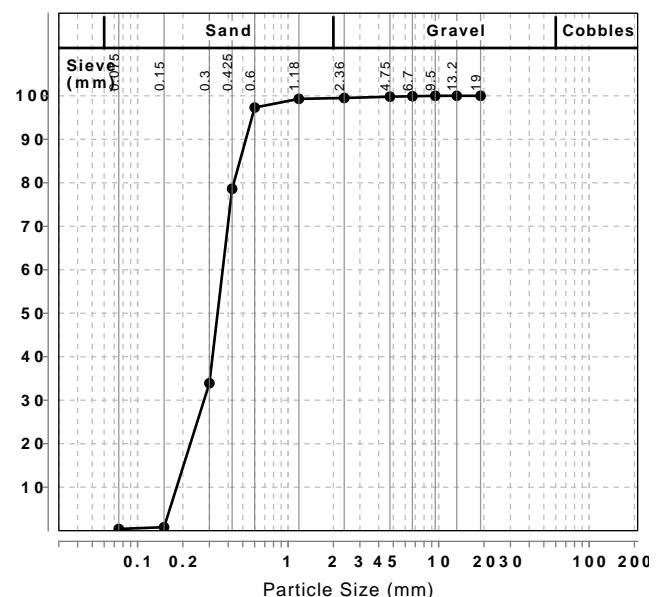
Particle Size Distribution

**Report Number:** 86050.01-1  
**Issue Number:** 1  
**Date Issued:** 30/04/2018  
**Client:** Southern Metropolitan Cemeteries Trust  
 12 Military Road, Matraville NSW 2036  
**Contact:** Tim Dowe  
**Project Number:** 86050.01  
**Project Name:** Proposed Extension of Existing Cemetery  
**Project Location:** Prince of Wales Drive, Matraville  
**Work Request:** 2906  
**Sample Number:** 18-2906B  
**Date Sampled:** 23/04/2018  
**Sample Location:** 4 (0.25-0.25)  
**Material:** Brown sand and gravel with some silt

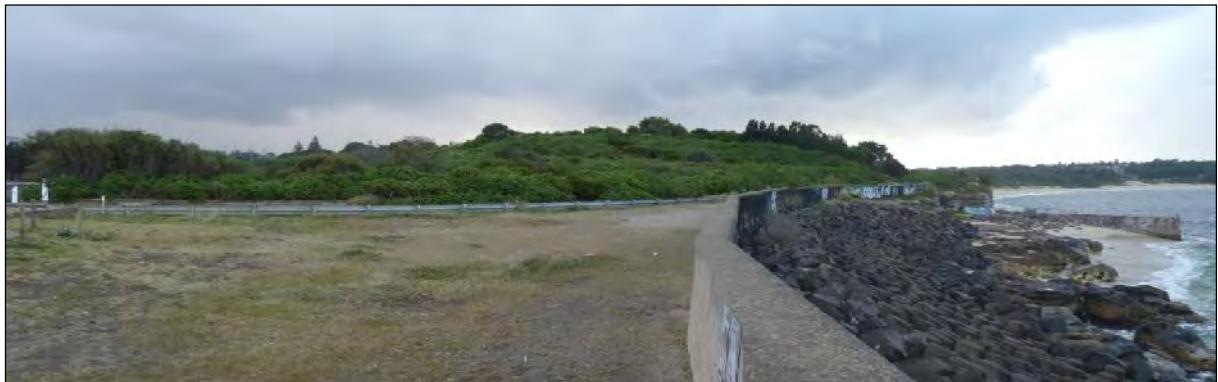
sandstone cliffs transitioned to concrete erosion protection measures founded on the rock platform as can be seen in Figure 1.

**Figure 1: View of site from western corner**

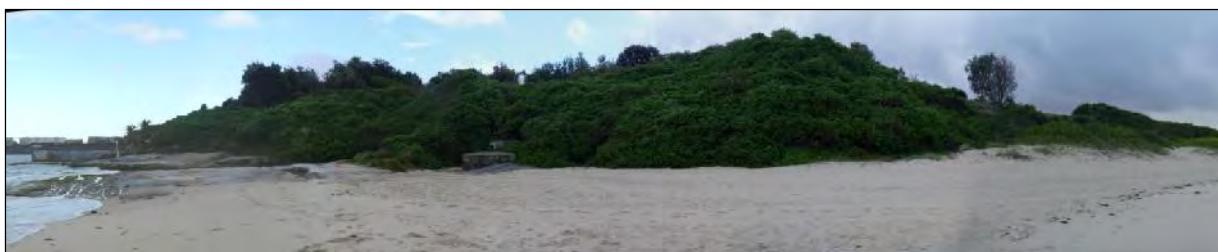
Towards the eastern side of the site, no sandstone cliffs nor rock platforms were visible, and site slopes were heavily vegetated (see Figure 2).

**Figure 2: View of site from near eastern corner.**

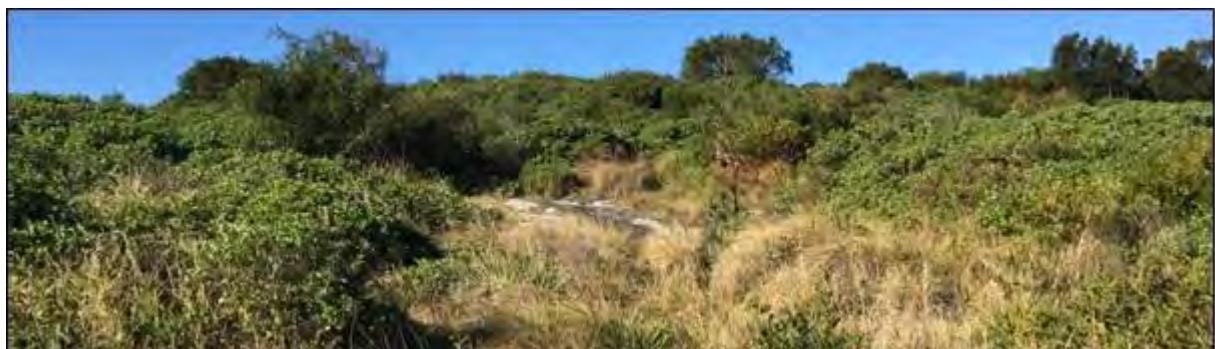
Grass, low shrubs and some trees were present towards the western side of the LPLALC land, with vegetation generally becoming more dense with distance from Prince of Wales Drive, and slopes in this area generally densely vegetated. A sandstone outcrop was visible, though not readily accessible towards the south-western area of the site, in an area of sloping ground, as shown in Figure 3, below, and Drawing 1 in Appendix B.

**Figure 3: Sandstone outcrop in south-western area**

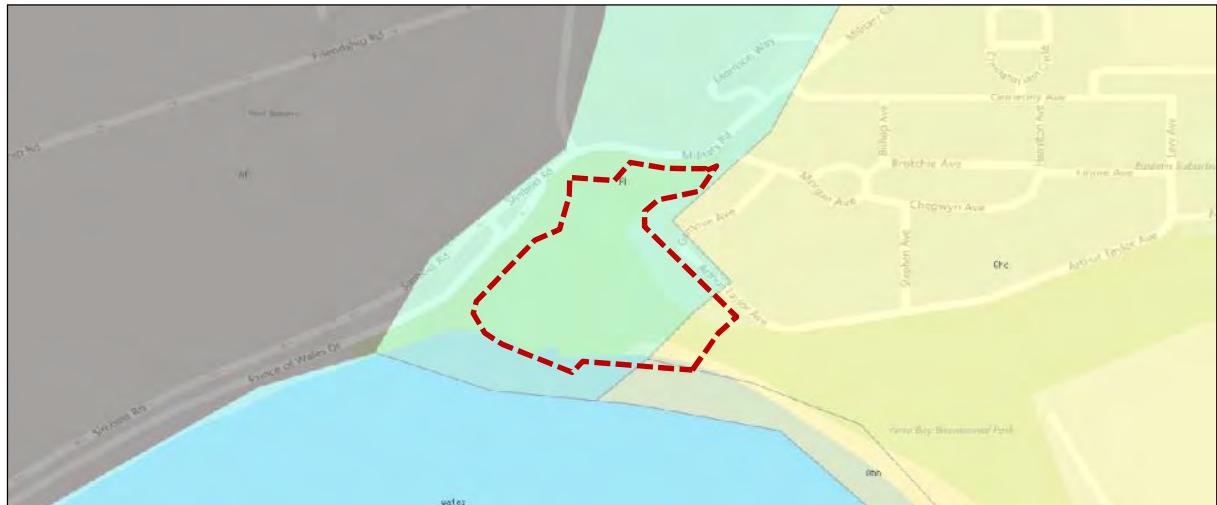
Reference to the 1:100,000 Sydney Geological Series Sheet indicates that the site is mapped as underlain by Hawkesbury Sandstone, near filling to the west of the site, and deep Quaternary Age soils at the south-eastern corner, and generally east of the site (refer Figure 4, below)

**Figure 4: Geological Mapping (green is Hawkesbury Sandstone, grey is filling and yellow is Quaternary Age soils)**

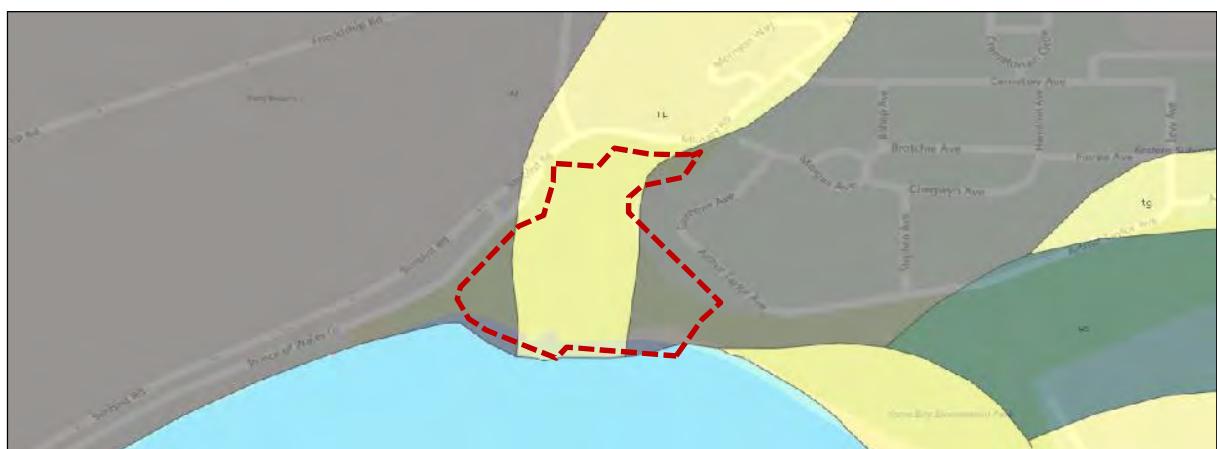
Reference to the 1:100 000 Soil Landscape Series indicates that the site is underlain by a central swathe of aeolian sand of the Newport Soil Landscape, and by disturbed terrain at the eastern and western sides of the site (see Figure 5, below).

**Figure 5: Soil Landscape Mapping (grey is disturbed ground; yellow is Aeolian sand)**

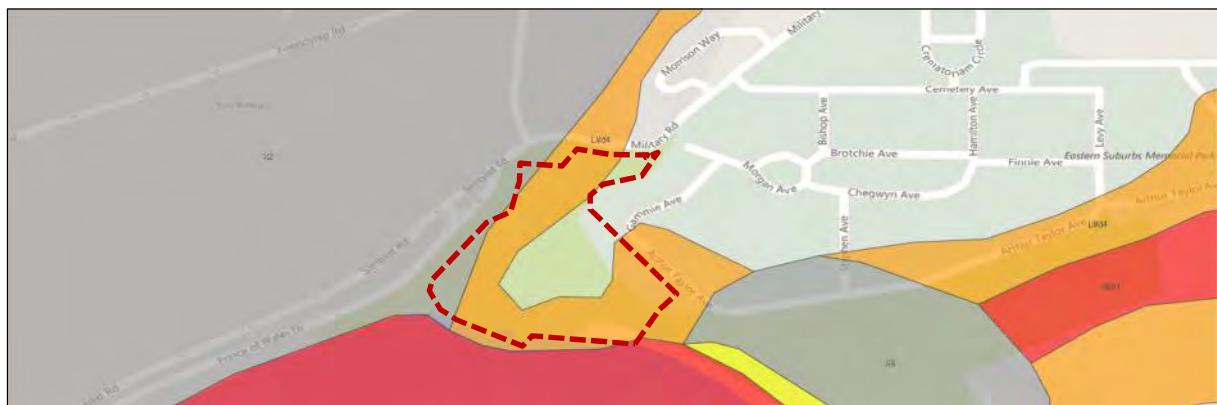
Reference to the 1:25,000 Acid Sulfate Soil Risk Mapping indicates that the site is variously located in areas of no, low and unknown probability of occurrence of acid sulfate soil. The areas affected are shown in Figure 6, below.

**Figure 6: Acid Sulphate Soil Risk Mapping (grey is unknown; orange is low probability)**

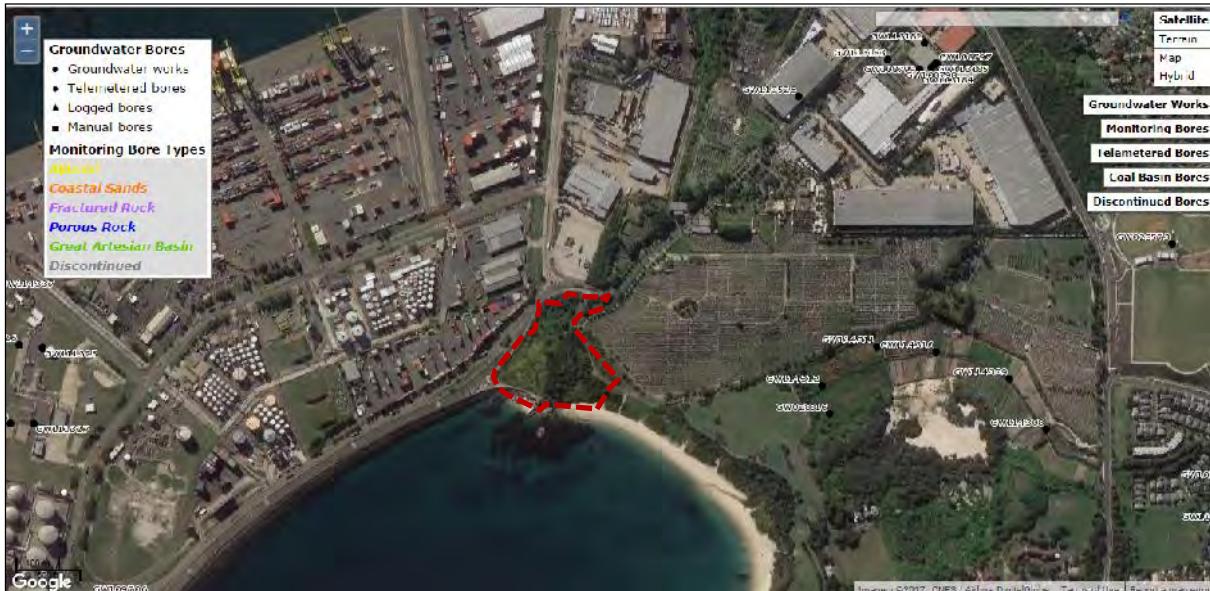
Reference to the Office of Water groundwater database indicates that four bores are located approximately 500 m from the subject site, as shown in Figure 7, below.

**Figure 6: Registered Groundwater Bores (Bore data from Department of Primary Industries, Office of Water, 2017)**

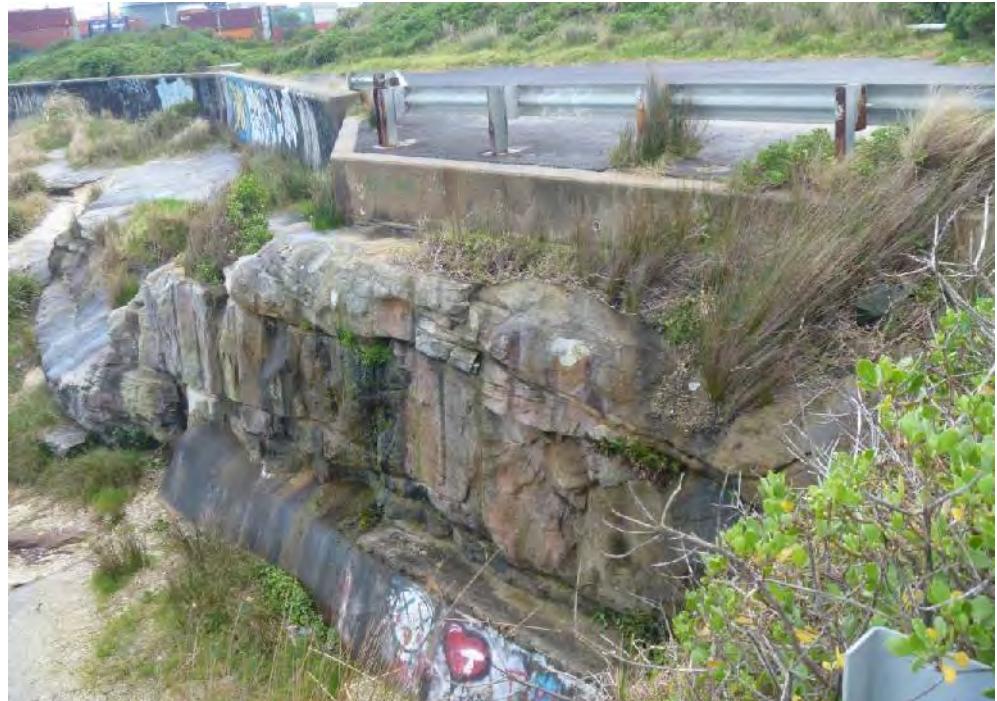
Some seepage was visible at the face of a sandstone cliff in the south-western part of the site, with associated vegetation growth (refer Photo 1 in Appendix C). Seepage was not observed from cliff faces towards the central waterfront area.

Photo 1 – Seepage from bedding plane in sandstone rock face, at waterfront.

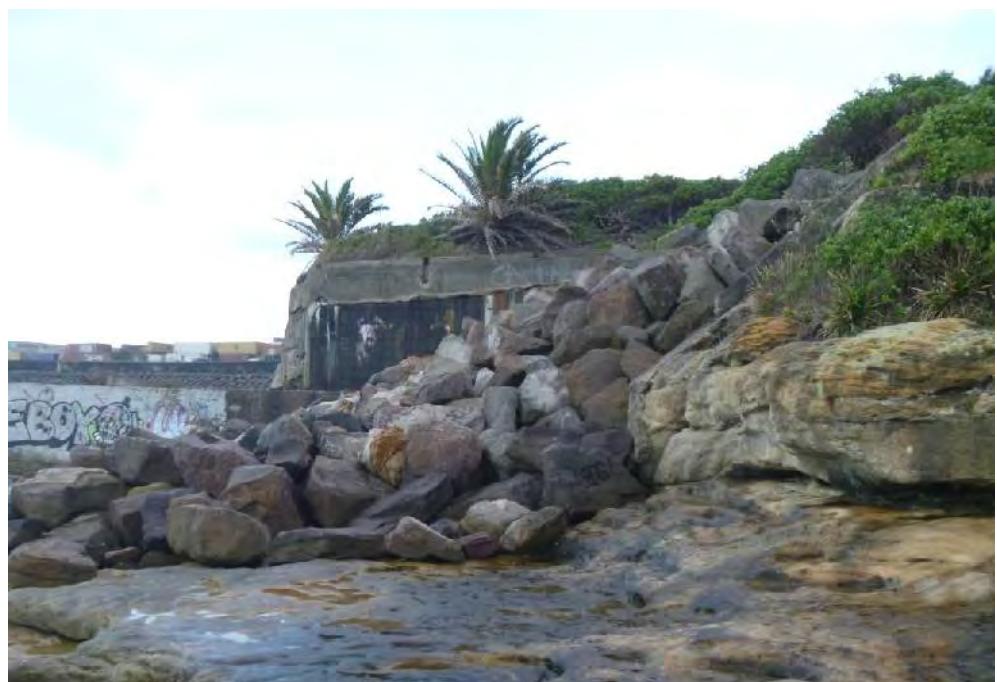
Photo 2 – Concrete sidewalls and rock fill at the water easement on the waterfront

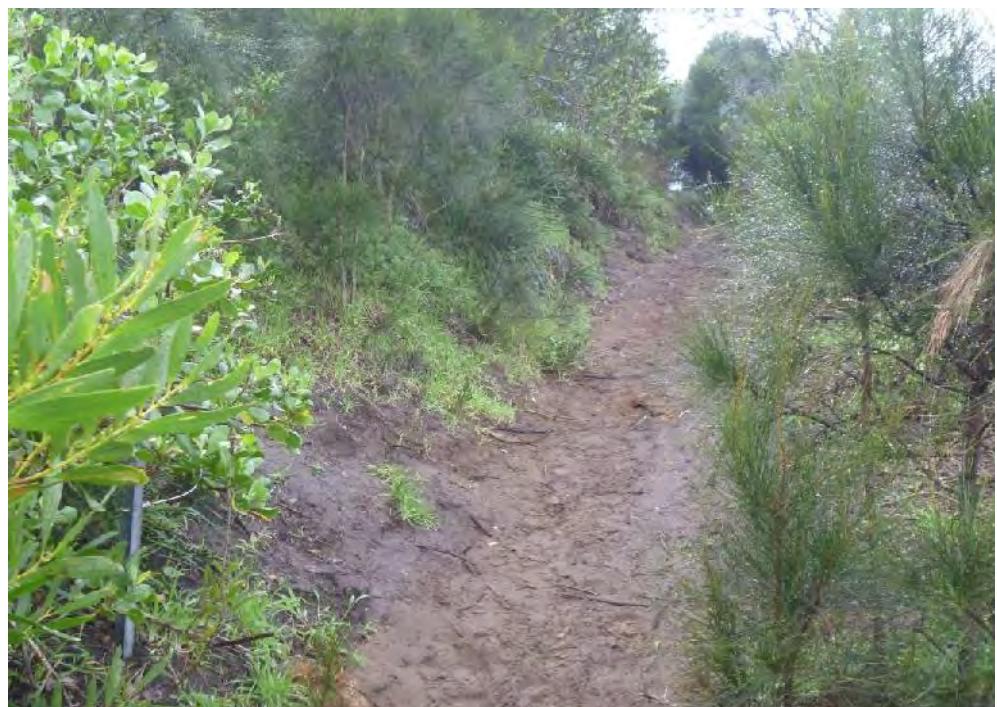
Sand tracks led up into the site from the waterfront, with apparently natural sand and filling variously exposed in the slopes (refer Photo 3 and Photo 4, in Appendix C).

Photo 3 – Sand track towards southern side of site.

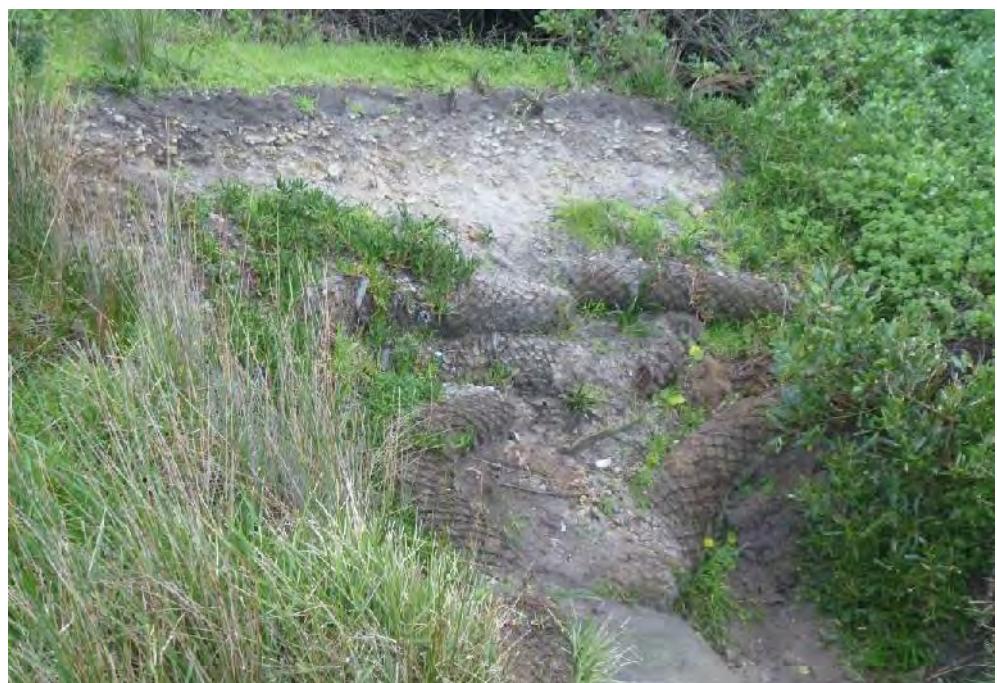
Photo 4 – Eroded slope in filling, with coir socks to limit erosion (limited effectiveness)

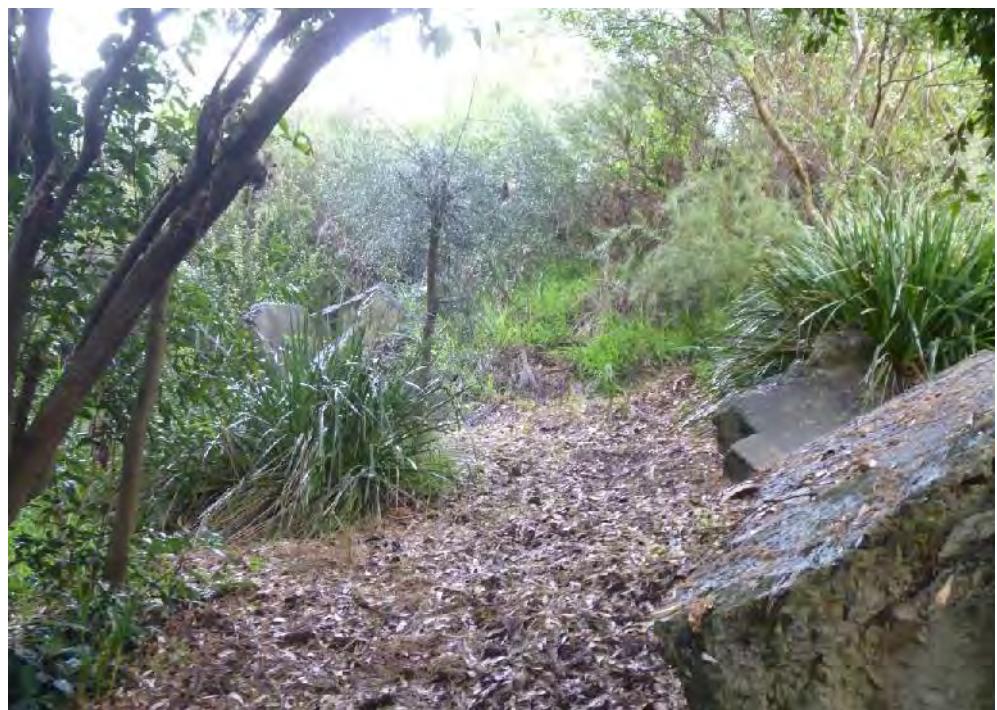
Photo 5 – Concrete blocks on elevated ground

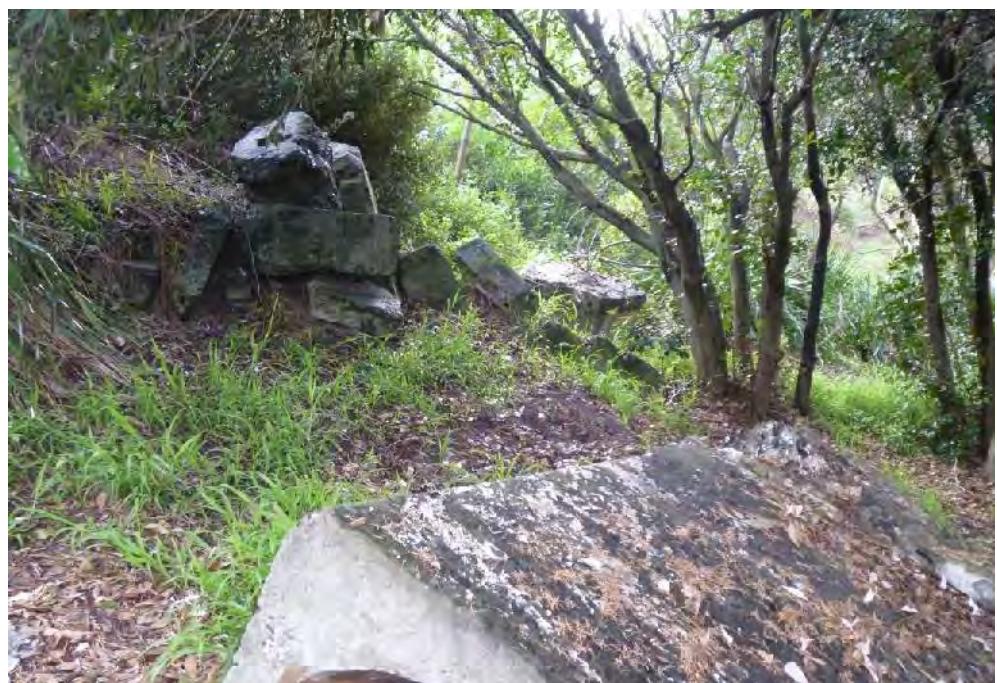
Photo 6 – Concrete blocks on elevated ground

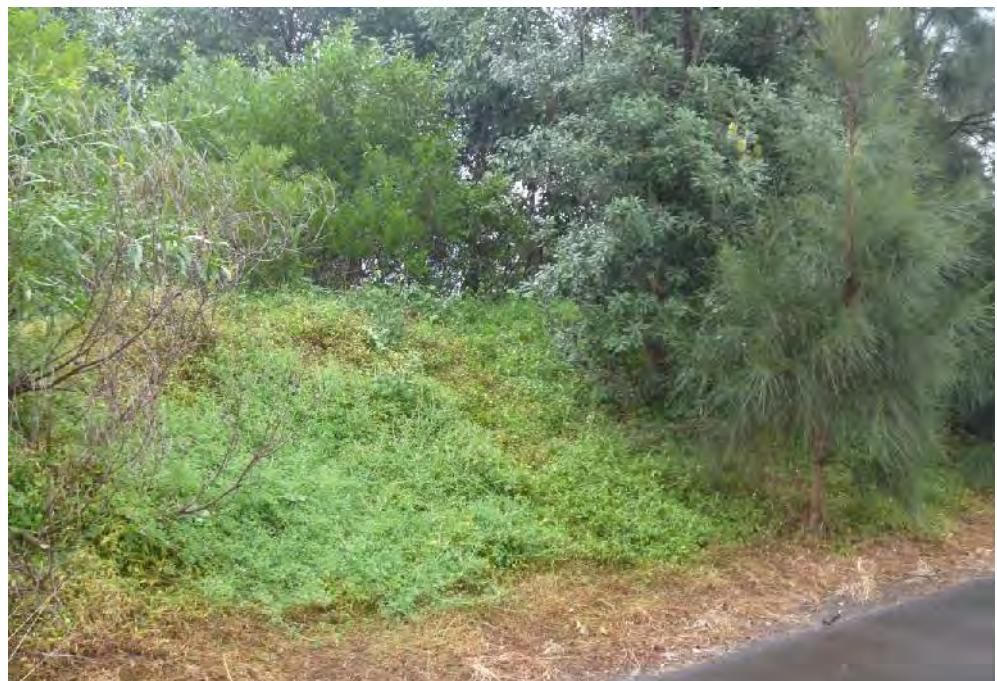
Photo 8 – Embankment on western side of bitumen track

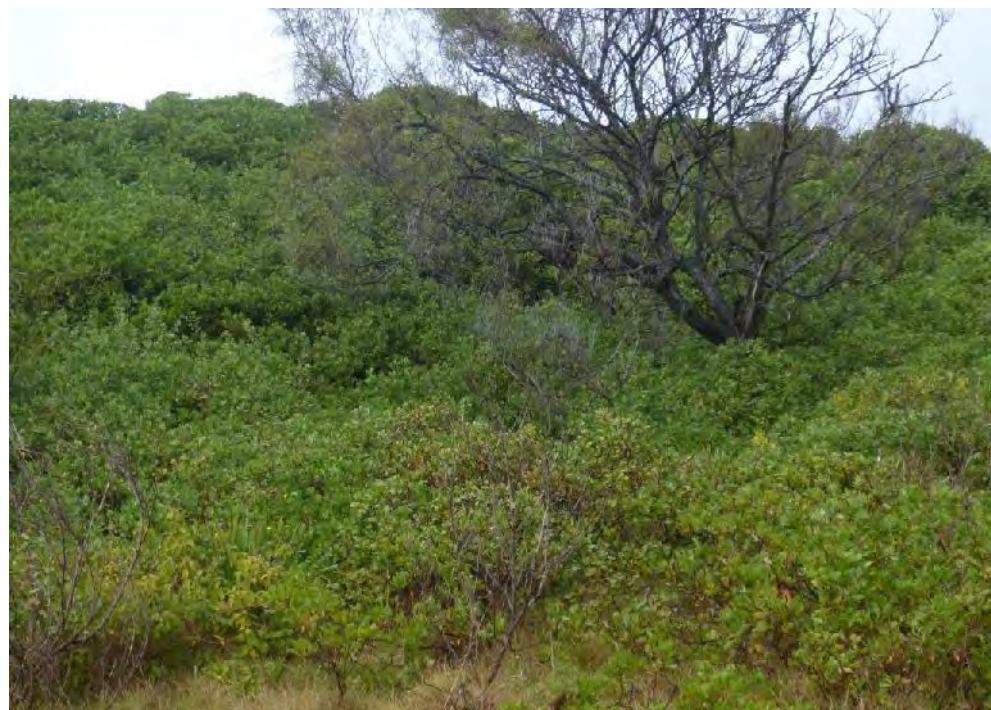
Photo 9 – Typical vegetation at western side of site.

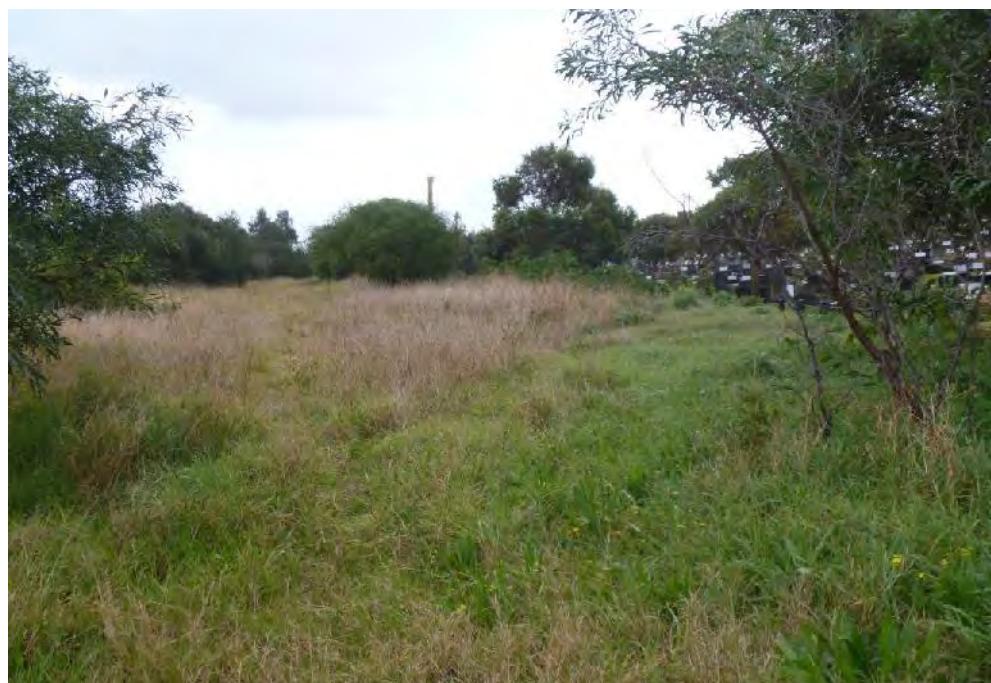
- | The land between the existing Memorial Park and LPLALC land is generally grassed, with some trees (see Photo 10). Building rubble is present in these areas, particularly towards the Memorial Park boundary.

Photo 10 – Grassed areas between the Memorial Park (at right) and LPLALC.

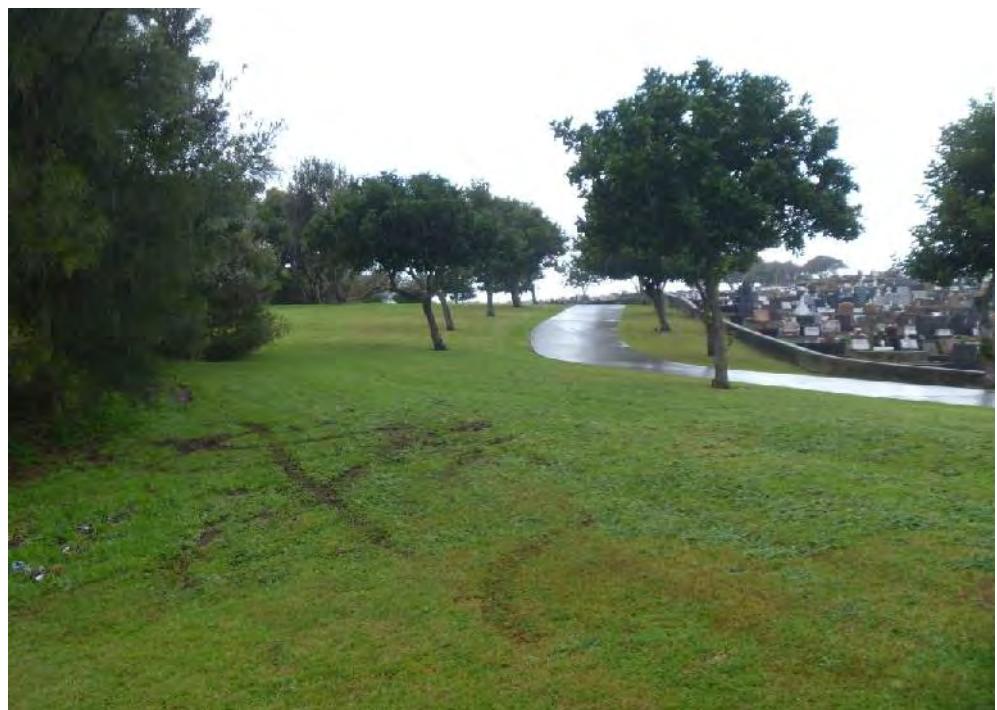
- | Further north, between the Memorial Park and Military Road, the site is more extensively landscaped, with grassed areas and trees adjacent to and at similar, undulating levels to the Memorial Park (see Photo 11) then sloping down vegetated slopes to Military Road. Some rock boulders were visible in the landscapes ground surface, and additional filling was evident in the slopes along Military Road. Some fibrous cement fragments were observed at ground surface in this area.

Photo 11 – Landscaped area between Military Road and the Eastern Suburbs Memorial Park

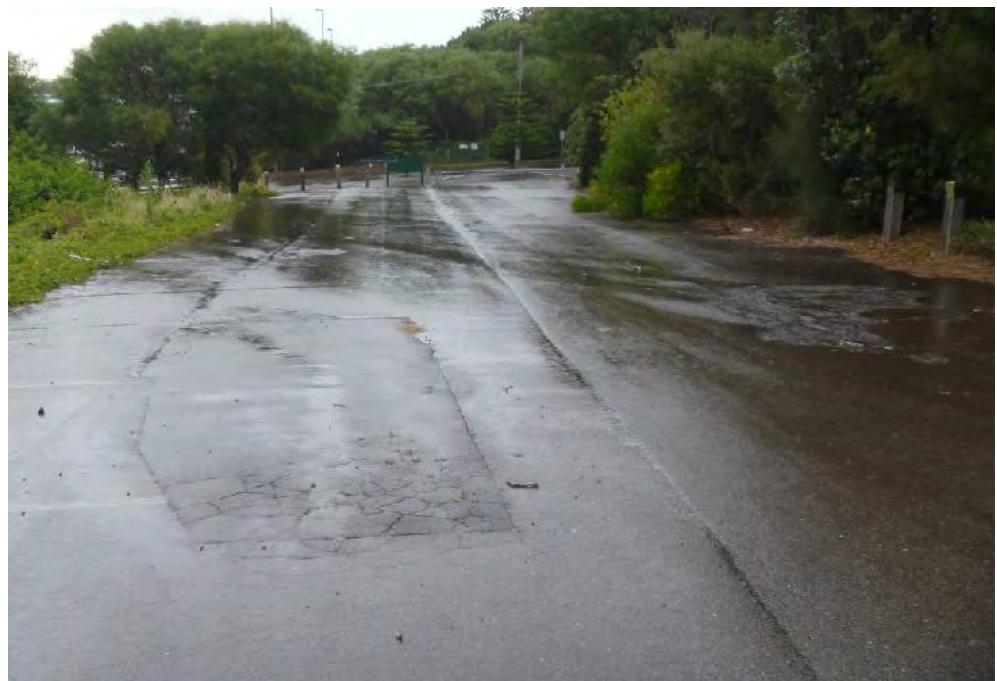
- | An existing, asphaltic concrete surface car park is present off Military Road. Some cracking and damage to the existing pavement is evident (see Photo 12 in Appendix C).

Photo 12 – Existing Car Park – note damage to existing pavement

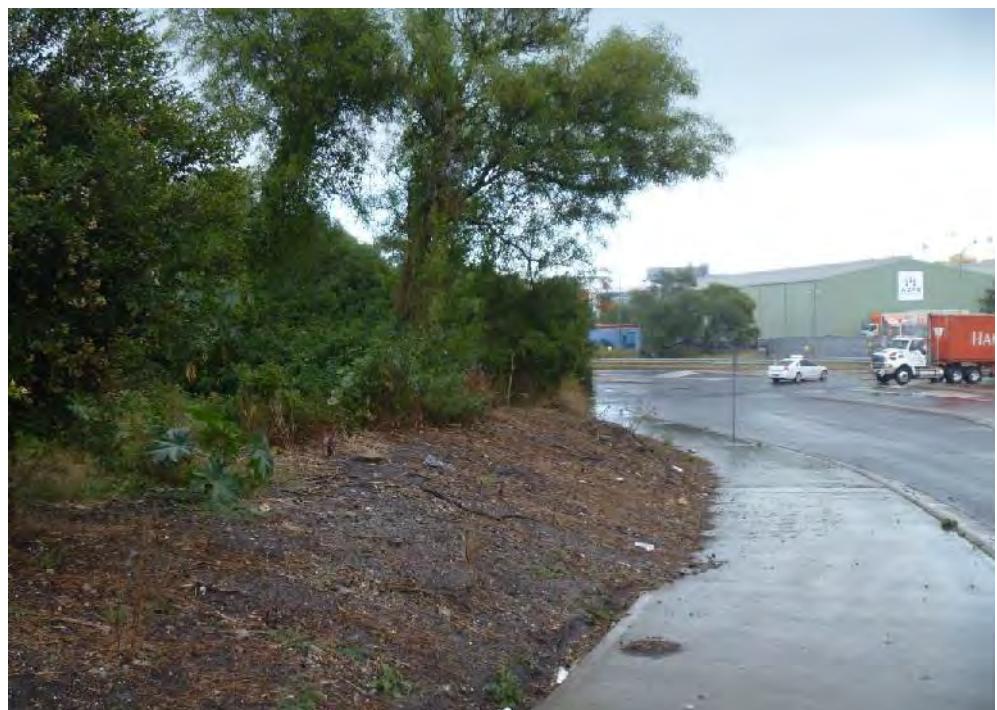
Photo 13 – Filling slope towards Military Road, west of car park.
