Randwick Junction Draft Heritage Items

Inventory Sheets and Heritage Study

Randwick Junction Inventory Sheets – Draft Heritage Items

Heritage Conservation Area Review Randwick Junction

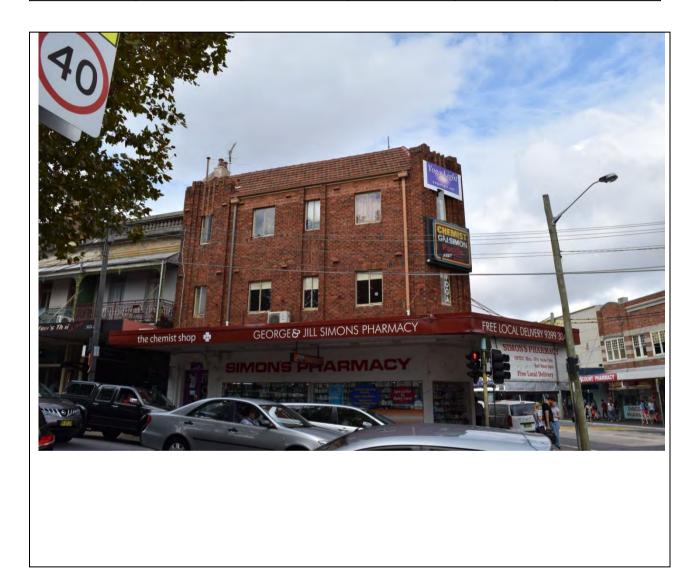
Image caption	The Inter-War Art Deco building on the corner of Alison and Belmore Roads.				
Image year	2015	Image by	City Plan Heritage	Image copyright holder	Randwick City Council

RECOMMENDATIONS
Recommendations	It is recommended that only the above awning facade and awning are to be listed on Schedule 5 of the Randwick LEP 2012. It is further recommended that the upper level signage on the splayed corner be removed as it obscures much of the significant fabric.
	A Heritage Assessment or Heritage Impact Statement should be prepared for the building prior to any major works being undertaken. Archival photographic recording, in accordance with the Heritage Office publication Photographic Recording Of Heritage Items Using Film or Digital Capture , should be undertaken before major changes.

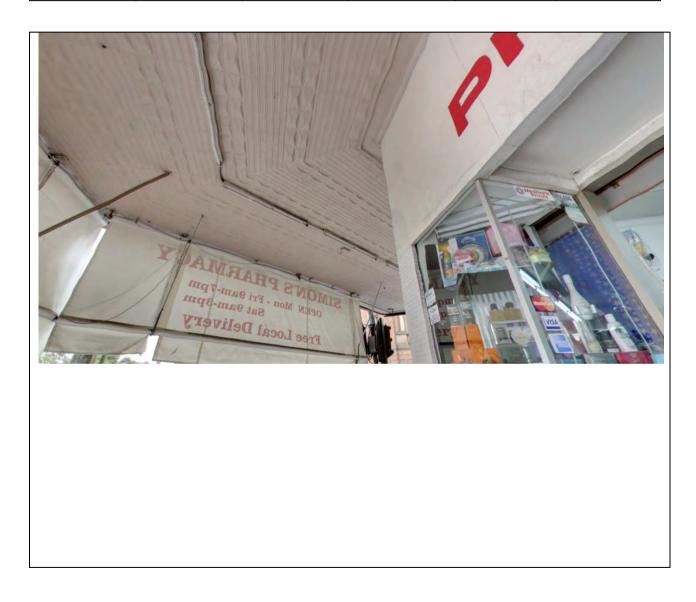
Image caption	The original 1920's pressed metal soffit still in good condition under the awning.					
Image year	2015	Image by	City Plan Heritage	Image copyright holder	Randwick City Council

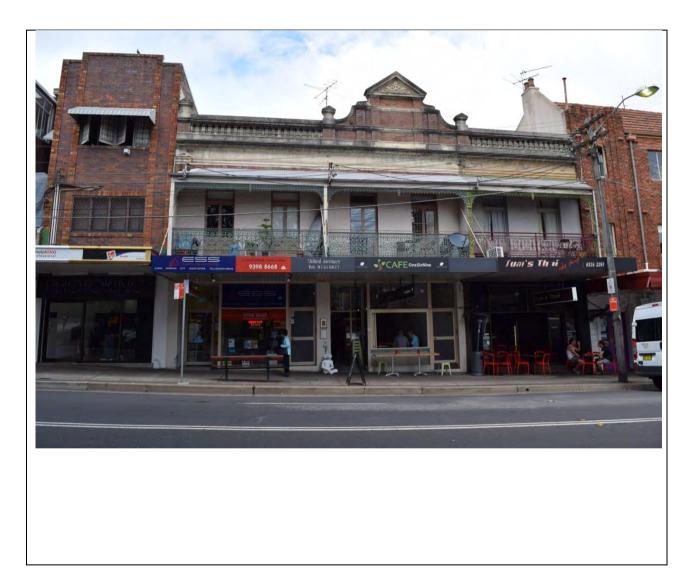
Physical condition and Archaeological potential	The first floor facade and the classically detailed decorative parapet with central pediment appear to be in good condition aside from the unsightly patina on the sandstone. Two of the wrought iron balcony posts are missing with the remaining showing some signs of deterioration.						
Construction years	Start year	1887	Finish year	1887	Circa	\boxtimes	
Modifications and dates	The subject building was originally part of a larger corner building that was demolished in the 1920's. During this demolition a large corrugated iron corner balcony supported on posts was also removed. The original balcony can be seen in Image 6. The subject building has also undergone a series of alterations predominately associated with the change of use for ground floor tenancies: 167 Alison Road 1986 – Alterations to convert the first floor area into an office space 1999 – Extension of outdoor seating for existing restaurant 169 Alison Road 2000 – Outdoor seating installed 2008 – Refurbishment and upgrade of existing commercial and residential tenancies including the subdivision of the property into two lots 2009 – Installation of a stairway between 167-169 Alison Road 2010 – Fit out and change of use to a cafe

Image caption	167-171 Alison Road taken from the opposite side of the Road.				
Image year	2015	Image by	City Plan Heritage	Image copyright holder	Randwick City Council

RECOMMENDATIONS
Recommendations	Listing of the building on Schedule 5 of the Randwick LEP 2012 as a Heritage Item is recommended.
	Full interior inspection should be undertaken on this building to establish if any significant original elements dating from the 1887 construction remain. An inspection of the ornate parapet is further recommended to detect and repair any deterioration of the face brick and sandstone.
	A Heritage Assessment or Heritage Impact Statement should be prepared for the building prior to any major works being undertaken. Archival photographic recording, in accordance with the Heritage Office publication Photographic Recording Of Heritage Items Using Film or Digital Capture , should be undertaken before major changes.

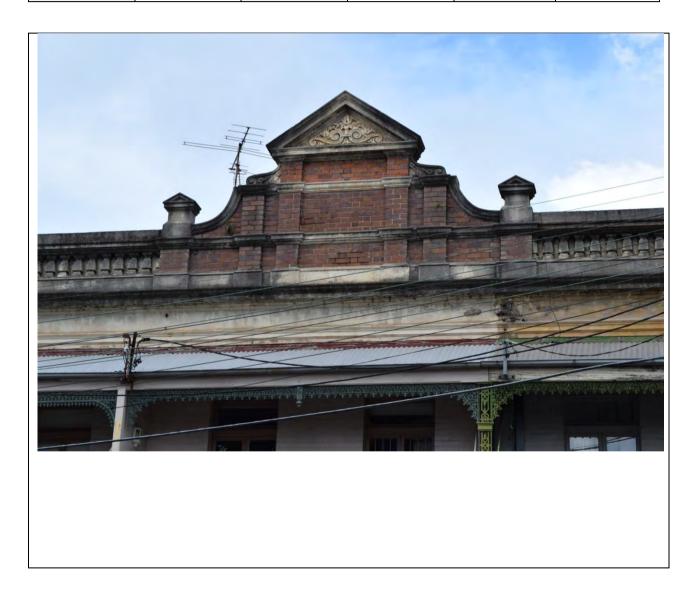
Image caption	A detailed view of the ornate parapet.				
Image year	2015	Image by	City Plan Heritage	Image copyright holder	Randwick City Council

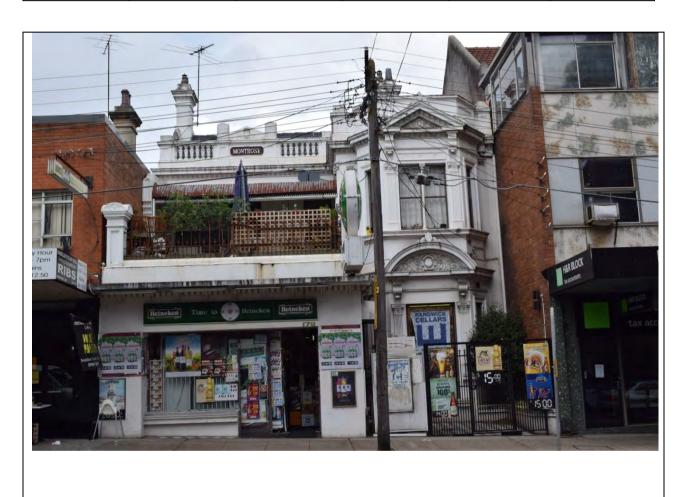
Aesthetic significance SHR criteria (c)	The facade of 'Montrose' is largely intact featuring Victorian Italianate architectural elements creating aesthetically distinctive building along Alison Road. Much of the original mouldings and embellishments are intact and in good condition.
Social significance SHR criteria (d)	The subject building has no known associations with a specific historically significant community or cultural group.
Technical/Research significance SHR criteria (e)	The research conducted to date does not indicate any potential for archaeological resource. The building, however, has potential to yield information on the construction system of the Victorian Italianate buildings.
Rarity SHR criteria (f)	The building is an architecturally distinctive Victorian Italianate style terrace featuring the key characteristics of the style that was once immensely popular in Australia as a domestic style and influenced the rapidly expanding suburbs of the 1870-1880s. Many examples of this style survive within the Randwick Junction Heritage Conservation Area and therefore this building is not considered a rare example of its type.

Image caption	The Victorian Italianate building known as 'Montrose' is viewed from Alison Road				
Image year	2015	Image by	City Plan Heritage	Image copyright holder	Randwick City Council

RECOMMENDATIONS						
Recommendations	It is recommended that the building be listed as a Heritage Item on Schedule 5 of the Randwick LEP 2012.						
	The amount of advertising signage from the bottle shop should be reduced as it detracts from the significant Victorian Italianate presentation of the building.						
	The building should be retained and conserved. A Heritage Assessment or Heritage Impact Statement should be prepared for the building prior to any major works being undertaken. Archival photographic recording, in accordance with the Heritage Office publication Photographic Recording Of Heritage Items Using Film or Digital Capture , should be undertaken before major changes.

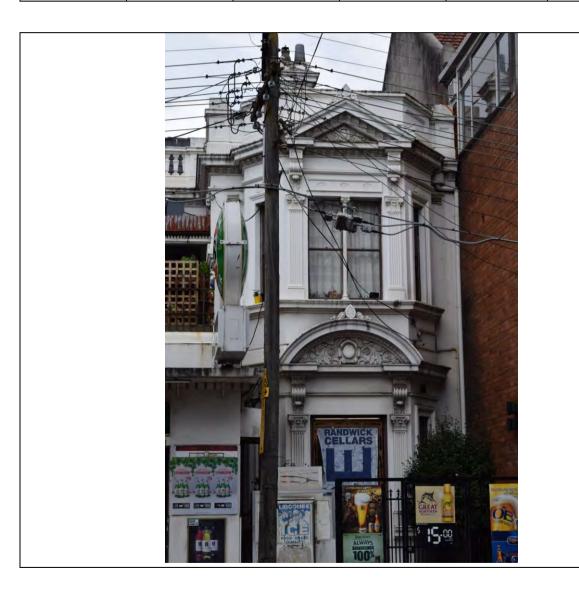
Image caption	A detailed view of the ornate faceted bay of 'Montrose'				
Image year	2015	Image by	City Plan Heritage	Image copyright holder	Randwick City Council

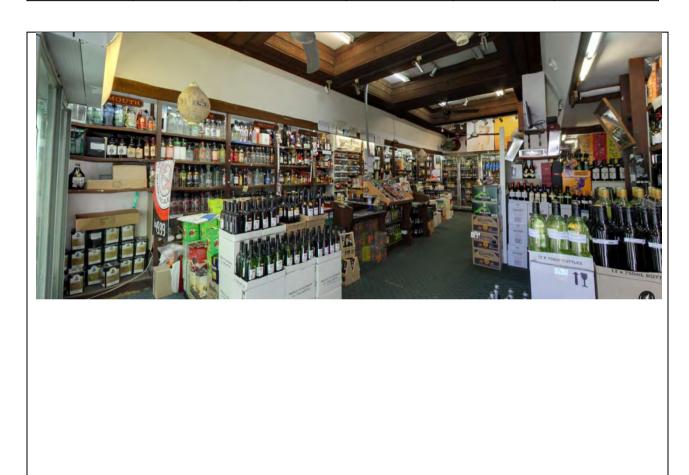
Image caption	Internal View of bottle shop (Source: Google Streetview)					
Image year	2015	Image by	Google Streetview	Image copyright holder	Randwick City Council

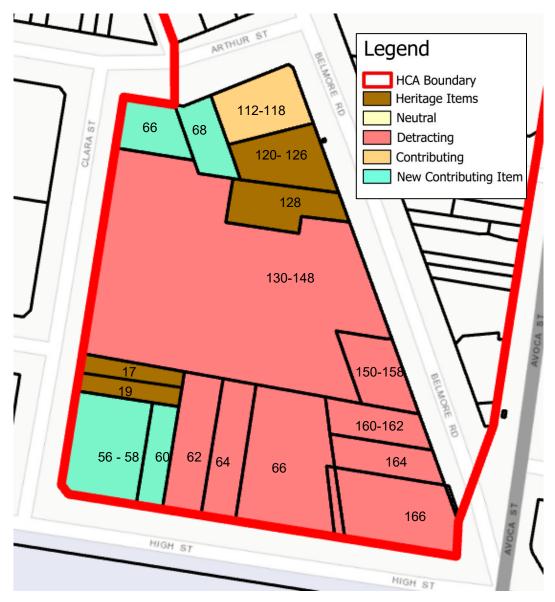
Figure 16: Detail of Block 01 showing contributions (Source: City Plan Heritage)

Block 01 is bounded by High, Clara and Arthur Streets, and Belmore Road. It is dominated by the Randwick Plaza and its associated facilities marking the southern end of the Randwick Junction HCA. Notwithstanding, the northern edge along Arthur Street and south western corner of the block are occupied by Heritage Items and Contributing buildings that significantly add to the heritage character of the Randwick Junction HCA through their mainly Inter-War, and Federation and Victorian residential architectural style and intact fabric. At the northern end of the block, several buildings have been sympathetically adapted for commercial uses (namely 68 Arthur Street). These modifications are representative of the changing character of the municipality and the increasing demand for retail and commercial uses within the Randwick Junction HCA.

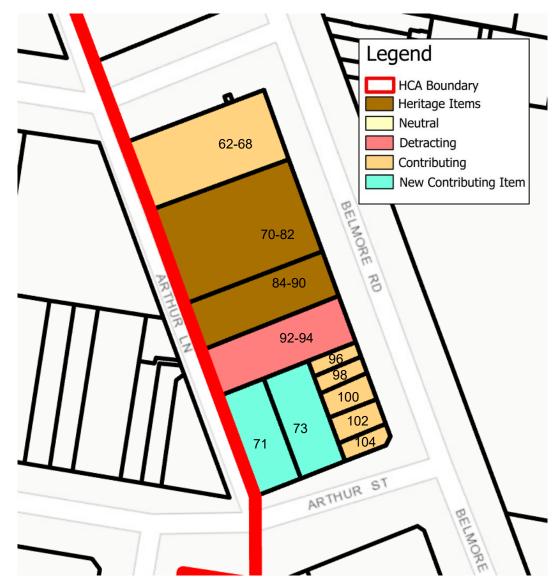
Figure 17: Detail of Block 02 showing contributions (Source: City Plan Heritage)

Block 02 is a small rectangular block bounded by Arthur Street to the south, Arthur Lane to the west, Waratah Avenue to the north and Belmore Road to the east. With the exception of one building (84-90 Belmore Road), the entire block consists of significant Inter-War residential flat and commercial buildings including two Heritage Items. The bulk of the properties are Contributing and essentially present three-storey building scale and highly decorated facade fenestrations that contrast with the neutral characteristic of the Royal Randwick Shopping Centre on the opposite side of Belmore Road.

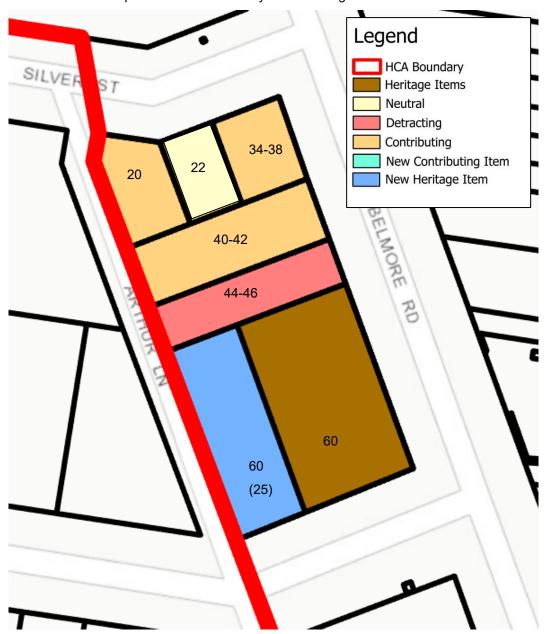
Figure 18: Detail of Block 03 showing contributions (Source: City Plan Heritage)

Block 03 is similar to Block 02 in terms of rectangular shape, small size and concentration of significant building stock. The Block has only one detracting element with the remainder being Contributing Items and a Heritage Item spanning along the half length of Belmore Road frontage of the Block. The Inter-War Art Deco residential and commercial building at Waratah Avenue corner acts as a transitional element from the three-storey, mainly residential flat developments, to the two-storey commercial strip of Belmore Road. The detracting building with its blank rendered parapet interrupts the decorative and aesthetically pleasing above awning facade fenestration of the Block. The vertical engaged piers on the facades of all Contributing Items and the Heritage Item clearly provide evidence of vertical pattern of individual bays seen throughout the Randwick Junction HCA.

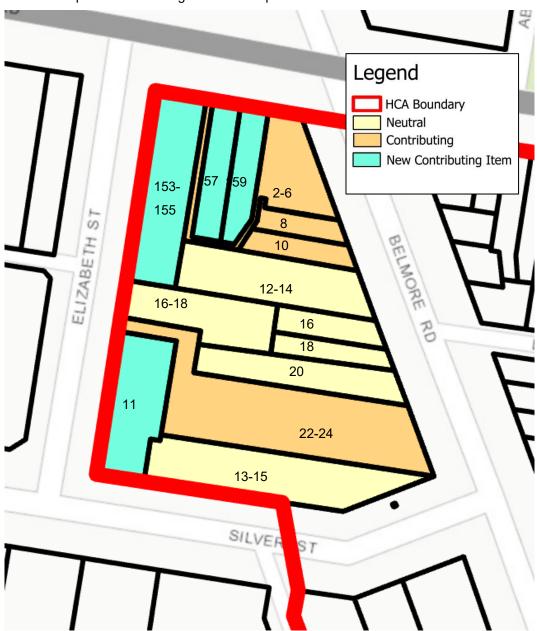
Figure 19: Detail of Block 04 showing contributions (Source: City Plan Heritage)

Block 04 is one of the six blocks within the Randwick Junction HCA that has no detracting element, which would adversely affect its significant characteristics. Bounded by Silver and Elizabeth Streets, and Alison and Belmore Roads this irregular Block is characterised by essentially two-storey Federation and Inter-War period residential and commercial strip featuring highly decorative segmental arched or stepped parapets, engaged piers, and ribbon windows reflecting the building's individual tenancy layout. Traditional materials and finishes of face brick with rendered or stone bands and projecting mouldings with neutral colour schemes give the dominant heritage streetscapes of the Block regardless of the unsympathetic paint finish of one building (153-155 Alison Road) and high blank parapet of another (12-14 Belmore Road). The 2008 new medical and commercial building at the corner of Silver Street and Belmore Road is considered to be a neutral infill building designed to take form of its allotment but at the same time marking the end of the block with a higher element opposite the three-storey Alkoomie Flats. Its copper like vertically panelled facades combined with vertically proportioned glazing allows somehow a comfortable presentation along the streetscapes of Belmore Road and Silver Street.

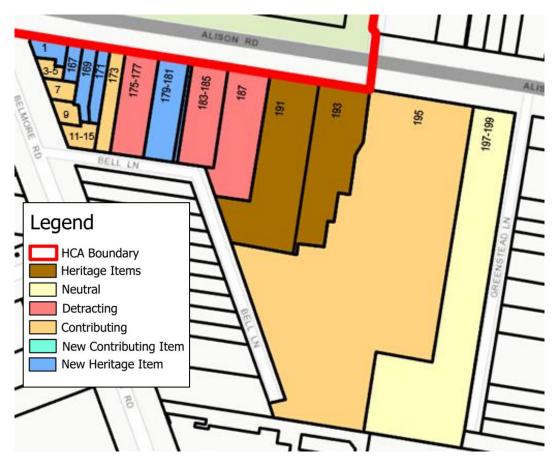
Figure 20: Detail of Block 05 showing contributions (Source: City Plan Heritage)

Block 05 is one of three large blocks within the Randwick Junction HCA occupying the majority of the Allison Road boundary of the Area. It is an irregular block bounded by Belmore and Alison Roads, and Bell and Greenstead Lanes adjoining the Royal Randwick Shopping Centre on the south boundary. This Block contains all periods of development that make the Randwick Junction HCA such a special and significant mixed commercial precinct. While the Alison Road frontage is dominated by the Victorian terraces and Inter-War educational buildings of residential scale and style the remainder of the Block presents a two-storey traditional shop-strip with awnings and decorative stepped parapets and well-articulated facades. This block features several detracting buildings scattered amongst Contributing Items. These detracting buildings are relatively recent developments and are readily identifiable by their uncharacteristic wall finishes and/or fenestration above awning level.

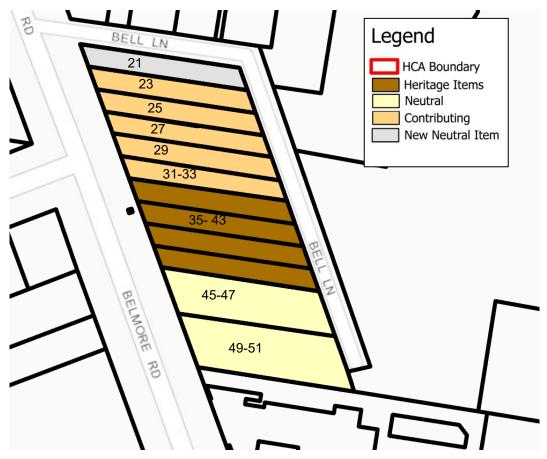
Figure 21: Detail of Block 06 showing contributions (Source: City Plan Heritage)

Block 06 is another small and rectilinear block with Neutral buildings flanking either side of the Heritage Items and Contributing buildings. The Neutral buildings have some intrusive elements attached to them but this does not significantly affect their presentation in terms of scale, finishes and continuing awning along the shopping strip. The contemporary infill building at 49-51 Belmore Road is considered Neutral complimenting the overall three-storey scale of the block and matching the dominant horizontal lines of the closest Heritage Item at 35-43 Belmore Road including the awning level with a projecting entrance canopy. The majority of the shops with commercial uses above are two-storey high Edwardian buildings with curvilinear parapets featuring different colour schemes and rendered painted finishes.

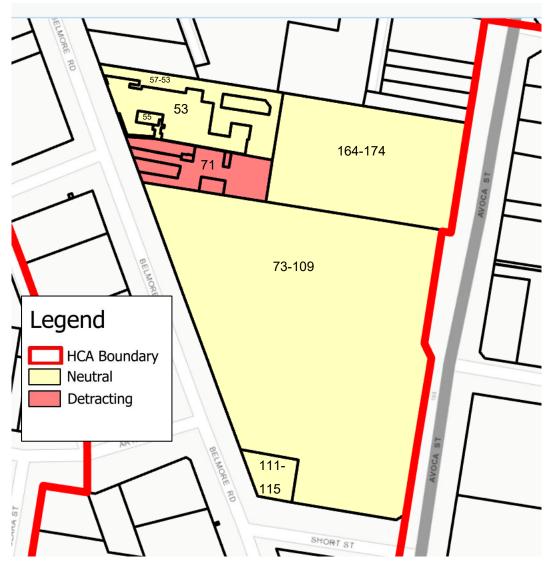
Figure 22: Detail of Block 07 showing contributions (Source: City Plan Heritage)

Block 07 occupies two-third of the Belmore Road frontage of the block between Short Street and Bell Lane. It is comprised mostly of new development including the Royal Randwick Shopping Centre, the former Gemini Hotel (now converted into residential units), and a new four-storey residential/commercial building. The converted Gemini Hotel is notable as an uncharacteristic building within the Randwick Junction HCA. The block is similar to the Randwick Plaza (Block 01) in that it introduces a new type of development within the traditional shopping strip of the Randwick Junction HCA. However, with the exception of the Gemini Hotel, development is generally more appropriate in terms of scale and articulation of parapets than Block 01, making the Block a Neutral element within the Randwick Junction HCA.

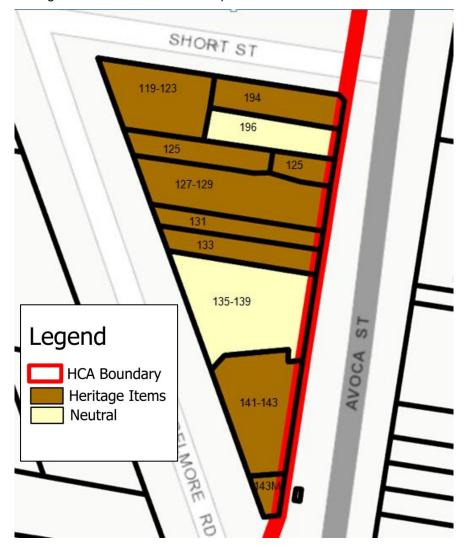
Figure 23: Detail of Block 08 showing contributions (Source: City Plan Heritage)

Block 08 is the southernmost end of the Randwick Junction HCA. It is a triangular block bounded by Belmore Road, Avoca Street and Short Street. The most distinctive feature within this block is the Statue of Captain James Cook. Combined with the Star & Garter Inn, the Heritage Items provide a prominent landmark and gateway to the Randwick Junction HCA. Other notable Heritage Items within the block are the two-storey Victorian commercial buildings which present a very cohesive and architecturally distinctive streetscape. The bright colour schemes of some of the Victorian shops break the consistency but this is a reversible painting finish and can be rectified when the opportunity arises with a more suitable period colour scheme that would highlight the architectural detailing and above awning embellishment of these shops.
