RE: Asbestos Air Monitoring Report

Site:	Little Bay Beach
Location:	Background air monitoring

Project Name LITTLE BAY BEACH

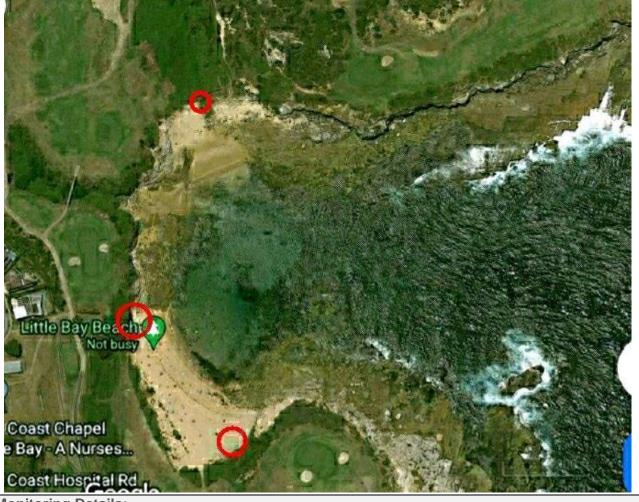
Requested by:	
Client Contact Name	Joe Santangelo
Client Contact Number	0436839760
Client Contact Email	joe.santangelo@randwick.nsw.gov.au
Site:	
Address	2 Coast Hospital Rd, Little Bay NSW 2036
Local Government Area	Randwick City Council
Site Boundary	
Air Monitoring Locations	0
