Report on Non Statutory Site Audit

Lot 97 in DP 270427  
Little Bay Beach, Little Bay NSW

Prepared for  
Randwick City Council

Project 205690.00  
November 2021

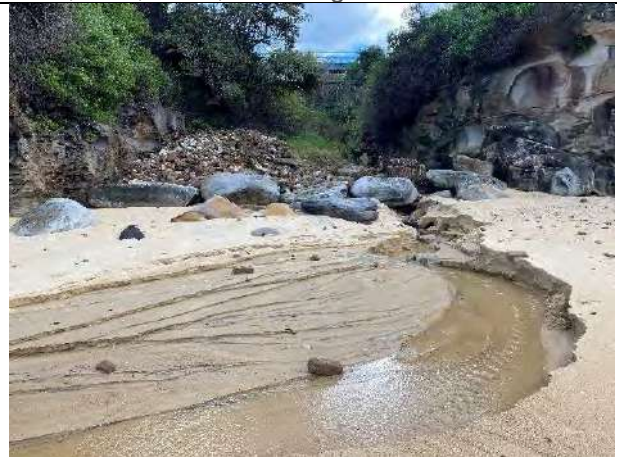
Middle beach, soil erosion and disturbance

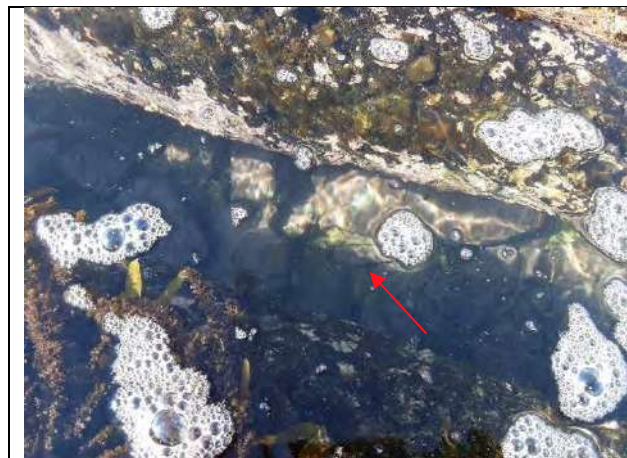
Middle beach, ACM fragments under water, low tide

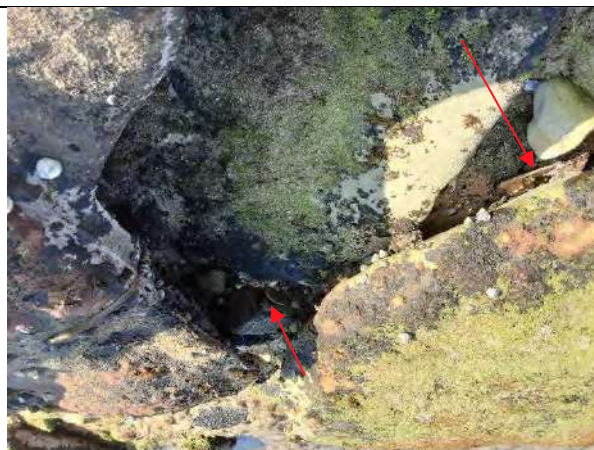
Middle beach, ACM fragments under water, low tide

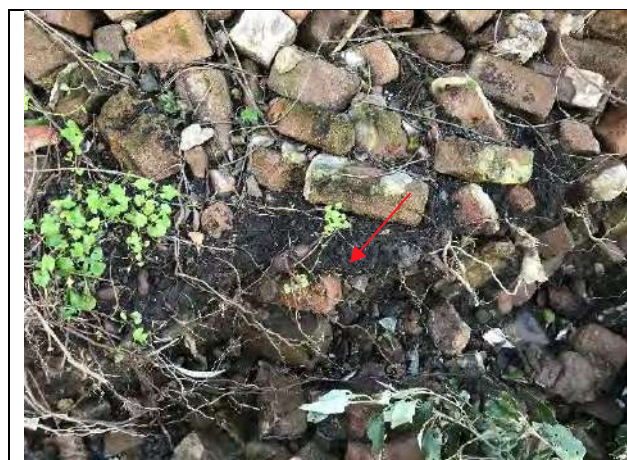
Crown Gully 2, landfill, ACM fragments

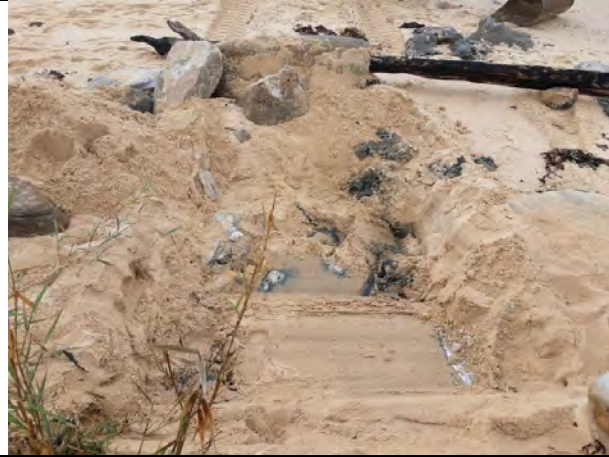
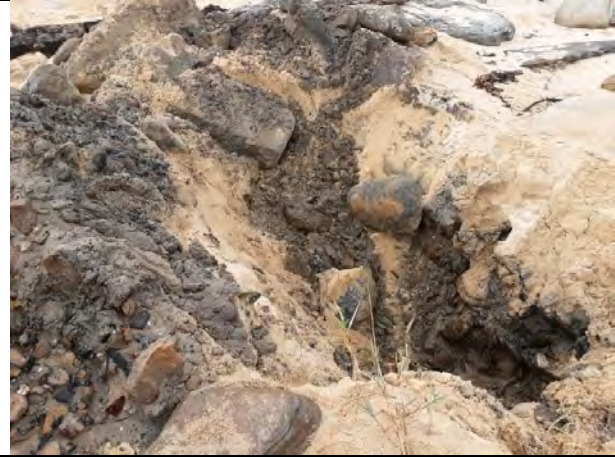
| <p>Northern beach, TP09_0.5, Sand with boulders, sediment or stained soil around boulders.</p> | <p>Northern beach, TP09_1.5, Fill with abundant glasses, brick, tiles and plastic.</p> |

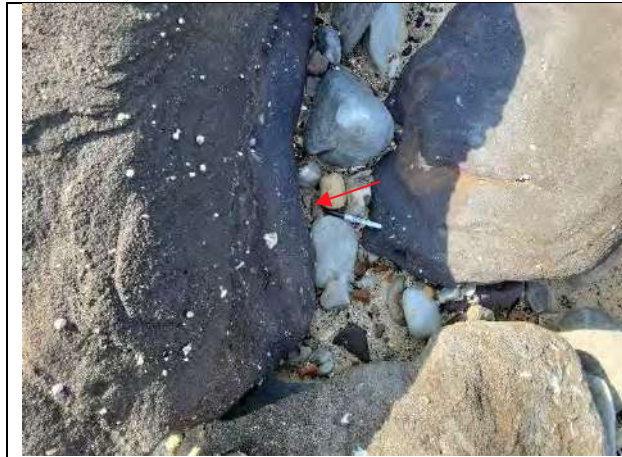
Northern Beach, Asbestos Observed in Rock Area

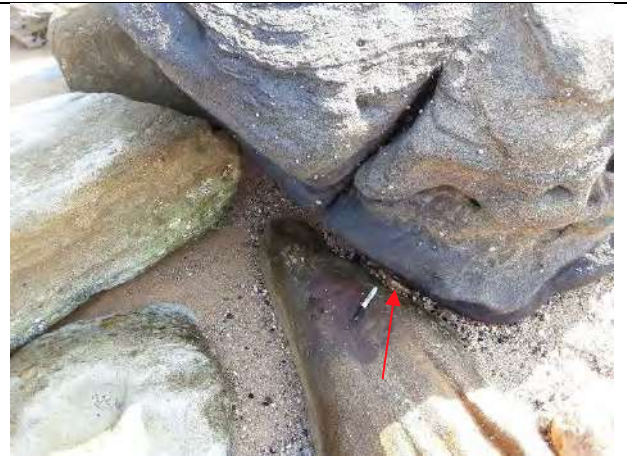
Northern Beach, Asbestos Observed in Rock Area

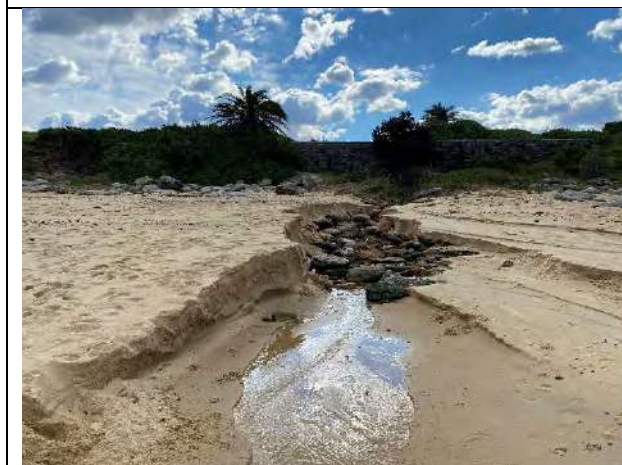
Northern Beach, eroded sand, up to 1 m deep, Gully 1

- *Stormwater runoff and soil erosion cut through the beds of Crown Gully 1 and Crown Gully 2, by over 1 m deep at some visible sections. The conditions and extents of contamination in these gullies were not clear.*

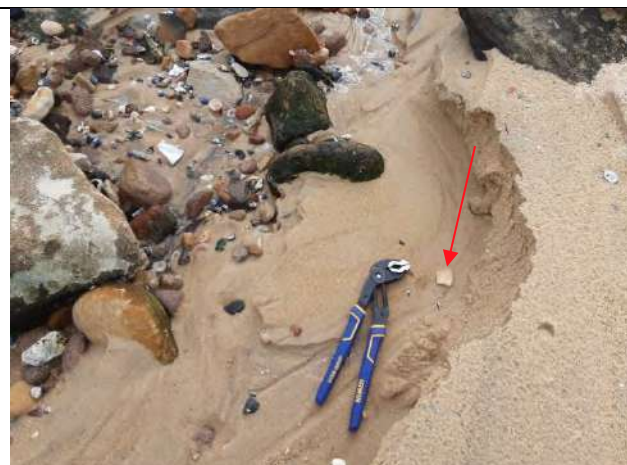
Northern Beach, ACM fragments on creek bed, Gully 1

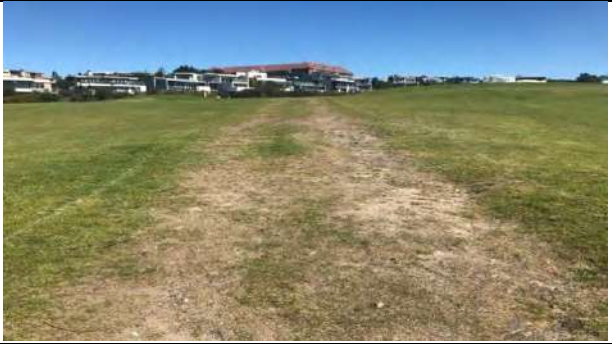
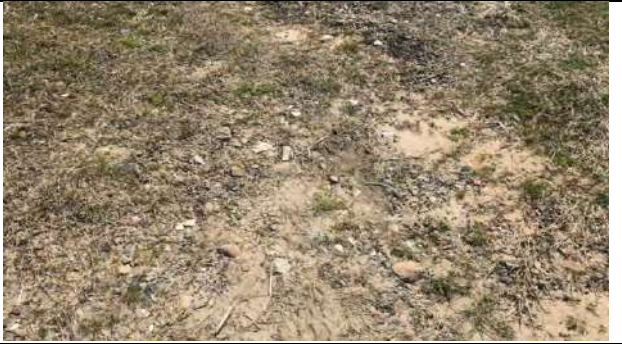
| <p>Exposed Soils on Golf Course, adjacent to Gully 1</p> | <p>Suspected ACM fragments on Exposed Soils, Golf Course, adjacent to Gully 1</p> |

- *Both soil erosion and bush clearance were observed at the upstream of Crown Gully 3 and Crown Gully 1. The sources of accumulative ACM fragments adjacent to the outlets were not known.*

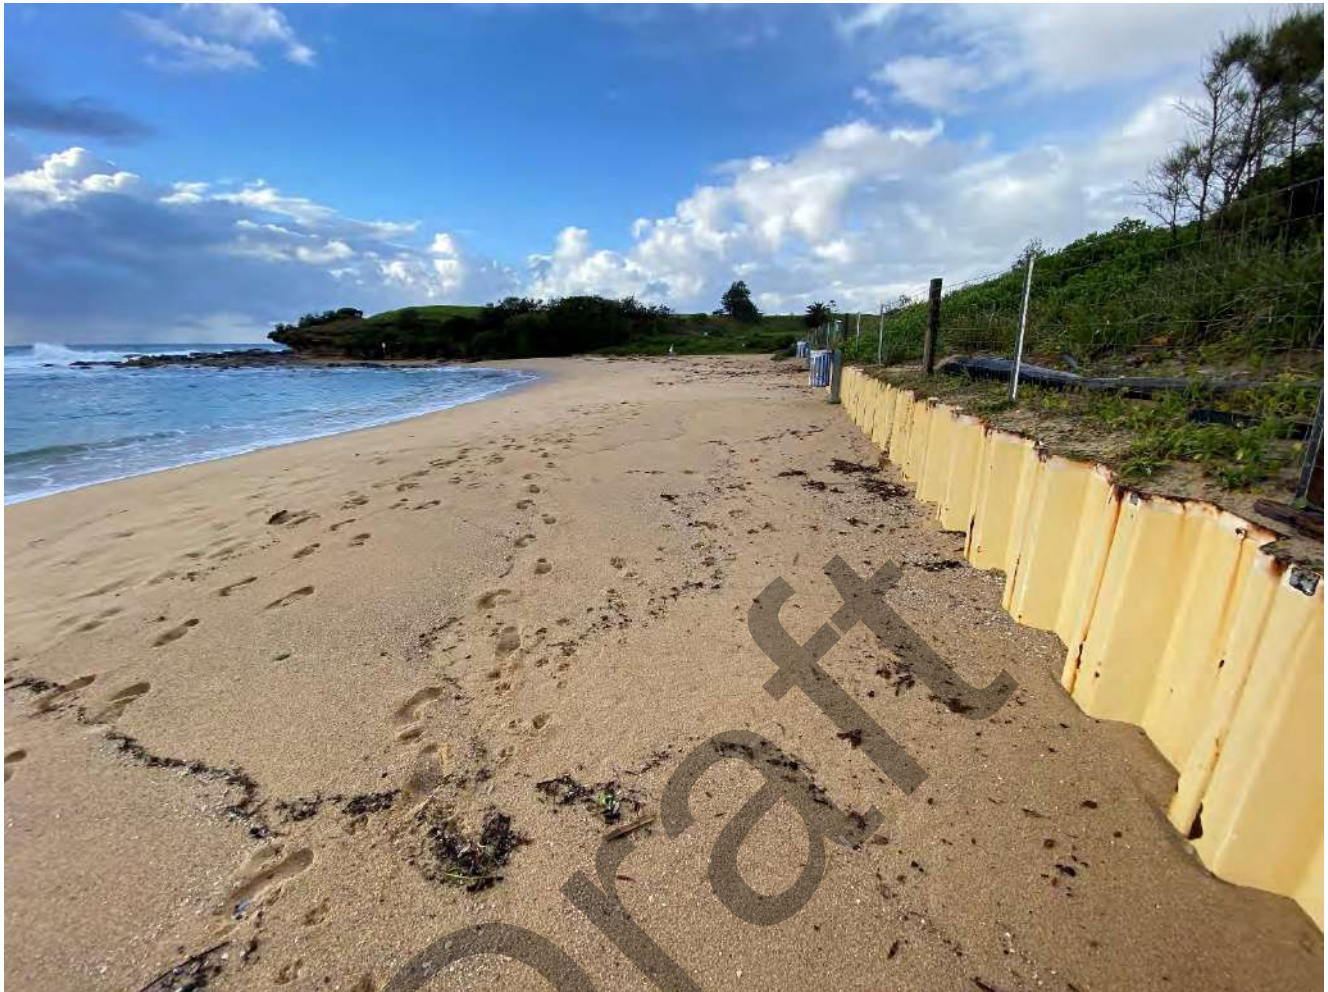
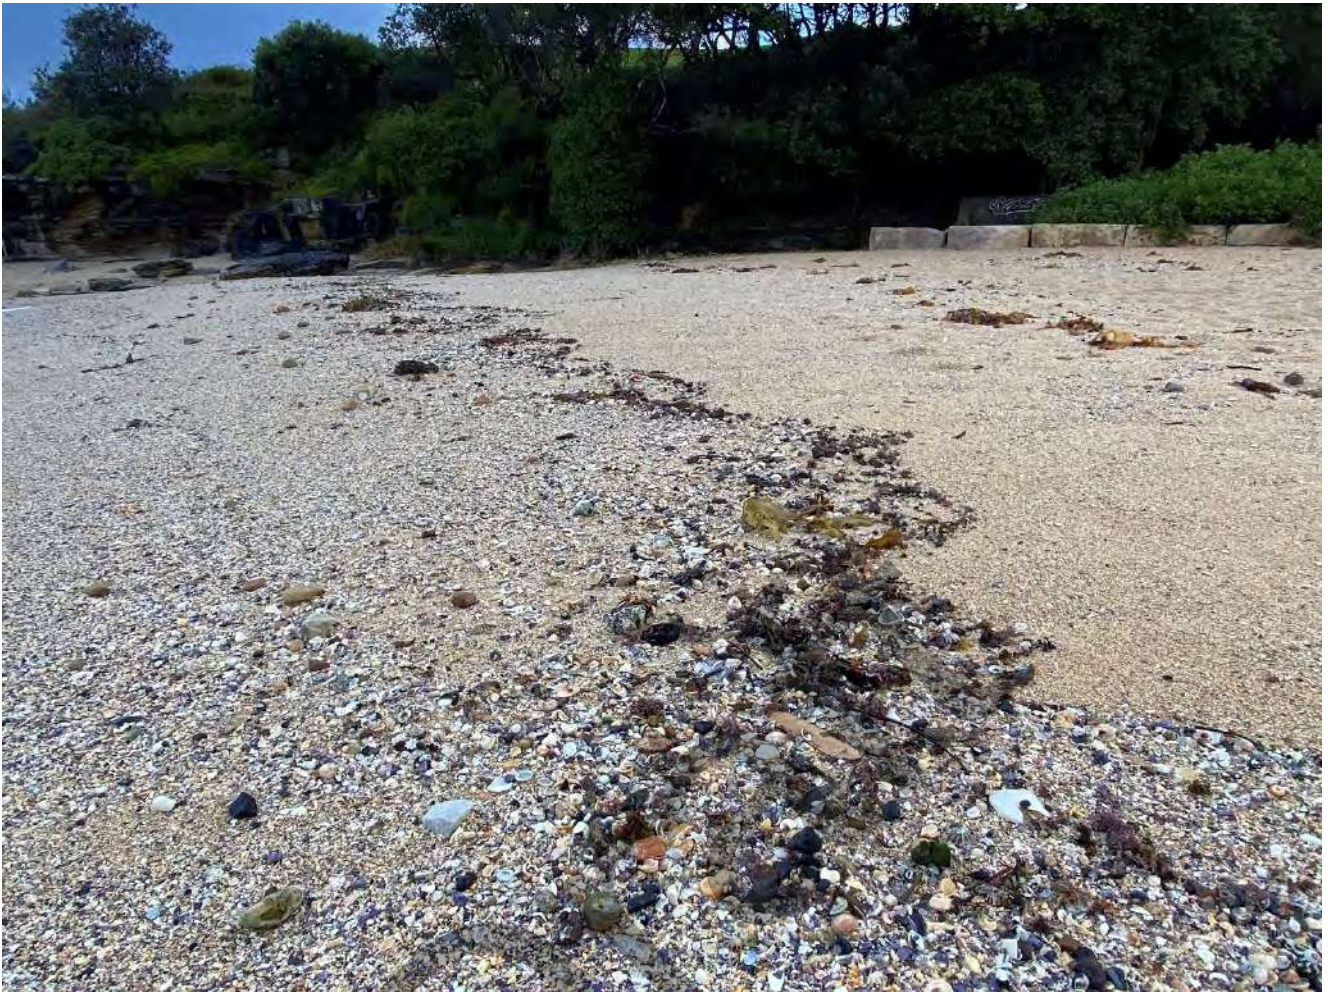
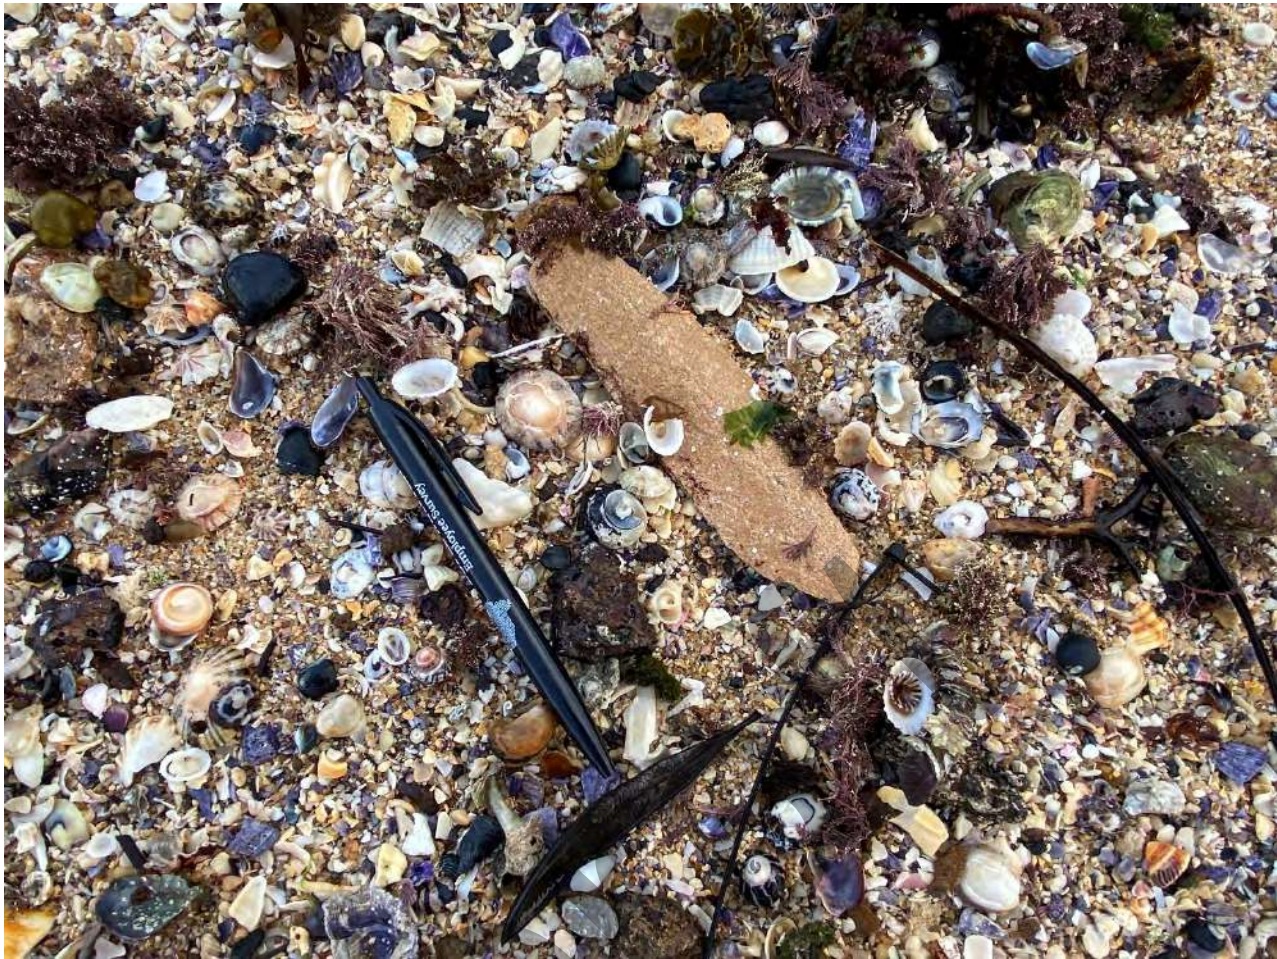
However, under extreme conditions, tides could impact the sand areas up to the Retaining Wall at Southern Beach. For example, with rough swell 3.5 m, 1.8 m tide, strong wind or gust, three beaches are severely impacted by natural elements (ACM fragments at Hotspot, Southern Beach were sighted as expected).

Figure Southern Beach impacted by Rough Swell and High Tide.

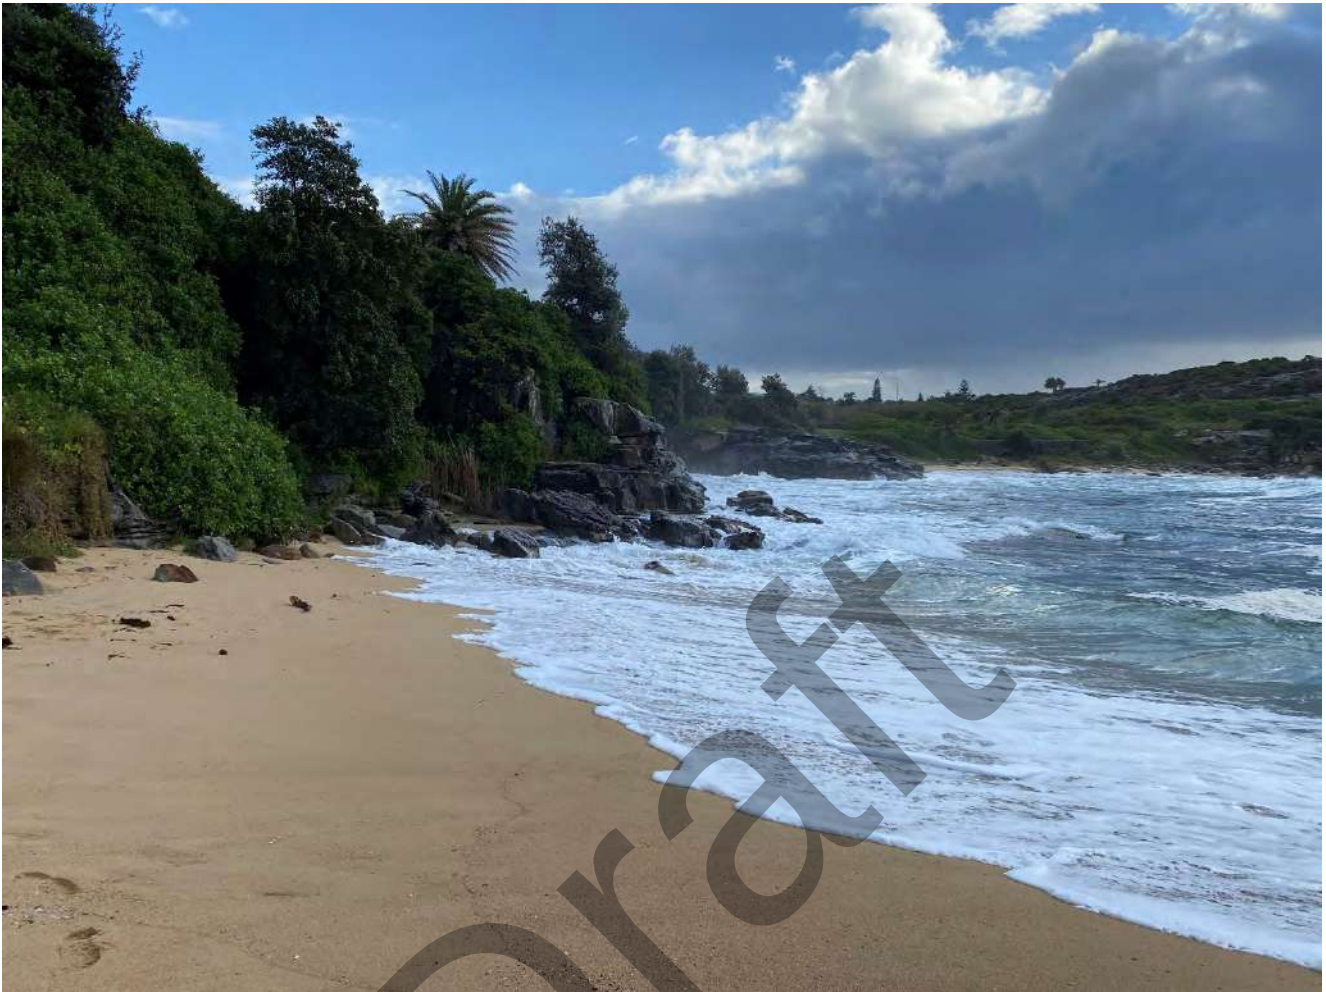
However, under extreme conditions, tides could impact the sand areas up to the Tip adjacent to Heritage Wall at Northern Beach. All of the Middle Beach is under water.

Figure. Northern Beach, Middle Beach and Southern Beach impacted by rough swell and high tide.

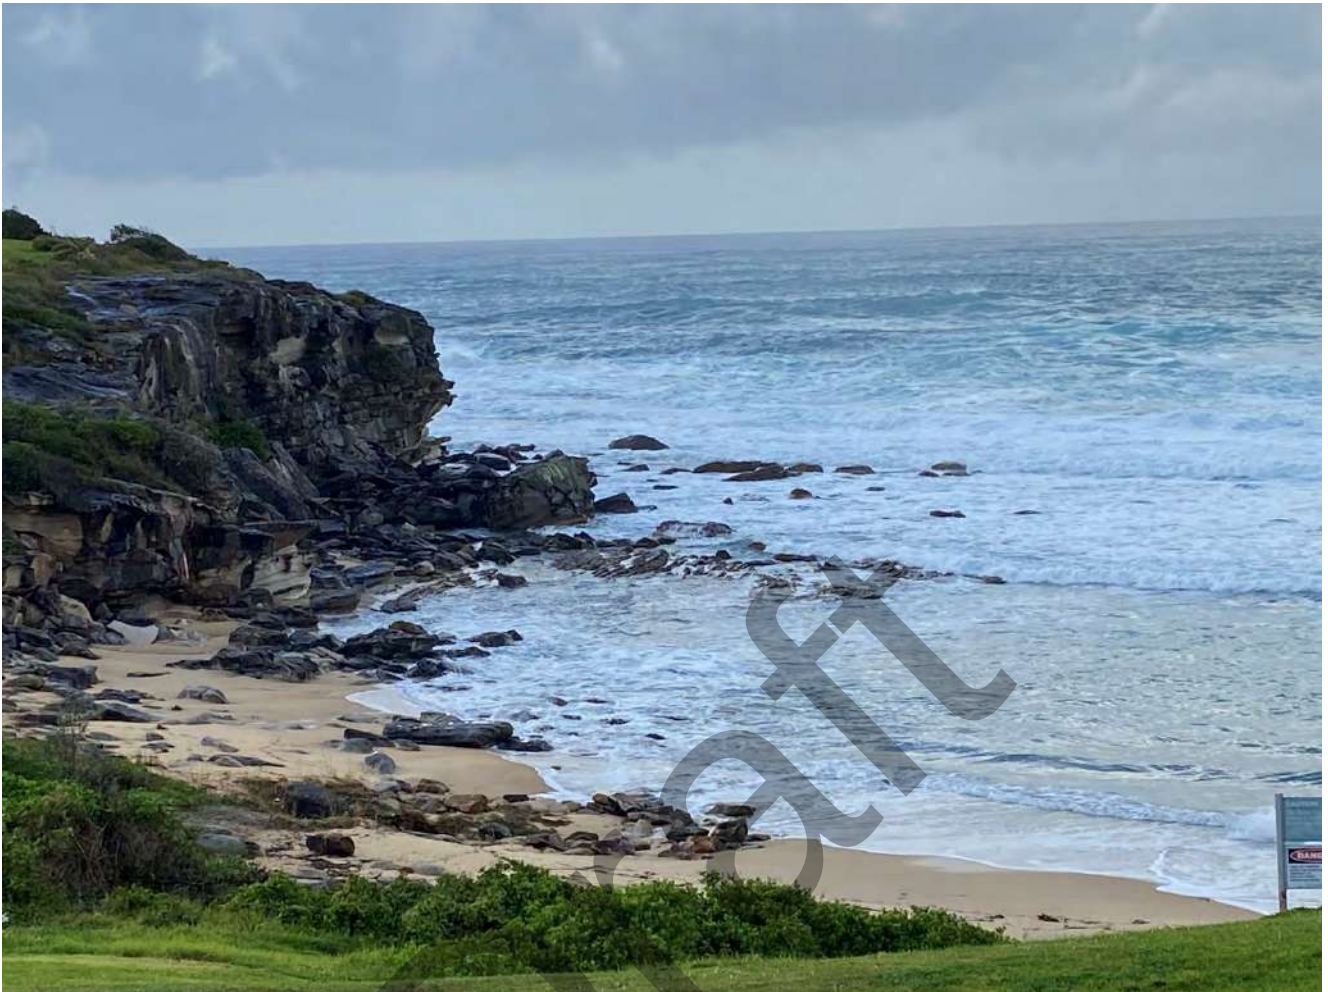
Figure. Northern Beach impacted by rough swell and high tide.
