RE: Asbestos Air Monitoring Report

Site:	Little Bay Beach
Location:	Background air monitoring

Appendix 1: Air Monitoring Locations

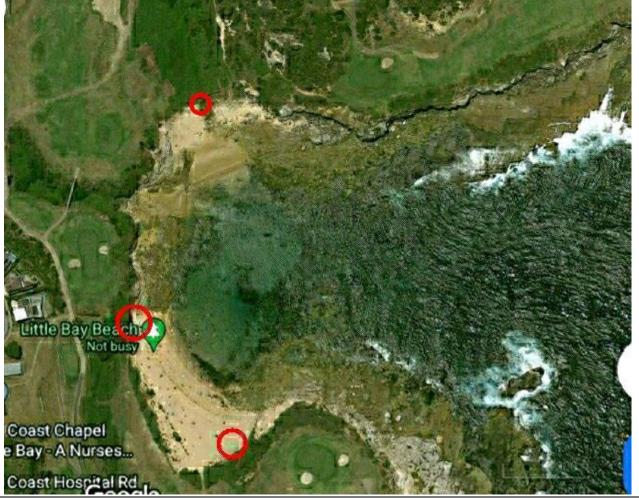
Requested by:	
Client Contact Name	Joe Santangelo
Client Contact Number	0436839760
Client Contact Email	joe.santangelo@randwick.nsw.gov.au
Site:	
Address	2 Coast Hospital Rd, Little Bay NSW 2036
Local Government Area	Randwick City Council
Site Boundary	
Air Monitoring Locations	0

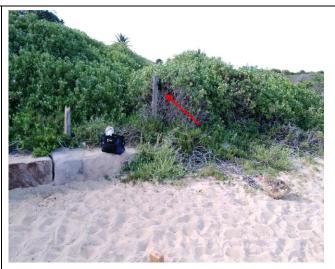
Image Id: 221228-081303

Location: Western elevation, Beach entry, on fence

Result: <0.01 f/ml
