RE: Asbestos Air Monitoring Report

Site:	Little Bay Beach
Location:	Background air monitoring

Wind Speed	3km/h
Scope of Work:	Background air monitoring
B.R. 41 1 1

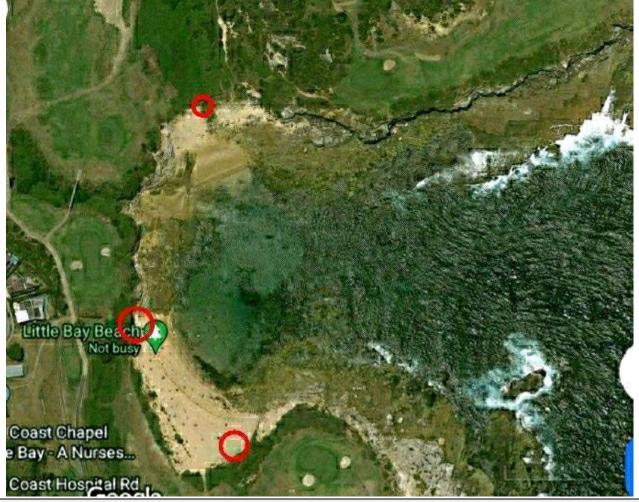
Requested by:	
Client Contact Name	Joe Santangelo
Client Contact Number	0436839760
Client Contact Email	joe.santangelo@randwick.nsw.gov.au
Site:	
Address	2 Coast Hospital Rd, Little Bay NSW 2036
Local Government Area	Randwick City Council
Site Boundary	
Air Monitoring Locations	0

Sample Location / Person Name	AM Type	Sample ID	Average Flow Rate (L/Min)	Time On	Total Sampling Time (Min)	Total Volume (L)	Results
Southern elevation, South Beach	В	DH153698	4.0	07:06	134	536.00	<0.01 f/ml
Southern beach, adjacent to entry stairway	В	DH153702	4.0	07:10	132	528.00	<0.01 f/ml
Northern beach, on wall column	В	DH153689	4.0	07:19	130	520.00	<0.01 f/ml
Field blank	BI	DH153686					0 fibres / 100 fields
