## Planning Proposal

To amend the Randwick LEP 2013 to permit child care centres at 270 Malabar Road, Maroubra

Prepared for Malak Group Pty Ltd

# PHASE 1 SITE CONTAMINATION ASSESSMENT

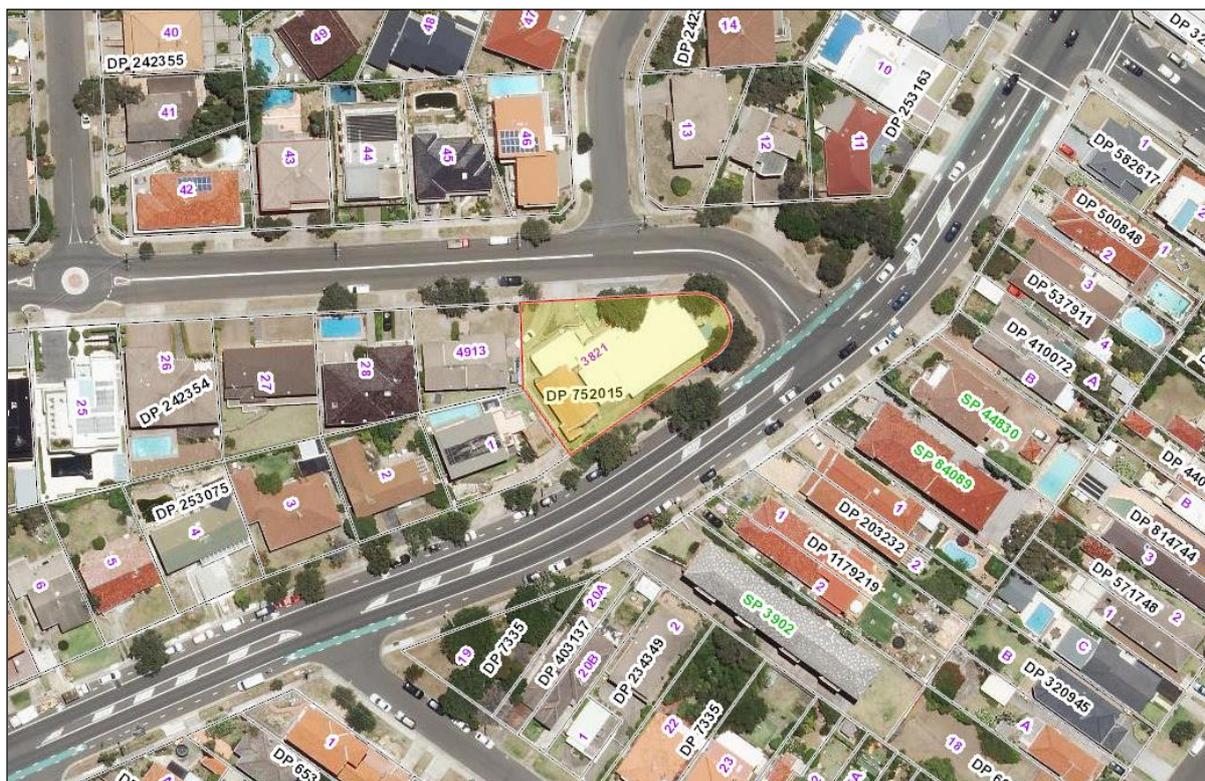
FIGURE 1 – AERIAL IMAGE OF THE SUBJECT SITE

This Planning Proposal is made in relation to a single allotment located at 270 Malabar Road, Maroubra which is formally identified as Lot 3821 in DP752015. The site measures 1,006.6sqm in area and is outlined below in **Figure 1 and 2**. The site features are described in **Table 2**.

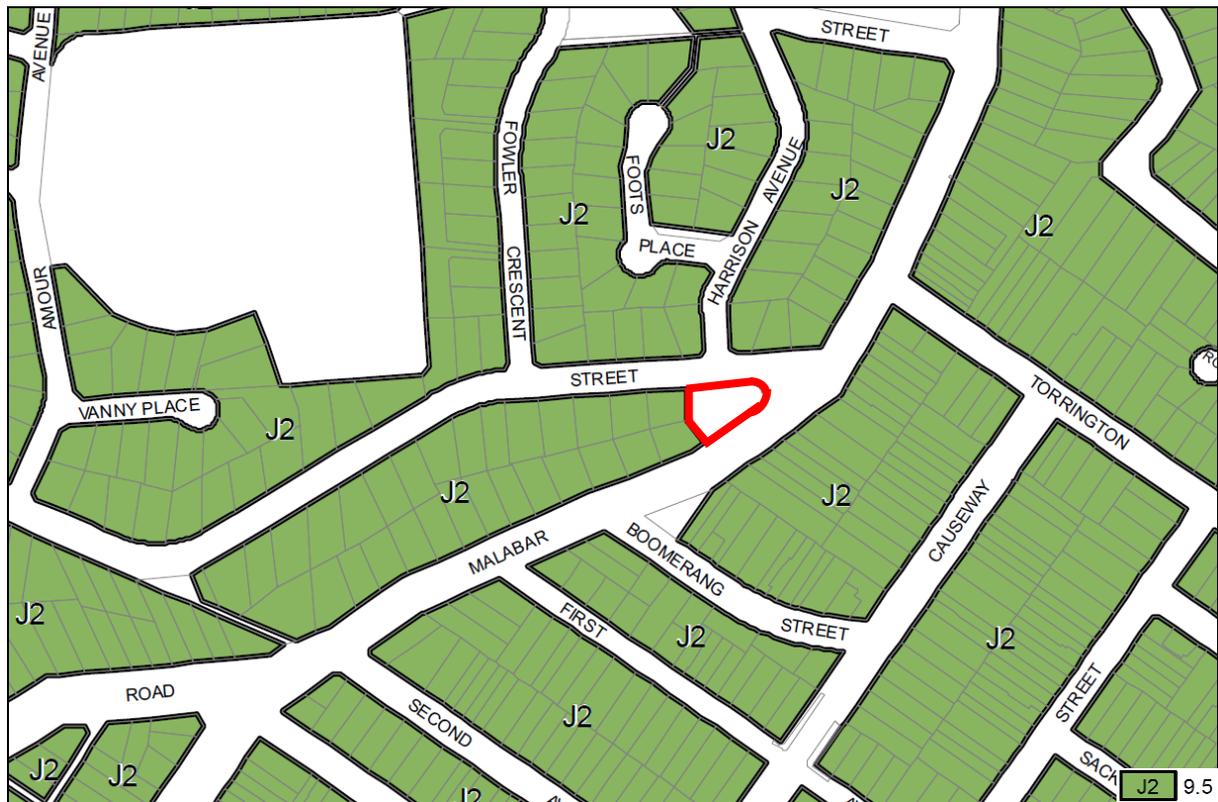
FIGURE 4 – RLEP2012 HEIGHT OF BUILDING MAP

The RLEP2012 does not apply a building height control to the site, as shown in **Figure 4**. The lots adjoining the site are assigned a height limit of 9.5m.

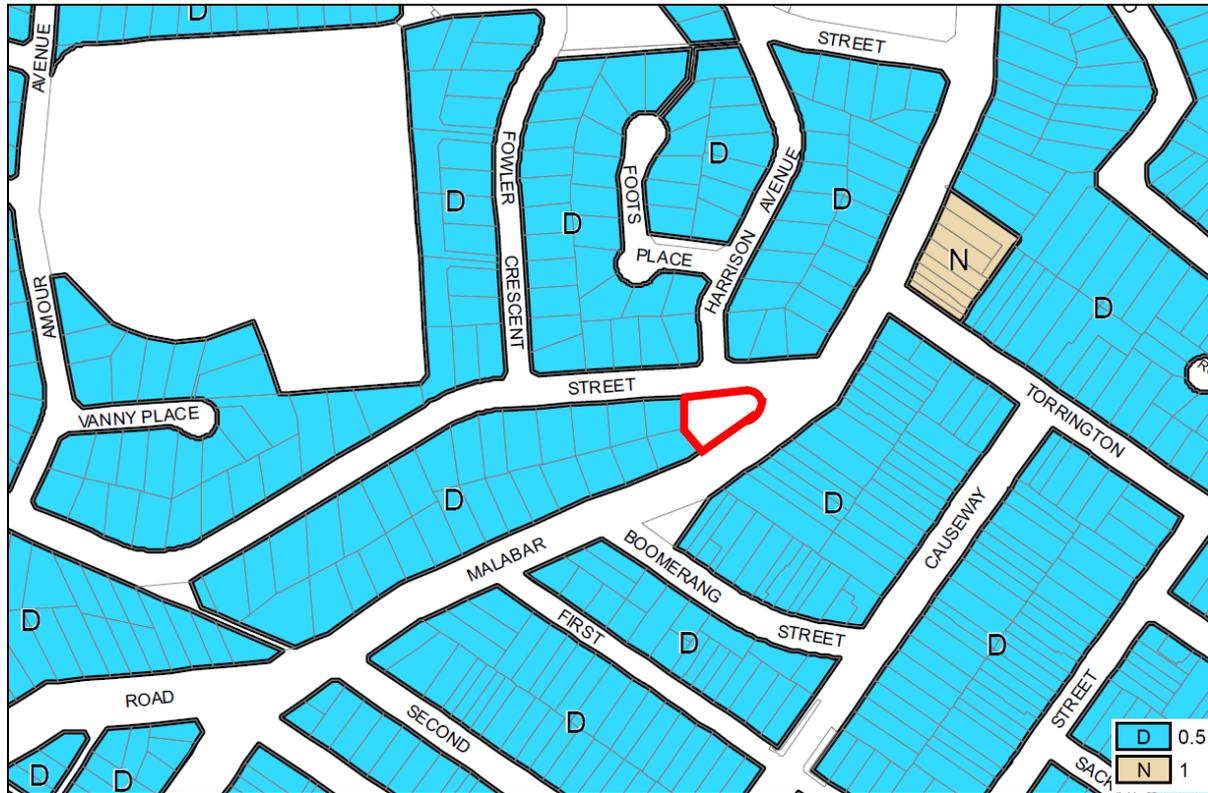
FIGURE 5 – RLEP2012 FSR MAP

The RLEP2012 does not apply a floor space ratio control to the site, as shown in **Figure 5**. The lots adjoining the site are assigned a floor space ratio of 0.5:1 with a small pocket of land zoned B1 Commercial Core assigned a floor space ratio of 1:1.

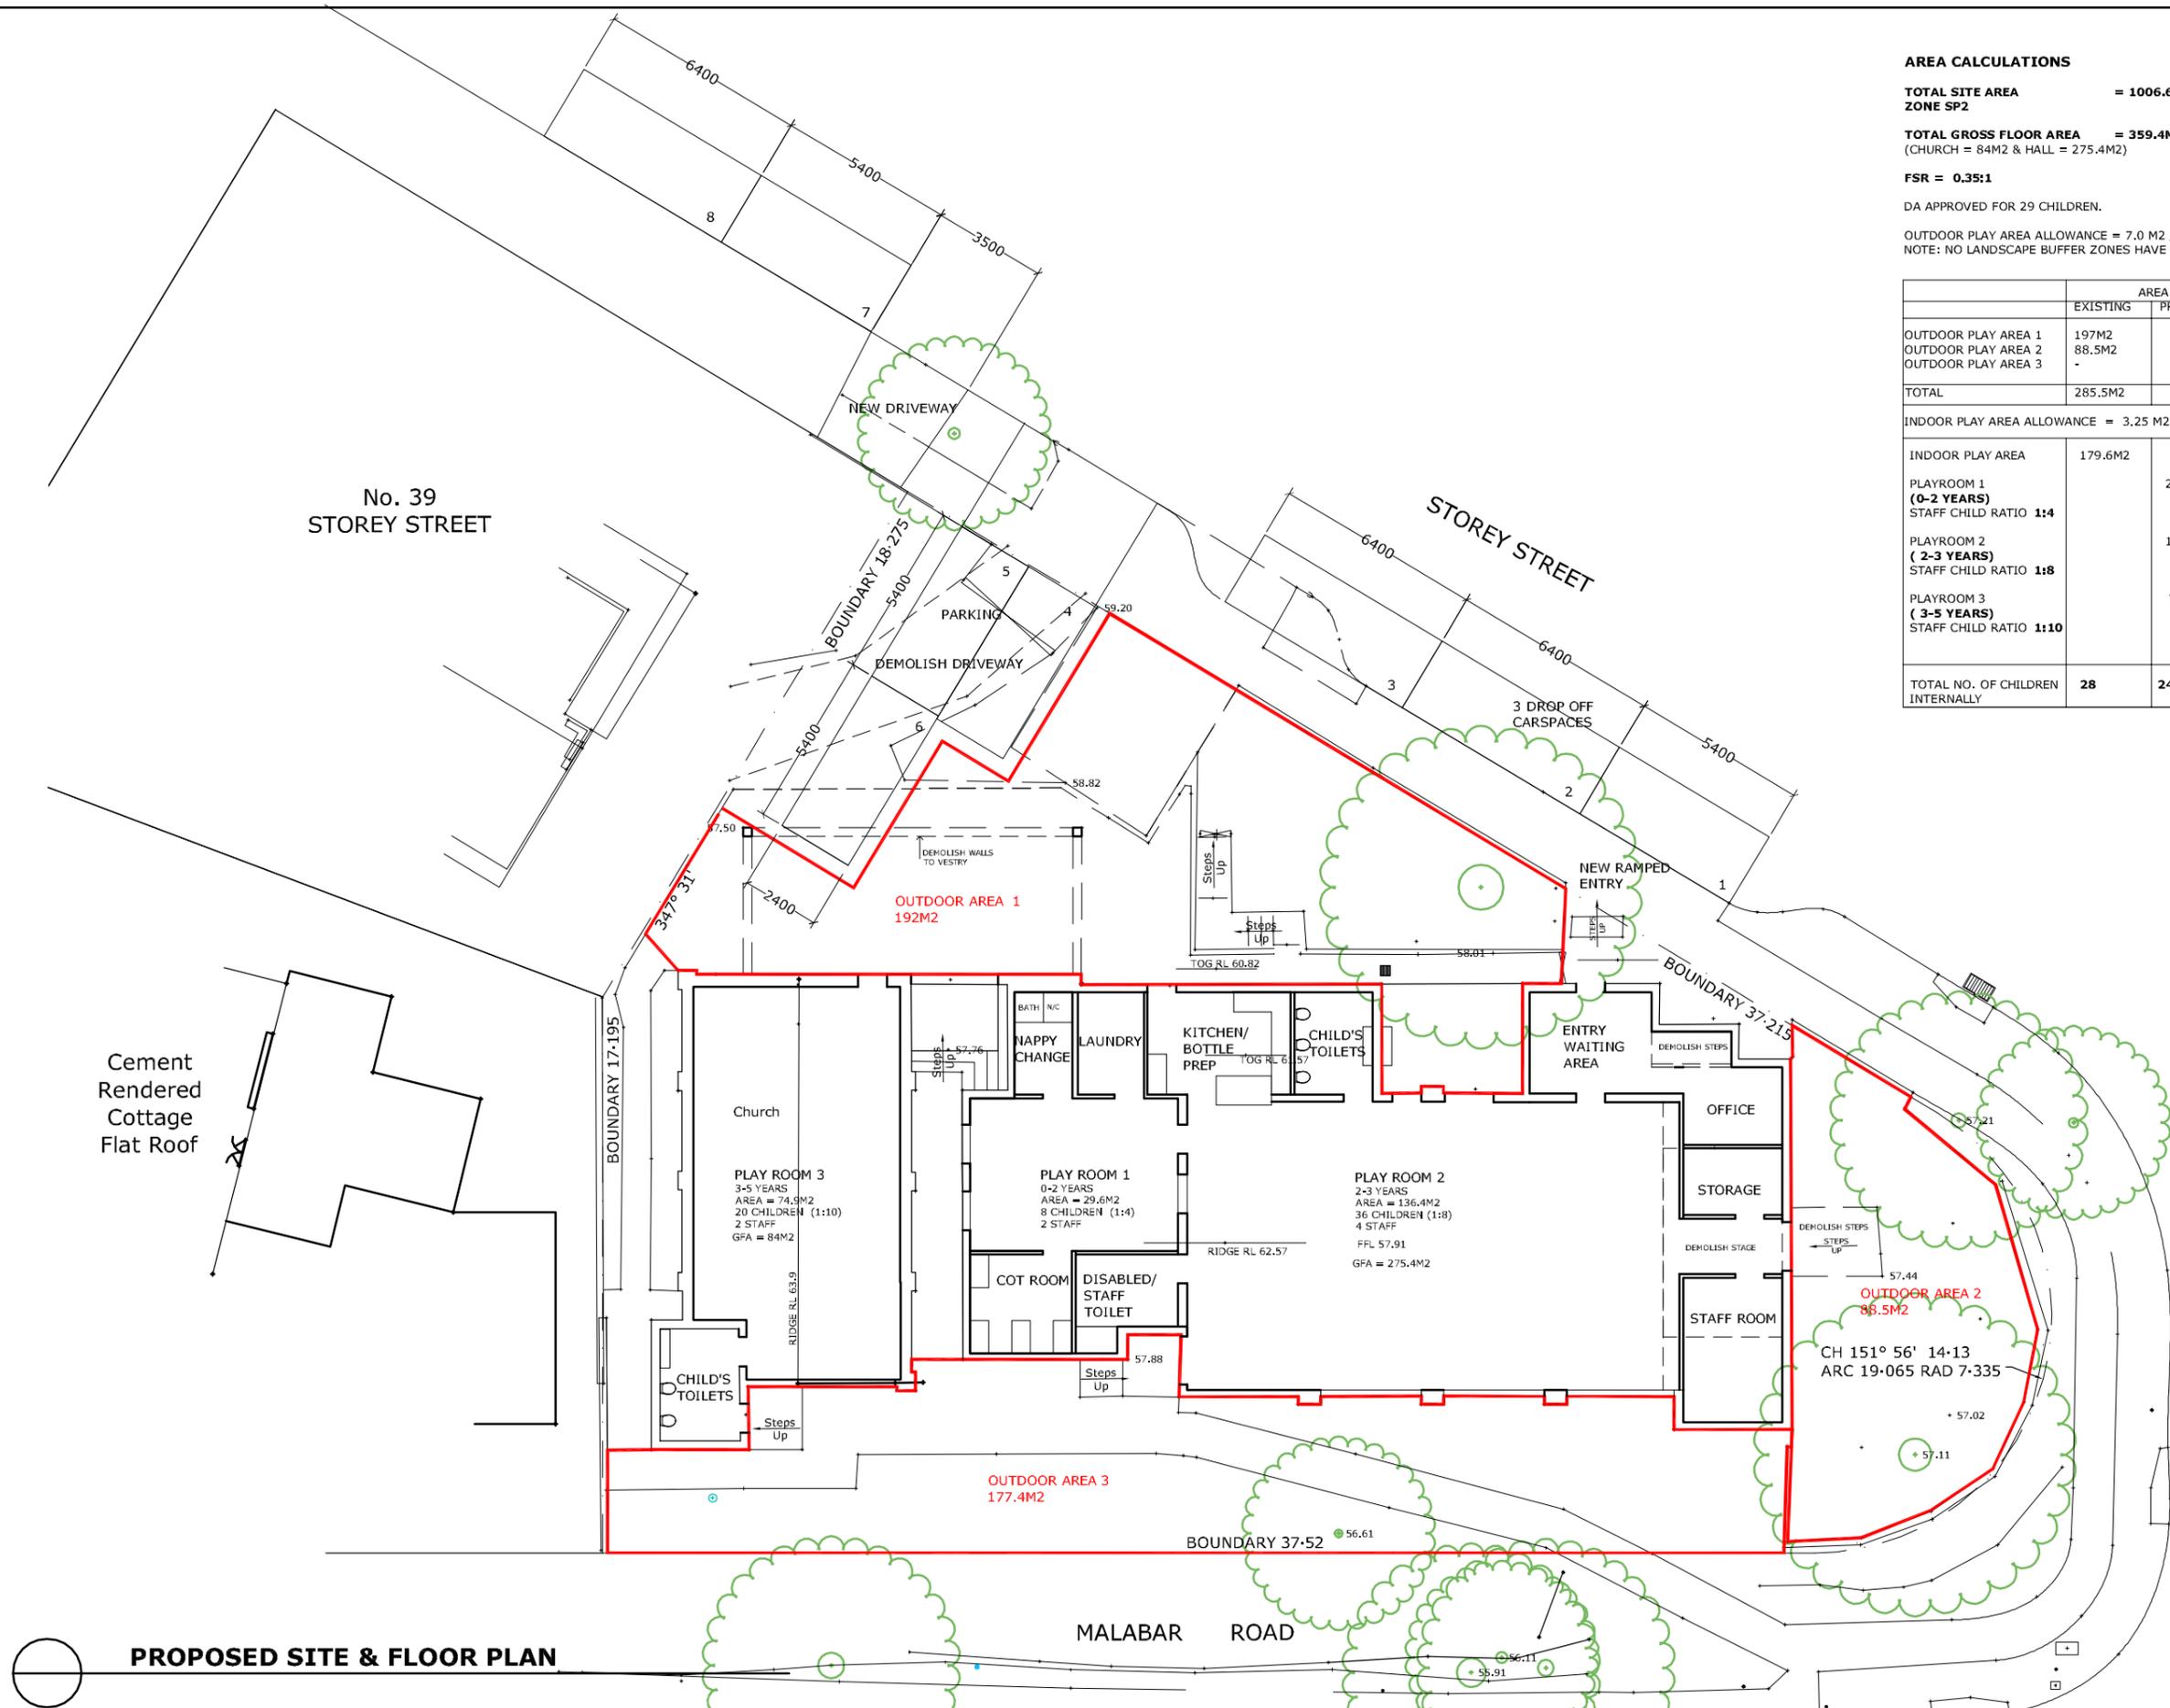
**PROPOSED SITE & FLOOR PLAN**

OUTDOOR PLAY AREA ALLOWANCE = 7.0 M2 / CHILD UNENCUMBERED SPACE  
NOTE: NO LANDSCAPE BUFFER ZONES HAVE BEEN INCLUDED ALONG PERIMETER.

AREA		NO. OF CHILDREN	STAFF REQUIRED
	EXISTING	PROPOSED		
OUTDOOR PLAY AREA 1	197M2	192M2	27	
OUTDOOR PLAY AREA 2	88.5M2	88.5M2	12	
OUTDOOR PLAY AREA 3	-	177.4M2	25	
<b>TOTAL</b>	<b>285.5M2</b>	<b>451M2</b>	<b>64</b>	
INDOOR PLAY AREA ALLOWANCE = 3.25 M2 / CHILD UNENCUMBERED SPACE				
INDOOR PLAY AREA	179.6M2			
PLAYROOM 1 (0-2 YEARS) STAFF CHILD RATIO 1:4	29.6M2	<b>8 CHILDREN</b>	<b>2</b>	
PLAYROOM 2 (2-3 YEARS) STAFF CHILD RATIO 1:8	136.5M2	<b>36 CHILDREN</b>	<b>5</b>	
PLAYROOM 3 (3-5 YEARS) STAFF CHILD RATIO 1:10	74.9M2	<b>20 CHILDREN</b>	<b>2</b>	
<b>TOTAL NO. OF CHILDREN INTERNALLY</b>	<b>28</b>	<b>241M2</b>	<b>64 CHILDREN</b>	<b>9 STAFF</b>

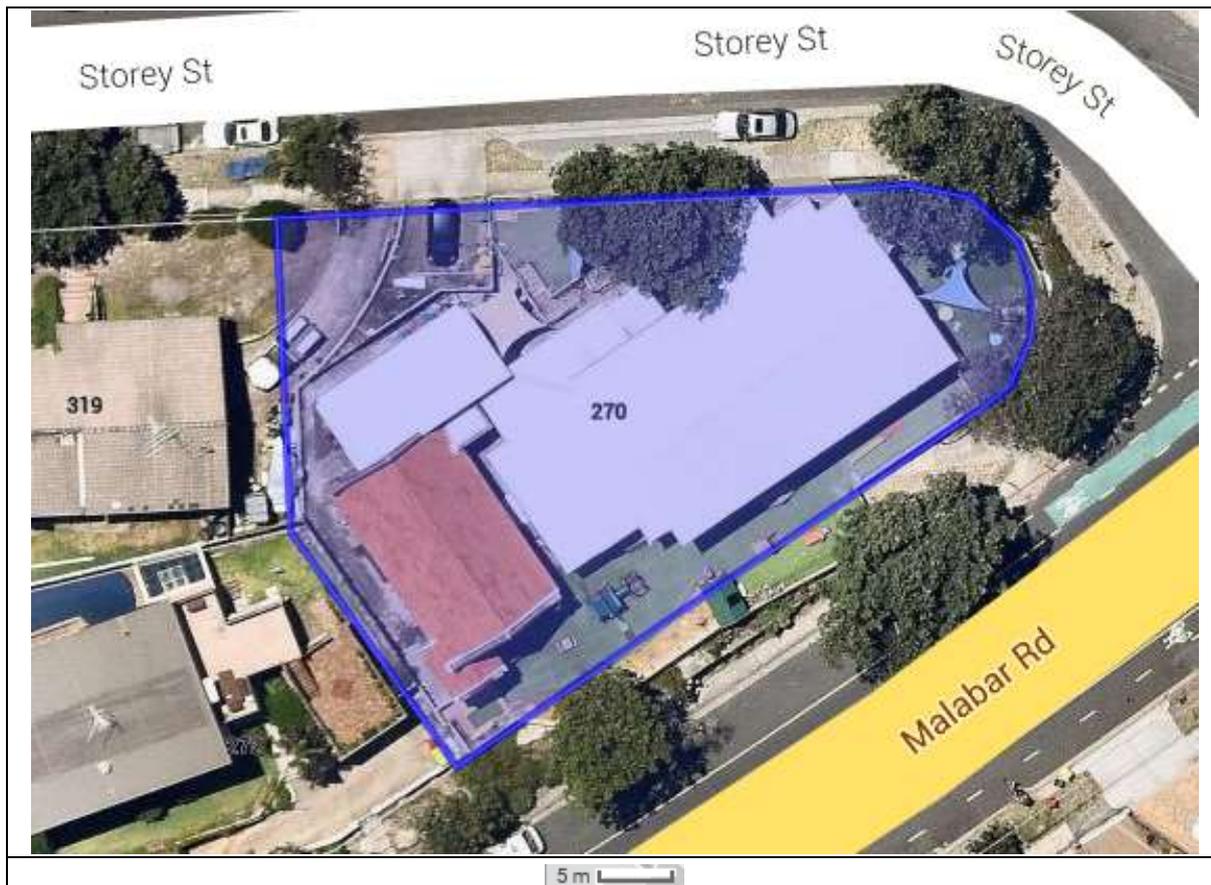
Figure 2.2 – Recent Satellite View of the Site (December 18<sup>th</sup> 2015)

A recent (December 18<sup>th</sup> 2015) satellite view of the site area is shown in Figure 2.2, on the following page.

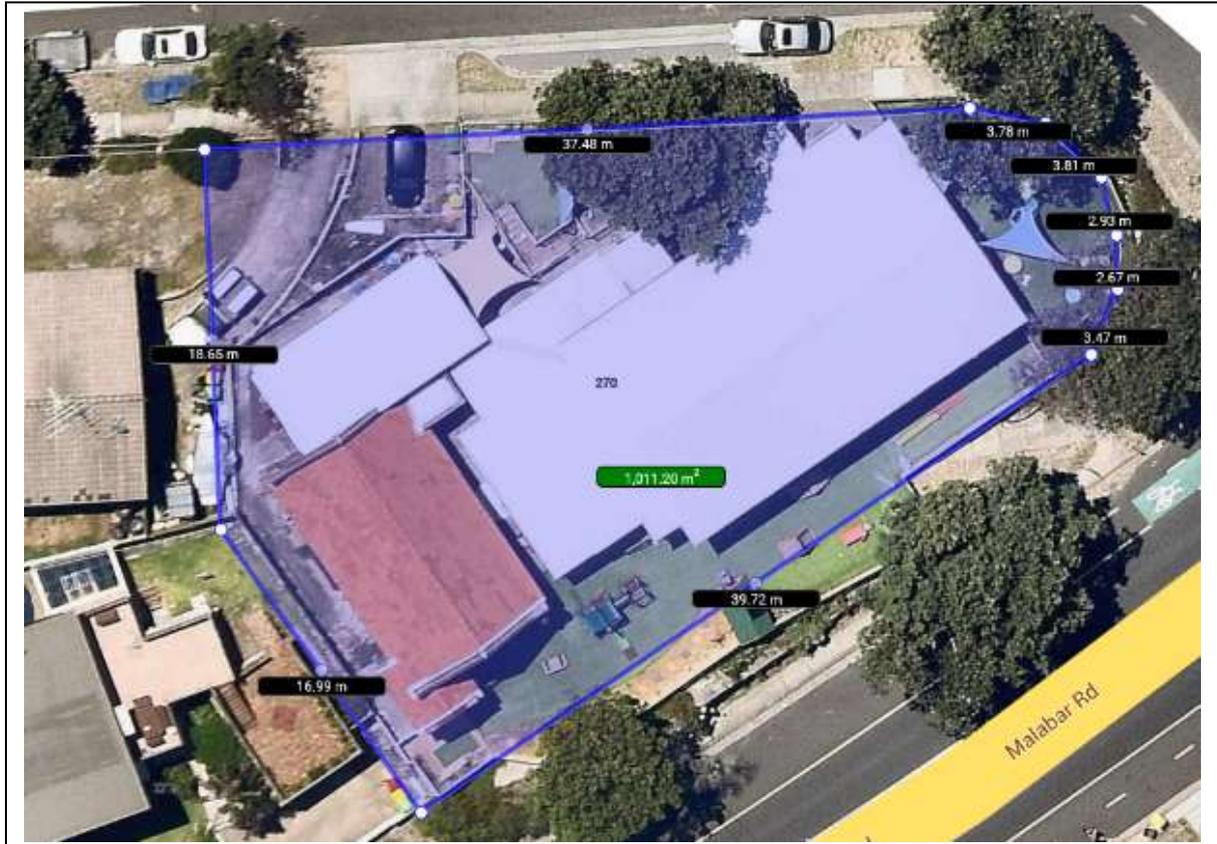
Figure 2.4 – Approximate Dimensions of the Site

The dimensions and approximate area of the site are shown in Figure 2.4, below.

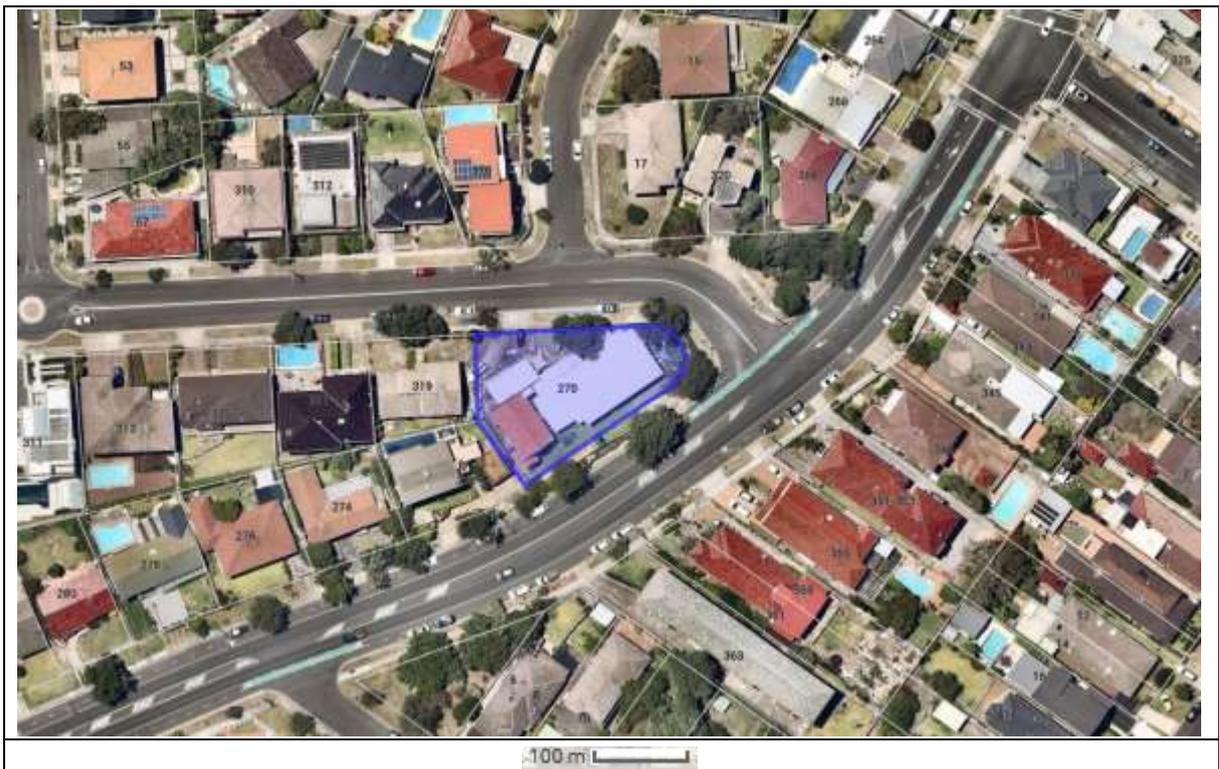
Figure 6.1 – Residential Properties near the 270 Malabar Road Maroubra Site

The site is located in an essentially low density residential area. This is clearly illustrated by the recent (December 18<sup>th</sup> 2015) satellite image in Figure 6.1, below, where the site area (shaded in blue) is shown surrounded by low density residential properties.

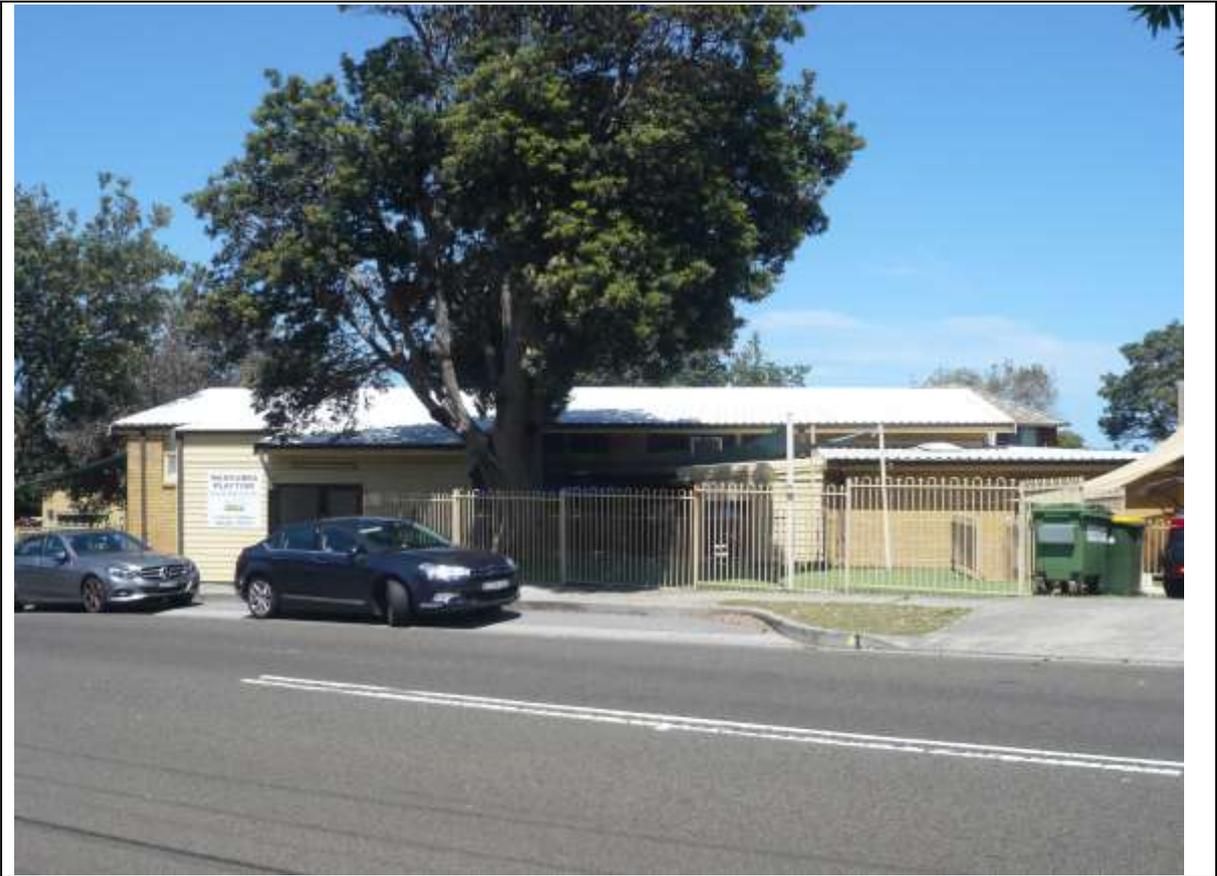
**Figure 6.2 – Child Care Centre at the Site Viewed from the Opposite Side of Storey Street**

There are existing buildings at the site, as illustrated in Figures 6.2 to 6.5 on subsequent pages, as follows:

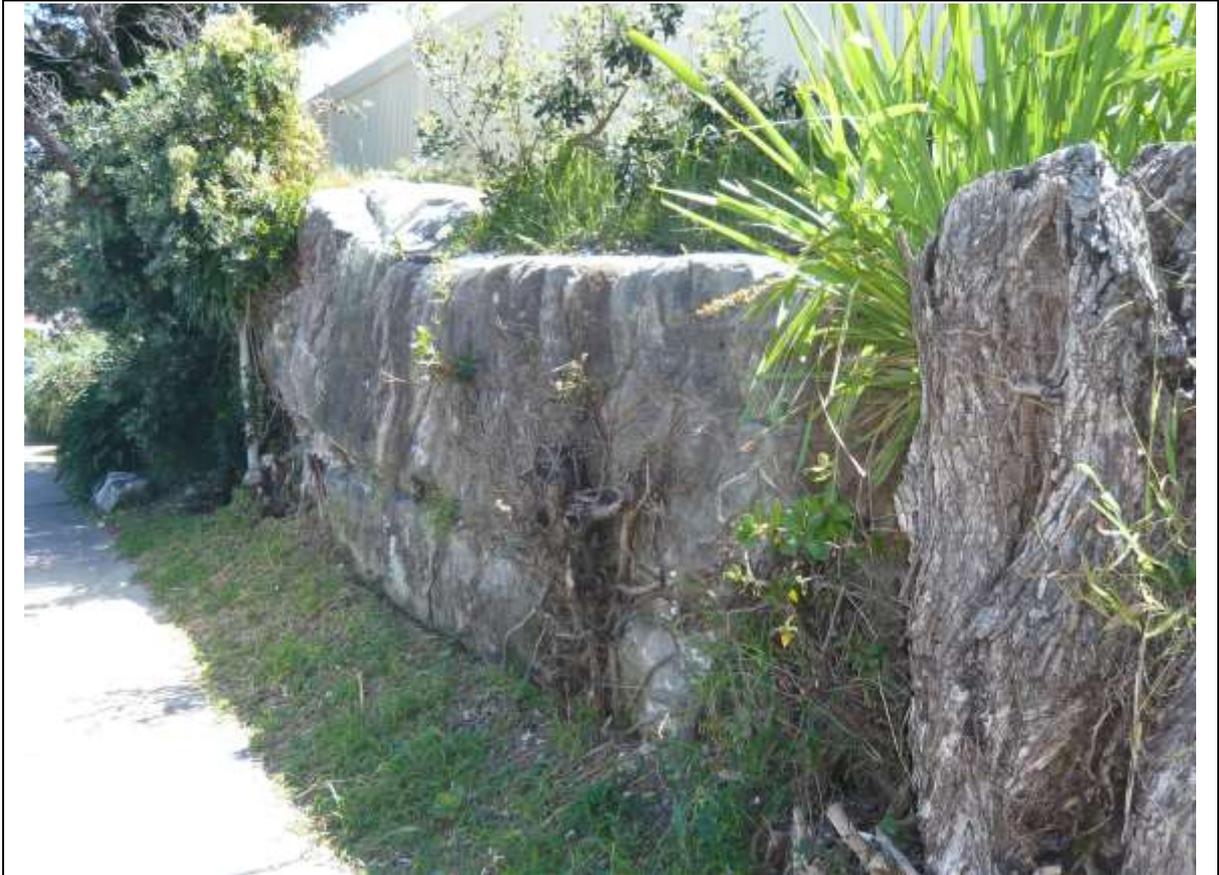
**Figure 6.6 – Underlying Sandstone along the Eastern Malabar Road Property Boundary**

The site is underlain by a natural sandstone shelf, as shown in Figures 6.6 and 6.7 on the following page, and both surface and sub-surface drainage were noted along this boundary.

No indication of odour, discoloration was noted in the surface and sub-surface drainage and seepage noted at this property boundary.

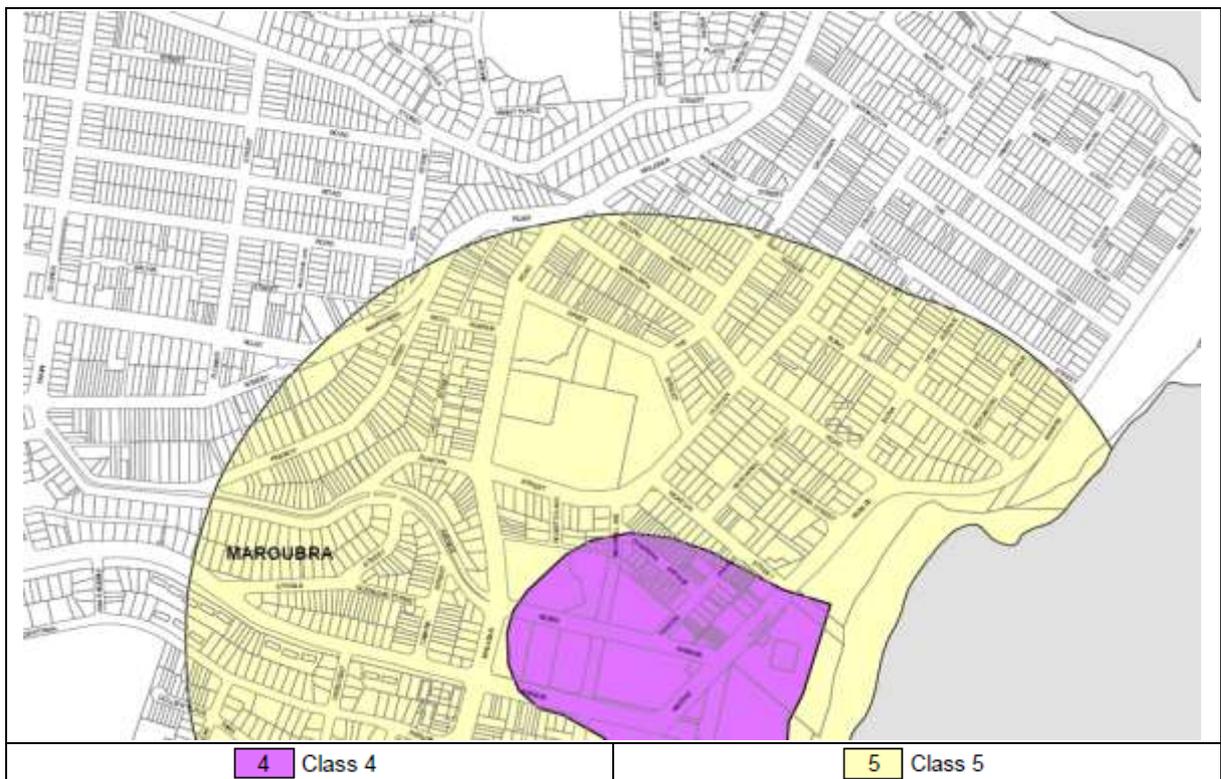
Figure 6.8 – Acid Sulphate Soil Map (Randwick City Council LEP 2012)

The site is shown slightly to the right of the top centre of Figure 6.8, below, at the intersection of Storey Street and Malabar Road. The closest identified acid sulphate soil zones (Class 5 and Class 4) are shown further to the south.

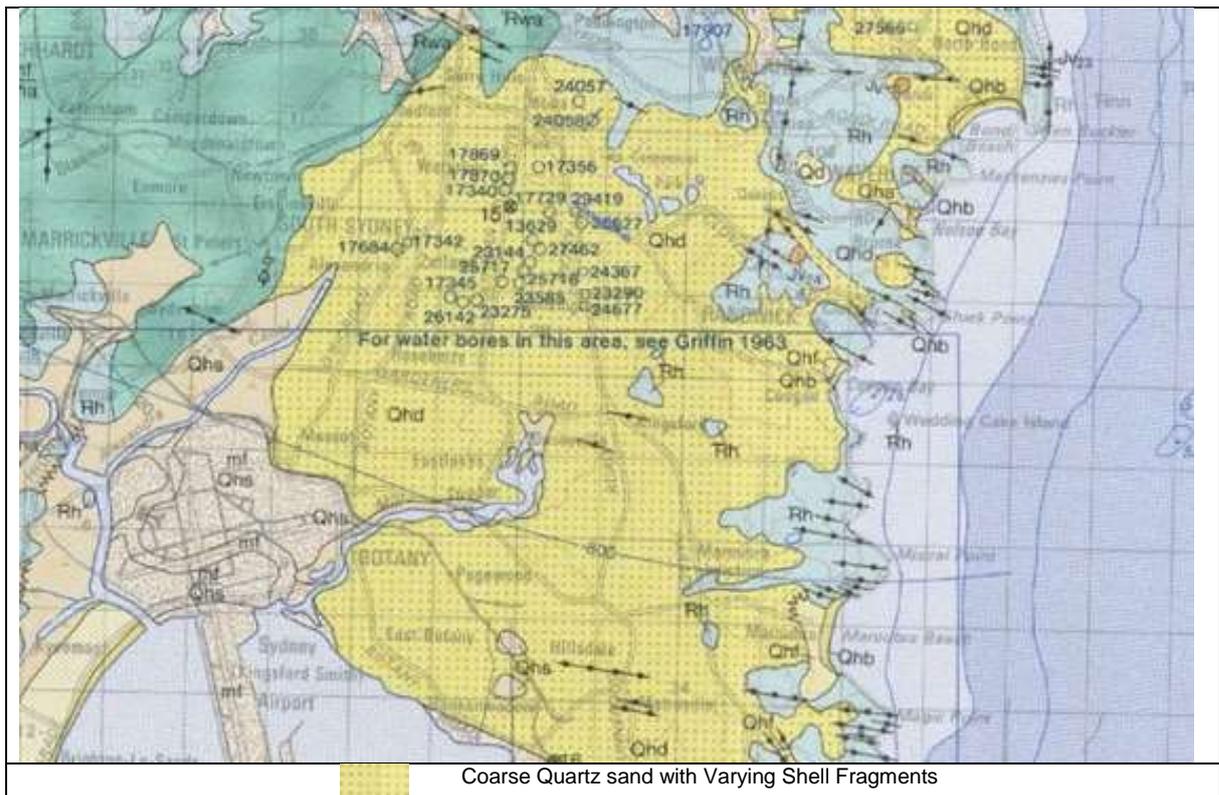
Figure 7.1 – Site Area on Sydney 1:100,000 Geological Map

Basaltic dykes intruding bedrock are common in the area north of Botany Bay. The eroded bedrock surface is overlain in most areas by Quaternary sediment deposits.

On land, the Quaternary deposits are dominantly aeolian (win-blown) sediments composed of fine to medium grained quartzose sand with occasional cemented layers associated with former soil horizons.

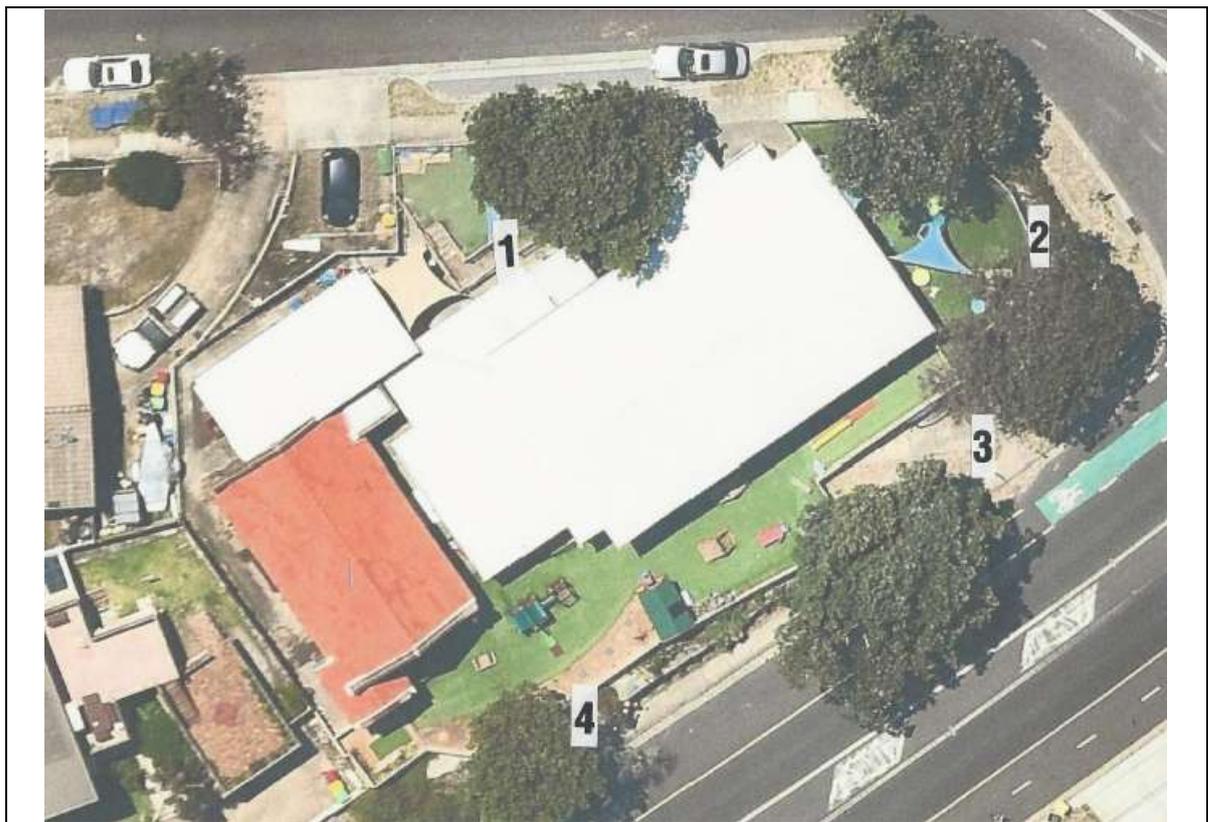
**Figure 7.2 – Soil Sampling Locations**

Soil bores were installed at four representative locations throughout the site area by hand augur, and soil samples were examined and collected from various depths at each of these four locations. The four locations are identified in Figure 7.2, below.

The four locations selected provide a sampling distribution consistent with relevant assessment guidelines, including the requirements of the NSW EPA Guidelines for Reporting on Contaminated Sites, and the May 2013 update of the National Environment Protection Measure (NEPM) relating to environmental site assessment. The four soil sampling locations are described in Table 7.1, on the following page.

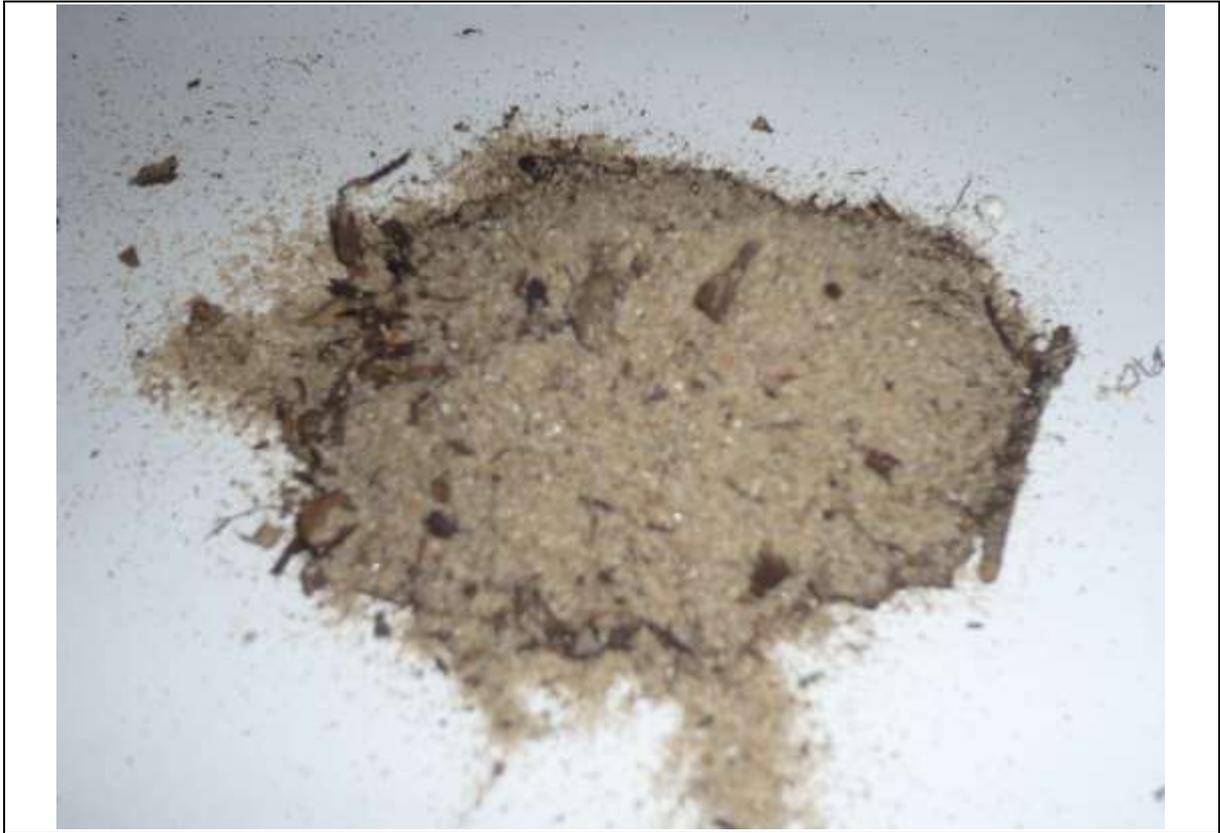
**Figure 7.3 – Soil Sample MRD-1-0300**

Samples from all depths were dominated by granular, sandy quartzite material as anticipated from the geological profile of the area provided in 7.2 above.
