# **GORDONS BAY**

## **Plan of Management**

**RANDWICK CITY COUNCIL**

**LAND SYSTEMS EBC PTY LTD**

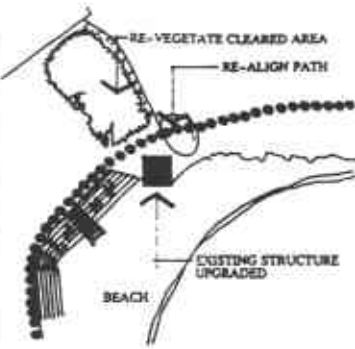
<p><b>Option A</b></p>

ISSUE	OBJECTIVE	GUIDELINES
	<p><b>Option a) Advantages:</b></p> <p>Relatively minor costs involved in refurbishing structure.</p> <p>Minimum interruption to fishing club activities.</p> <p>Minimum disturbance to surrounding area.</p> <p><b>Option a) Disadvantages:</b></p> <p>The structure remains in a very visually prominent location.</p> <p>Pathway around clubhouse structure will require to be re-designed and directed further into existing vegetated area to rectify circulation problems, thus removing existing vegetation.</p> <p>Refurbishment potential is limited.</p> <p>Use of prime foreshore space by a minority user group for essentially storage purposes only.</p> <p style="text-align: center;">or</p> <p><b>Option b)</b></p> <p>Relocate club house structure to the cleared area behind but maintain existing racks and boats.</p>

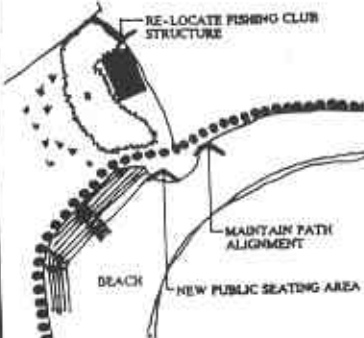
<p style="text-align: center;"><b>Option B -</b></p>

ISSUE	OBJECTIVE	GUIDELINES
	<p><b>Option b) Advantages</b></p> <p>Makes available foreshore space for public area – specifically circulation.</p> <p>Solves circulation safety problems.</p> <p>Generally a more efficient use of space.</p> <p>More visually desirable with an opportunity to create a structure that is more in keeping with the landscape and more appropriately sited.</p> <p>Increased amenity for fishing club through design of a more suitable storage facility.</p> <p>Proposed location already cleared therefore creating minimal disturbance.</p> <p><b>Option b) Disadvantages</b></p> <p>Significant capital cost.</p> <p>Use of existing reserve area for fishing club storage.</p>	<p>Implement Option – 'b'. Provide club house storage facilities within existing cleared garden area. Demolish existing structure and restore foreshore pedestrian path.</p>
<p><b>3e) Land Use – Boats and Boat Racks</b></p>	<p>Reduce number of boats without eliminating existing rights of users. Payment of an equitable lease commensurate with the significance of the high space and public value.</p>	<p>Retain minimum of boats on racks.</p> <p>Amount of boats and boat racking reduced based upon number of regularly used boats (eg. once per month min.).</p> <p>Lease to be at an agreed rate based upon Council's standard lease rates and similar boat mooring facilities. However, consideration is to be given to the contribution that the boats make to the character of the bay.</p>

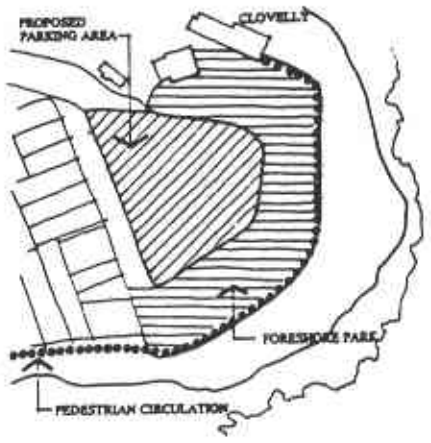
<p><b>Long Term Concept</b></p> <p>The redesign of the headland is to be subject to a traffic management study and detail landscape design. Since the above concept involves major capital costs the following interim concept has been prepared. The interim concept is based upon retention of much of the existing car parking area in its existing condition but reclaiming a 20m strip along the foreshore for passive recreation open space.</p>

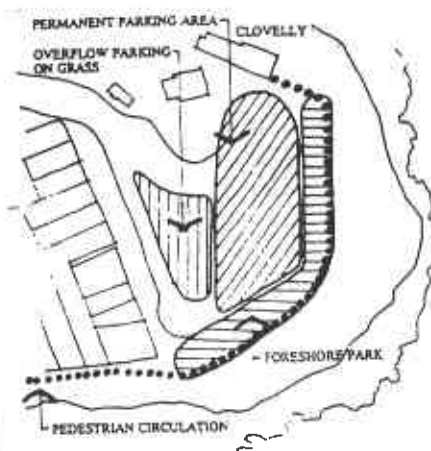
<p><b>Interim Concept</b></p>

ISSUE	OBJECTIVE	GUIDELINES
4b) Aesthetics	Visually soften the car park through the introduction of planting and the breaking up of the large area into several smaller areas.	Refer sketch above.
<b>ZONE 5 - BUSHLAND AND NATURAL AREAS</b>		
5a) Pollution and Rubbish	Minimise/eliminate dumping of rubbish and litter including garden refuse.	<p>Promote local community awareness.</p> <p>Increase public vigilance.</p> <p>Communication with public by Council inspectors.</p> <p>Promote residential composting facilities.</p>
5b) Visual Quality	Maintain and improve the visual quality of the beach and natural areas without affecting existing views from adjacent residences.	<p>Promote awareness and education of scenic quality among local residents.</p> <p>Additional strategic planting on public and private land in consultation with local residents.</p>
5c) Habitat	Prevent further loss of habitat and increase indigenous vegetation.	<p>Regenerate indigenous vegetation.</p> <p>Ensure protection of existing heath areas.</p> <p>Ensure protection of Port Jackson Figs.</p> <p>Maintain and rehabilitate reed areas.</p> <p>Increase community awareness: eg. keeping cats indoors at night.</p> <p>Minimise use of herbicides and pesticides.</p> <p>Encourage planting of native species in private gardens.</p> <p>Provide regular on-going maintenance.</p>

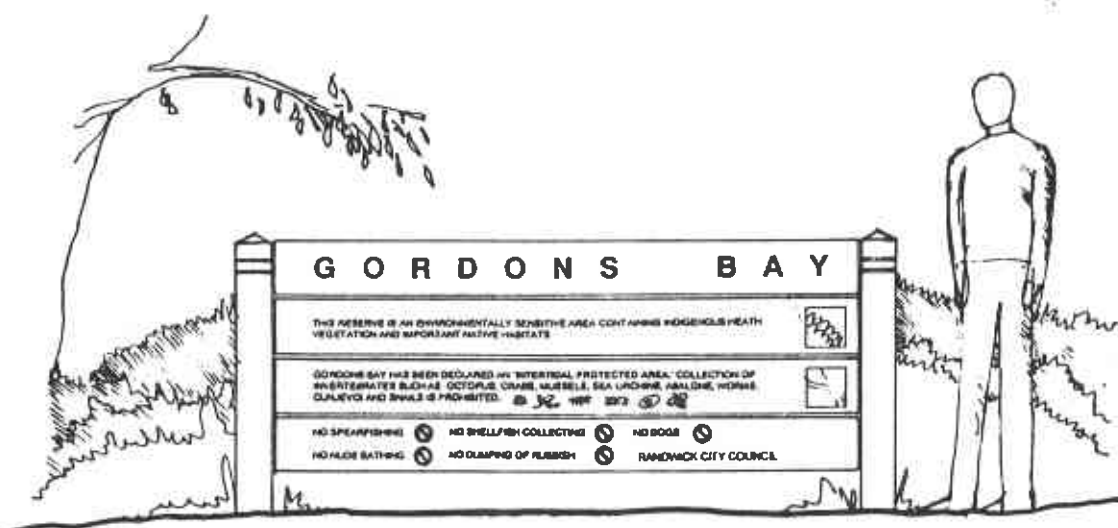
Figure No. 16: Typical Signage Stations

Signage 'stations' (Refer Figure No.'s: 16 and 17), consisting of one structure but displaying various graphic messages, can be located at the major entrances and one at the head of the bay near the fishing club structure.
