RE: Asbestos Air Monitoring Report

Site:	Little Bay Beach
Location:	Background Air Monitoring

Appendix 1: Air Monitoring Locations

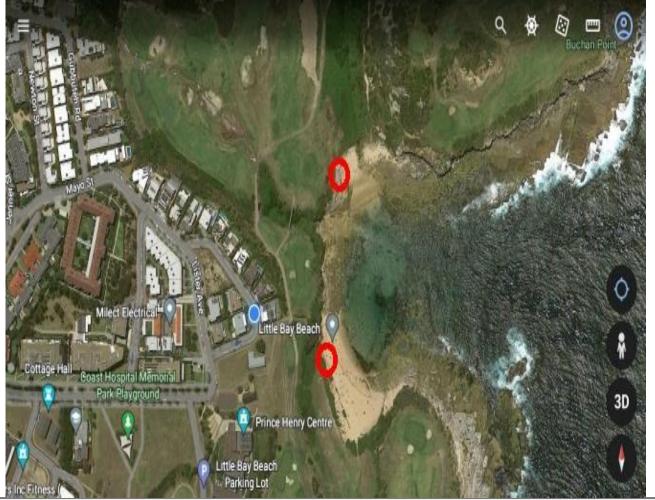
Requested by:	
Client Contact Name	Joe Santangelo
Client Contact Number	0436839760
Client Contact Email	joe.santangelo@randwick.nsw.gov.au
Site:	
Address	2 Coast Hospital Rd, Little Bay NSW 2036
Local Government Area	Randwick City Council
Site Boundary	
Air Monitoring Locations	0
