RE: Asbestos Air Monitoring Report

Site:	Little Bay Beach
Location:	Background Air Monitoring

Scope of Work: Background Air Monitoring

Appendix 1: Air Monitoring Locations

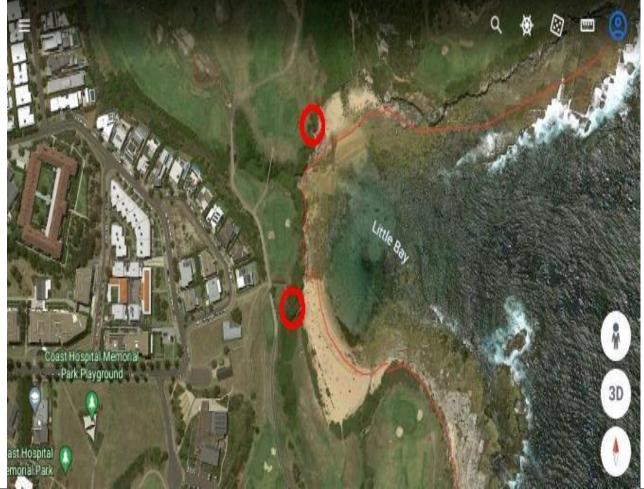
Requested by:	
Client Contact Name	Joe Santangelo
Client Contact Number	0436839760
Client Contact Email	joe.santangelo@randwick.nsw.gov.au
Site:	
Address	2 Coast Hospital Rd, Little Bay NSW 2036
Local Government Area	Randwick City Council
Site Boundary	
Air Monitoring Locations	0
