JBS&G 68409-169640

## L003 Imported Materials Assessment, Recycled DGB20 – Finucane Reserve (Rev 0)

### Material Import Assessment: Recycled DGB20, Finucane Reserve, Matraville, NSW

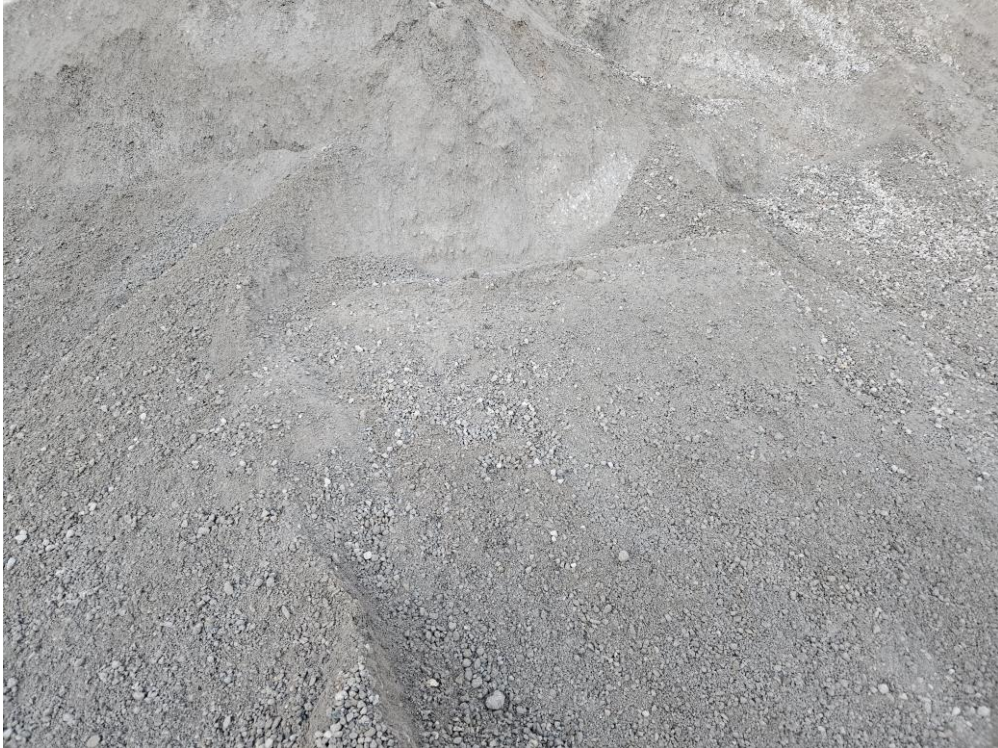
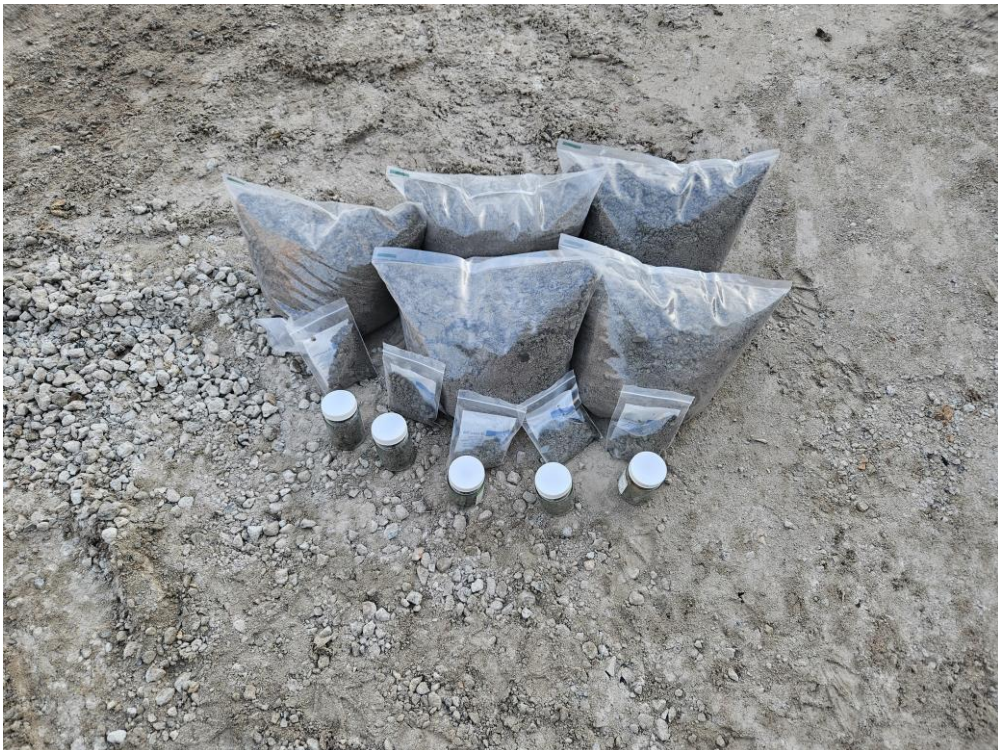
Typical Soil Profile

The stockpiled material assessed as part of this investigation comprised brown grey sandy gravel. No odours or signs of contamination were observed during the investigation.
