# Coogee Bay Flood Study

Final Report | April 2013

Prepared For: Randwick City Council

Prepared By: BMT WBM Pty Ltd (Member of the BMT group of companies)

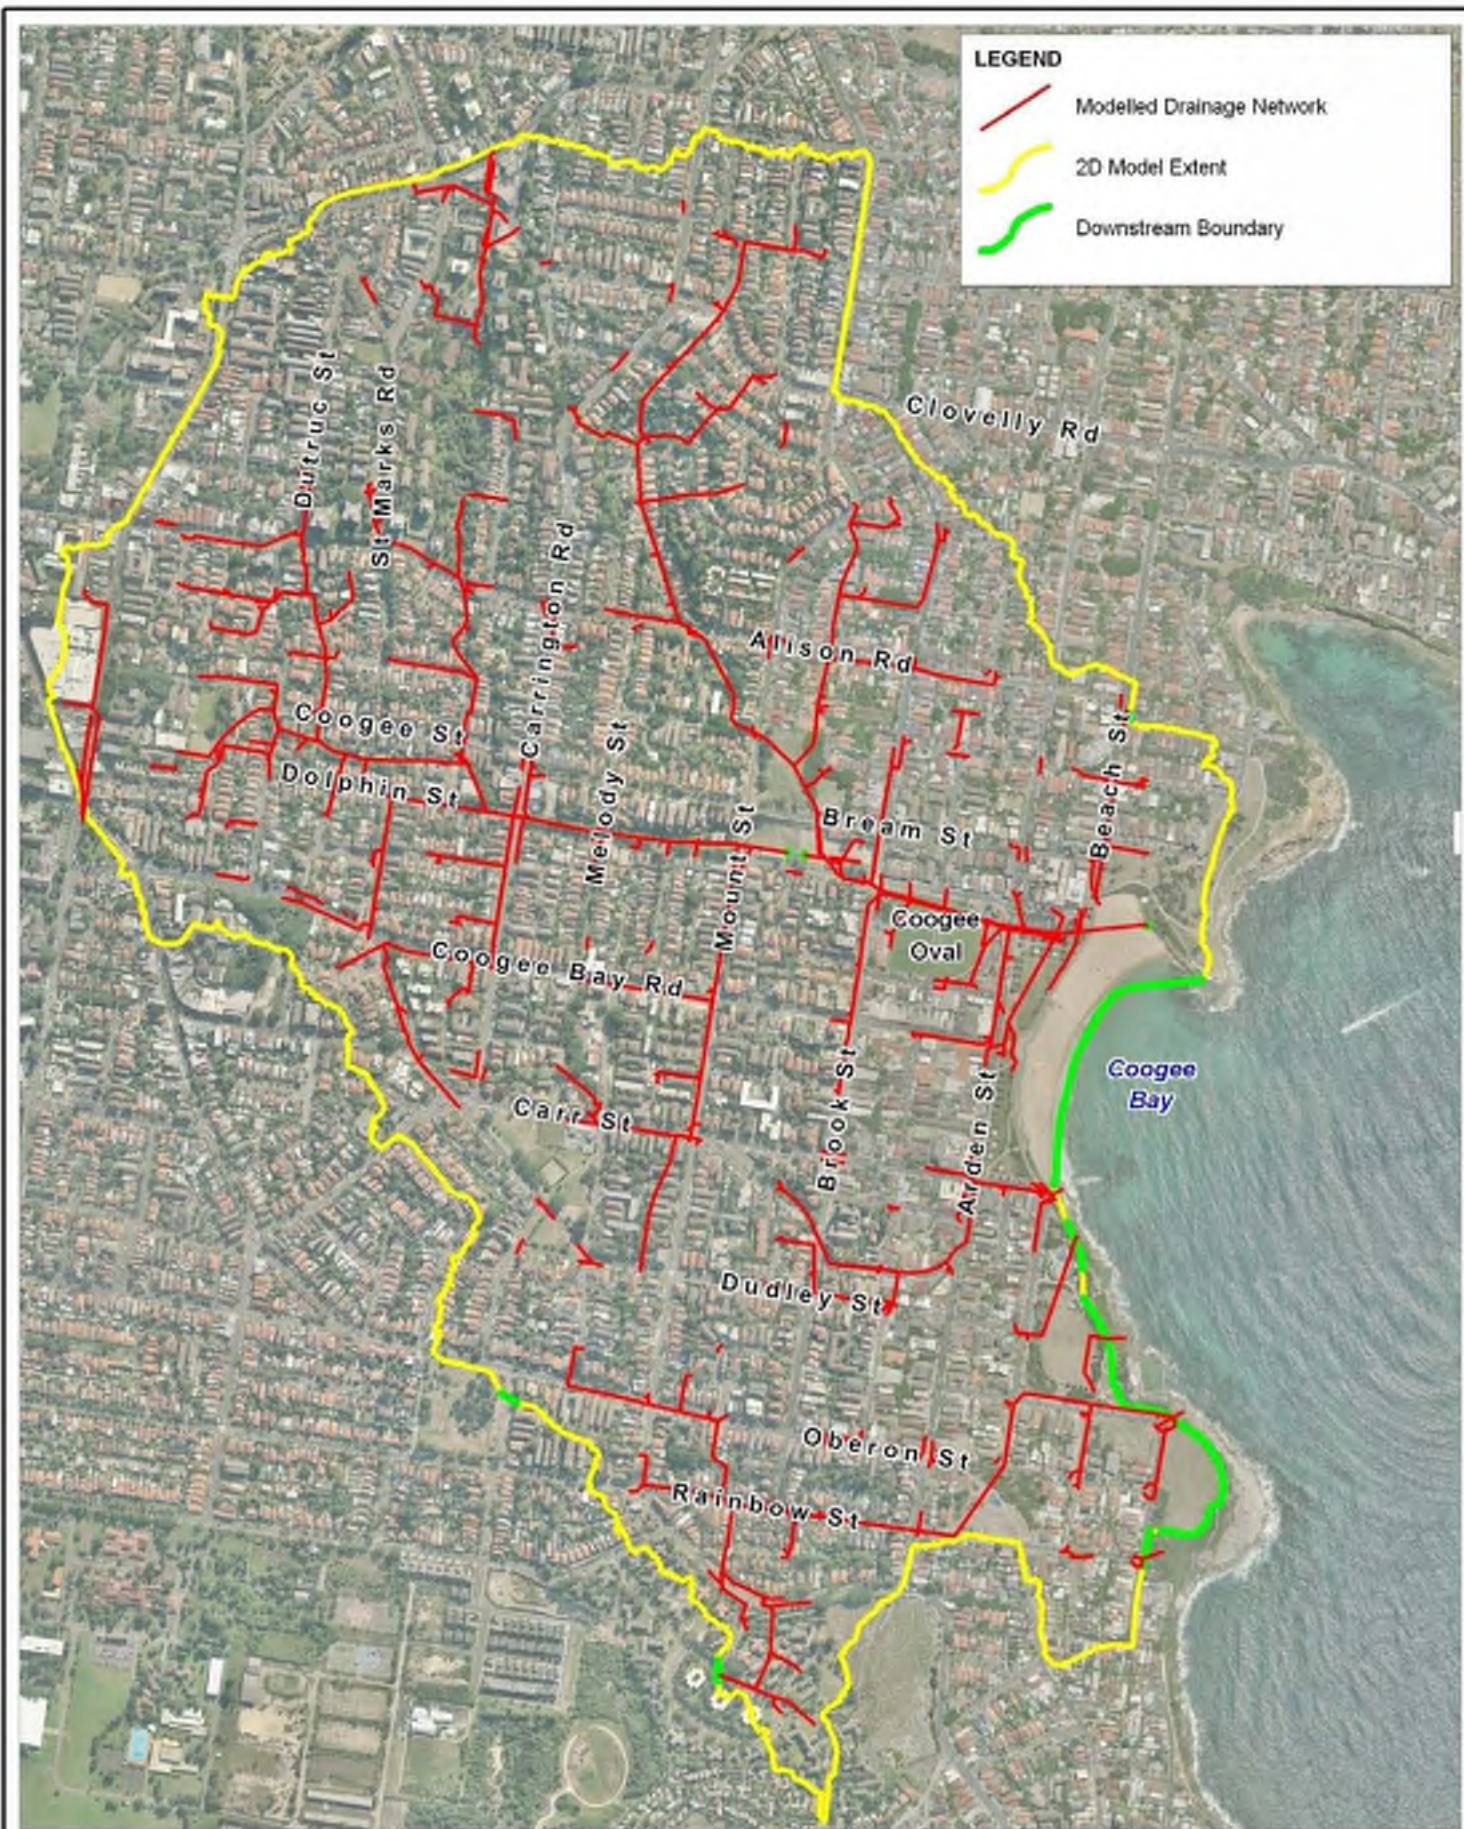
Figure:  
**4-2**

Title:  
**Linked 1D/2D Model Layout**

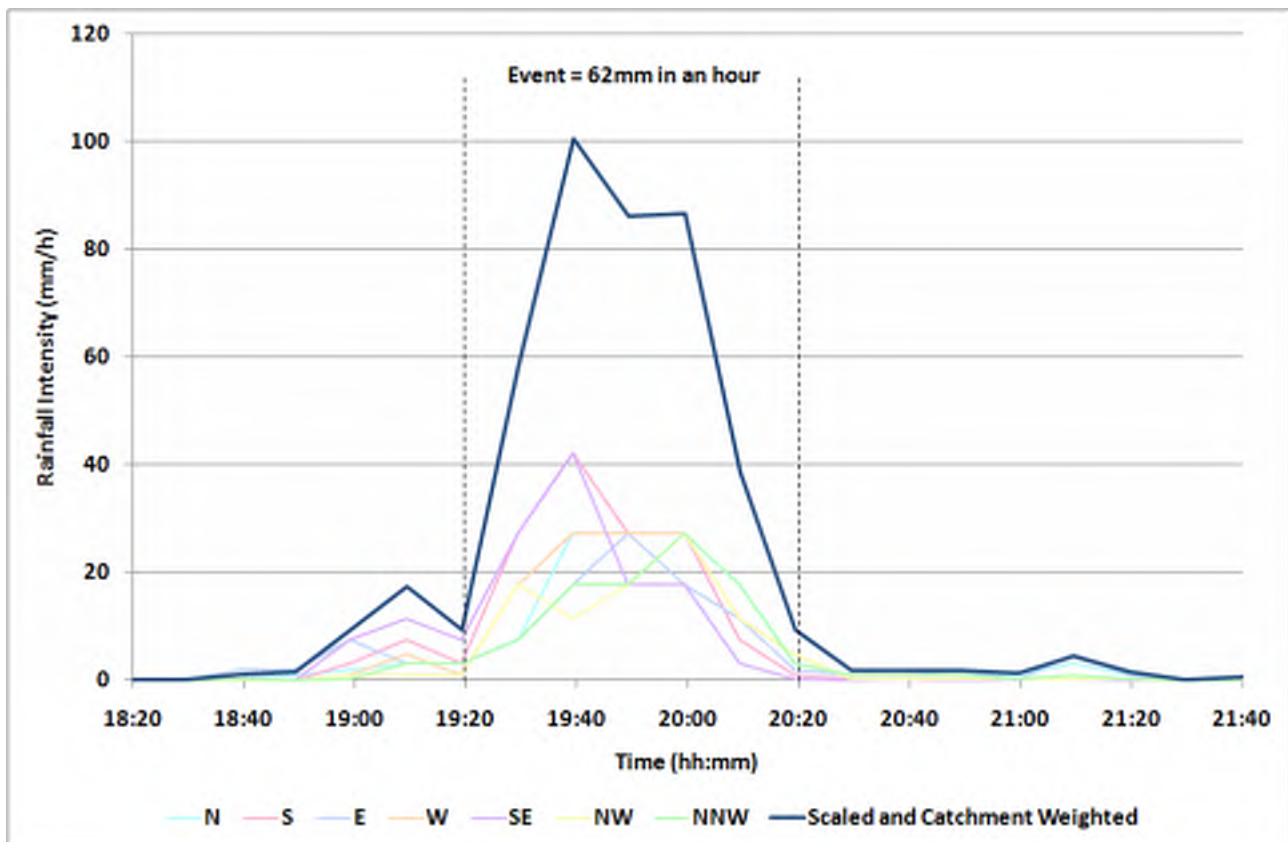
**Figure 5-2 Rainfall Intensity Profiles for the May 2009 Event**

A representative rainfall profile for the catchment was then derived from the scaled radar rainfall intensities using an areal weighted approach. The area of each radar cell that intersects with the study catchment are also shown in Table 5-2 and were used to derive the areal weighted catchment average rainfall. The rainfall intensities calculated for each radar cell and the resultant scaled catchment weighted average intensity are presented in Figure 5-2. A total rainfall depth of 105mm was determined to have fallen on the catchment in the 24 hour period. However, the main event lasted around one hour, with a rainfall depth of around 62mm. Around 12mm fell in the three hours preceding the event, with a further 27mm within the six hours following the event.

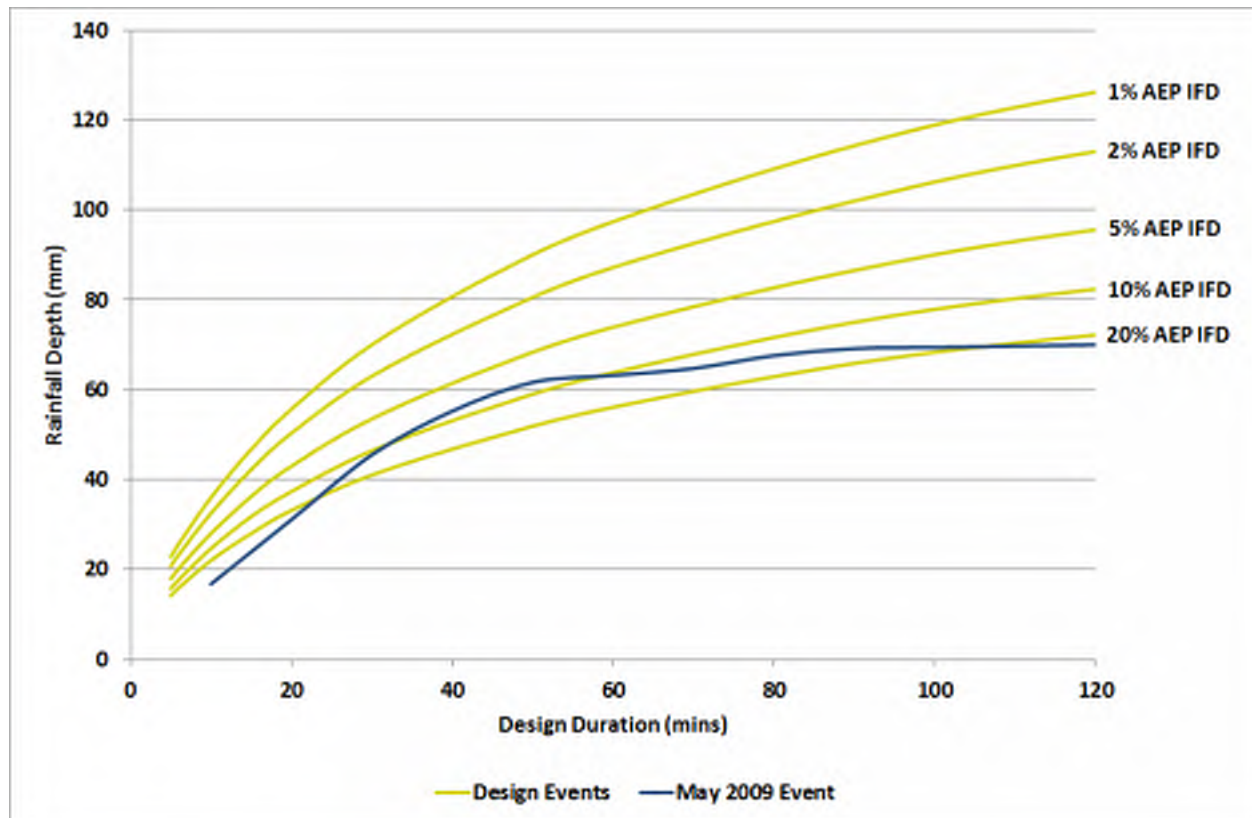
Figure 5-3 Comparison of Derived May 2009 Rainfall with IFD Relationships

The derived depth vs. duration profile for the May 2009 event from the scaled catchment averaged radar data shows it generally tracking around the design 10% AEP (10-year ARI) rainfall for a one hour duration event.

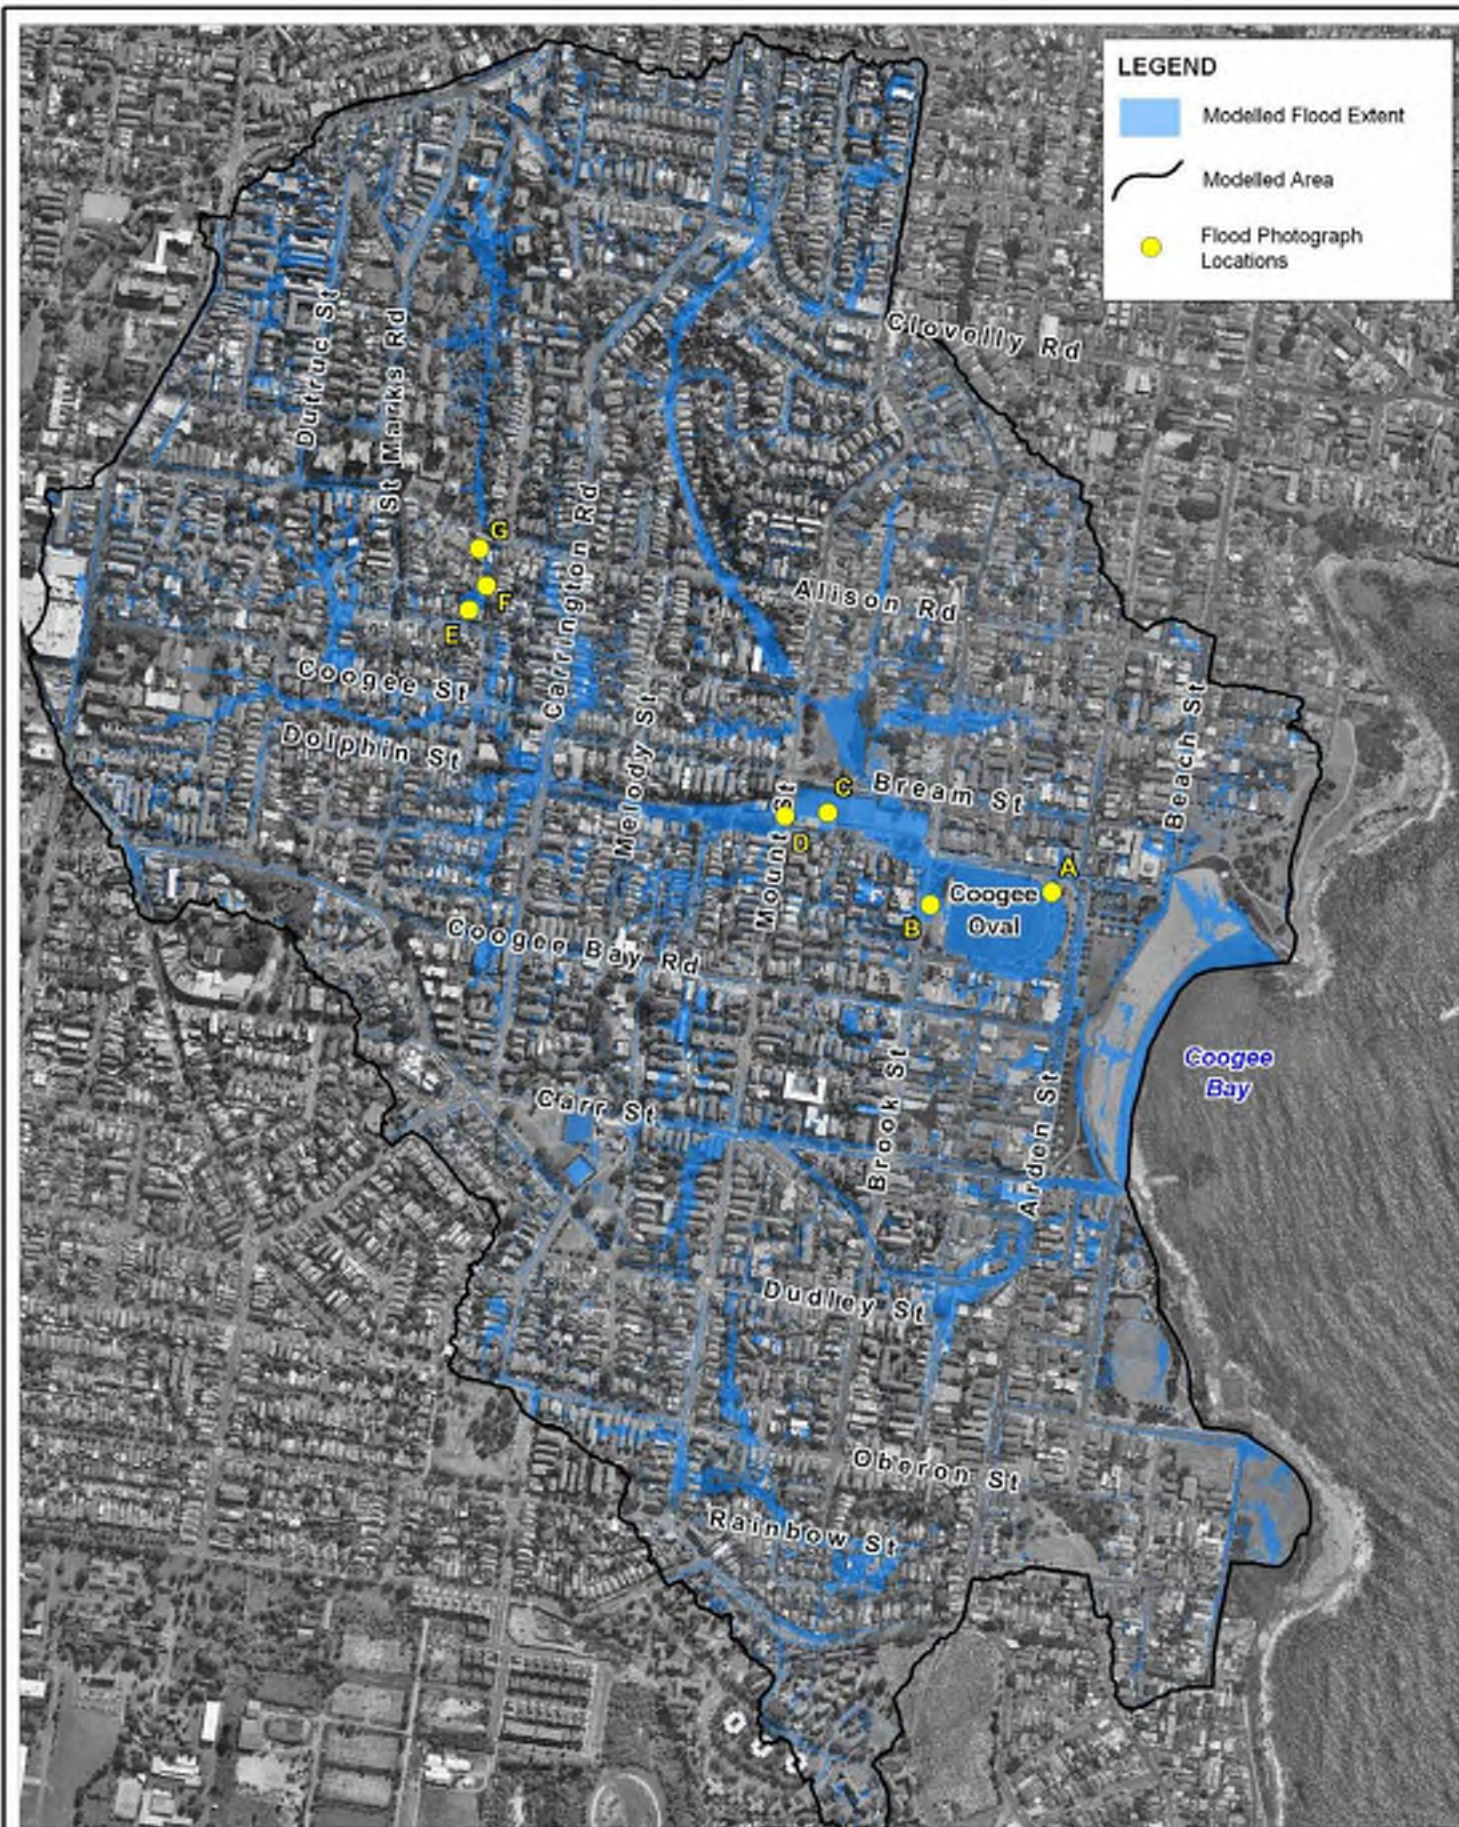
Figure:  
**5-6**

Title:  
**May 2009 Flood Photograph Locations**

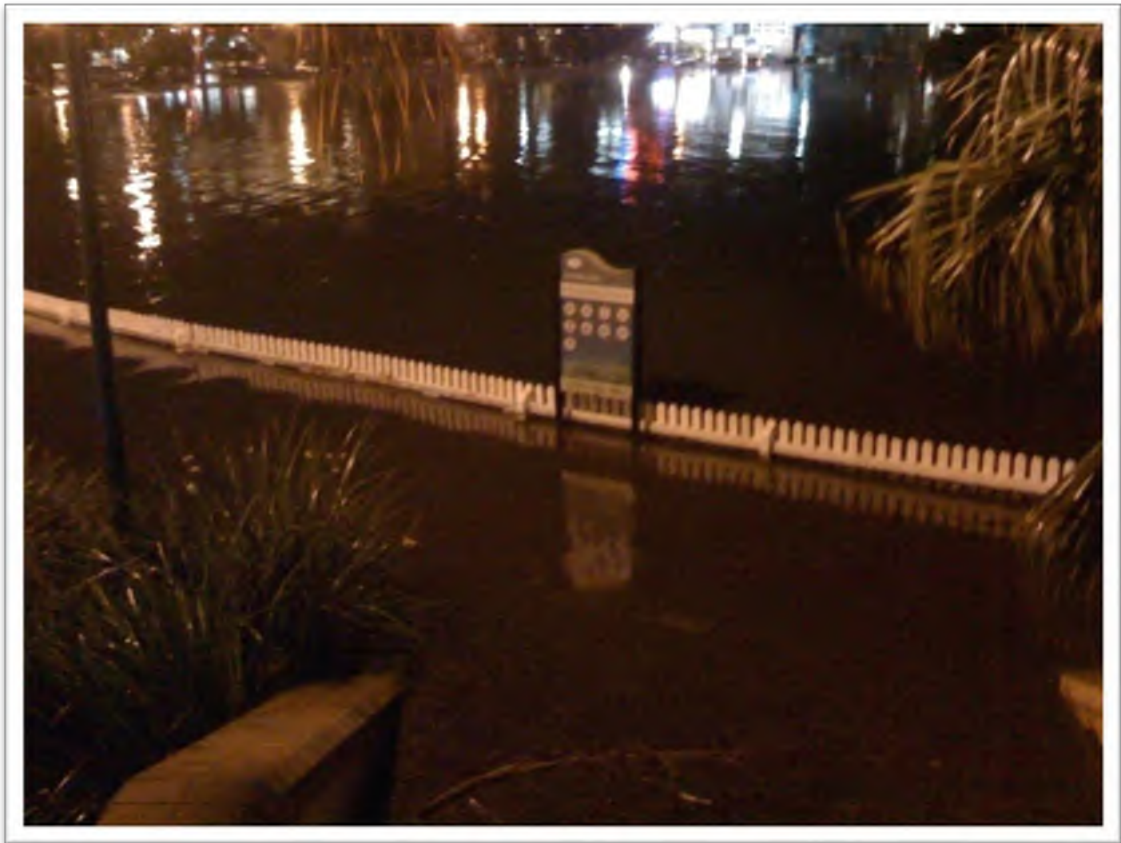
**Figure 5-7 May 2009 Flood Photograph: Location A**

With the May 2009 event occurring during the evening the availability of flood photos for Coogee Oval was not as substantial as for other events. However, some flood photos were available, one of which is presented in Figure 5-7 (Location A on Figure 5-6). A flood level of around 5.4m AHD has been estimated from the photograph. However, it is not known whether the photograph was taken at the peak of the flood and so the peak level in the Oval may have been higher than this. The peak modelled flood level in Coogee Oval for the May 2009 flood event is around 5.7m AHD.

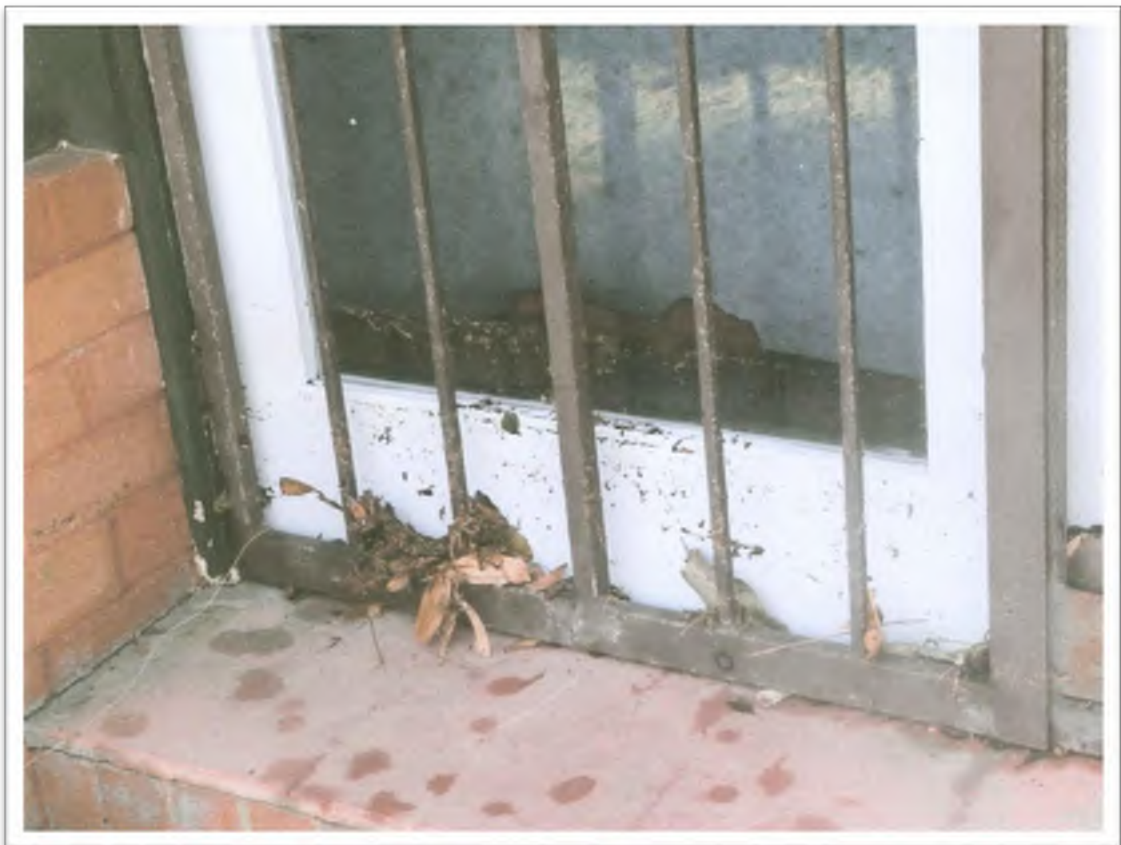
**Figure 5-8 May 2009 Flood Photograph: Location B**

Another photo is available showing a flood mark on the door of the Senior Citizens Centre, located just to the west of the Oval on Brook Street and presented in Figure 5-8 (Location B). A flood level of around 6.8m AHD has been estimated from the photograph, based on the height of the flood mark above the local kerb level. A similar peak level was modelled by the May 2009 calibration event.

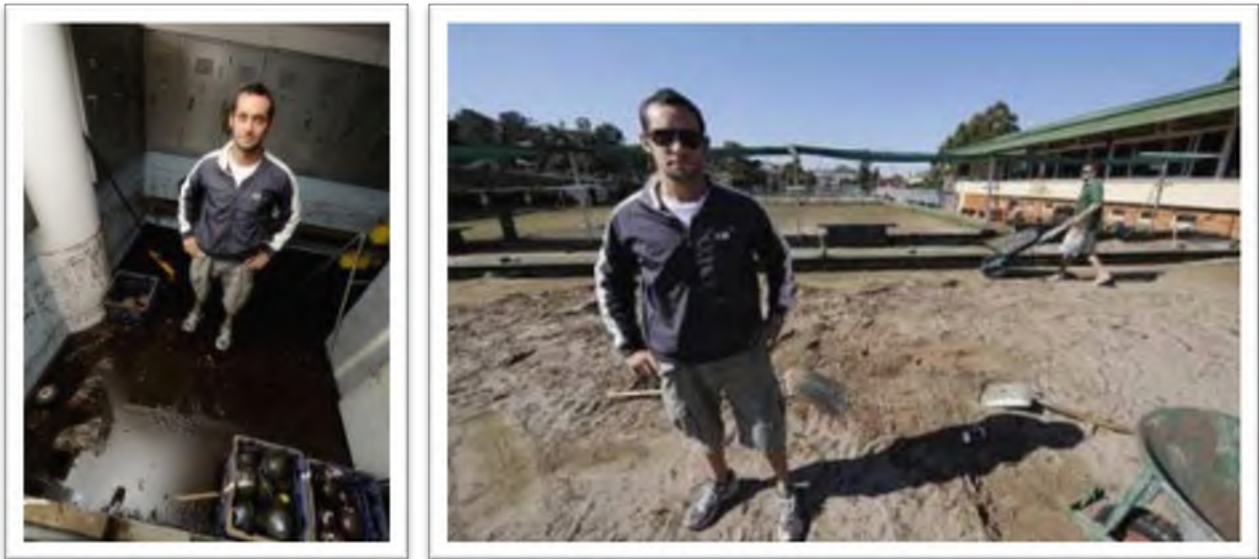
**Figure 5-9 May 2009 Flood Photographs: Location C**

Photographs showing flood debris on the Bowling Green and a flood mark in the Bowling Club basement were included in a May 4<sup>th</sup> article by the Southern Courier and are presented in Figure 5-9 (Location C). The flood mark shows around a 1m peak flood depth within the basement, which based from site observations could represent a flood level of around 8.8m AHD. The modelled flood level here is close to this at around 9.0m AHD. A number of local hydraulic controls were incorporated into the model at this location to properly represent the local flood behaviour. These were based on site investigations and include wall structures between the bowling greens and around the tennis courts. The floor levels of the Bowling Club and Tennis Club are set below ground level.

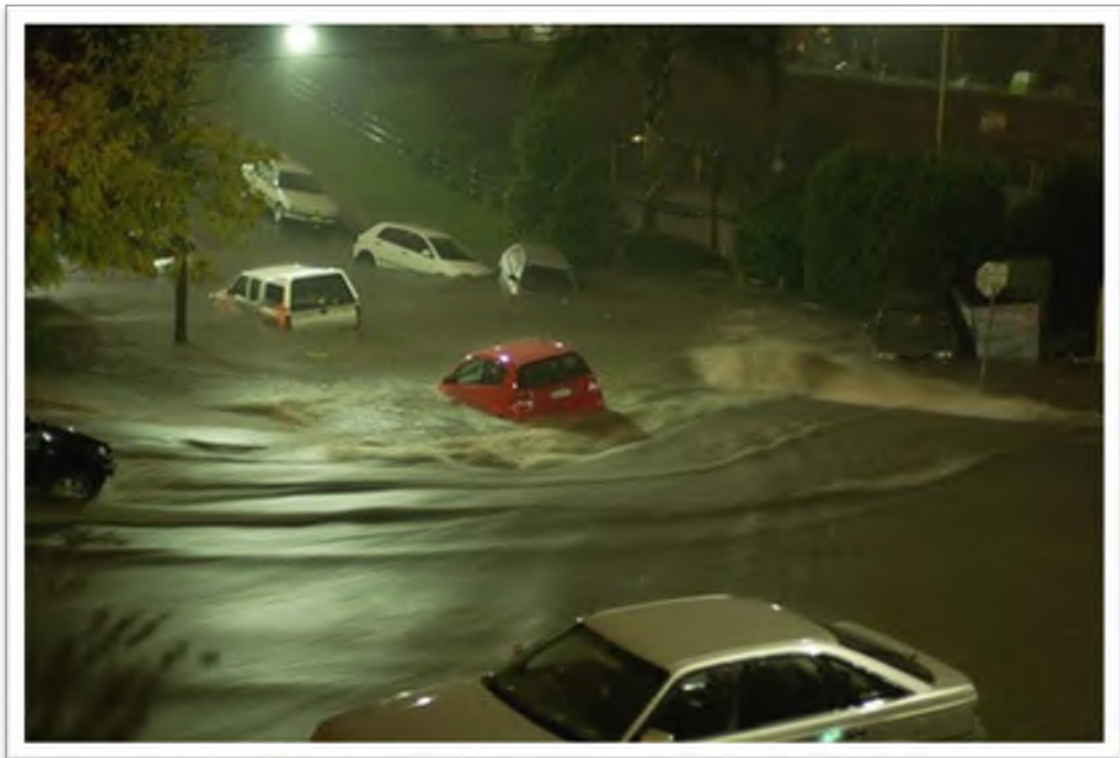
**Figure 5-10 May 2009 Flood Photograph: Location D**

from the photograph that local scouring has undermined the corner of the property, resulting in failure of the wall. Runoff from Alison Road will flow down a steep embankment and into the rear of the properties on Farnham Avenue. There are likely to be locally high velocities, which could result in scouring such as this. The flood mark of around a 0.7m depth is not evident further along the walled section of the building, or within internal photographs of the damaged room. The model has generated an overland flow path in the vicinity of this property.

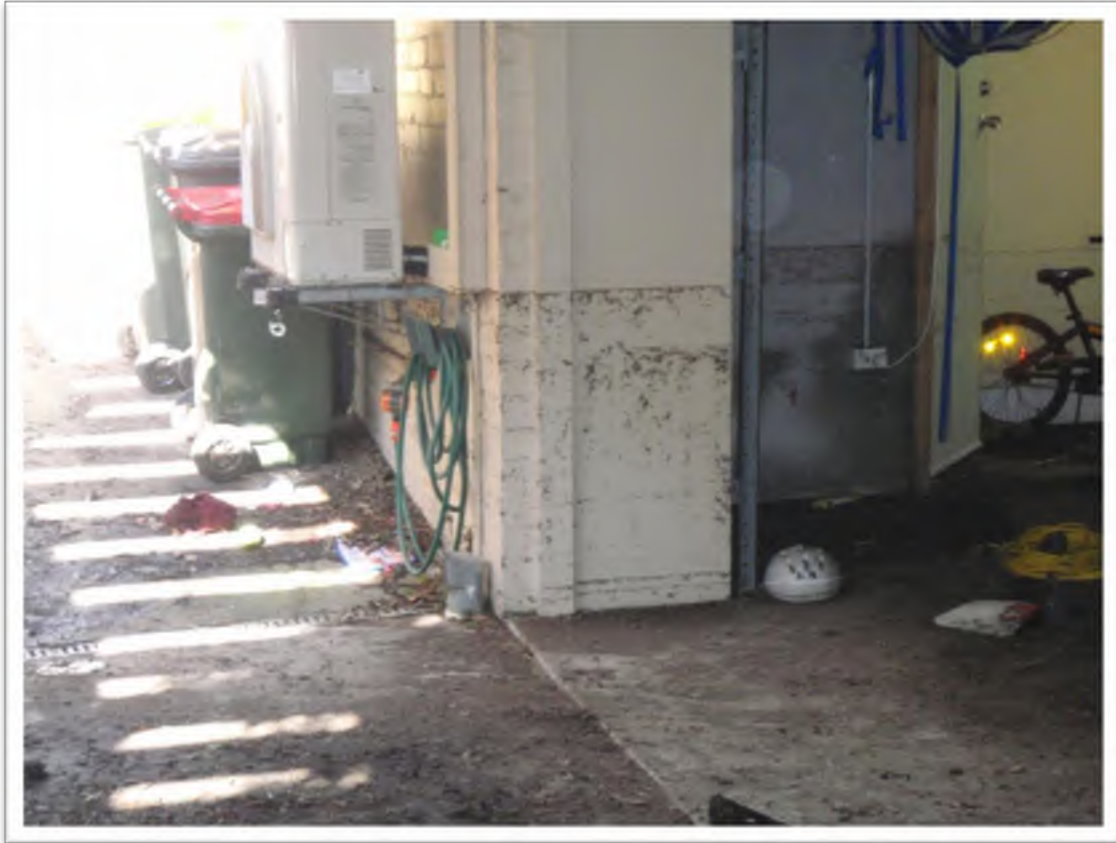
**Figure 5-11 May 2009 Flood Photograph: Location E**

Further up the catchment, there is a depression located behind the eastern end of Oswald Street which will fill with this excess runoff and result in significant flood depths. Figure 5-11 (Location E) shows a flood mark at Oswald Street indicating a flood depth of around 1m. At this location the ground level is around 22.1m AHD (based on the LiDAR data points), giving a flood level of around 23.1m AHD. The modelled flood level is higher, at around 23.8m AHD. This location is a topographic depression with no local drainage included in the model. As it is an isolated depression with no modelled connection to Council's drainage network, the flood level will be highly sensitive to the volume of water spilling into the depression. Council have indicated that a drain cover was removed at this location to help drain the water away and this may account for the lower water level than that which has been modelled.

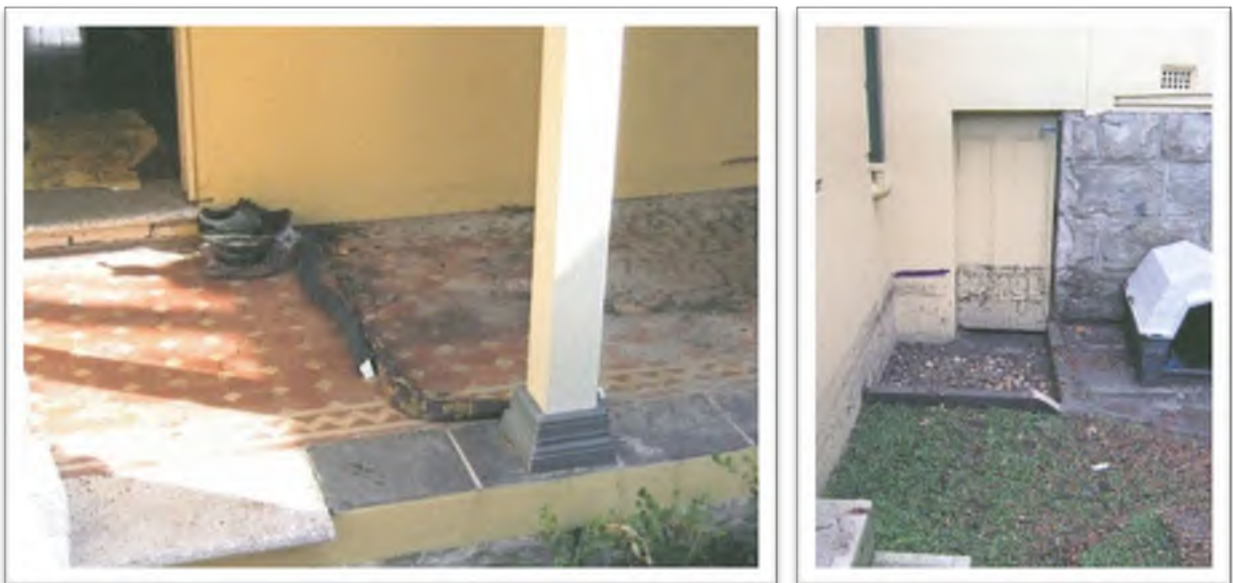
**Figure 5-12 May 2009 Flood Photographs: Location F**

A property located behind Oswald Street, on Farnham Avenue, also reported flooding, providing flood photographs of the front and rear of the property, as shown in Figure 5-12 (Location F). The flood depths at the front and rear of the property can be judged to be around 0.1m and 0.5m respectively. Using elevations from the LiDAR data, flood levels of around 24.7m AHD at the front and 24.1m AHD at the rear of the property are appropriate. The model results indicate flood levels of 24.7m AHD and 23.8m AHD.

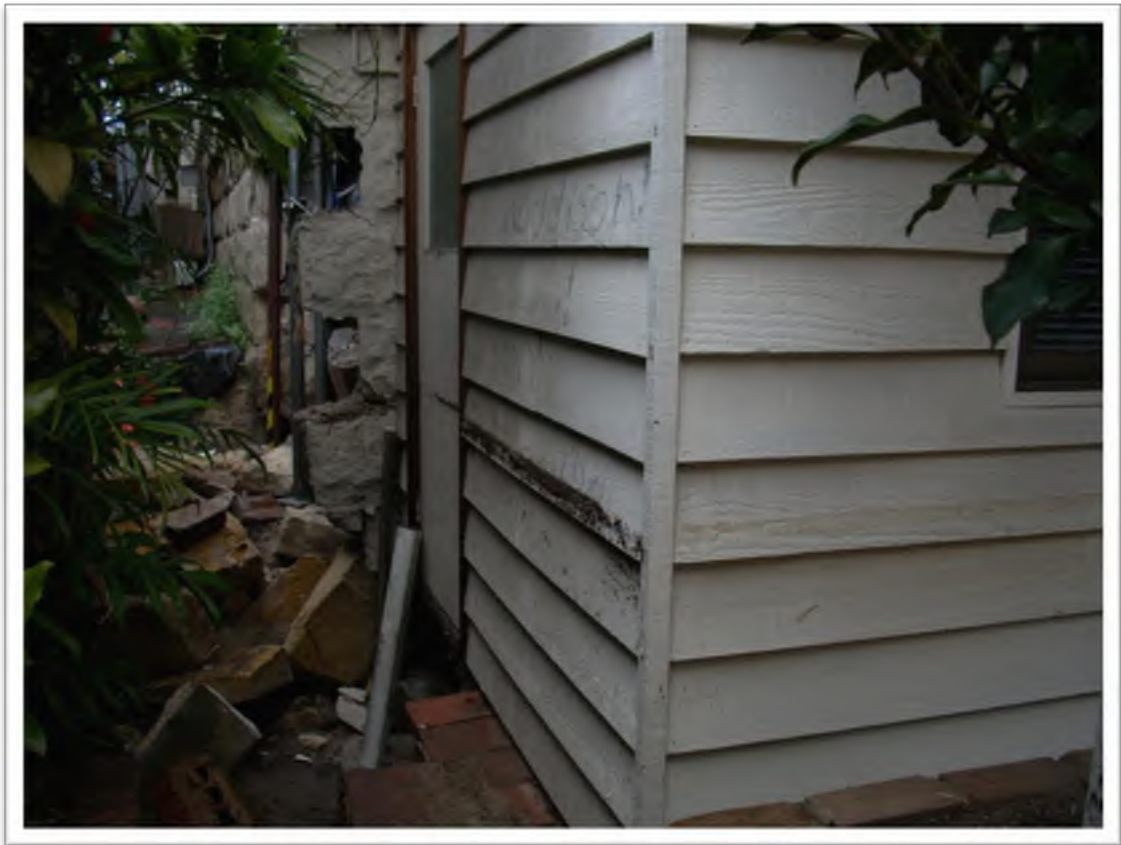
**Figure 5-13 May 2009 Flood Photograph: Location G**

Another property, located on the Alison Road side of Farnham Avenue suffered from flood damage during the May 2009 event, a photograph of which is provided in Figure 5-13 (Location G). It appears

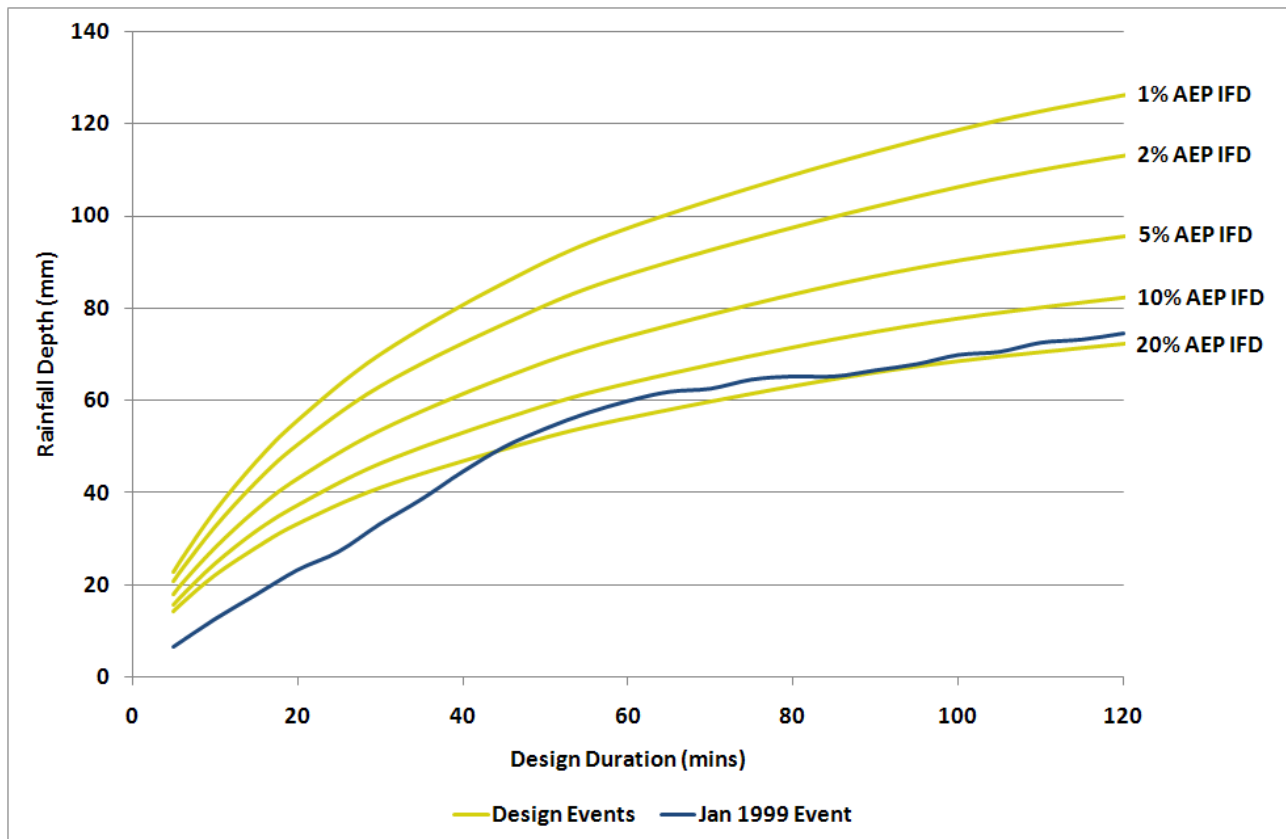
Figure 5-14 Comparison of Derived January 1999 Rainfall with IFD Relationships

The derived depth vs. duration profile for the January 1999 event from the adopted catchment rainfall shows it generally tracking between the design 20% AEP (5-year ARI) and 10% AEP (10-year ARI) rainfall for a one to two hour duration.

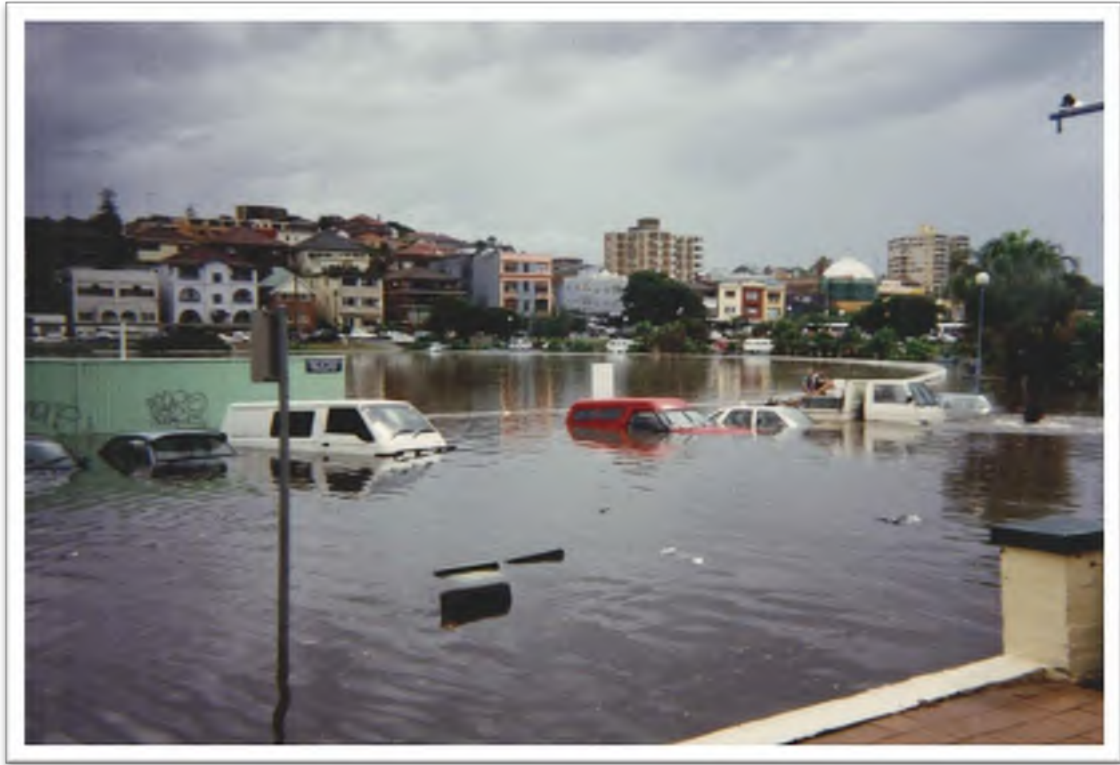
Figure 5-15 January 1999 Flood Photograph of Coogee Oval

The January 1999 event was used in conjunction with the May 2009 event to assess appropriate rainfall losses for the catchment. The Coogee Oval and Bowling Club Flooding Assessment references a flood level of around 5.4m AHD in the Oval. This level is also supported by the available flood photographs taken of the Oval during the flood. Figure 5-15 shows vehicles parked along the southern side of Coogee Oval. At the deepest area of flooding the water level is at the level of the car bonnets, or around 0.9m deep. The ground elevation here is around 4.5m AHD, giving an approximate flood level of 5.4m AHD. The modelled flood level in Coogee Oval for the January 1999 calibration event is 5.5m AHD.

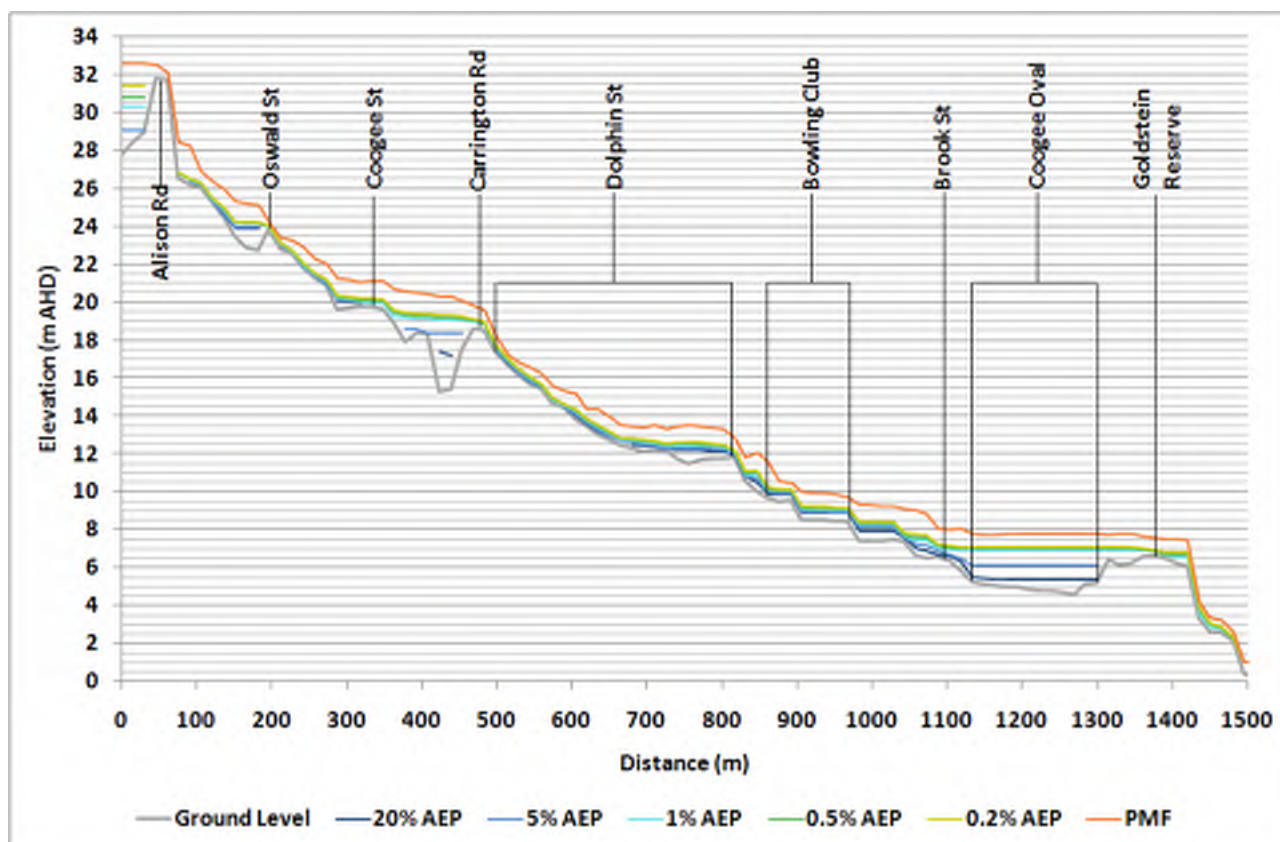
**Figure 6-3 Design Flood Level Long Section**

ID	Location	Design Event Flood Level (m AHD)					
		20% AEP	5% AEP	1% AEP	0.5% AEP	0.2% AEP	PMF
1	Coogee Oval	5.4	6.1	6.9	7.0	7.1	7.8
2	Brook Street	6.6	6.8	7.0	7.1	7.2	8.1
3	Coogee Tennis Club	7.9	8.1	8.2	8.3	8.4	9.2
4	Coogee Bowling Club	8.9	9.0	9.1	9.1	9.2	10.1
5	Dolphin Street	12.2	12.3	12.4	12.5	12.6	13.5
6	Carrington Road	17.2	18.4	19.0	19.2	19.3	20.3
7	Oswald Street	23.8	23.9	24.1	24.2	24.2	25.2
8	Glen Avenue	28.2	29.1	30.3	30.7	31.4	32.6
9	32 Coogee Street	20.1	20.2	20.7	20.8	20.9	21.6
10	9 Coogee Street	25.3	25.8	26.0	26.1	26.2	26.9
11	Bardon Park	12.5	12.7	13.0	13.1	13.3	13.9
12	Mount Street	13.8	14.4	15.0	15.1	15.2	16.0
13	Pauling Avenue	17.2	17.7	18.0	18.1	18.2	18.9
14	Leeton Avenue	19.4	19.6	19.8	19.8	19.9	20.1
15	Rainbow Street	42.1	42.4	42.8	43.0	43.3	47.6
