Randwick Heritage Study Volume 1

Heritage Conservation Area Review

Heritage Study Randwick City Council

March 2021—Final

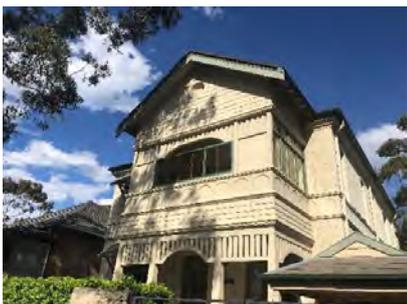
The house is located at 37 Darley Road. The condition of this item is in keeping with its description on the SHI. The balcony enclosure is the most obvious alteration, however overall the item appears otherwise intact and in good condition.
Federation house, c 1915 (I340)	Local

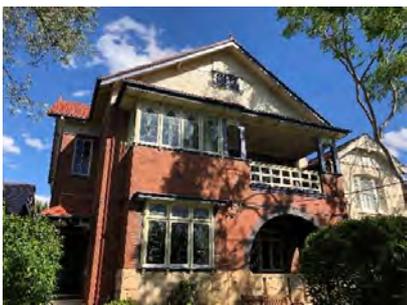
The house is located at 71 Darley Road. The overall condition and integrity match the image on the SHI database. The building appears to be in good condition and with most original details.
Bungalow style dwelling, c 1920s (I341)	Local

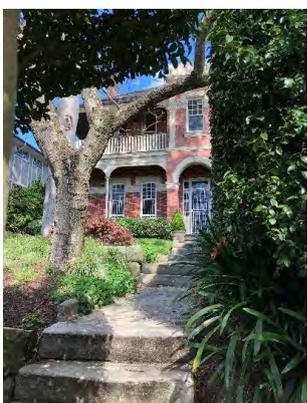
85 Darley Road has a high hedge that makes viewing the property from the public domain difficult, however, the building appears to be in a good condition and intact.

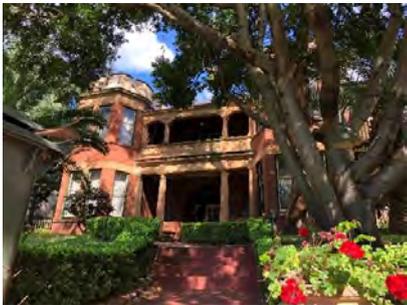
Due to the high fence this property, 87 Darley Road, was difficult to see from the public domain, however, appears to be in good condition. The SHI entry for this item suggests face brickwork has been painted, but this does not appear to be the case. Suggest further inspection.
"Wollungra", corner bungalow (I344)	Local

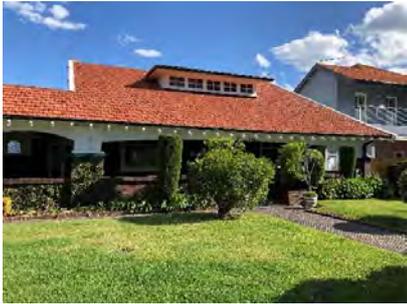
The house is located at 115 Darley Road. The item is consistent with the description in the SHI database. The terracotta roof appears to have recently been cleaned and/or potentially replaced.
"Alhawa", Federation house, c 1920 (I345)	Local

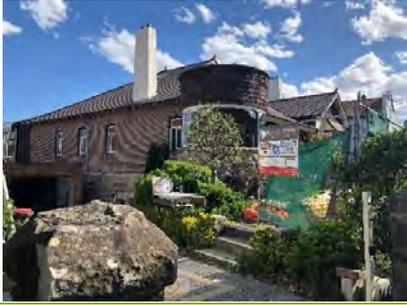
Construction is currently occurring at this dwelling and the front façade of the house is obscured by a construction fence. Suggest further inspection.
Unusual symmetrical style house, c 1915 (I346)	Local

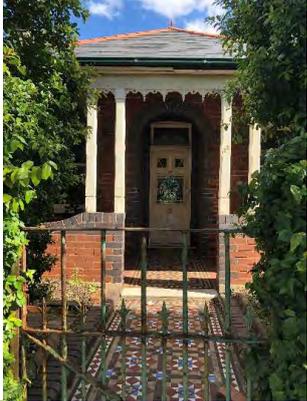
The house is located at 135 Darley Road. The item appears to be consistent with the description in the SHI database, however due to the high fence and hedge is difficult to see from the public domain. Suggest further inspection.

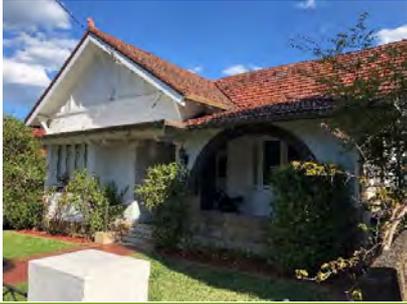
Late Edwardian house, c 1919 (I347)	Local

The house is located at 143 Darley Road. The item appears to be consistent with the description in the SHI database, with front almost entirely covered in pebbledash. Some biological growth noted on terracotta roof tiles.

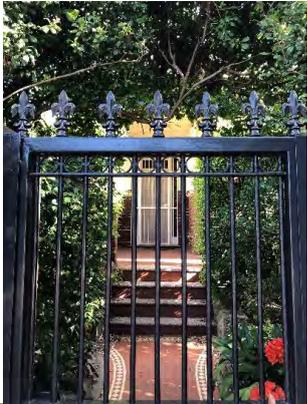
The house is located at 147 Darley Road. The item appears to be consistent with the description in the SHI database, however due to the high fence is difficult to see from the public domain. Suggest further inspection
Row of attached cottages, c 1905 (I349)	Local

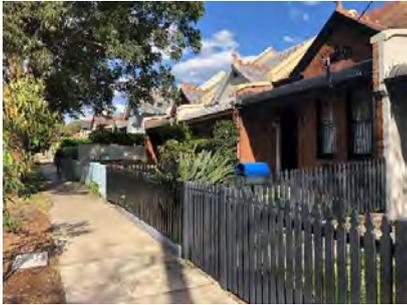
These houses are located at 169-177 Darley Road. The item is consistent with the description in the SHI database, with several unsympathetic additions such as the painting of face brickwork at Nos 171 and 175. However, the item is still contributory to the streetscape overall.
Triple-gabled bungalow (I350)	Local

- Further removal of detailed timber elements or painting of face brickwork should be discouraged.
- No development of an inappropriate form and scale should be considered. Scale should be carefully monitored to ensure internal vistas are protected and maintained.
- If opportunities arise to remove unsympathetic additions, such as modern front fences, and replace with a more sympathetic alternative this should be undertaken.
- It is recommended that the heritage item 'Pair of late Victorian terraces and Edwardian style corner house (1450)' be split into two items; one item for the terrace and one item for the Edwardian style corner house, for consistency of items within the precinct.

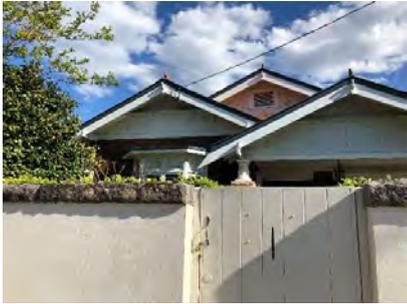
This house is located at 195 Darley Road. The item is obscured by a high fence and is not visible from the public domain. Suggest further inspection.
Federation style semi (I351)	Local

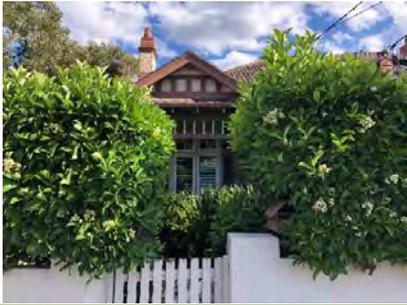
These houses are located at 199-201 Darley Road. The item is obscured by a high fence and is not visible from the public domain. Suggest further inspection.

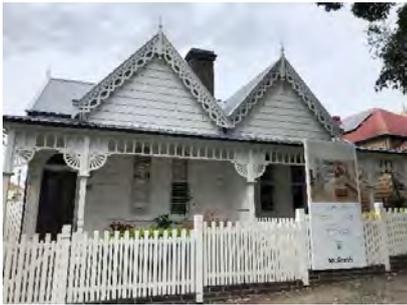
Timber semi, c 1910 (I364)	Local

These houses are located at 55-57 Earl Street. The item appears to be consistent with the description in the SHI database, with strong Gothic influences in the dwellings form. This semi has been split into two distinct dwellings, with sympathetic extensions to the rear.

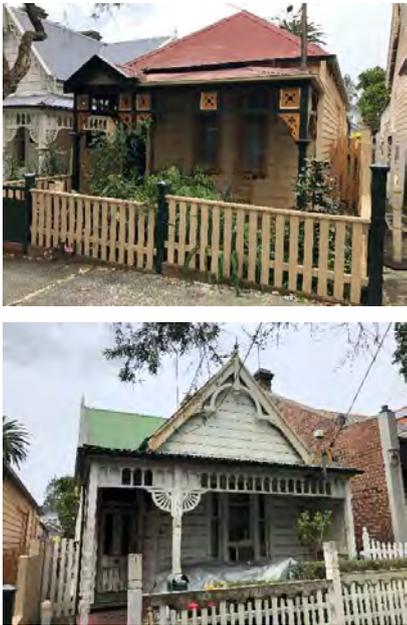
Name (ID)	Sig.	Image	Fieldwork Observations
Timber cottages, c 1910 (I365)	Local

<p>These houses are located at 59 and 61 Earl Street. The item appears to be mostly consistent with the description in the SHI database, with the below exceptions.</p> <p>59 Earl Street is noted in the SHI database as having an unsympathetic decramastic pressed metal roof. This has been replaced with Colourbond roof sheeting.</p> <p>61 Earl Street is similar in style to 55-57 Earl Street, however, is in a poorer condition, with deterioration of timber elements noted during the inspection.</p>
Federation residence, c 1905 (I417)	Local

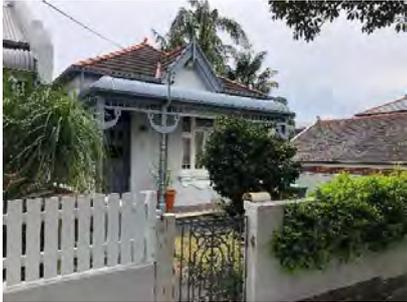
<p>This house is located at 2 Monmouth Street. The item appears to be consistent with the description in the SHI database, apart from painting of the original face brickwork. Otherwise, the item is relatively intact and in a good condition.</p>
Bungalow, c 1931 (I418)	Local

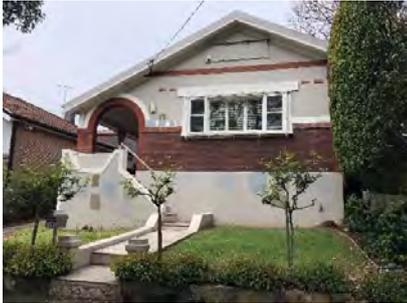
<p>This house is located at 19 Monmouth Street. The item appears to be consistent with the description in the SHI database. At time of inspection sample areas of paint were noted on the render in, suggesting it is soon to be repainted.</p>

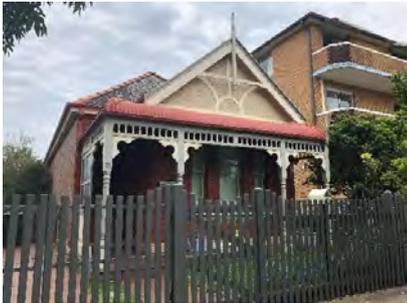
Edwardian style cottage, c 1900 (I430)	Local

<p>This house is located at 71 Pine Street. The item appears to be consistent with the description in the SHI database, with some original detailing and a replacement fence. There is some corrosion on the verandah roof corners.</p>

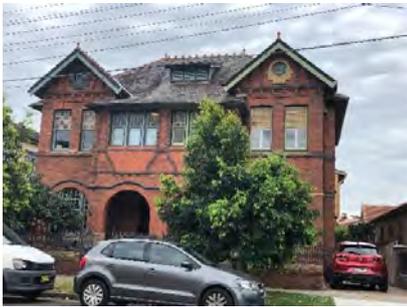
This property is located at 81-83 Pine Street. The item appears to be consistent with the description in the SHI database, with decorative brickwork. 81 and 83 have been painted in different colour schemes. There is a sympathetic extension to the rear of the property.
Pair of late Victorian terraces and Edwardian style corner house (I450)	Local

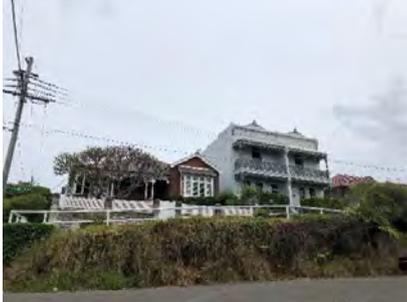
<p>This house and terrace pair are located at 10-14 Stephen Street.</p> <p>The terrace pair at 10-12 appear consistent with the description in the SHI database, with the exception that they have recently been repainted. The SHI database additionally notes the terrace pair as having two mismatched doors, new matching doors have been installed.</p> <p>The house at 14 does not have a physical description included within the SHI listing, however, appears to be in good condition and intact.</p>

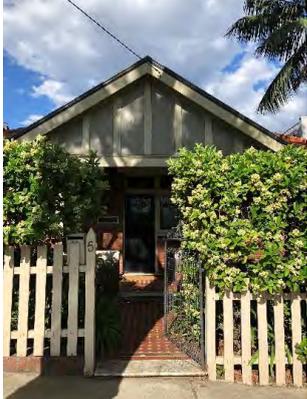
"Keletera", symmetrical cottage, c 1920 (I456)	Local

This house is located at 5 Wentworth Street. The item is mostly obscured by a high fence and hedge and is not visible from the public domain. Suggest further inspection.

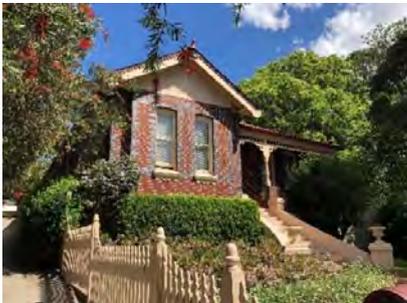
This house is located at 6 Balfour Road. The item appears to be consistent with the description in the SHI database, in good condition and with significant detailing intact. Was unable to see the side addition mentioned due to vegetation.
"Hastings", Federation style dwelling, c 1915 (I135)	Local

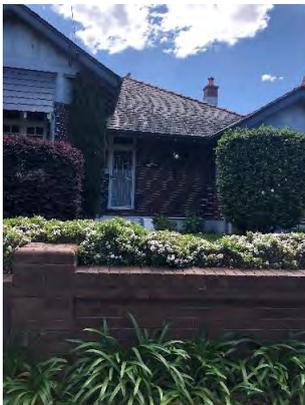
This item is located at 25 Lenthall Street and appears to be in a similar condition to the SHI listing. Fence is a sympathetic replacement, and overall the item is in good condition with many details intact.
Late Federation style dwelling, c 1915 (I136)	Local

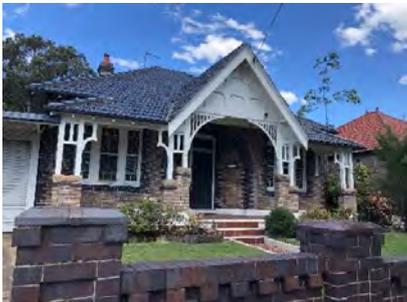
This item is located at 42 Lenthall Street and appears consistent with the description in the SHI database, in good condition and with relatively little modification. The front fence is likely a replacement but is sympathetic.
Federation style house (I137)	Local

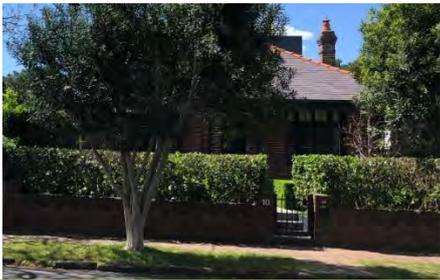
Federation style house (I138)	Local

This item is located at 10 McDougall Street and appears to be in good condition, however, is very difficult to see due to the hedge. Appears mostly intact. Suggest further inspection.

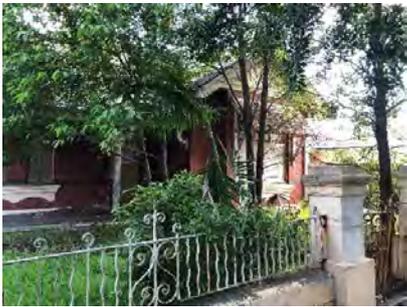
This item is located at 55 Milroy Avenue. While the SHI listing identifies the item as being in excellent condition, the site inspection identified the item as being in very poor condition and deteriorating. As outlined further below. Urgent attention is needed to prevent further deterioration.
Row of Art Deco flat buildings (I141)	Local

Most heritage listed items remain in good condition and relatively intact, with little unsympathetic additions or removal of original elements. Of particular concern is the heritage listed building at 55 Milroy Avenue. This item is in deteriorating condition and needs urgent attention to prevent further decay. Overgrown vegetation has both kicked up original tiles on both the walkway and verandah, and is preventing guttering and downpipes from functioning correctly, resulting in further water damage and corrosion of metal elements. Windows and entryways have been boarded up, which is likely resulting in a build-up of mould and mildew in the interior of the property. The above factors are currently resulting in this particular heritage item having a negative overall effect on the streetscape.

- The item at 55 Milroy Avenue (I139) is in a poor, deteriorated condition such that it is impacting on the significance of the place. Opportunities to conserve the item through repairs to deteriorated fabric should be investigated and encourage to improve the heritage item and make a positive contribution to the aesthetic values of the HCA.

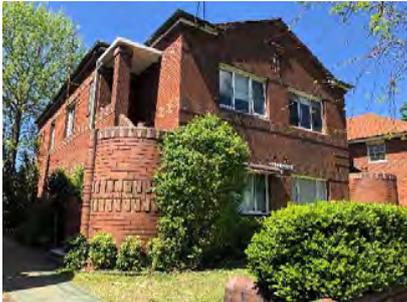
These buildings are located at 1 and 3 Samuel Terry Avenue. The item appears to be consistent with the description in the SHI database, with face brickwork and terracotta tile roofs both in good condition. Windows have been replaced on both blocks.
Edwardian Style house, c 1915 (I142)	Local

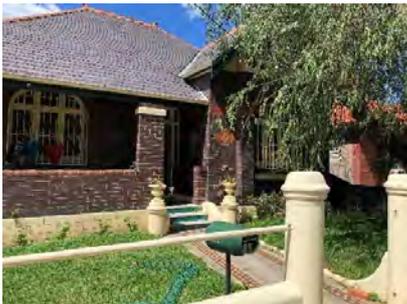
This item is located at 57 Samuel Terry Avenue and appears to be consistent with the description in the SHI database. Some unsympathetic additions such as security screening on windows, but otherwise is moderately intact and in good condition.

- The physical description for 57 Samuel Terry Avenue (I142) mentions that it may be a copy of the house at 63 Samuel Terry Avenue, which is currently unlisted. There is the potential to list this item separately or consolidate both dwellings into the one listing as a matching pair.

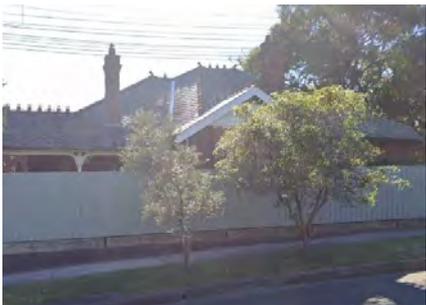
This item is located at 67 Samuel Terry Avenue and appears to be consistent with the description in the SHI database, however, is difficult to see from the public domain due to fencing and a large hedge. Suggest further inspection.
Row of Art Deco flat buildings (I144)	Local

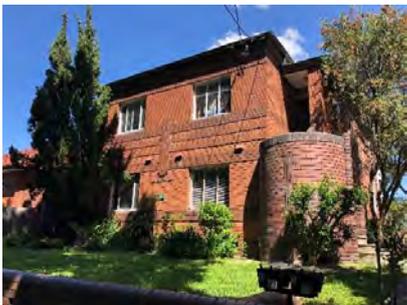
These buildings are located at 1-21 Todman Avenue. The item appears to be consistent with the description in the SHI database, however would suggest bricks are more red-orange than 'dark red' as the SHI listing suggests. Buildings appear in good condition and are intact.

- It is recommended that the two sets of art deco flat buildings (1144 on Todman Avenue and 1141 on Samuel Terry Avenue) may be consolidated into the one heritage item for consistency, and to ensure the potential risk of development and/or change to one set of items is minimised.

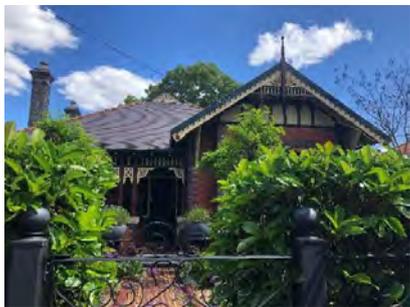
This item is located at 85 Todman Avenue and appears to be consistent with the description in the SHI database, however, is difficult to see from the public domain due to fencing and a large hedge. Suggest further inspection.

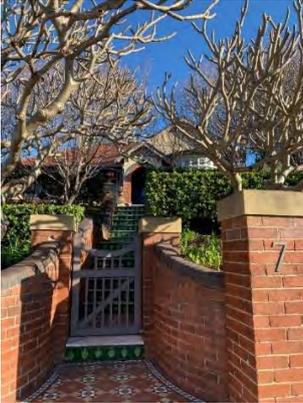
<p>This item, located at 7 Thomas Street, is a large Federation Bungalow set back from the street on a large elevated site behind a well planted garden and a scalloped rendered masonry wall with face brick piers along the street frontage.</p>
4 large freestanding bungalow style residences (I356)	Local

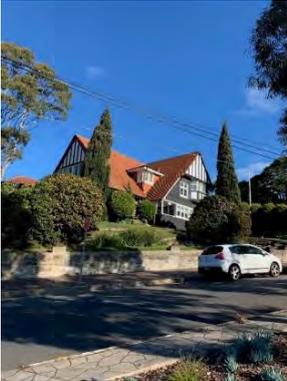
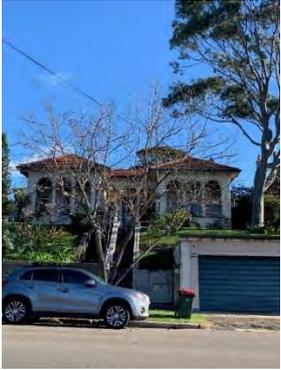
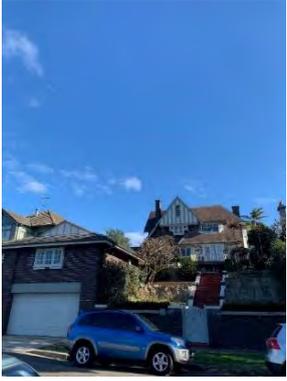
<p>This item consists of 4 freestanding residences at 16-22 Dudley Street.</p> <p>16 Dudley Street is a large two storey house complex with Arts and Crafts set on a large elevated corner site appears consistent with the description in the SHI database, in good condition.</p> <p>18 Dudley Street is an impressive Spanish Mission Style residence with large arched porches on either side of the arched entry courtyard between. It appears consistent with the description in the SHI database, in good condition.</p> <p>20 Dudley Street is a grand style residence on an elevated site with the design incorporating Edwardian and Queen Anne features and the garage on the street in the same style. The item appears consistent with the description in the SHI database, and is in good condition</p> <p>22 Dudley Street is a large two storey asymmetrical residence on an elevated site with design influences similar to No.16. The item appears consistent with the description in the SHI database, and is in good condition</p>

- Further unsympathetic additions at the street frontage within this HCA should be minimised, where possible.
- Further removal of timber trim elements or painting of face brickwork should be discouraged.
- Recommendation that currently listed items such as 16, 18, 20 & 22 Dudley Street are split into four separate items rather than having all four under the same listing. They are quite different architecturally and with varying levels of intactness.
- It is recommended 1 Thomas Street is individually listed on the Randwick LEP.

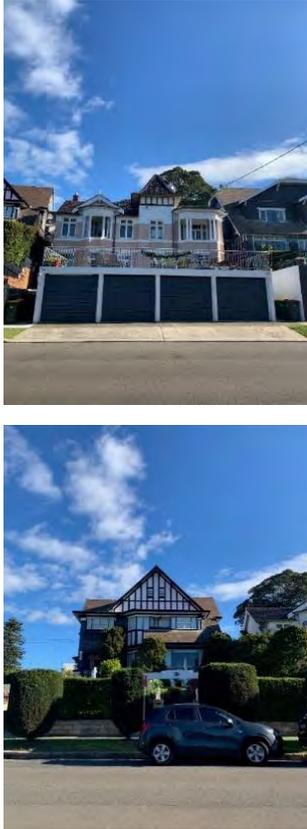
<p>32 -34 Dudley Street is a large 1920's style house with large tower featuring pyramidal roof and a mixture of design influences including Italianate, Classical and Art Nouveau. There is an intrusive garage structure at the street frontage.</p> <p>36 Dudley Street is a highly individual bungalow style mansion constructed on a corner site C.1936. The slate roof is steeply pitched with unusual corner porches with flat roofed balconies.</p> <p>Original stone retaining walls and well planted grounds</p> <p>Alterations have been made to enclosing the balconies.</p>
Inter War Bungalow (I467)	Local

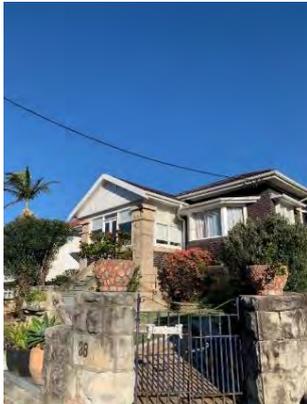
<p>38 Dudley Street is on the corner of Dudley and Byron Street is an example of an interwar freestanding residence C.1929-30. The house has a scale, quality and response to the setting which demonstrates the historic evolution of the Interwar house and the last stages of the suburban consolidation of Coogee. The item appears consistent with the description in the SHI database, and is in good condition.</p>

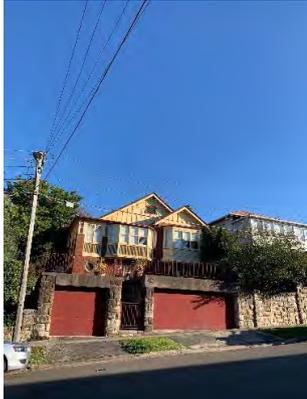
<p>42 Dudley Street is a notable example of a late Federation house C.1917 located on the higher grounds of Coogee.</p> <p>Later alterations include partial enclosure of the verandah and and construction of street front garages.</p> <p>The item appears consistent with the description in the SHI database, and is in good condition.</p>

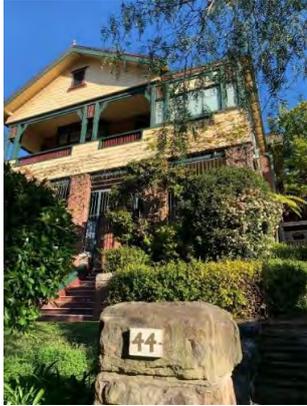
<p>44 Dudley Street is a notable example of a late Federation house C.1917 located on the higher grounds of Coogee.</p> <p>Later alterations include partial enclosure of the verandah and replacement of original roof cladding.</p> <p>The item appears consistent with the description in the SHI database, and is in good condition.</p>
Late Federation House (I470)	Local

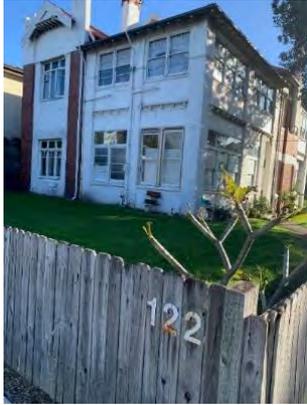
<p>The house at 122 Mount Street is a late Federation house c. 1917. The residence remains substantially intact as a prominent aspect of the streetscape. The residence forms part of a cohesive group of similar history and related styles demonstrating the evolution of quality housing about the upper slopes of the Coogee valley through the Inter War period. Later [reversible] alterations include enclosure of verandas and unsympathetic paint finishes.</p>

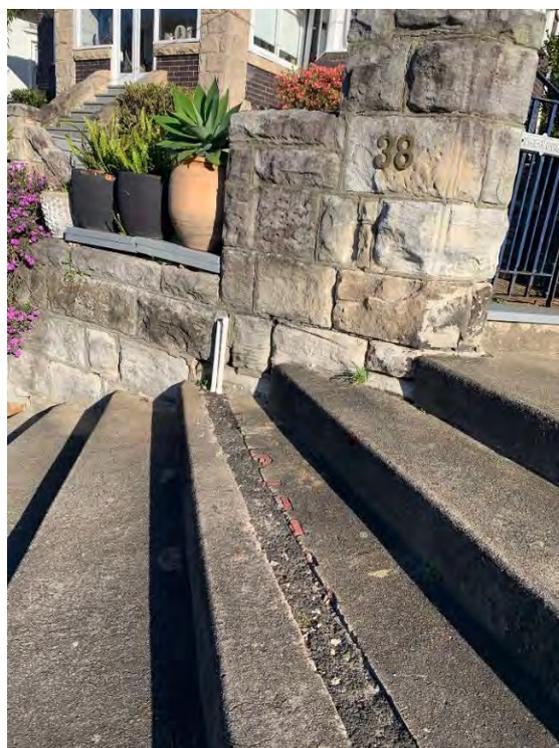
Figure 30. Dudley Street Name embedded in concrete has been cut through for installation of services

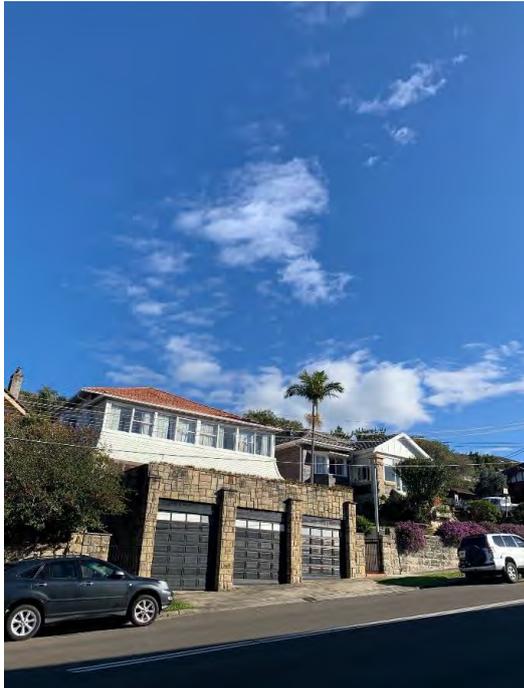
Figure 31. Multiple garages on the street frontage obscure the street elevation

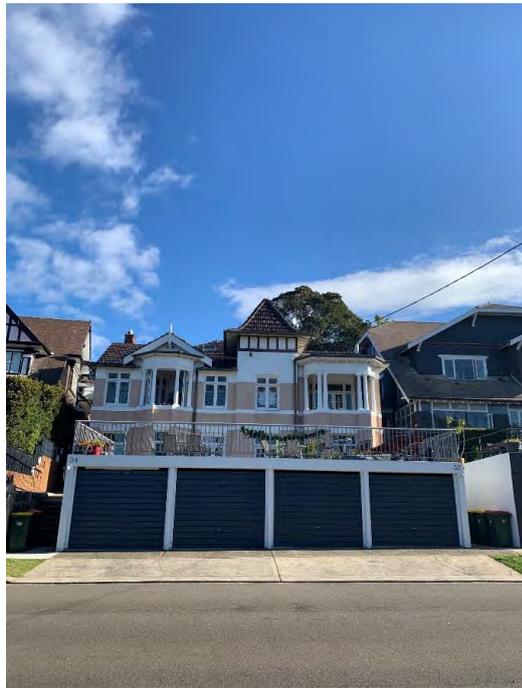
Figure 32. Multiple garages on the street frontage obscure the street elevation

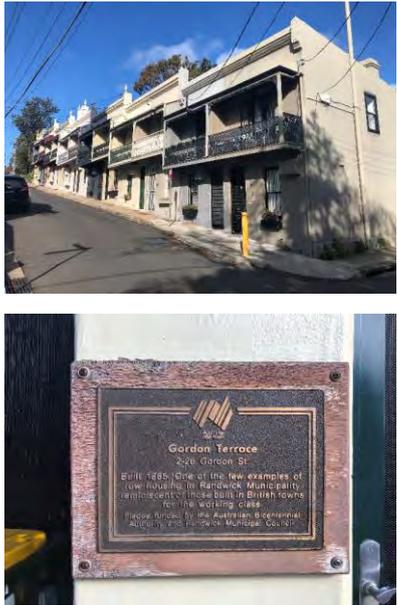
<p>A series of mid-Victorian style terraces dated to 1885 with step-downs to align with the surrounding landscape. This heritage item also has a plaque installed adjacent to 26 Gordon Street. This item appears to be in good condition and relatively intact.</p>

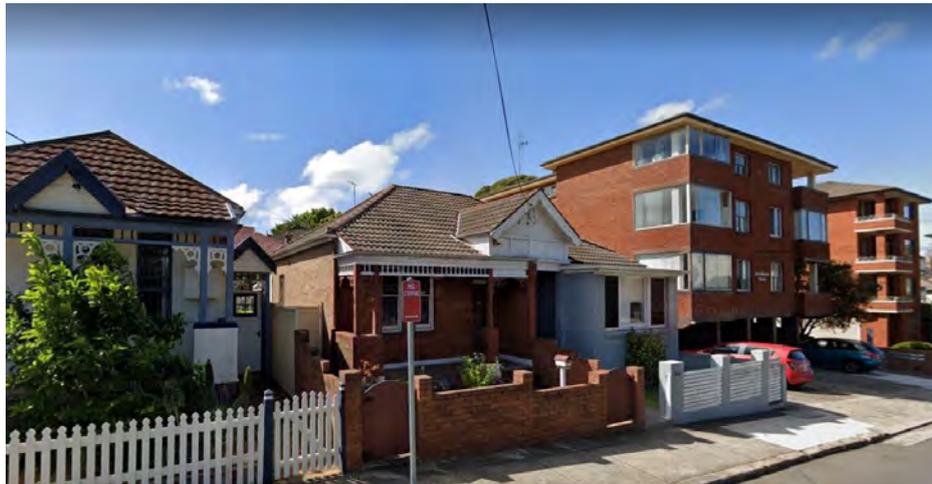
Figure 38. Example of unsympathetic addition of four-storey post-war modernist housing blocks adjacent to freestanding cottages. (Source: Google Streetview)

- The subdivision and street layout of the HCA should be preserved.
- In order to maintain the aesthetic significance of Gordon Square HCA, it is recommended that no additional large apartment blocks are built within this HCA. New medium to high rise buildings in this HCA have the potential to adversely impact upon the aesthetic significance of the HCA. Future development will have to consider the existing built form of the HCA so that any new development within or adjacent the HCA does not overwhelm and negatively impact the form, scale and streetscape character of the area. Where the height of the building is considered a constraint on the HCA, the permissible height of new developments should be stepped down as they near or are adjacent to the HCA boundary to reduce/mitigate the impact.

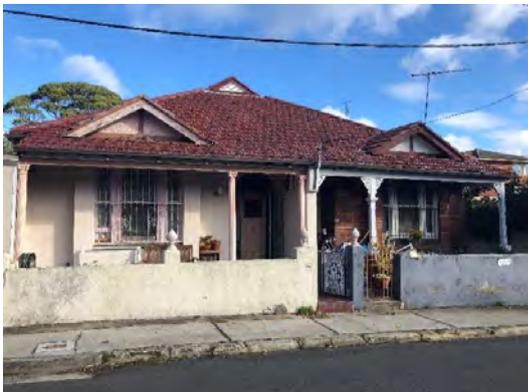
The precinct is now the *'best surviving example of early workers' housing in Randwick'* however ongoing maintenance must be undertaken to preserve this streetscape character and to protect contributory dwellings. The addition of Post-SWar modernist apartment blocks along Randwick Street has altered this streetscape character. Some contributory houses within this HCA on Gordon Street have front fences in disrepair.

Figure 39. Image indicating dwellings and fences along Gordon Street.

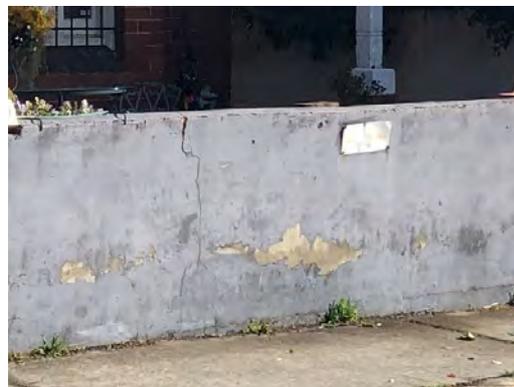
Figure 40. Close up of fence on Gordon Street requiring repair.

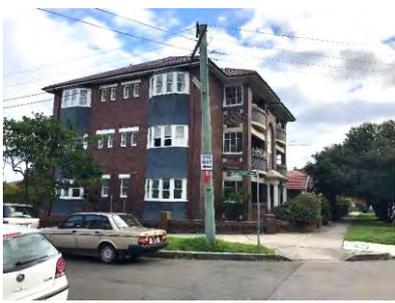
Building appears to be in good condition, viewed from public domain. Materials, features and detailing are in keeping with the physical description outlined in the SHI.
"Romona Hall", Spanish Mission influence flat building, c 1940 (I404)	Local

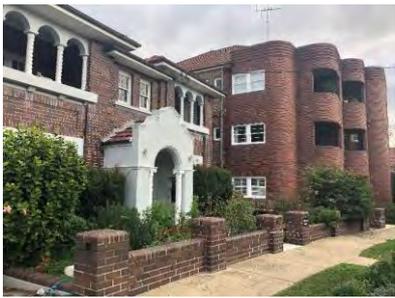
Building appears to be in good condition, viewed from public domain. Materials, features and detailing are in keeping with the physical description outlined in the SHI.

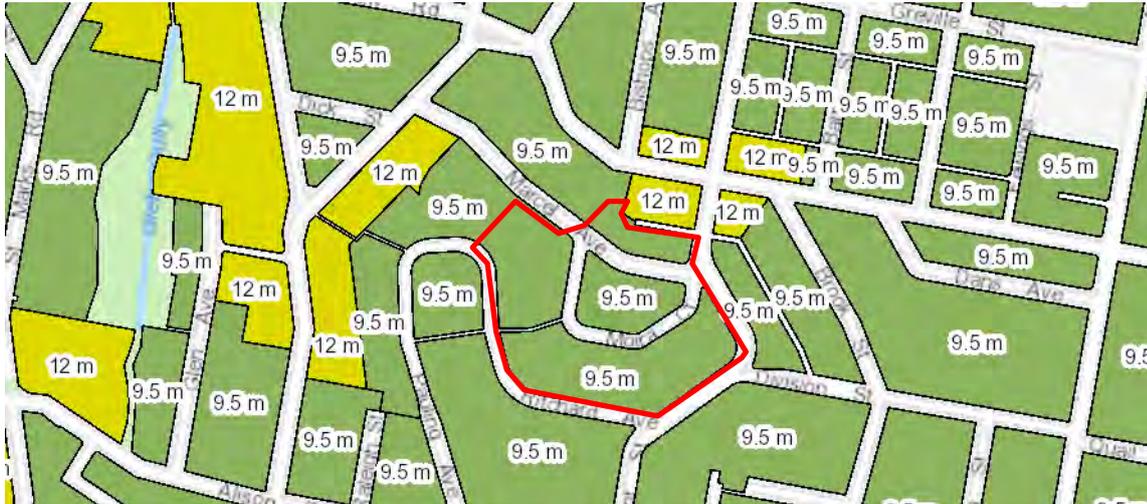
The general scale of the precinct is protected by both the land zoning and building height restrictions in the area. The surrounding precinct consists almost entirely of medium density residential dwellings (R3) with small areas of lower-density residential (R2) nearby and a neighborhood centre (B1) at the Clovelly shopping district, outside of the HCA. Height limits in this area are between 9.5 metres and 12 metres (M), as indicated on the below figure.

Figure 47 Height of Buildings (HoB) map with the approximate area of Moira Crescent outlined in red

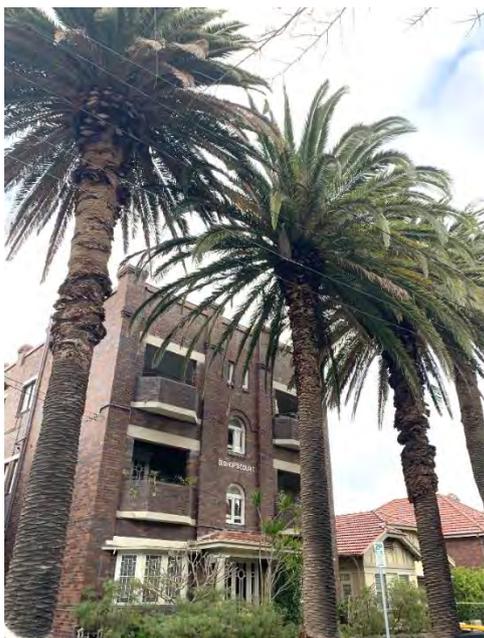
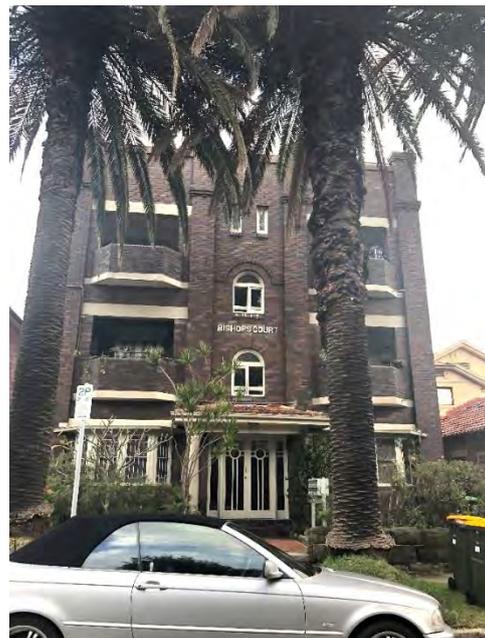
No other information is provided for the item within the SHI database. It is possible that the building listed at the location, also named “Bishopscourt”, (identified in the below photographs) should be captured as a built heritage item also and that this listing contains an error.

Figure 48. Bishopscourt apartment building.

Figure 49. Bishopscourt apartment building.

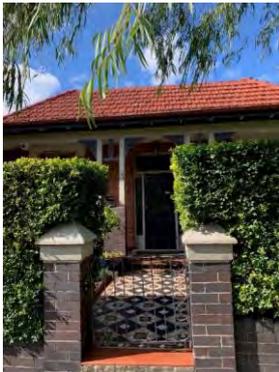
The item at 3 Cook Street is a fine Edwardian House with a hipped roof and symmetrical façade. The house retains many original features including timber mouldings and decoration. Alterations include retiled front verandah and pathway. Materials, features and detailing are in keeping with the physical description outlined in the SHI.

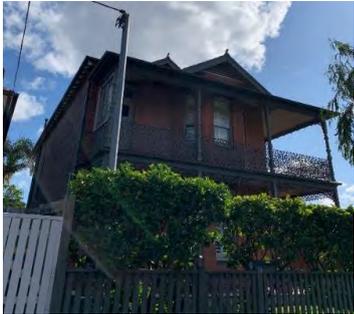
The Item at 14 Cook Street is a two storey Edwardian house in excellent condition set back from the street behind a well planted garden and an original iron palisade fence. Materials, features and detailing are in keeping with the physical description outlined in the SHI.
Single storey Federation house, c 1900 (I329)	Local

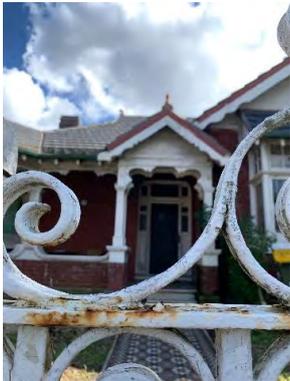
The item at 26 Cook Street is a Federation style house c.1915 with a complex plan arrangement and a splay corner verandah feature specifically designed for the corner block. There are many intact features including bay windows, balustrades and brackets. Materials, features and detailing are in keeping with the physical description outlined in the SHI.
“Juvena” Art Deco Apartments (I330)	Local

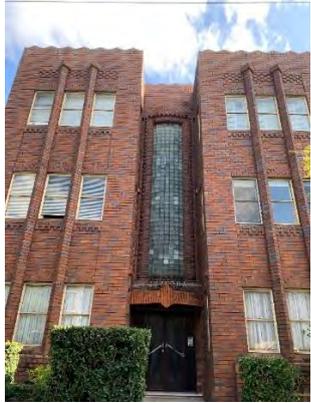
The item at 50 Cook Street is a three level art deco residential flat building in good condition generally as built. It has a deeply recessed central feature stairwell with translucent glass blocks, thematic brickwork, including brick columns, decorative parapet features and herringbone brickwork on the foyer ceiling. The original fence, entry doors and windows have been retained.

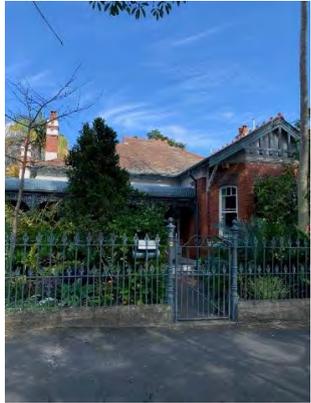
The item at 11 Frances Street is one of a pair of Federation Queen Anne style matching houses. Original intact features include a roughcast gable and timber decoration, bullnosed verandah with cast iron posts, lace fringes and original slate roof

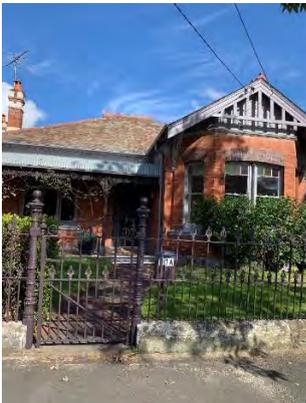
<p>The item 11A Frances Street is one of a pair of Federation Queen Anne style matching houses. Original intact features include a roughcast gable and timber decoration, bullnosed verandah with cast iron posts, lace fringes and original slate roof.</p>
<p>“The Centre” “Wiringulla” “Ballarat House” Federation mansions (I373)</p>	<p>Local</p>

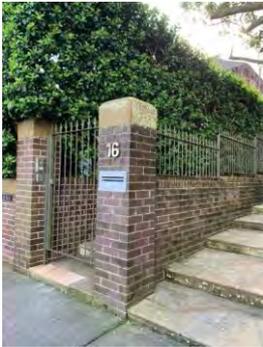
<p>16 Frances Street “Wiringulla”</p>

<p>18 Frances Street “Ballarat House”</p>	<p>The three separate items at 14 - 14a, 16 & 18 Frances Street are all large two storey Federation mansions with multiple gabled roofs and decorative timber detailing on the verandahs and porticos. Each item is in excellent condition with generally original retained features. No’s 16 and 18 are well set back behind significant hedges and largely concealed from street view.</p>

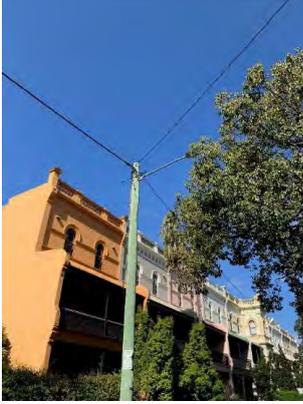
The item at 26-42 The Avenue is one of the finest rows of Victorian terraces in Sydney, in magnificent park setting overlooking a row of large Moreton Bay Figs. Remarkable for high degree of integrity despite alterations to some terraces. All are redeemable. Local historical interest associated with education.

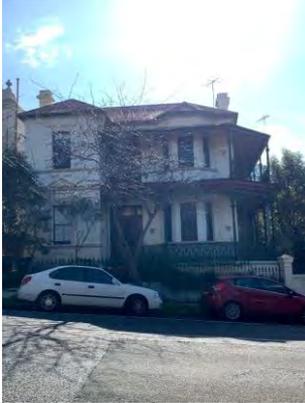
The large Italianate, two storey house is located at 238 – 242 Alison Road. The house has some loss of detail including some mouldings and lacework, although has been generally well-restored. . The item is in a good condition and is considered to be of high integrity.
Site of Father Shaws Wireless works Complex of timber and iron building (I265)	Local

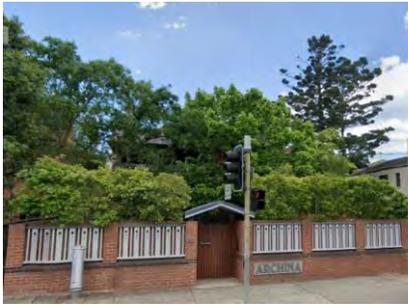
The item at 51 Avoca Street is an impressive two-storey Federation building located at a key intersection. The item was not visible from the public domain and was not able to be assessed as a part of this study.
Group of Federation house, pre 1915 (I268)	Local

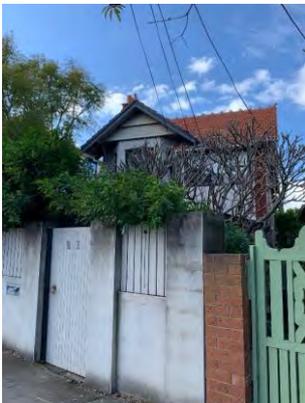
The Federation house is located at 87 Avoca Street. This house unfortunately has been spoiled by significant alterations, in particular the balcony enclosure and painted brickwork. A new unsympathetic rendered fence surrounds the front of the property. The item is in a fair condition and is considered to be of moderate integrity.

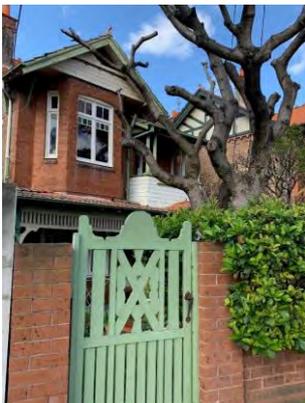
The Federation house is located at 89 Avoca Street, Randwick and is one of a group of three Federation houses. The item's physical description should be updated in the SHI database. A new sympathetic brick fence with timber gate has been added. The item maintains a high integrity and is considered to be in a good condition with all detailing intact.

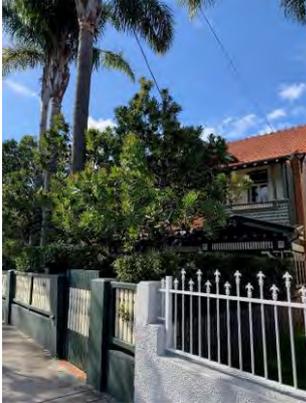
The Federation house is located at 91 Avoca Street, Randwick and is one of a group of three Federation houses. The item is consistent with the description in the SHI database. A new sympathetic brick fence with timber gate has been added. The item maintains a high integrity and is considered to be in a good condition with all detailing intact.
Victorian Residence 4 Dutruc Street (I358)	Local

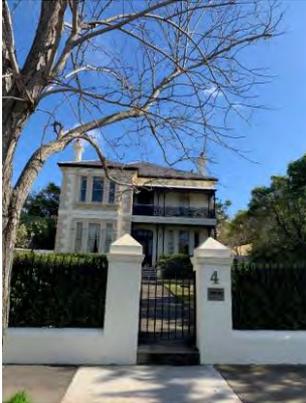
The two-storey Victorian Mansion at 4 Dutruc Street has been recently restored and is well-maintained. The item is consistent with the description in the SHI database. The item has been painted to a new colour scheme. The item is in an excellent condition and is of high integrity.
Electricity Substation No.287 C, 1929 (I359)	Local

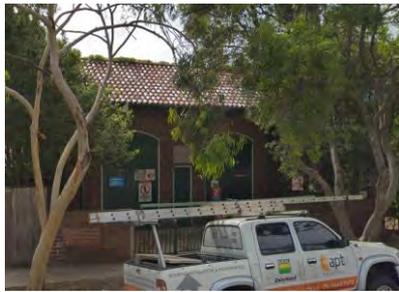
The Electricity substation is located at 9S Dutruc Street, Randwick. The item is consistent with the description in the SHI database, however, the address should be updated as 9S Dutruc Street. The item maintains a high integrity and is considered to be in a good condition with all detailing intact.

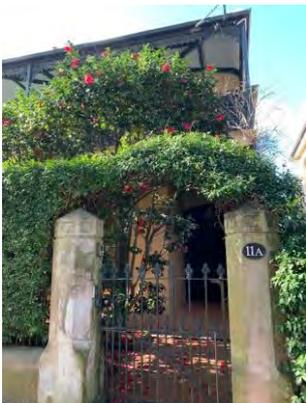
The item is located at 11A and 15 Dutruc Street, Randwick. The item is mostly consistent with the description in the SHI database. The item maintains a high integrity and is considered to be in a good condition with all detailing intact. No. 15 is currently ongoing restoration and possibly alterations. It appears the front door to No. 15 has been removed.

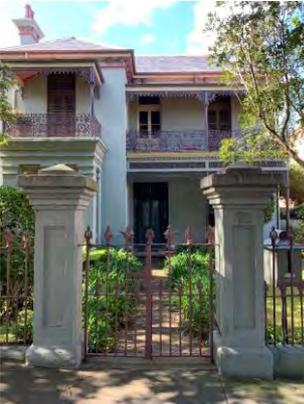
<p>The item is located at 21 Dutruc Street, Randwick. The item has been attractively restored since it was last updated in the SHI database. The item maintains a high integrity and is considered to be in a good condition with all detailing intact.</p> <p>The SHI database should be updated to reflect these changes.</p>
<p>Victorian Italianate residence, c 1890 (I362)</p>	<p>Local</p>

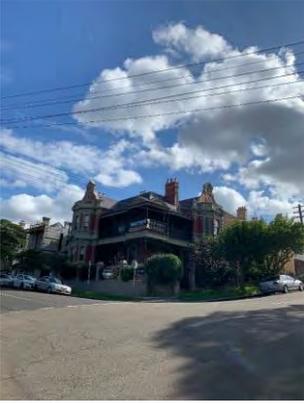
<p>The item is located at 54 Dutruc Street, Randwick. The item has been attractively restored since it was last updated in the SHI database with the verandah and balconies reinstated. The item maintains a high integrity and is considered to be in a good condition.</p> <p>A Development Application (2019) has been approved for alterations and additions to the item including the demolition of a modern addition to the rear. The SHI database should be updated to reflect these changes.</p>

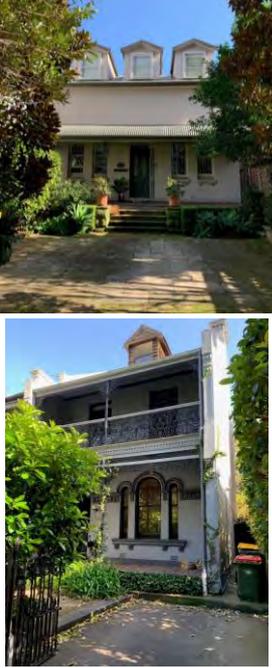
<p>The item at 62-64 Dutruc Street, Randwick is mostly consistent with the description in the SHI database. The item maintains a high integrity and is considered to be in a good condition.</p> <p>60B Dutruc Street has been highly modified and is no longer consistent with its description in the SHI database. The addition of a second storey and of three dormers to the front is detracting and intrusive. Removal of intrusive elements and reinstatement of historic elements should be encouraged, as the building is no longer identifiable as a mid-Victorian house. It is recommended that the house be</p>

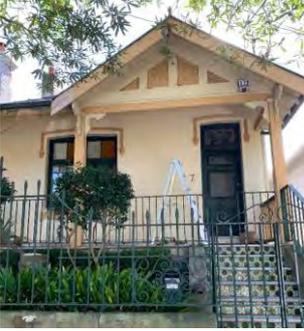
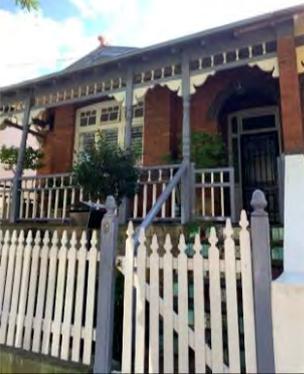
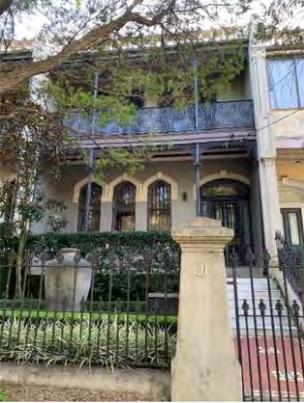
<p data-bbox="991 1234 1401 1576">The group of houses at 11A-23 Rae Street, Randwick are mostly consistent with the description in the SHI database although Nos 11 to 21 have been recently restored. The item has a moderate integrity and is considered to be in a good condition. No. 23, however, is in a poor condition and has an enclosed balcony.</p>
<p data-bbox="193 1765 408 1868">Victorian residence, c 1889 (I436)</p>	<p data-bbox="440 1823 507 1852">Local</p>

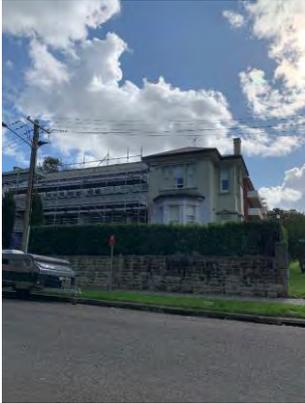
<p data-bbox="991 1682 1401 1995">The item is located at 37-39 Rae Street, Randwick. The item is consistent with the description in the SHI database. The item maintains a moderate integrity and is considered to be in a good condition. Currently, there are some works occurring to the enclosed balcony at the front.</p>

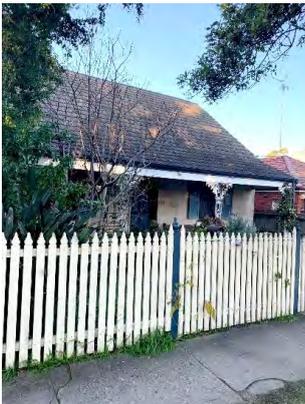
Item (ID)	Sig.	Image	Fieldwork Observations
Georgian house, c 1860s (I308)	Local

The house is located at 139 Botany Street. The overall condition and integrity match the details provided in the SHI database, the house having been substantially modified and only the original stonework remaining intact. Otherwise, the house is in good condition.

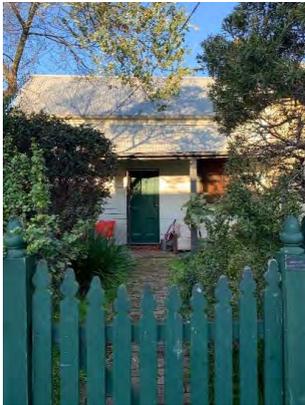
Item (ID)	Sig.	Image	Fieldwork Observations
Worker's cottage, c 1865 (I392)	Local

The house is located at 11 Jane Street. The overall condition and integrity match the details provided in the SHI database, having been substantially altered and original materials having been extensively replaced. It is difficult to see from the public domain due to the fence, but this item appears to be in good condition but not particularly intact. Suggest further inspection.
Two-storey sandstone cottage, c 1860s (I393)	Local

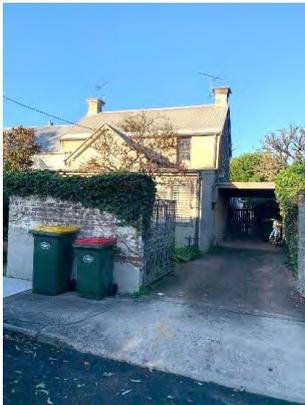
The house is located at 15 Jane Street. The overall condition and integrity match the details provided in the SHI database, with extensive replacements to original features. The house is however difficult to see over the high fence so further inspection is suggested.
St Jude's Mission Church, c 1885 (I411)	Local

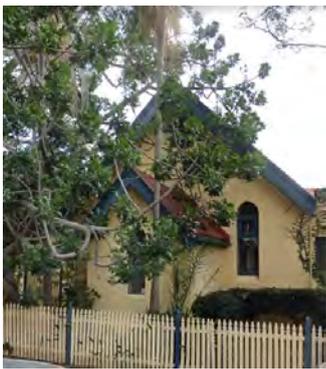
The house is located at 84 Middle Street. The overall condition and integrity match the details provided in the SHI database. This dwelling, once a church, is now a private residence. Brickwork has been painted and many original details have been lost. The integrity of the item is low, however it appears to be in fair condition.

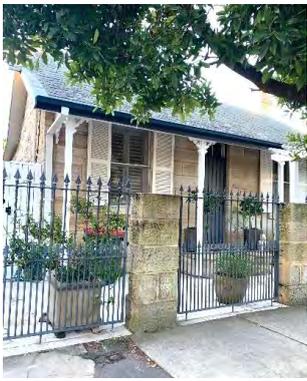
Item (ID)	Sig.	Image	Fieldwork Observations
Old stone cottage, c 1865 (I412)	Local

The house is located at 88 Middle Street. The overall condition and integrity match the details provided in the SHI database, with minor redeemable alterations. Overall, the condition of the item is good. The SHI description states that this 'may be the oldest house in Randwick' but this requires substantiation.
Edwardian timber cottage, c 1905 (I413)	Local

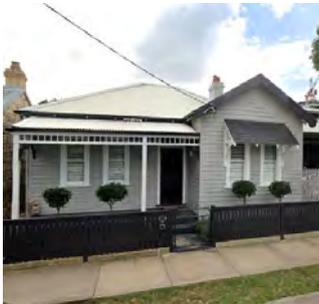
The house is located at 90 Middle Street. The overall condition and integrity mostly match the details provided in the SHI database, however the house has been subject to some renovations including painting and a new replacement fence. Most detailing remains intact.
Weatherboard cottage, c 1870 (I457)	Local

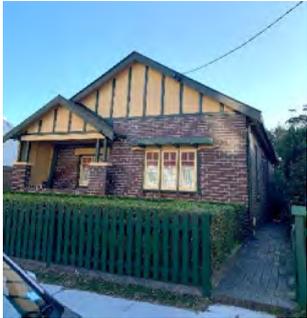
22 Young Street

86 Middle Street	<p>There appears to be an error relating to this item within the SHI. The listing for 'weatherboard cottage' (I417) gives the address as 22 Young Street, however this is a brick dwelling.</p> <p>It is likely that this listed item is located at 86 Middle Street, Randwick and should be amended as such.</p>

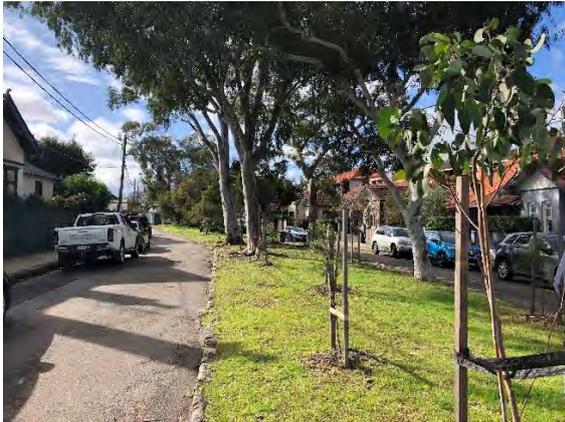
Figure 70. The wide planted median.

The overall form of the cul-de-sac subdivision separate from the main street grid has been maintained, the precinct remains intimately scaled. The wide planted median is intact both with mature trees and juvenile saplings, with sandstone kerbing present on either side of the road, both alongside the footpath and median. This sandstone has been subject to minor localised impacts, likely due to vehicle traffic or ongoing wear and tear.

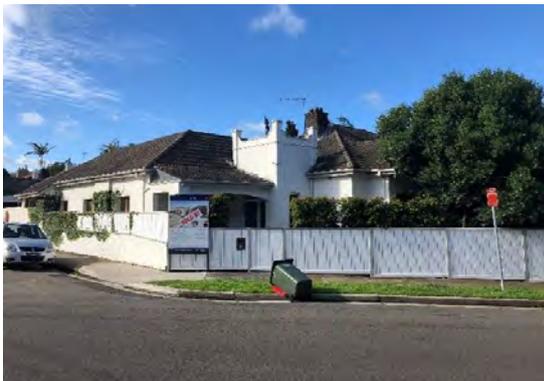
Figure 72. Example of outlying property on Chapel Street.

Side and front setbacks do not appear to be at risk, these have largely been maintained in keeping with the development vision for the precinct. Caerleon Crescent contains mostly single-storey cottages, however there are several outlying properties that do not conform to the general scale or vision of the precinct such as 5 Caerleon Crescent, a two-storey dwelling with a deeper front setback, or the two corner properties facing Chapel Street.

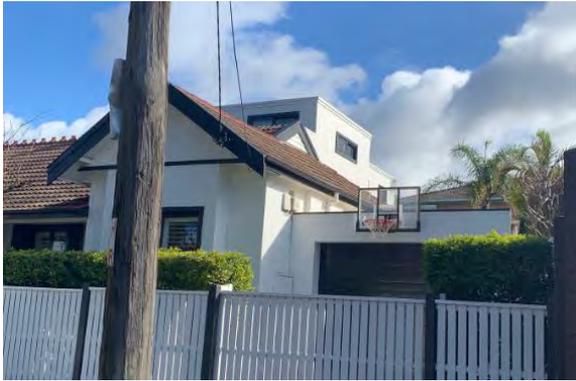
Figure 74. Example of unsympathetic 'pop top' addition above the roofline.

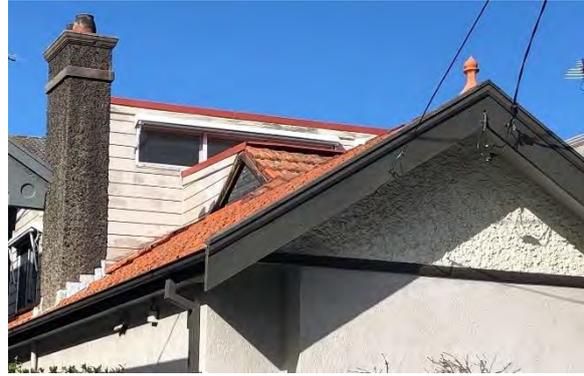
Figure 75. Example of unsympathetic addition above the roofline.

The largest threat to the precinct is the deterioration of the 'cohesive roofscape' identified as an important element of the HCA. Additions to the roofline can be seen on several properties, interrupting this consistent roofline, and representing unsympathetic additions to the traditional pitched roof within the precinct.

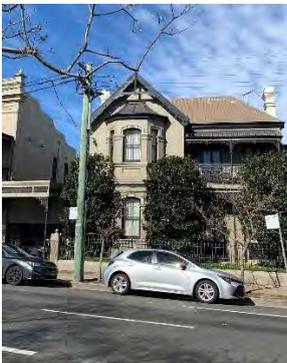
Item (ID)	Sig.	Image	Fieldwork Observations
“Edith”, Victorian House (I337)	Local

The Victorian House is located at 2-4 Milford Street, Randwick. The item is mostly consistent with the description in the SHI database. The item has been repainted to a new colour scheme. It maintains a high integrity and is considered to be in a good condition.
Californian Bungalow (I415)	Local

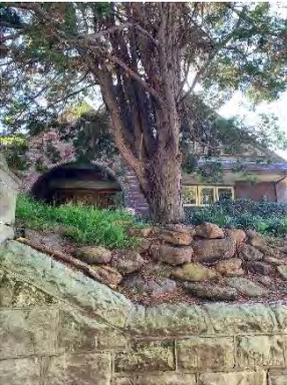
The Californian Bungalow is located at 10 Milford Street, Randwick. The item is consistent with the description in the SHI database. It maintains a high integrity and is considered to be in a good condition.

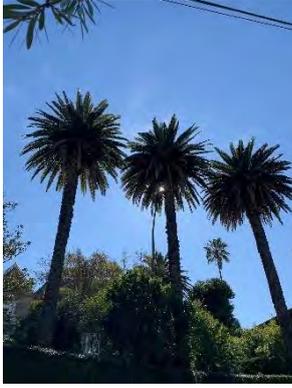
Gothic Revival Sandstone Mansion, c 1843 (I416)	State

The Gothic Revival Sandstone Mansion at 16-18 Milford Street, Randwick was not completely visible from the public domain. From what was observed, the item is mostly consistent with the description in the SHI database. It maintains a high integrity and is considered to be in a good condition.

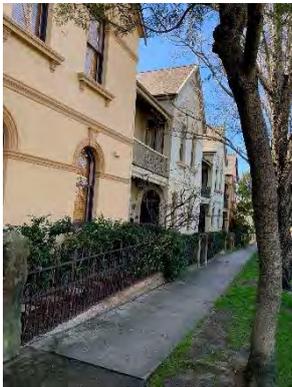
Item (ID)	Sig.	Image	Fieldwork Observations
Brighton Terrace, c 1886 (I410)	Local

Brighton Terrace is a row of two-storey Victorian houses at 2-20 Mears Avenue, Randwick. The item is mostly consistent with the description in the SHI database. It maintains a high integrity and is considered to be in a good condition.
Edwardian Residence (I323)	Local
