Randwick Heritage Study Volume 1

Heritage Conservation Area Review

Heritage Study Randwick City Council

March 2021—Final

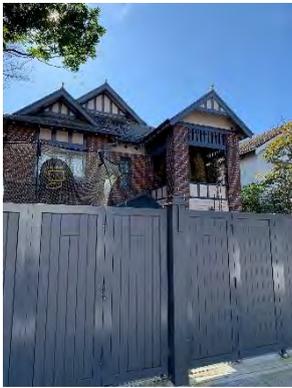
The residence is present at 12 Coogee Bay Road, Randwick. The item is mostly consistent with the description in the SHI database. It maintains a high integrity and is considered to be in a good condition, although there is some biological growth on the slate tiled roof. An unsympathetic timber fence has been built along the front boundary of the item.
“Essex”, Victorian House c 1890 (I336)	Local

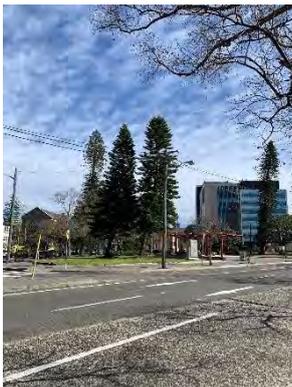
High Cross Reserve (I288)	Local

High Cross Road is present, located at the corner of Avoca Street, Cuthill Street and Belmore Road, Randwick. The item is consistent with the description in the SHI database. It maintains a high integrity and is considered to be in a good condition.

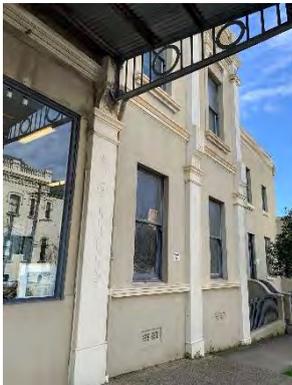
Item (ID)	Sig.	Image	Fieldwork Observations
"Goldring House", c 1886 (I286)	Local

The terrace row of four shops are present at 203-209 Avoca street, Randwick. The item is consistent with the description in the SHI database. It maintains a high integrity and is considered to be in a good condition.
"Gower-Galtees", Art Deco residential flat building including fence and gate (I322)	Local

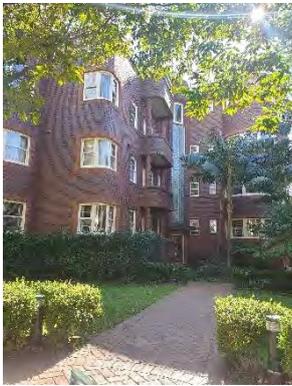
The Art Deco flat building is present at 8-10 Coogee Bay Road, Randwick. The item is consistent with the description in the SHI database. It maintains a high integrity and is considered to be in a good condition.

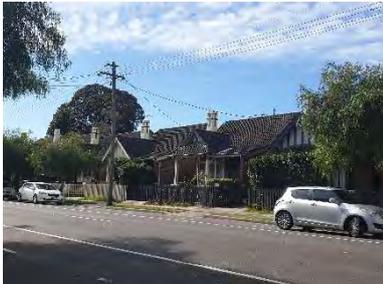
The Federation Queen Anne single-storey row house is present at 68-82 Doncaster Avenue. The item is consistent with the description in the SHI database. It maintains a high integrity and is considered to be in a good condition.

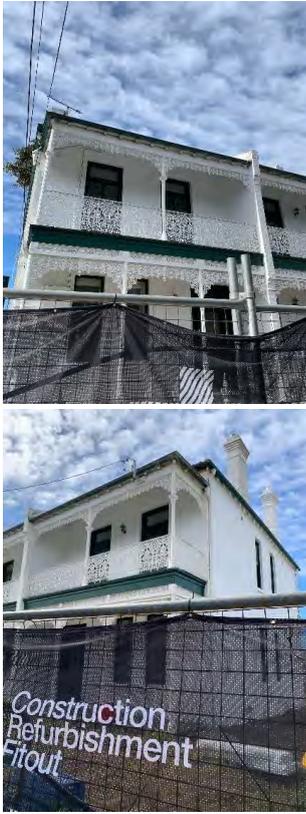
<p>The two-storey pair of terraces are present at 10-12 Doncaster Avenue. The item is consistent with the description in the SHI database, although there is a threat of a reduction in the large curtilage. The item maintains a moderate integrity and is considered to be in a fair condition being in the process of restoration.</p> <p>The surrounding properties have been demolished and a planning proposal has been submitted to incorporate the item into new development. There is a potential risk for insensitive redevelopment of this area.</p>
"Creswell", Victorian terrace, c 1890s (I124)	Local

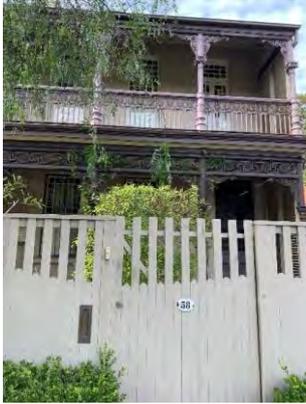
<p>The Victorian Terrace is present at 58 Doncaster Avenue. The item is consistent with the description in the SHI database. It maintains a moderate integrity and is considered to be in a good condition.</p> <p>Notable additions to the property include a rear addition, that is not overly visible from the public domain, an unsympathetic timber panel fence.</p>

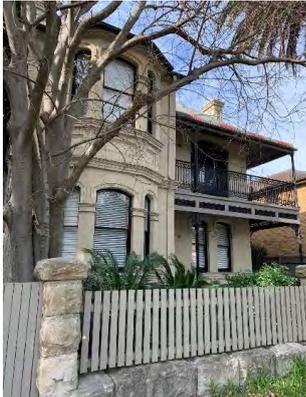
<p>The Victorian mansion is present at 8 Doncaster Avenue. The item is consistent with the description in the SHI database. It maintains a high integrity and is considered to be in a good condition.</p>

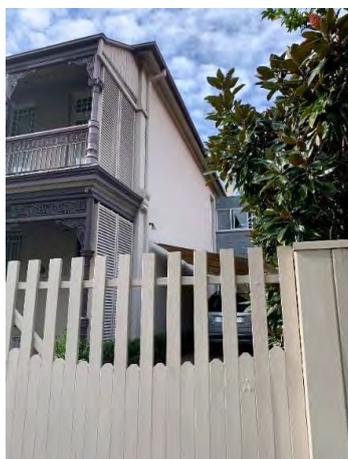
Figure 87 . Addition to the rear of 58 Doncaster Road. Not overly visible from street.

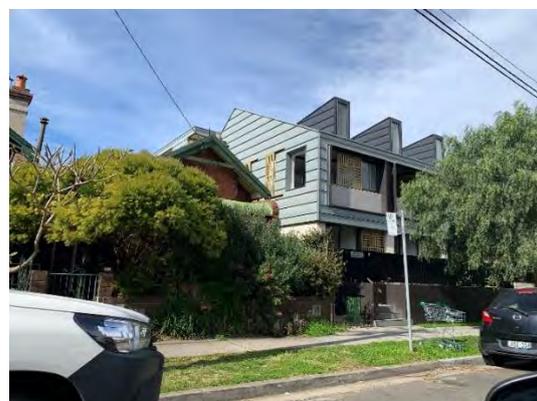
Figure 88. View of modern infill development at 150 -152 Doncaster Avenue.

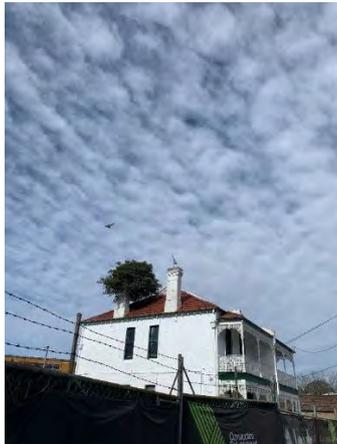
Figure 89. View showing 10-12 Doncaster Avenue and the demolition of surrounding buildings.

The largest threat to the precinct is the threat of encroaching new development. This is particularly visible at the northern end of Doncaster Avenue where Nos. 6, 14 and 16 have been demolished to make way for new development. The heritage items at 10-12 Doncaster Avenue have been retained, however, there is a development application to incorporate these items into the new development.

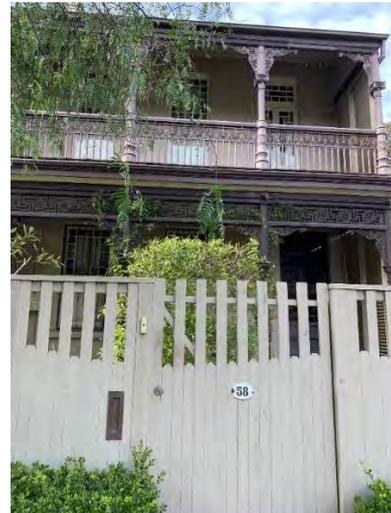
Figure 90. Unsympathetic fence.

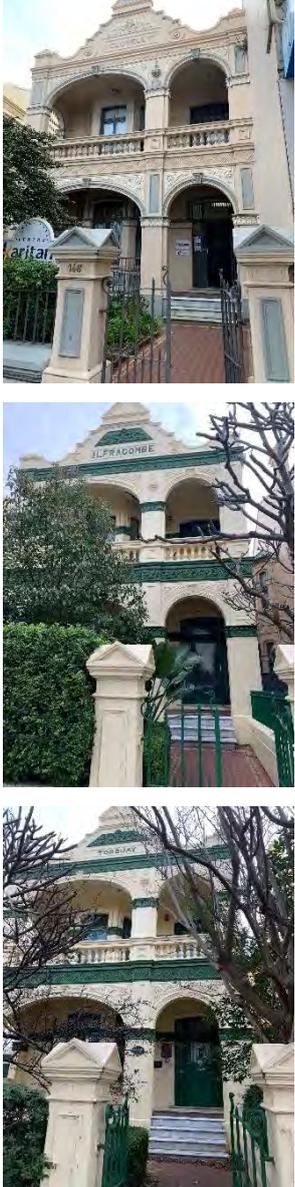
<p>The Italianate houses are located at 146-150 Avoca Street, Randwick. The item is consistent with the description in the SHI database. It maintains a high integrity and is considered to be in a good condition with all detailing intact.</p>

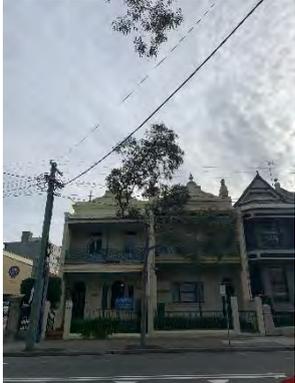
<p>The two terraces are located at 160-162 Avoca Street, Randwick. The item is mostly consistent with the description in the SHI database. No. 162 is considered to be of high integrity and in a good condition. No. 160 is of moderate integrity as the terrace has been modified with new windows and the loss of moulded detailing at the ground level.</p>
Two late Victorian terraces, c 1890 (I282)	Local

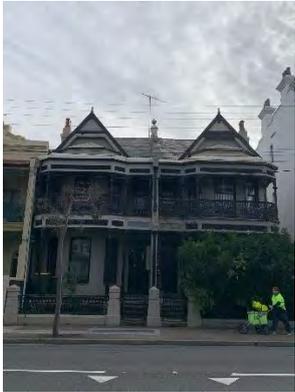
<p>The terraces are located 156-158 Avoca Street, Randwick. The item is mostly consistent with the description in the SHI database although is in a fair condition. There are scratches to the rendered façade, the slate roof tiles are in need of repair, the filigree balustrade to No. 158 is broken and a new unsympathetic screen door has been added to No. 156. The item has moderate integrity.</p>
Two three-storey terraces, c 1885 (I281)	Local

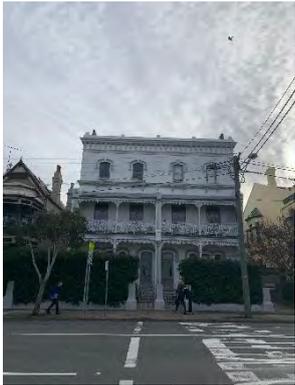
<p>The two three-storey terraces are located at 152-154 Avoca Street, Randwick. The item is inconsistent with the description in the SHI database as the buildings have been restored since the database was last updated. The balconies and lower ground verandahs have been reinstated, the exterior staircase has been removed, and the façade has been restored. The terraces maintain a high integrity and is considered to be in a good condition with all detailing intact. The SHI database should be updated to reflect these changes.</p>

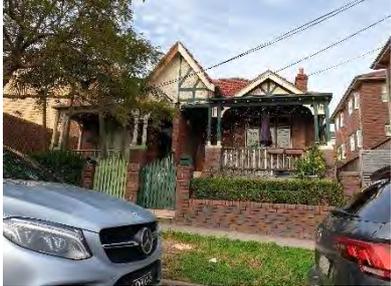
The Edwardian semis are located 117-19 Clara Street, Randwick. The item is consistent with the description in the SHI database. It is considered to have high integrity and is in a good condition, although the façade could be repointed should the opportunity arise.

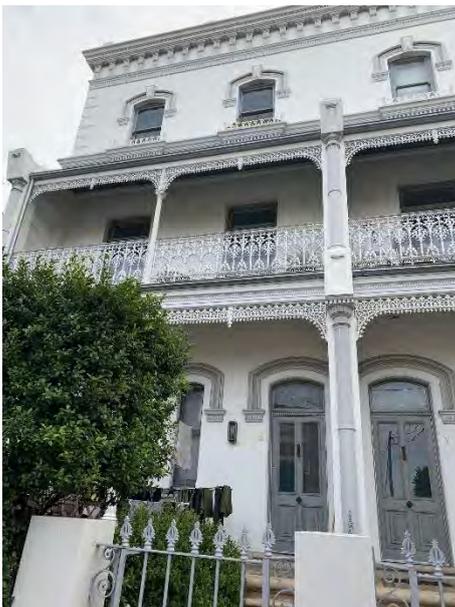
Figure 96. Restoration of the heritage item at 152-154 Avoca Street (I281) contributes positively to the character of the HCA.

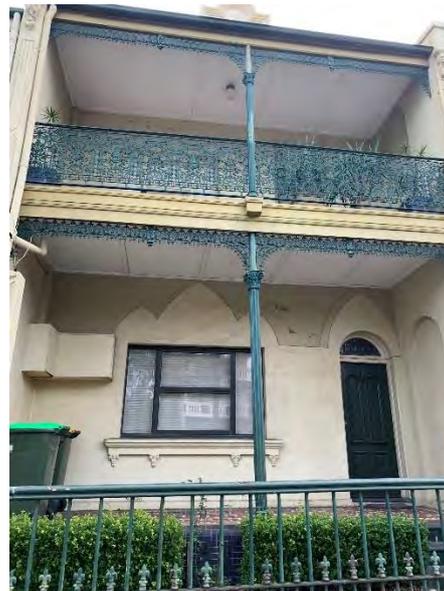
Figure 97. Unsympathetic replacement of windows and removal of moulded architrave at 160 Avoca Street.

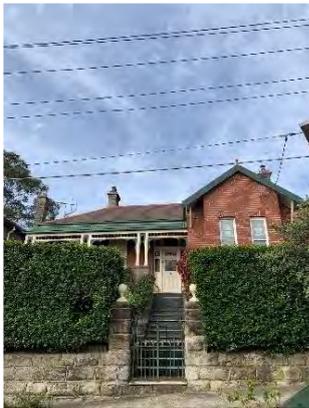
The residence is located at 13 Lee Street, Randwick. The item is consistent with the description in the SHI database. It maintains a high integrity and is considered to be in a good condition.

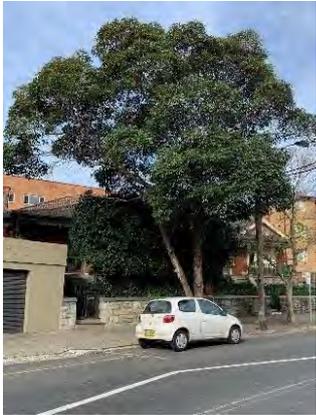
The house is located at 15-19 Perouse Road, Randwick. The item is mostly consistent with the description in the SHI database. No. 19 has a second storey addition set back from the front of the property. The addition is mostly sympathetic, however, has unsympathetic timber weatherboards painted lime green. The roofs to both houses have been retiled and the front fence may have been repointed in a cementous mortar. The item is of moderate integrity and is in a good condition.
Grand Edwardian mansion (I424)	Local

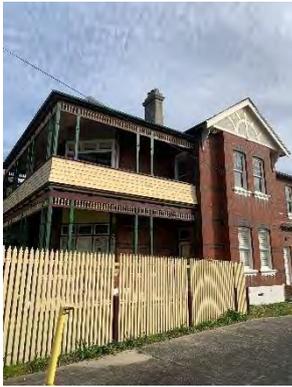
The mansion is located 84 Perouse Road, Randwick. The item is consistent with the description in the SHI database. It maintains a high integrity and is considered to be in a good condition with all detailing intact. A new timber picket fence surrounds the property.
Federation house, c 1915 (I425)	Local

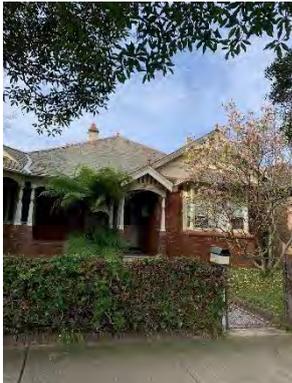
The house is located at 85 Perouse Road, Randwick. The item is consistent with the description in the SHI database. It maintains a high integrity although is in a fair condition. There is biological growth on the slate tiled roof, the timber fence has rotted, and the paint to the timber detailing is peeling.

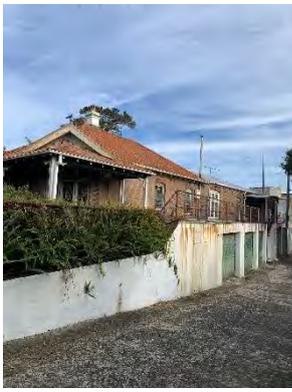
The house is located at 98-100 Perouse Road, Randwick. The item is consistent with the description in the SHI database. It maintains a high integrity although has an unsympathetic garage addition which extends down Avoca Lane. The item is in a fair condition due to the overgrown landscape, and presence of pigeons nesting across the property
Federation Queen Anne house (I427)	Local

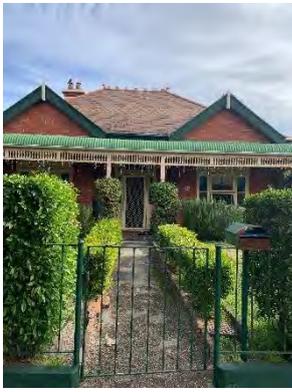
The house is located at 106 Perouse Road, Randwick. The item is consistent with the description in the SHI database. It maintains a high integrity and is in a good condition with all detailing intact. A new screen door has been added and landscaping has been altered.
Federation Queen Anne houses (I428)	Local

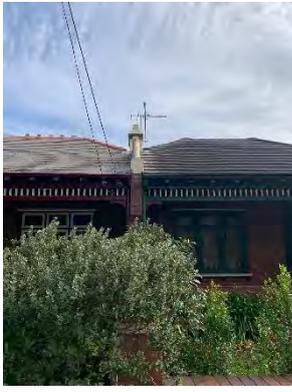
The houses are located at 108 and 110 Perouse Road, Randwick. The item is consistent with the description in the SHI database although the roof of No. 108 has been retiled with decramastic pressed metal tiles. The item maintains a high integrity and is in a good condition.

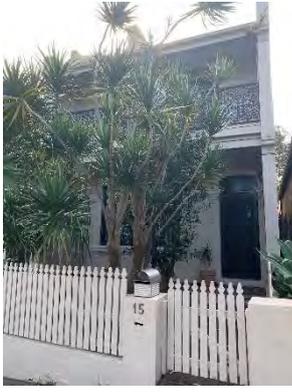
The house is located at 15 St Pauls Street, Randwick. The item is consistent with the description in the SHI database and has been restored sympathetically. The boundary fence has new timber picket inserts. It maintains a moderate integrity and is in a good condition.

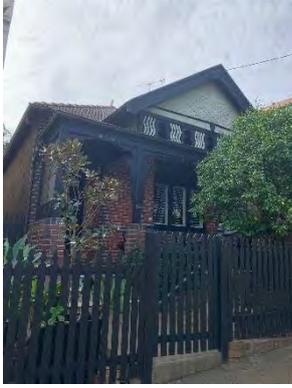
The house is located at 17 St Pauls Street, Randwick. The item is consistent with the description in the SHI database. It maintains a high integrity and is in a good condition with all detailing intact.
Victorian Italianate boom style two-storey house (I445)	Local

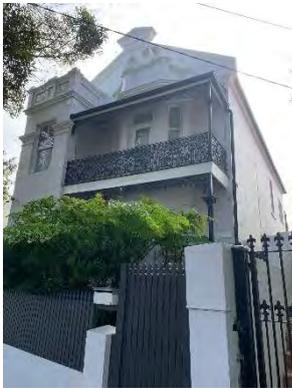
The house is located at 19 St Pauls Street, Randwick. The item is consistent with the description in the SHI database although the house has been painted to a new colour scheme and has new timber picket inserts along the house's boundary fence. It maintains a high integrity and is in a good condition with all detailing intact.
Terraced pair (I446)	Local

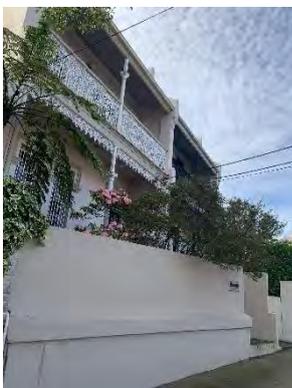
The house is located at 25-27 St Pauls Street, Randwick. The item is mostly consistent with the description in the SHI database. The balconies have been reinstated and a new unsympathetic boundary wall has been added along the front of the property. The item is considered to be of moderate integrity and is in a good condition with all detailing intact.

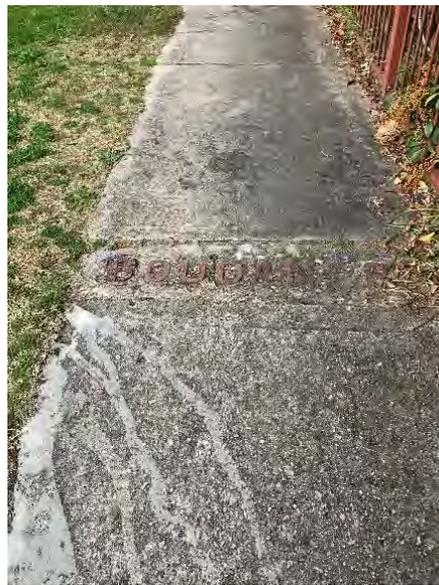
Figure 102. 'Soudan St' laid into the concrete. It is recommended that these are retained as a feature of the Heritage Conservation Area.

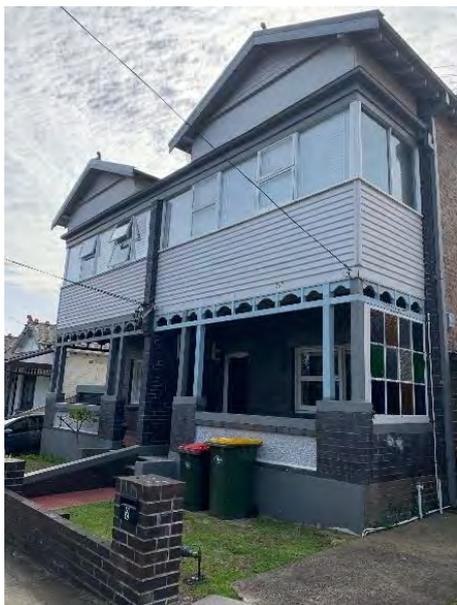
Figure 103. Restored building at 227 Barker Street. Unsympathetic use of materials and infilling of verandah. This property has lost some of its integrity.

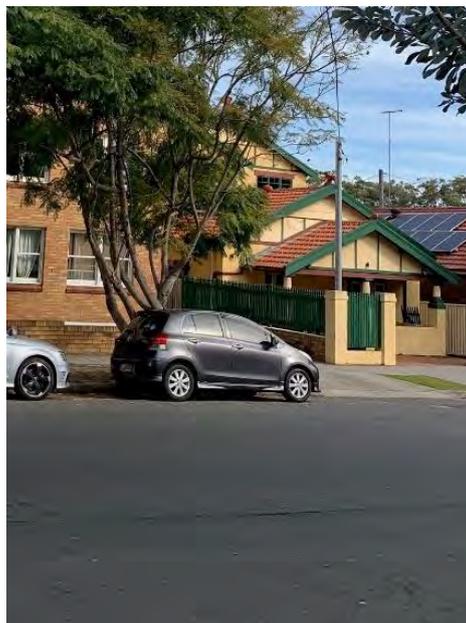
Figure 104. Example of unsympathetic second storey additions at 210 Barker Street.

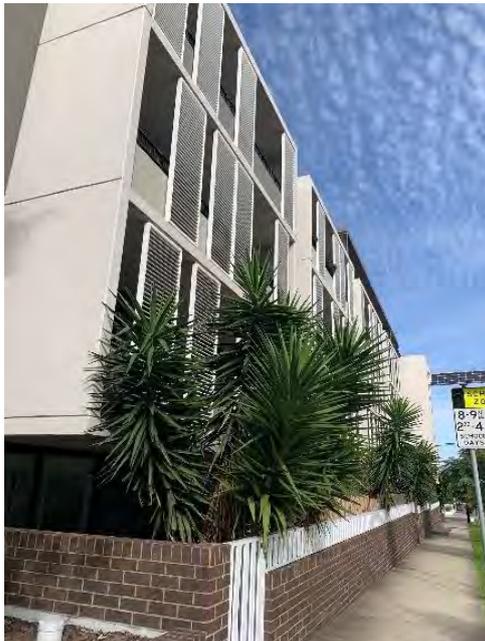
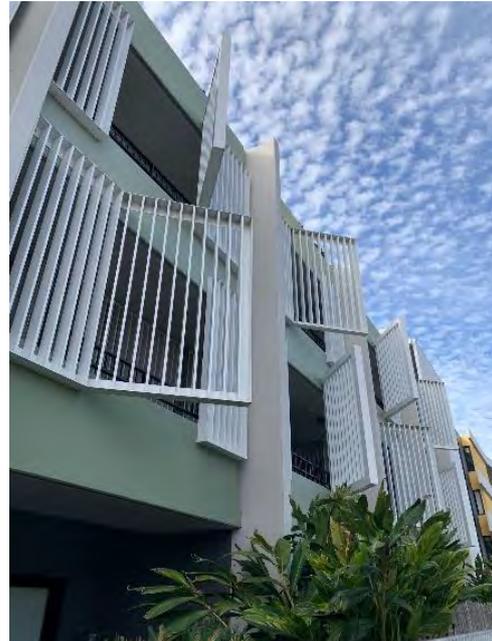
Figure 105. Encroaching development at 201-207 Barker Street (outside HCA).

Figure 106. Encroaching development at 201-207 Barker Street (outside HCA).

The largest threat to the precinct is that of encroaching new development on the outskirts of the HCA. This is particularly visible at the western end of Barker Street where the new development at 201-207 Barker Street (Figure 105 and Figure 106). It is recommended that any further new development on the outskirts of this HCA consider the HCA in the vicinity when considering, the form, scale and use of materials in their design.

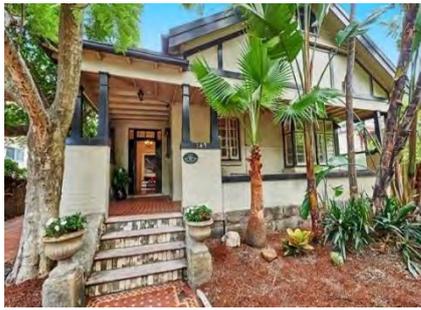
Address	Image	Reason for listing
149 Darley Road, Randwick

<p>This property is within the North Randwick HCA.</p> <p>A desktop assessment suggests this was once the residence of prominent educator, Alfred Godwin Alanson (1863-1943). There is the potential to list this item on the Randwick LEP, subject to further detailed assessment.</p>
30 Eastern Avenue, Kingsford

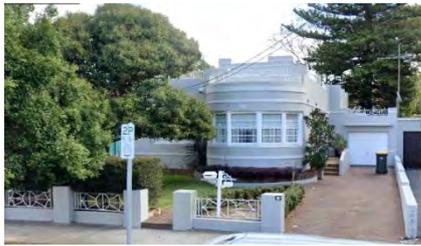
<p>This is a good representative example of an Inter-War Functionalist 1940s P&O style residence. The rarity of this architectural style in this area suggests representative examples should be protected.</p> <p>This forms a pair with 32 Eastern Avenue, it is recommended both be listed subject to further detailed assessment.</p>
32 Eastern Avenue, Kingsford

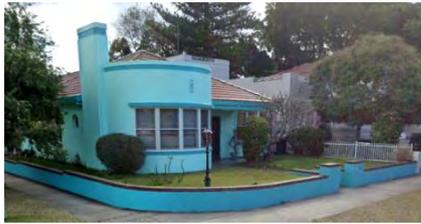
<p>This is a good representative example of an Inter-War Functionalist 1940s P&O style residence. The rarity of this architectural style in this area suggests representative examples should be protected.</p> <p>This forms a pair with 30 Eastern Avenue, it is recommended both be listed subject to further detailed assessment.</p>

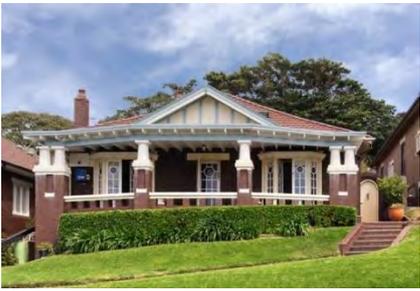
Address	Image	Reason for listing
10 Cottenham Avenue, Kensington

<p>A desktop assessment of this property suggests that many original timber interior elements may survive, as well as original leadlight windows.</p> <p>Subject to further detailed assessment, it is recommended this property be listed.</p>
5 Severn Street, Maroubra

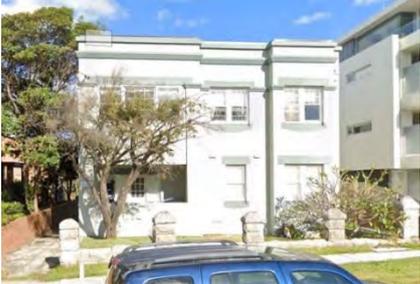
<p>This building may have historical significance as one of the first block of 'holiday flats' in the Maroubra area and is a good representative example of early Art Deco 'beach' architecture. The building appears to have recently been renovated. Community submissions suggest there may be potential historical archaeological value relating to the former stables.</p> <p>Subject to further detailed assessment, it is recommended this property be listed.</p>
69 Darley Road, Randwick

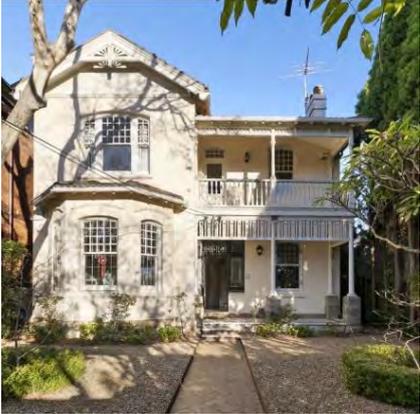
<p>This property is within the North Randwick HCA.</p> <p>Two-storey federation mansion on a large parcel of land with tapered timber columns, timber gable decoration and multi pane top sash windows. A desktop assessment suggests interiors may be partially intact. This building is typical of similar Darley Road properties that are already listed.</p> <p>Subject to further detailed assessment, it is recommended this property be listed.</p>

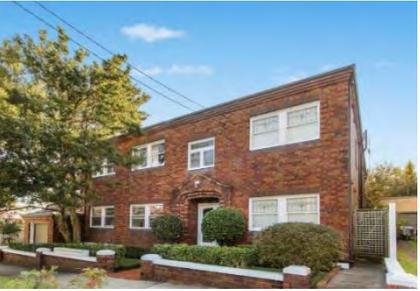
14 Moira Crescent, Randwick

<p>This property is within the Moira Crescent HCA.</p> <p>This address is a two-storey block of brick flats with many intact original features including brick detailing and leadlight glazing.</p> <p>Subject to further detailed assessment, it is recommended this property be listed.</p>

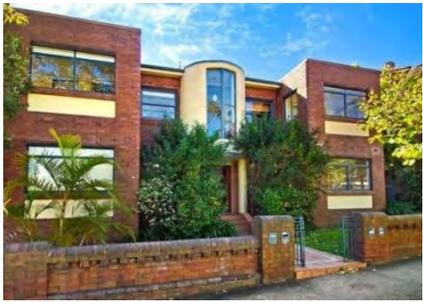
Address	Image	Reason for listing
18 Moira Crescent, Randwick

<p>This property is within the Moira Crescent HCA.</p> <p>This is a fairly unusual Art Deco style block of flats, which appears to have mostly intact features.</p> <p>Subject to further detailed assessment, it is recommended this property be listed.</p>
1 Winburn Avenue, Kingsford

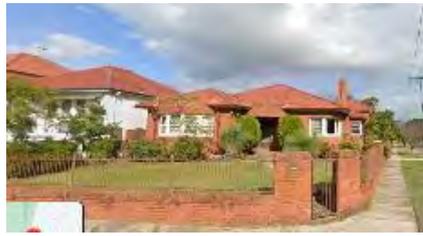
<p>Situated on a prominent corner block, an Inter-war Functionalist dwelling with original rear garage c 1940s. Interesting curved brick bay windows. Highly intact exterior.</p> <p>Subject to further detailed assessment, it is recommended this property be listed.</p>
10 Broome Street, Maroubra

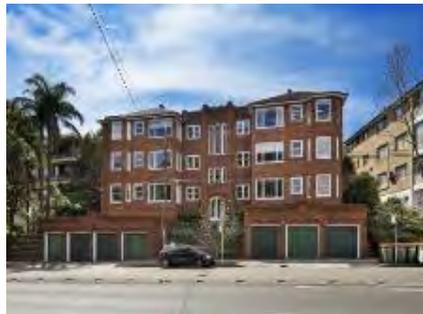
102 Alison Rd, Randwick

<p>Block of Art Deco flats with interesting Art Deco brickwork and features. The building has been built to a unique plan. Some windows may have been replaced but otherwise appears to be highly intact.</p> <p>Subject to further detailed assessment, it is recommended this property be listed.</p>
122 Brook St, Coogee

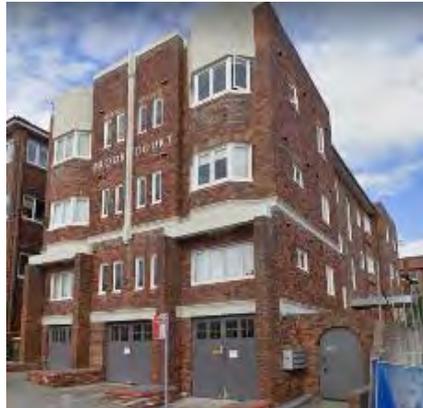
<p>Art Deco apartment which has a good contribution to the streetscape. Unusual features and ground level doors. Further historical research may provide more valuable information.</p> <p>Recommend further research for potential listing.</p>

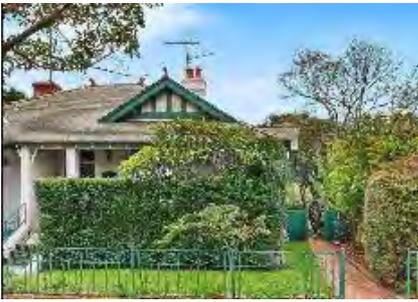
Address	Image	Reason for listing
123 Perouse Rd, Randwick

<p>This property is within The Spot HCA.</p> <p>Half of an intact Federation semi-detached residence with intact exterior and interior.</p> <p>Recommended for listing, however only if No. 121 Perouse Road is included in this listing.</p>
124 Brook St, Coogee

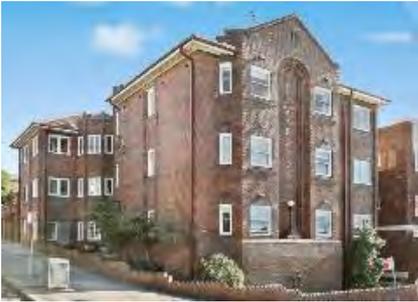
<p>Art Deco apartment which has a good contribution to the streetscape. Unusual features and ground level doors. Further historical research may provide more valuable information.</p> <p>Recommend further research for potential listing.</p>
129 Coogee Bay Road, Coogee

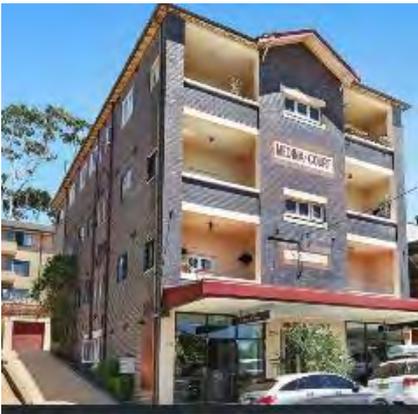
<p>An intact Art Deco building constructed of liver brick. Internal photos show cornices and ceiling decorations have been retained. Very impressive along the streetscape. Modified ground floor shop fronts.</p> <p>Subject to further detailed assessment, it is recommended this property be listed.</p>

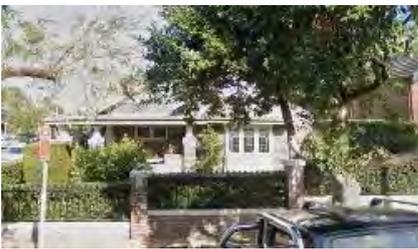
13 Roma Avenue, Kensington

<p>Elegantly restored Federation cottage, in a prominent corner siting. Requires further investigation to determine significance.</p> <p>Recommend further research for potential listing.</p>
135 Clovelly Road, Randwick

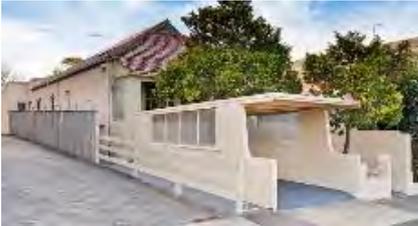
<p>Very unusual, unique semi-detached dwelling. Requires further research.</p> <p>Subject to further detailed assessment, recommend listing with No. 137, 139 and 141.</p>

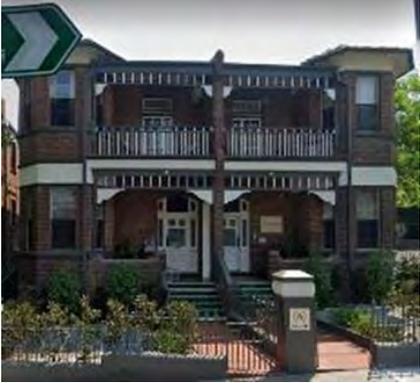
Address	Image	Reason for listing
136-138 Alison Rd, Randwick

<p>Neat, restored two-storey semi-detached residence. Modified windows and new timber details added.</p> <p>Subject to further detailed assessment, it is recommended this property be listed.</p>
14-16 Glebe St, Randwick

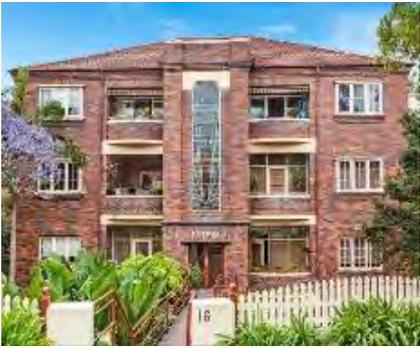
<p>Art deco apartment block. Large decorative leadlight glass on the facade still intact. Some windows on the front have been replaced. Deep setback and good contribution to streetscape.</p> <p>Subject to further detailed assessment, it is recommended this property be listed.</p>
140-156 Beach St, Coogee Originally nominated as separate items.

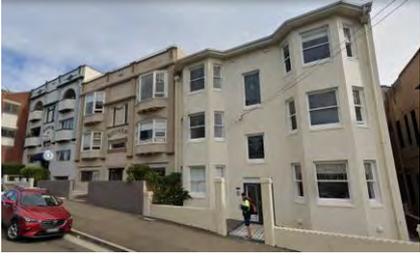
<p>Part of a group of elaborately decorated and rendered Art Deco/Federation apartments. The group of buildings could be listed as a group as they form a highly intact streetscape.</p> <p>Subject to further detailed assessment, recommended for listing and should include No's 140-156.</p>

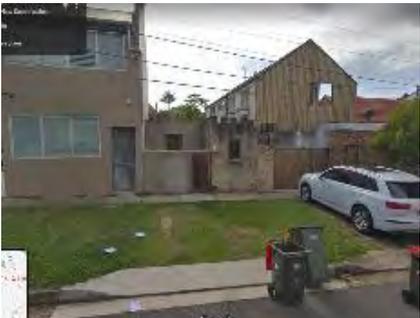
16 Carey Street, Randwick

<p>In the wall of the property of 16 Carey is a 'milk station' that is a remnant of the dairy that was on the property.</p> <p>Unusual and interesting feature. Requires further investigation as it is not identifiable from a desktop assessment.</p> <p>Recommend further research for potential listing.</p>

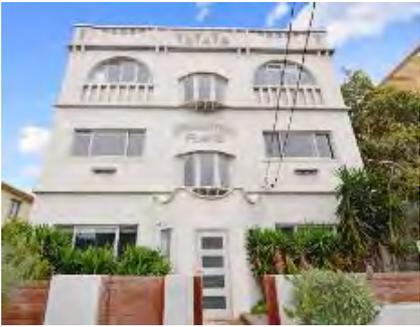
Address	Image	Reason for listing
174 Arden Street, Coogee

<p>Interesting art deco apartment in Coogee with interesting siting on a steep incline. Internal photographs seem to be distinctive with high and decorated ceilings and brick fireplaces. The facade is somewhat modified. Not easily visible from a desktop assessment.</p> <p>Recommend further research for potential listing.</p>
12, 14 and 16 Bishops Avenue, Randwick Originally Nos. 16 and 18 were proposed

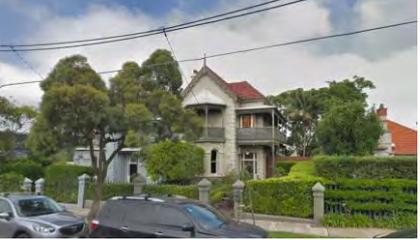
<p>Would recommend further investigation of these three properties as they are very difficult to see from the street.</p> <p>Recommend further research for potential listing.</p>
18 Day Avenue, Kensington

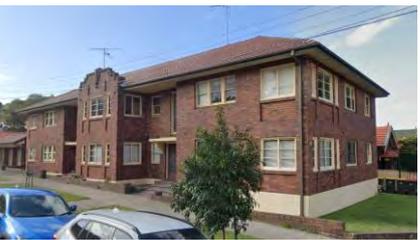
<p>'Lorn Court' - Inter-war (c. 1930s) Art Deco flat building. Highly intact art deco apartment building. Decorative leadlight windows and doors over two entrances. Decorative brickwork façade. Prominent building within the streetscape.</p> <p>Subject to further detailed assessment, recommended for listing.</p>

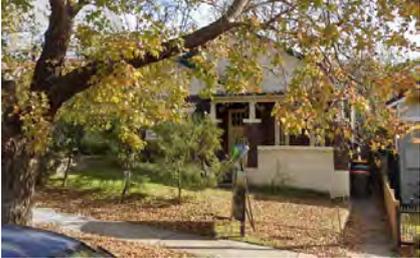
18 Titania St, Randwick

<p>Highly intact federation cottage with excellent timber details and roughcast elements to façade. Internal fireplaces have been bricked over, potentially original timber floorboards.</p> <p>Subject to further detailed assessment, recommended for listing.</p>
182-184 Clovelly Road, Randwick

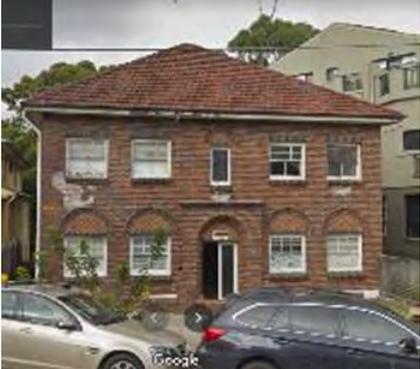
<p>Inter-War Art deco inspired apartment block with a hipped roof. Interesting brickwork detail to the façade. The timber window frames, gutters and brick appear to be in poor condition. The interior appears to be intact with many original features retained.</p> <p>Subject to further detailed assessment, recommended for listing.</p>

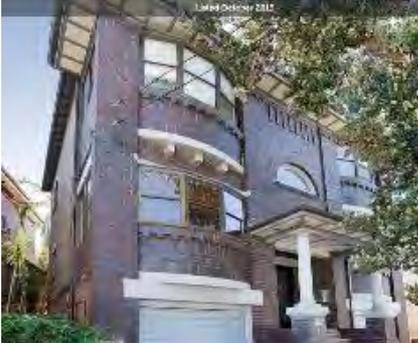
Address	Image	Reason for listing
187 Clovelly Road, Randwick

<p>Art deco apartment complex, dark brick with rounded windows.</p> <p>Apartments appear to have original decorative door frames, ceilings, and cornices. Interior appears relatively intact. The property warrants investigation.</p> <p>Subject to further detailed assessment, recommended for listing.</p>
19-21 Berwick Street

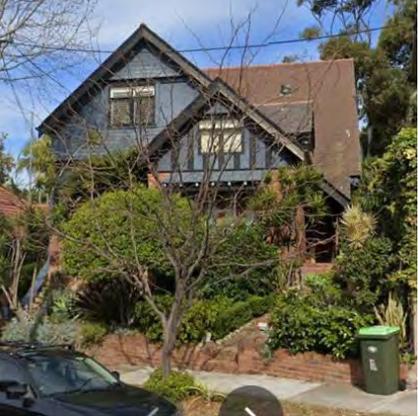
<p>Interesting Federation Arts and Craft, that has some unsympathetic alterations but presents well within the streetscape and is unique to the Randwick LGA.</p> <p>Subject to further detailed assessment, recommended for listing.</p>
190 and 192 Clovelly Road, Randwick

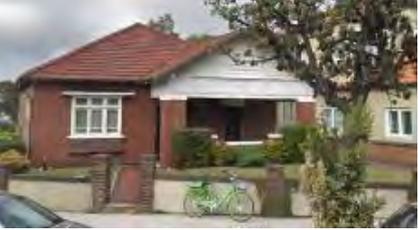
<p>Matching intact Californian bungalows. Neat presentation on the streetscape with a deep setback. Potential to list 190 and 192 as a group listing.</p> <p>Subject to further detailed assessment, recommended for listing.</p>
195 Clovelly Road, Randwick

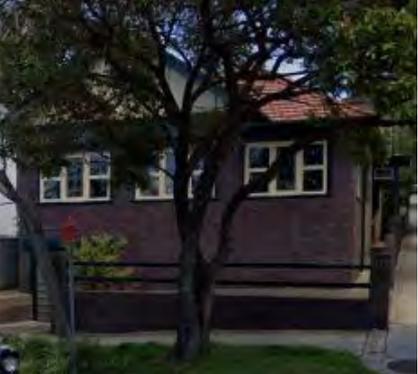
2 George St, Randwick

<p>Unusual Federation bungalow. Looks like the dwelling may have been extended quite early on. The building is difficult to view from streetview and further investigation should be undertaken.</p> <p>Recommend further research for potential listing.</p>

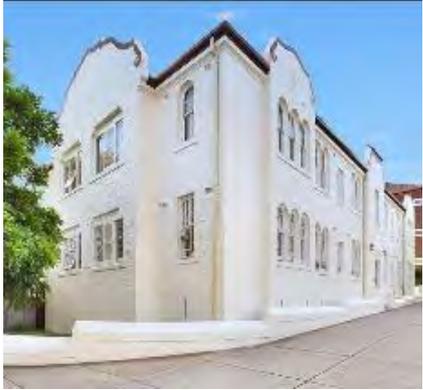
Address	Image	Reason for listing
44 Marcel Ave, Randwick

<p>Unique Spanish mission style Inter War Apartments. Excellent presentation on the streetscape. Further research required to determine if meets criteria to be listed as a heritage item.</p> <p>Recommend further research for potential listing.</p>
5 Kurrawa Ave, Randwick

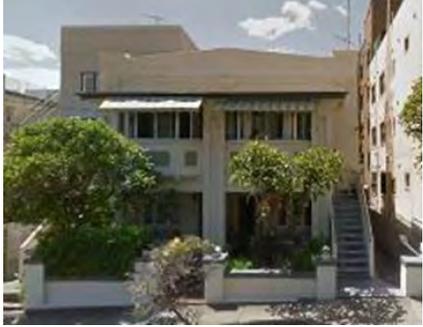
<p>Art deco style semi-detached house with timber floors, decorative door and window frames, decorative high ceilings.</p> <p>Interesting, well-maintained and intact two-storey Inter-War semi-detached house.</p> <p>Subject to further detailed assessment, recommended for listing</p>
51 Doncaster Avenue, Kensington

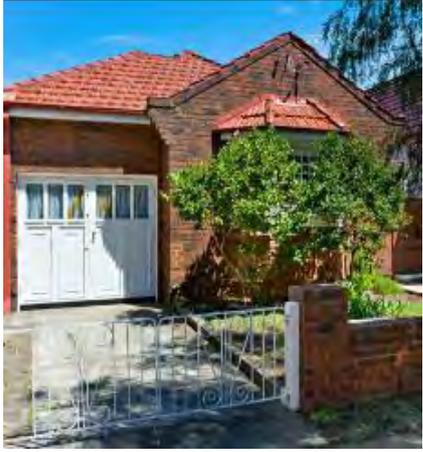
<p>1940-50's Freestanding Residence. Original red textured brickwork, bay window and garage door still intact. Original fence matches in its brickwork. Unique style and design in the Kensington area.</p> <p>Subject to further detailed assessment, it is recommended this property be listed.</p>

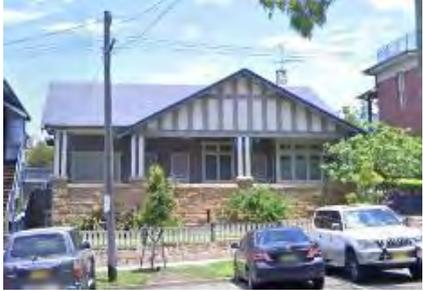
7 Mears Ave, Randwick

<p>This property is within the High Cross HCA.</p> <p>A desktop assessment suggests that this property, a Californian Bungalow c. 1917, is intact throughout with many original features preserved including verandah tiles, leadlight windows and both internal and external timber elements. The property is a good representative example of the Californian bungalow style.</p>

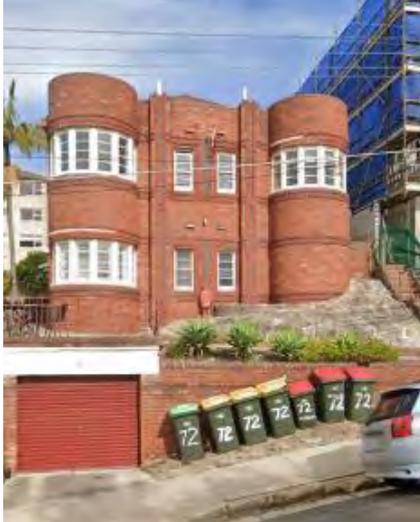
<p>Inter-War Art deco/functionalist redbrick building, decorative brickwork on the face. Rounded 'turret' like structures on the left and right side of the façade. No internal photos</p> <p>Interesting brick parapet and use of curved brick for an apartment. Very prominent withing the streetscape.</p> <p>Subject to further detailed assessment, recommended for listing</p>
8 Glen Ave, Randwick

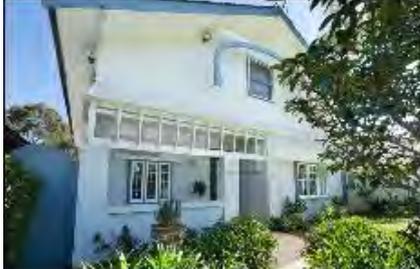
<p>Large, bungalow style property with timber floors, distinctive architecture inside. Set low and not visible in streetview. Very unique building.</p> <p>Subject to further detailed assessment, recommended for listing.</p>
90 Dudley St Randwick

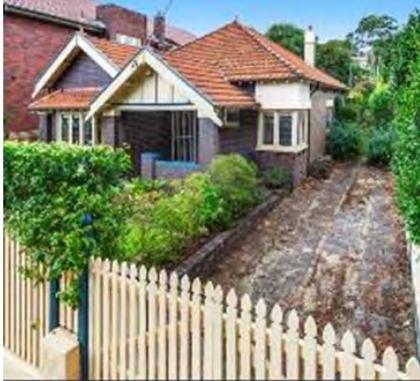
Address	Image	Reason for listing
20 Day Avenue, Kensington

<p>Appears to be a good intact example for its style. Contributes positively to a wider historic streetscape.</p> <p>Subject to further detailed assessment, it is recommended this property be listed.</p>
20 Inglethorpe Avenue, Kensington

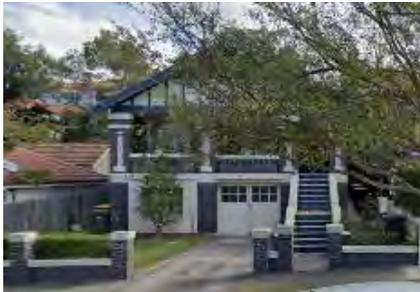
<p>Appears to be a good intact example for its style. Basement garage level would be a rare feature for this period of house.</p> <p>Subject to further detailed assessment, it is recommended this property be listed.</p>
21 Baden St, Coogee

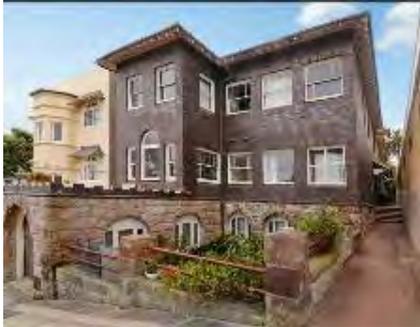
<p>Fine interwar apartment. Intact exterior and looks to also have intact fine traditional features internally. However, if it has been converted into individual apartments it may have had some significant physical interventions.</p> <p>Subject to further detailed assessment, it is recommended this property be listed.</p>
21 Marcel Ave, Randwick

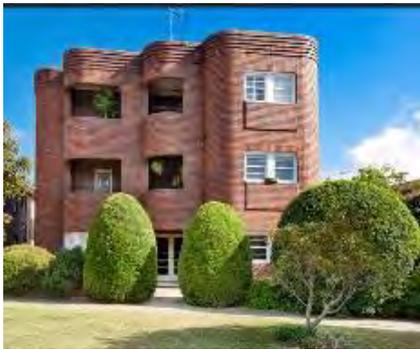
<p>A unique Inter-War building that deserves individual listing as a local heritage item. Highly intact exterior.</p> <p>Subject to further detailed assessment, it is recommended this property be listed.</p>

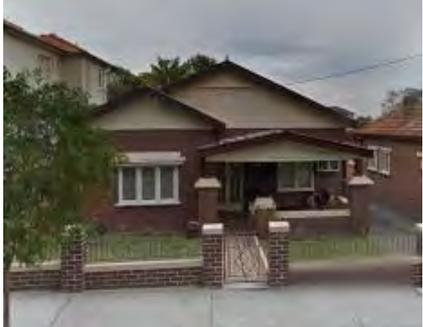
Address	Image	Reason for listing
22 Figtree Avenue, Randwick

<p>Good intact example. However, the streetscape is very heavily modernised, so this item is a bit lost within its wider more modern landscape.</p> <p>Subject to further detailed assessment, it is recommended this property be listed.</p>
222 Coogee Bay Road, Coogee

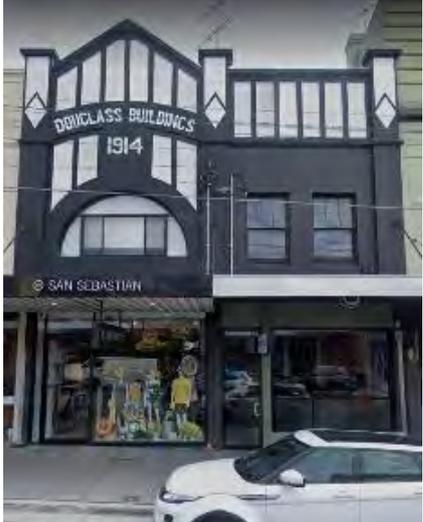
<p>Intact interwar façade in a varied streetscape.</p> <p>Subject to further detailed assessment, it is recommended this property be listed.</p>
23 Dudley St Randwick

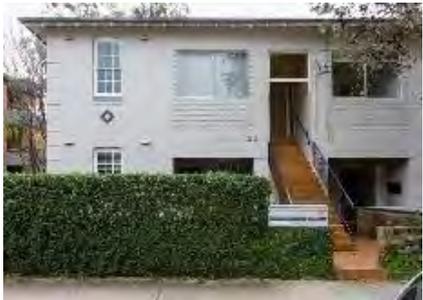
<p>Good example of its type, retaining a number of its original features.</p> <p>Subject to further detailed assessment, it is recommended this property be listed.</p>
230 Coogee Bay Road, Coogee

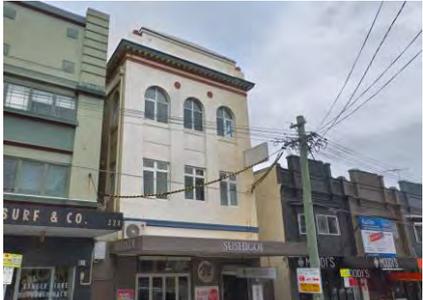
<p>Has decorative features including highly decorative parapet that indicate it could have had an original civic function.</p> <p>Subject to further detailed assessment, it is recommended this property be listed.</p>

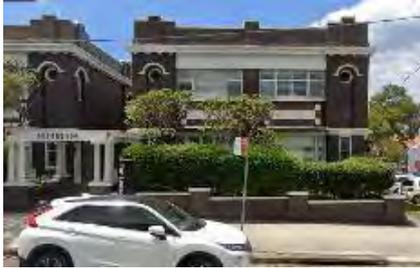
Address	Image	Reason for listing
231 Avoca St, Randwick

<p>Internal photographs show a range of modifications and interventions. Additionally, the present exterior indicates that potentially the front balcony has been enclosed. However, if this is a rare example of this type in the area, it should be listed.</p> <p>Subject to further detailed assessment, it is recommended this property be listed.</p>
237-245 Maroubra Road, Maroubra

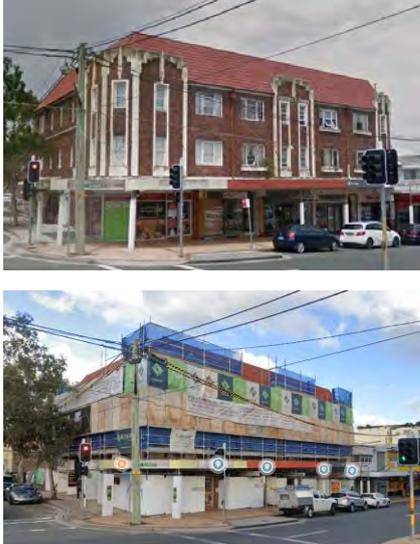
<p>Appears to have a very interesting and detailed façade detailing. Not a typical mixed residential apartment building. May have undergone recent modifications but those could be restorations.</p> <p>Modern streetview imagery suggests the property may be under construction.</p> <p>Recommend further research for potential listing.</p>
24 Eastern Avenue, Kensington

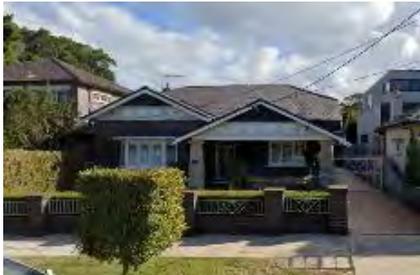
<p>A well-presented, well maintained and highly intact example.</p> <p>Subject to further detailed assessment, it is recommended this property be listed.</p>

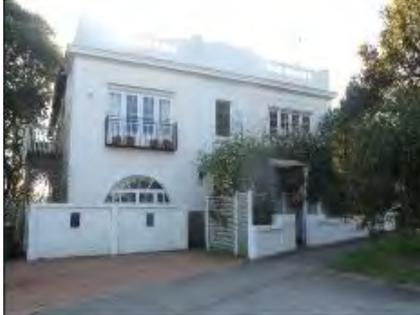
24 Glebe St, Randwick

<p>Internals show a range of modifications and interventions. Additionally, the external present potentially that the front façade is an enclosed balcony. However, if this is a rare example of this type in the area, it should be listed.</p> <p>Recommend further research for potential listing.</p>

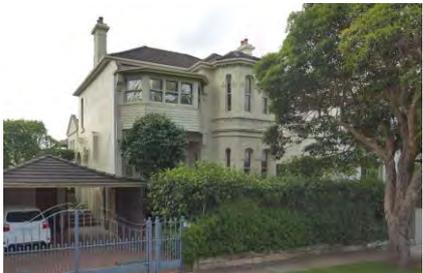
Address	Image	Reason for listing
25 Bishops Avenue, Randwick

<p>Some interesting moulding to the façade, although it is not the best example of its type along Bishops Avenue. No internals available.</p> <p>Recommend further research for potential listing.</p>
25 Duke Street, Kensington

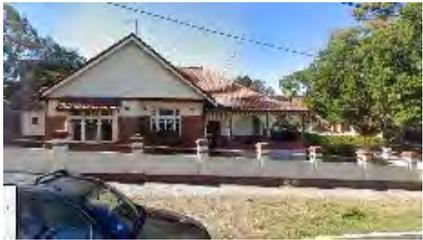
<p>A fine example of its type.</p> <p>Subject to further detailed assessment, it is recommended this property be listed.</p>
25 Mulwarree Ave, Randwick

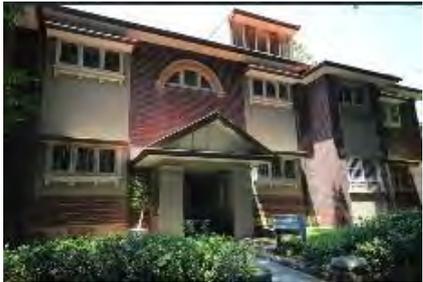
<p>A good example of interwar, art-deco style apartment building with many interesting traditional finishes</p> <p>Subject to further detailed assessment, it is recommended this property be listed.</p>
252 Coogee Bay Road, Coogee

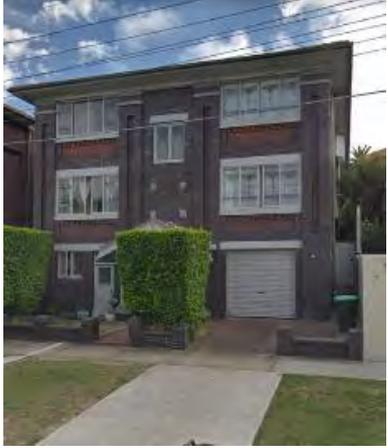
Address	Image	Reason for listing
26 Marcel Ave, Randwick

<p>Very intact features and well-presented externally.</p> <p>Subject to further detailed assessment it is recommended this property be listed.</p>
27 Prince St Randwick

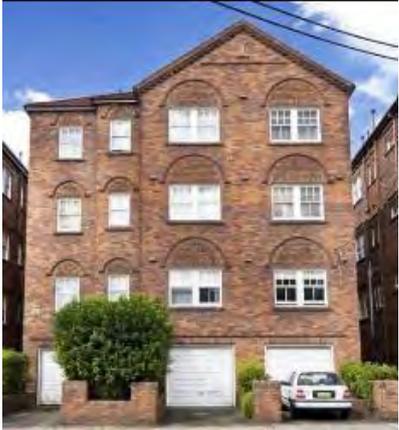
<p>Very intact features and well-presented externally.</p> <p>Subject to further detailed assessment it is recommended this property be listed.</p>
27 The Corso, Maroubra

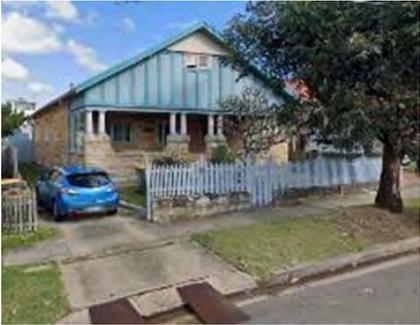
<p>A good example of its type with some interesting, potentially rare traditional finishes.</p> <p>Subject to further detailed assessment it is recommended this property be listed.</p>

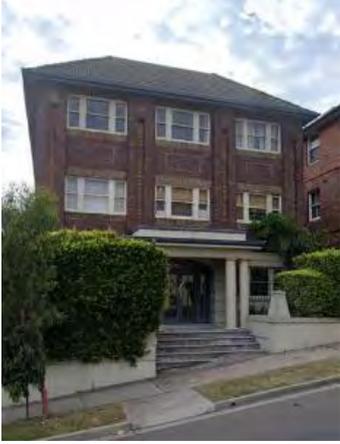
Address	Image	Reason for listing
289 Arden Street, Coogee

<p>Well-presented externally.</p> <p>Subject to further detailed assessment it is recommended this property be listed.</p>
29 Bishops Avenue, Randwick

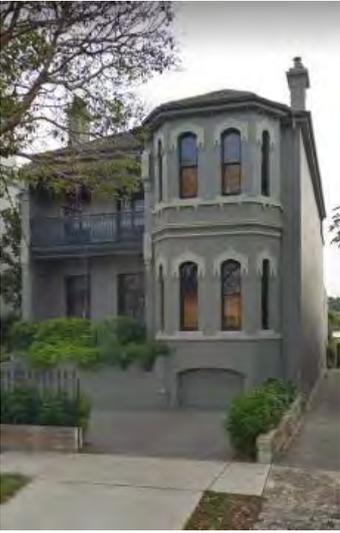
<p>Well-presented externally.</p> <p>Subject to further detailed assessment it is recommended this property be listed.</p>
293 Arden Street, Coogee

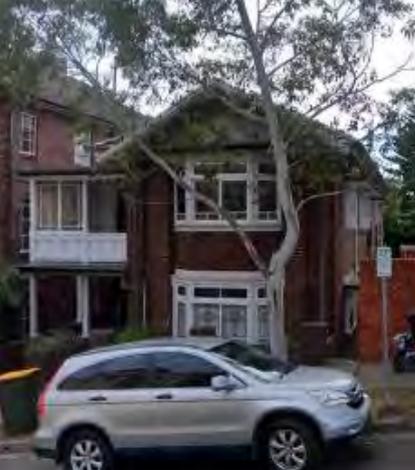
<p>Very intact features and well-presented externally.</p> <p>Subject to further detailed assessment it is recommended this property be listed.</p>

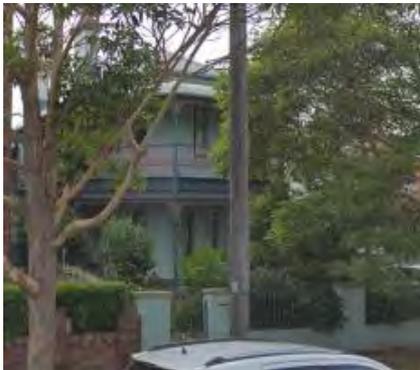
Address	Image	Reason for listing
3 Bishops Avenue, Randwick

Not visible from streetview. Requires further investigation to determine whether it should be listed.
3 Glenwood Ave, Coogee

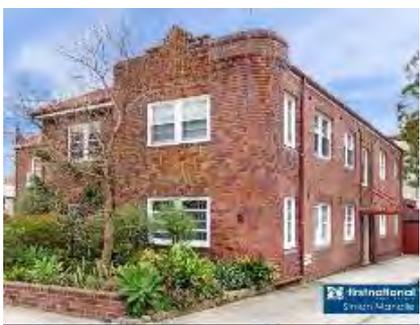
<p>Recommend for listing. Very intact features and well-presented externally. Appears to contribute to a wider streetscape.</p> <p>Subject to further detailed assessment it is recommended this property be listed.</p>
3 Nathan St, Randwick

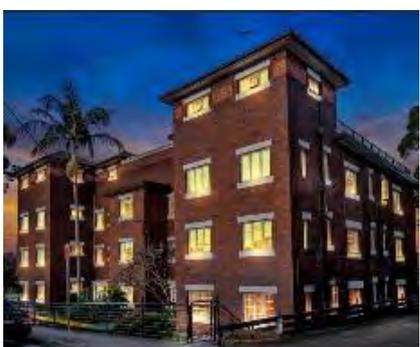
<p>Very intact features and well-presented externally.</p> <p>Subject to further detailed assessment it is recommended this property be listed.</p>
32 Mooramie Avenue, Kensington

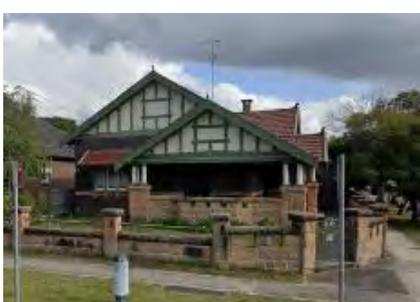
<p>Highly intact internal and external features. Well-presented and maintained, grander than most bungalow style, a good example of its type.</p> <p>Subject to further detailed assessment it is recommended this property be listed.</p>

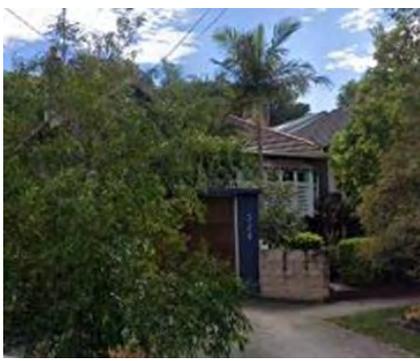
Address	Image	Reason for listing
328 Alison Road, Coogee

<p>The blocks around the sandstone areas already preserved are a good example of early 20th century housing styles and the area may be conserved with that in mind.</p> <p>Further investigation of the streetscape required with the possibility to list N.328 and several other Federation buildings along this street.</p>
34 Eastern Avenue, Kingsford

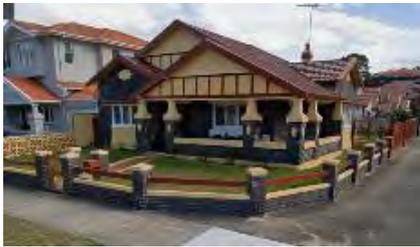
<p>Highly intact external features. Well-presented and maintained, grander than most bungalow style, a good example of its type. Contributes to a very intact surrounding streetscape. Could consider forming a HCA around here.</p> <p>Subject to further detailed assessment it is recommended this property be listed.</p>
3-5 Goodwood Street, Kensington

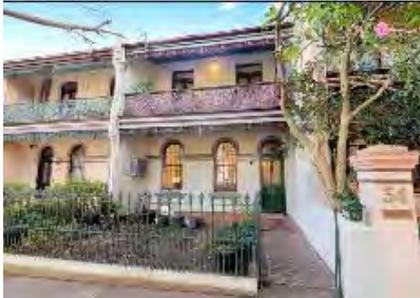
36 Cook St, Randwick

<p>Part of a row of Victorian filigree terraces at Nos 36 – 42.</p> <p>Recommend further investigation of Nos 36-42 for potential listing.</p>
36 Cottenham Avenue, Kensington
