Randwick Heritage Study Volume 1

Heritage Conservation Area Review

Heritage Study Randwick City Council

March 2021—Final

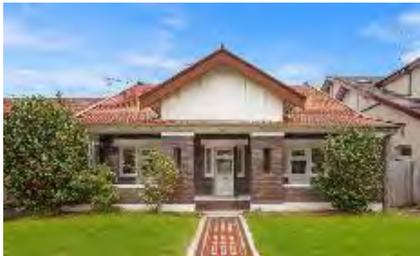
<p>Intact Federation bungalow. In a fair condition.</p> <p>Subject to further detailed assessment it is recommended this property be listed.</p>

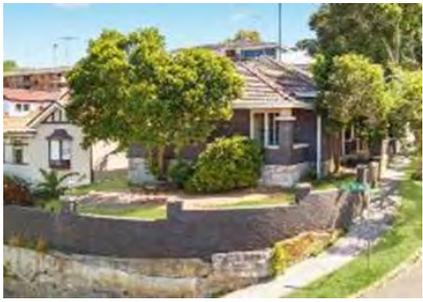
Address	Image	Reason for listing
4 Judge St, Randwick

<p>Prominent siting on top of a rise. Most intact although may have been restored. Further investigation required.</p> <p>Subject to further detailed assessment it is recommended this property be listed.</p>
42a Fern Street, Clovelly

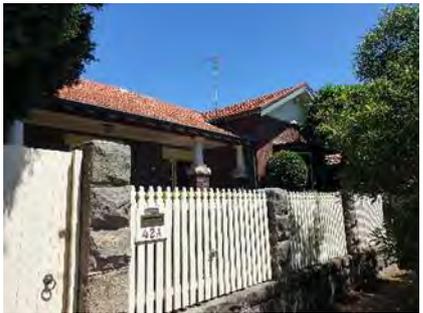
<p>Interesting Federation Bungalow situated quite low on the landscape. In a fair condition.</p> <p>Recommend further research for potential listing.</p>
43 Kyogle Street, Maroubra

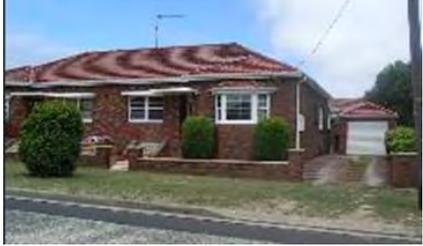
<p>Neat and intact example of a Post-War building. Recommend further investigation as there are few Post-War buildings recognised for their heritage significance on the Randwick LGA. Possibly constructed for housing commission.</p> <p>Subject to further detailed assessment it is recommended this property be listed alongside No. 41.</p>
43 Broome Street, Maroubra

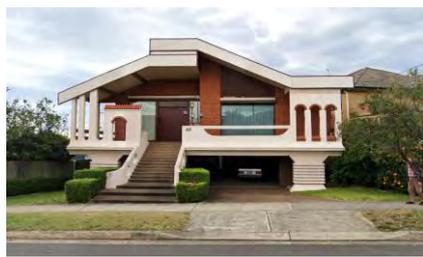
<p>An example of a 1970s modernist style home, rare for the Randwick area.</p> <p>Subject to further assessment it is recommended that this property be listed.</p>

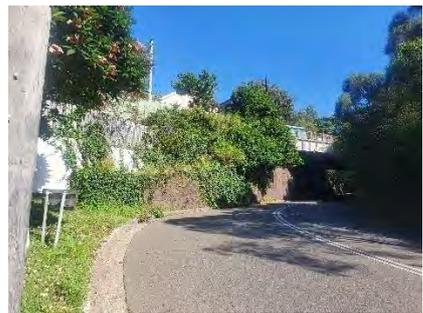
Former tramway fence along both sides of Havelock Avenue, Coogee.

<p>This former tramway fence is situated on either side of Havelock Avenue and extends and passes under Brook Street in the form of a retaining wall.</p> <p>This appears to be a rare element within the LGA, subject to further detailed assessment it is recommended that this element be listed.</p>

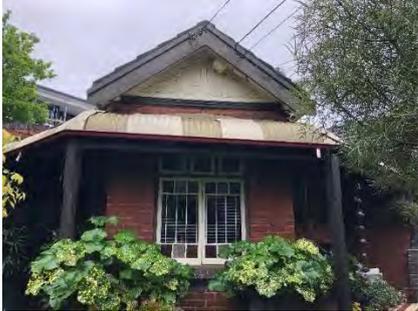
Address	Image	Reason for listing
11-13 Abbotford Street, Kensington

<p>Intact Federation semi-detached dwelling built c.1909. The side entrances and wrap-around bull nosed veranda are unusual additions that make the dwelling a rare example within the style.</p> <p>This forms a pair with 13 Abbotford Street. The property was subject to an expedited heritage assessment due to an existing DA to demolish. It is recommended this property be listed.</p>
5 Berwick Street, Randwick

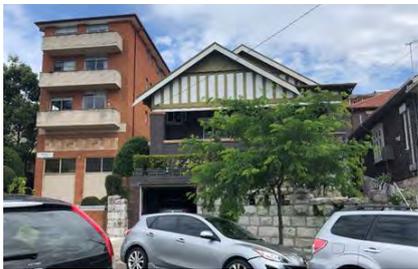
<p>Intact example of an Inter-War Californian Bungalow with intact interiors that exemplifies the principal characteristics of its architectural type.</p> <p>This appears to be rare within the LGA and is recommended it is listed.</p>

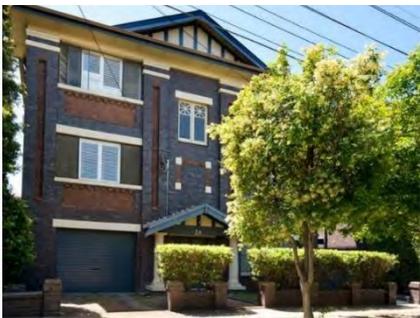
Address (Lot/DP)	Image	HCA
24 Marcel Ave, Randwick (3/SP43075)

<p>These Art Deco style apartments sit close to the north-western boundary of the Moira Crescent HCA. Considering their architectural features align with those outlined in the HCA statement and assessment of significance, it would make sense to extend the northern boundary of the HCA to cover these items.</p>

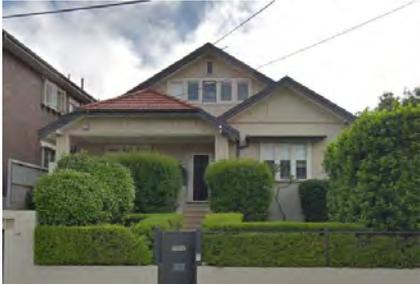
28 Marcel Avenue (8/DP13587)

<p>This Bungalow would therefore be brought into the HCA. The property would act as a neutral item within the new boundary.</p>
15 Marcel Avenue (50/DP318884)

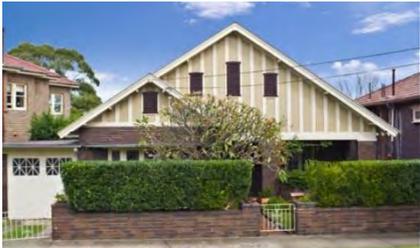
<p>This Federation home would therefore be brought into the HCA. The property would act as a neutral item within the new boundary.</p>

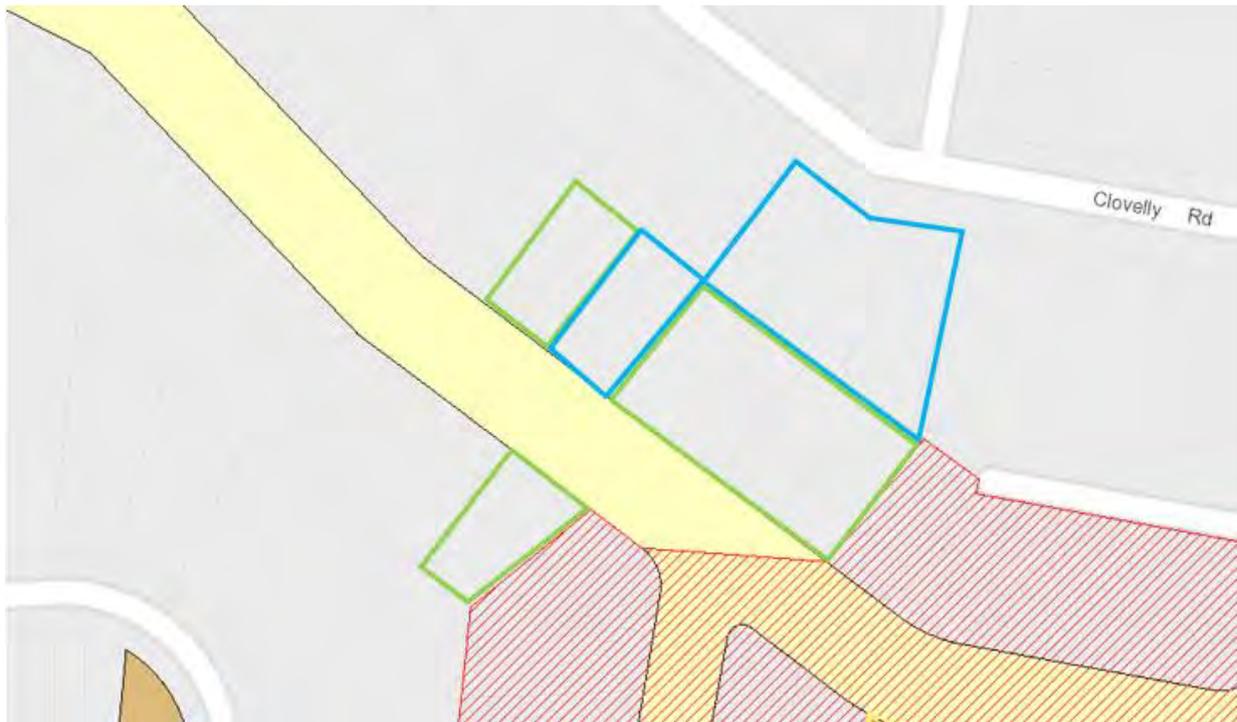
Figure 109 Figure indicating the north-western portion of the current boundary of the Moira Crescent HCA in red hatching, with nominated heritage items in blue and potential contributory and/or neutral items in green.

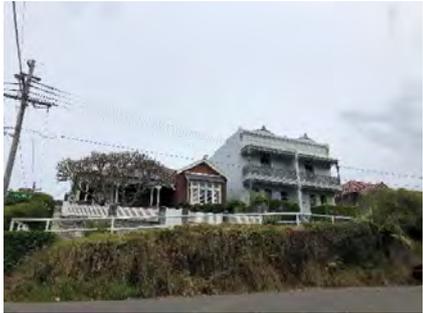
<p>This listed heritage item is located within the North Randwick HCA and consists of a terrace pair and freestanding house.</p> <p>It is recommended this heritage item be split into two separate listings; one for the terrace and one for the Edwardian style corner house, for consistency of items within the precinct.</p>
<p><i>Row of Art Deco flat buildings (I141)</i></p> <p><i>Row of Art Deco flat buildings (I144)</i></p> <p>1-21 Todman Avenue and 1-3 Samuel Terry Avenue (West Kensington)</p>

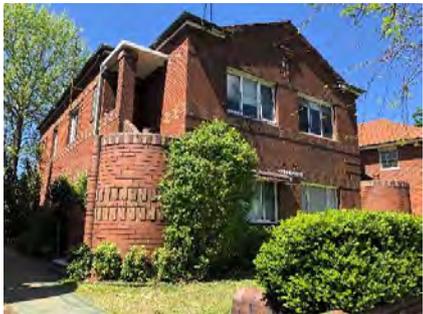
<p>These listed heritage items are located within the West Kensington HCA.</p> <p>It is recommended that the two sets of art deco flat buildings (I144 on Todman Avenue and I141 on Samuel Terry Avenue) be consolidated into the one heritage item for consistency, and to ensure the potential risk of development and/or change to one set of items is minimised</p>

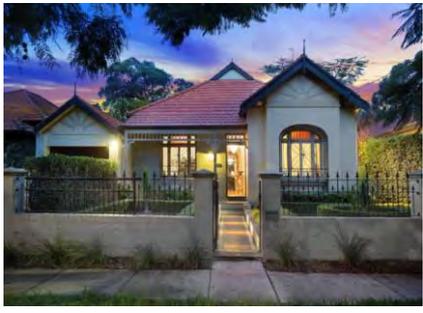
<p>63 Samuel Terry Avenue (West Kensington)</p>

<p>This item is located within the West Kensington HCA.</p> <p>The physical description for 57 Samuel Terry Avenue (I142) mentions that it may be a copy of the house at 63 Samuel Terry Avenue, which is currently unlisted. There is the potential to list this item separately or consolidate both dwellings into the one listing as a matching pair.</p>

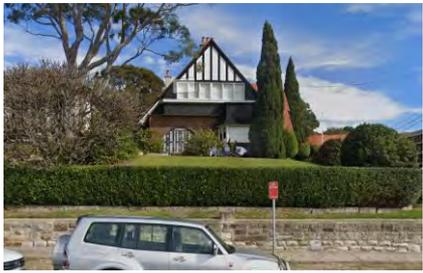
<p>16 Dudley Street for reference</p>	<p>These listed heritage items are located within the Dudley Street HCA. It is recommended that the currently listed items at 16, 18, 20 & 22 Dudley Street are split into four separate items. They are quite different architecturally and with varying levels of intactness.</p>
<p>1 Thomas Street, Coogee (Dudley Street)</p>

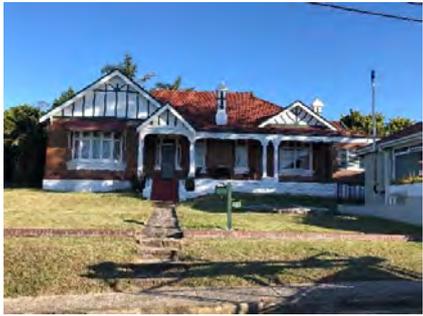
<p>This item is located within the Dudley Street HCA. The address is specifically mentioned as part of the HCA statement of significance; however, the item is not currently individually listed. It is recommended this item be listed.</p>
<p><i>'Bishopcourt' (A1)</i> 21-29 Moira Crescent (Moira Crescent)</p>

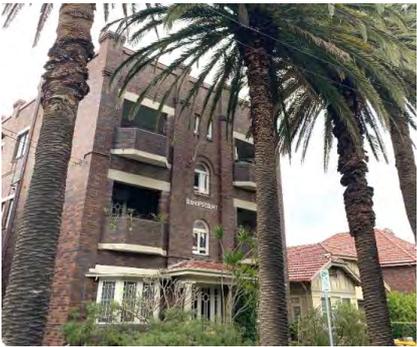
<p>This listed heritage item is located within the Moira Crescent HCA. It should be determined, via a check of Council's records, if the locally listed item Bishopcourt (A1) is purely archaeological or if the building (and associated landscaping) on the site itself should also be protected.</p>

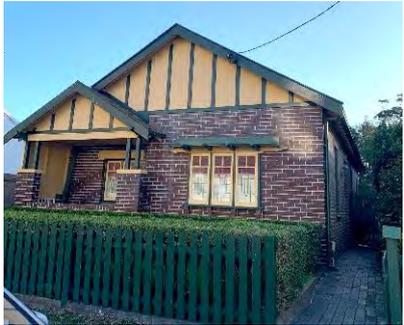
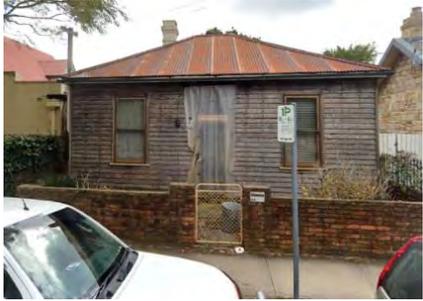
<p><i>'Weatherboard cottage' (I417)</i> 86 Middle Street (Struggletown)</p>

<p>22 Young Street</p>	<p>This listed heritage item is located within the Struggletown HCA. There appears to be an error relating to this item within the SHI database. The listing for 'weatherboard cottage' (I417) gives the address as 22 Young Street, however this is a brick dwelling. It is likely that this listed item is located at 86 Middle Street, Randwick and should be amended as such.</p>

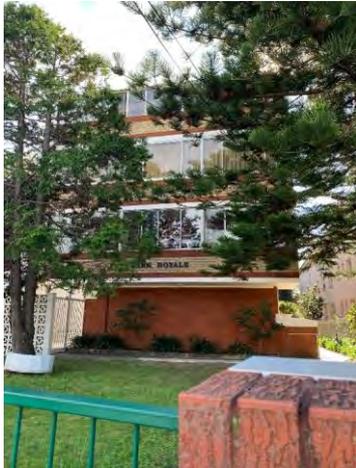
<p data-bbox="949 757 1398 965">There is an opportunity to list underrepresented items within the High Cross HCA, particularly late 20th century development that exhibits Post War/Modernist architectural styles.</p> <p data-bbox="949 987 1382 1155">The property at 2 Coogee Bay Road is a good example of this style and subject to further detailed assessment it is recommended this property be listed.</p>
<p data-bbox="193 1570 355 1664">Street names embedded in footpaths</p> <p data-bbox="193 1686 316 1715">LGA-wide</p>

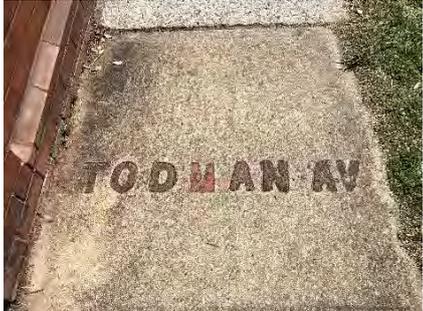
<p data-bbox="497 1552 916 1648"><i>Example of street name embedded in footpath within West Kensington HCA</i></p>

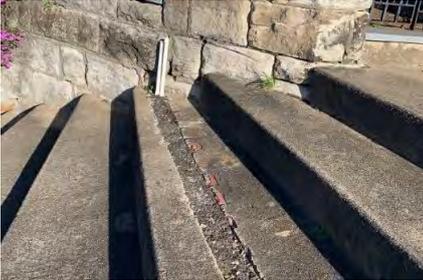
<p data-bbox="497 1973 916 2069"><i>Example of where 'Dudley Street' street name has been impacted for installation of services.</i></p>	<p data-bbox="949 1361 1406 1917">In several HCAs street names have been embedded into the concrete at street intersections. These represent important features of the streetscape and contribute to the character of these precincts. These features are in varying stages of condition, with some having been partly or wholly removed through the installation of services or replacement of sections of footpath. It is recommended that a condition and significance assessment of these elements be undertaken, so effort can be made to protect and conserve these elements for the future.</p>

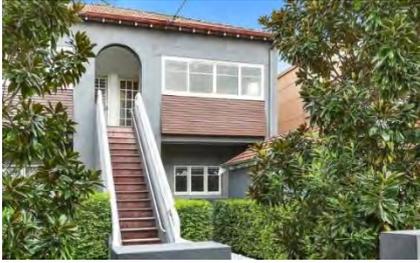
<p>A desktop assessment suggests that the property has been subject to several unsympathetic alterations including rendering of original brickwork and verandah has been enclosed. Few original elements remain.</p> <p>It is not recommended that this property be listed.</p>
146 Rainbow St, Randwick

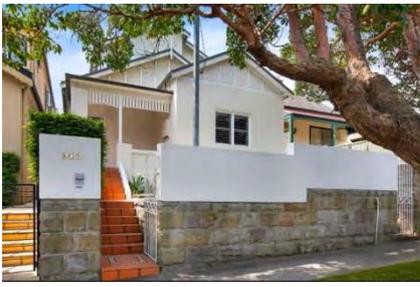
<p>The desktop assessment suggests this house has been extensively renovated, with painting of face brickwork and removal of many original timber elements.</p> <p>It is not recommended that this property be listed.</p>
18 Caerleon Crescent, Randwick

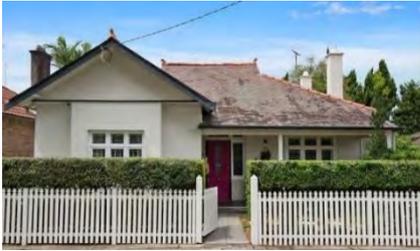
<p>This proposed item is within the Caerleon Crescent HCA.</p> <p>The property has been subject to unsympathetic renovations such as painting of original face brickwork.</p> <p>The general scale and form of the property is protected by the HCA, other than that no distinguishing features suggest it would meet the criteria for local listing. It is not recommended that this property be listed.</p>

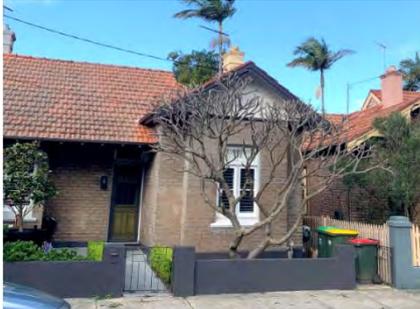
12 Caerleon Crescent, Randwick

<p>This proposed item is within the Caerleon Crescent HCA.</p> <p>It appears some small original timber detailing on the verandah has been removed. The general scale and form of the property is protected by the HCA, other than that no distinguishing features suggest it would meet the criteria for local listing. It is not recommended that this property be listed.</p>

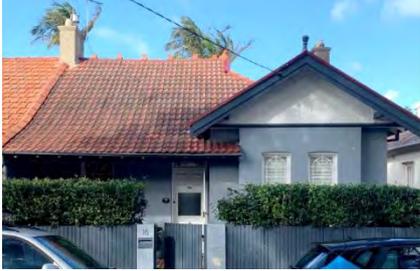
<p>This proposed item is within the Caerleon Crescent HCA.</p> <p>The property has been subject to some unsympathetic renovations such as rendering and painting of original face brickwork.</p> <p>The general scale and form of the property is protected by the HCA, other than that no distinguishing features suggest it would meet the criteria for local listing. It is not recommended that this property be listed.</p>
12 Dutruc Street, Randwick

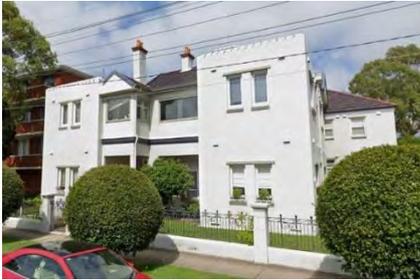
<p>This property is within the St Marks HCA.</p> <p>This large freestanding house has been converted to up to twelve (12) apartments with the addition of two rectangular side wings with castellated parapets.</p> <p>These later additions have concealed much of the original façade.</p> <p>It is not recommended that this property be listed.</p>
13 Wood St, Randwick

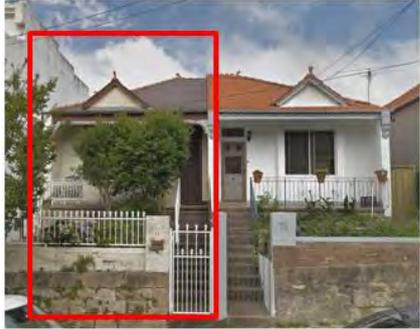
<p>This property is within the St Marks HCA.</p> <p>This address is one half of a pair of semi-detached houses, with features differentiated from the partner house.</p> <p>The dwelling appears to have original roofing; however, the front cast iron fence gate and balustrade appear to be replicas.</p> <p>It is not recommended that this property be listed.</p>

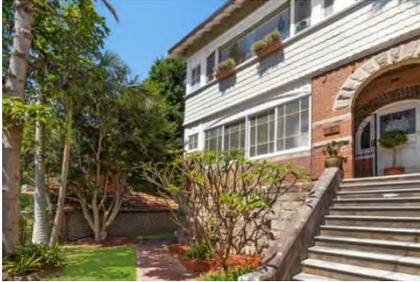
15-19 Mears Ave, Randwick

<p>This property is within the High Cross HCA.</p> <p>The property is a large two-storey Federation house with many original features; however, the upstairs verandah has been enclosed.</p> <p>It is not recommended that this property be listed.</p>
26 Dudley Street, Randwick

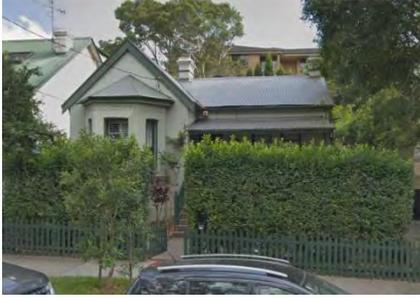
<p>This property is within the St Marks HCA.</p> <p>This house has been repainted blue with white features and has a contemporary rear addition; it is largely concealed from street view by the hedging.</p> <p>It is not recommended that this property be listed.</p>
<p>46 Dudley Street, Randwick</p>

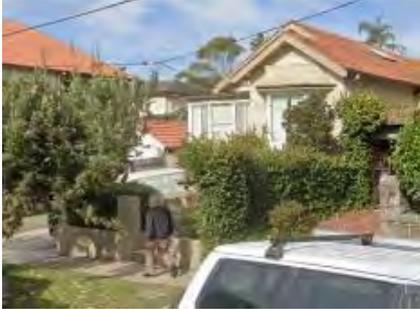
<p>This property is within the Dudley Street HCA.</p> <p>This house is a Federation bungalow, set back from the street and modified at the street frontage.</p> <p>It is not recommended that this property be listed.</p>
<p>9 Frances Street, Randwick</p>

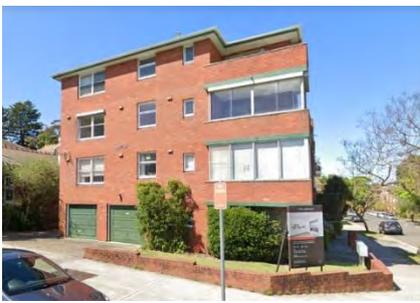
<p>This property is within the St Jude's HCA.</p> <p>The property is a block of mid-century four-storey walk up flats. This type of dwelling is very common in the area and does not exhibit any remarkable features.</p> <p>It is not recommended that this property be listed.</p>

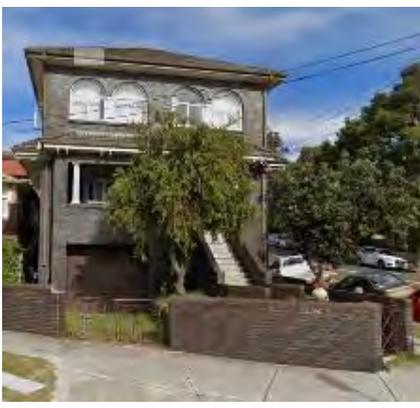
<p>1 Berwick Street, Coogee</p>

<p>No 1 Berwick Street was approved by council in 1925 and built 1926. A three-storey flat building with interesting Art Deco features. It is highly intact and has an interesting corner block siting, however it is not considered to be the most interesting or best example within the LGA.</p> <p>Not recommended for listing.</p>

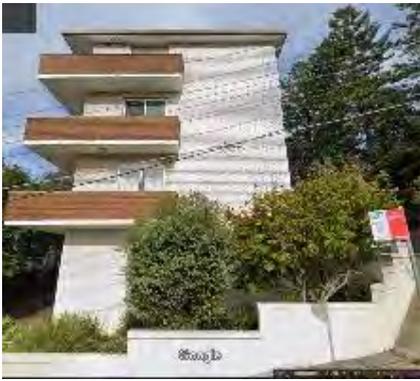
<p>A highly intact Post-War flat, however, the building has minimal streetscape contribution and is not of aesthetic interest. There are many similar style buildings within the Randwick LGA.</p> <p>It is not recommended that this property be listed.</p>
10 Bishops Avenue, Randwick

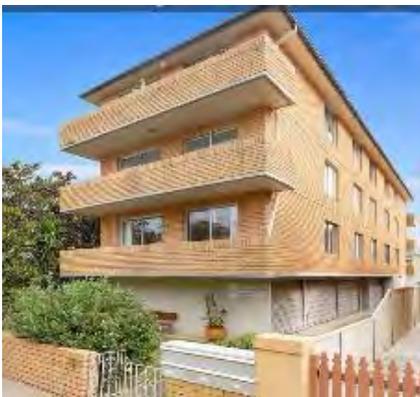
<p>A highly intact Post-War flat, however, the building has minimal streetscape contribution and is not of aesthetic interest. There are many similar style buildings within the Randwick LGA.</p> <p>It is not recommended that this property be listed.</p>
10 Canberra Street, Randwick

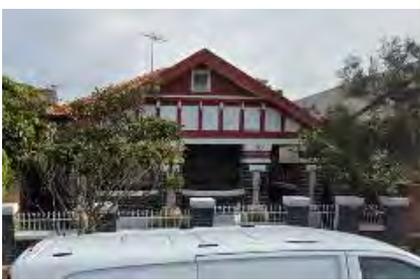
<p>Intact Californian Bungalow single-storey dwelling. Painted to a new colour scheme and new fence. There are better and more intact examples of this architectural style in the Randwick LGA.</p> <p>It is not recommended that this property be listed.</p>

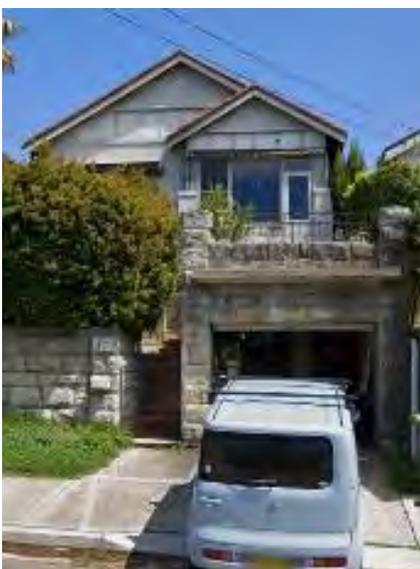
10 Heath Street, Randwick

<p>A collection of federation bungalows set above the street scape. Interesting collection of houses that are mostly intact with some unsympathetic additions. While the streetscape is notable for the sandstone walls and garages, the houses vary in levels of intactness, condition, and integrity. There are better examples within the Randwick LGA.</p> <p>It is not recommended that this property be listed.</p>

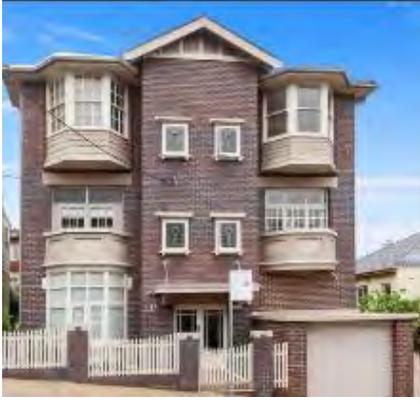
<p>A three storey Art-Deco flat building with some interesting features. Although highly intact, the house has been painted to a new colour scheme and there are better examples in the Randwick LGA.</p> <p>It is not recommended that this property be listed.</p>
102 Mount St, Coogee

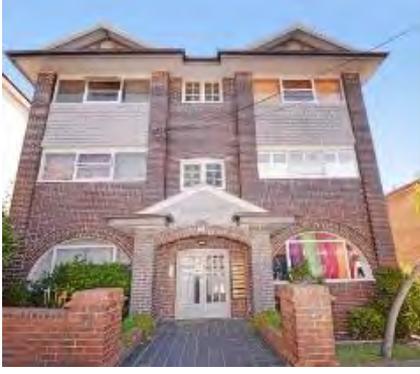
<p>Art Deco flat that is mostly intact, although some windows have been replaced. There are better and more intact examples of this architectural style in the Randwick LGA.</p> <p>It is not recommended that this property be listed.</p>
11 Bradley Street, Randwick

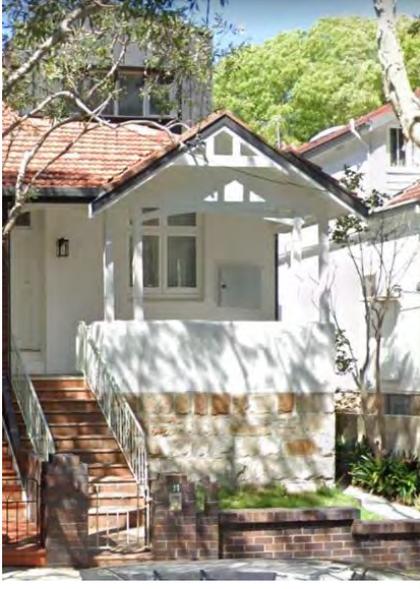
<p>A highly modified Federation Style Semi-detached house with large, intrusive second storey addition. Painted in an unsympathetic colour scheme.</p> <p>It is not recommended that this property be listed.</p>

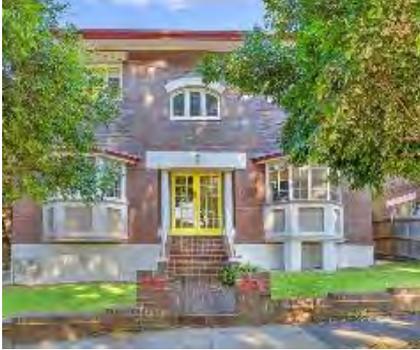
<p>A three storey Art-Deco flat building with some interesting features. Although highly intact, the house has some elements replaced and there are better examples in the Randwick LGA.</p> <p>It is not recommended that this property be listed.</p>
11 Wansey Rd, Randwick

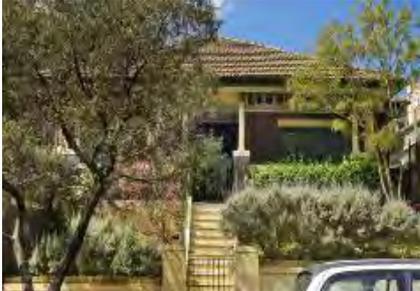
<p>A Federation style bungalow with some original fabric, however boundary fence has been replaced. Does not have an overly impressive streetscape contribution and is a common style with better examples in the Randwick LGA.</p> <p>It is not recommended that this property be listed.</p>
110 Beach St, Coogee

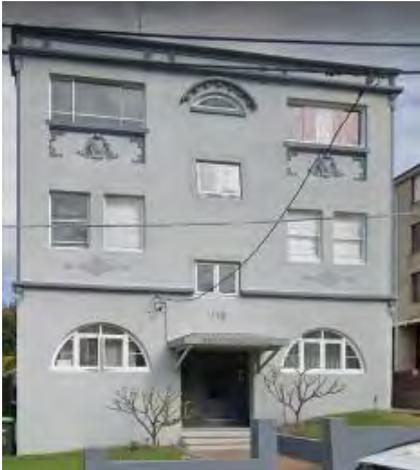
<p>A three storey Art-Deco flat building with some interesting features. Although highly intact, the house has some elements replaced and there are better examples in the Randwick LGA.</p> <p>It is not recommended that this property be listed.</p>

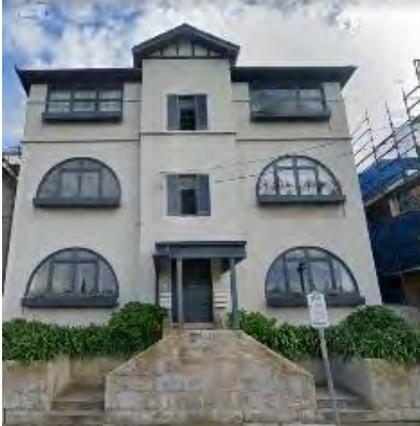
111 Dolphin Street Randwick

<p>A three storey Art-Deco flat building with some interesting features. Although highly intact, the house has some elements replaced and repainted. There are better examples in the Randwick LGA.</p> <p>It is not recommended that this property be listed.</p>

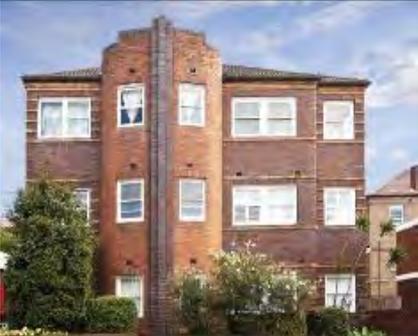
Address	Image	Reason for decision not to list
118 Brook St, Coogee

<p>Art deco apartment building in the vicinity of many blocks of art deco flats. There is already a similar heritage item along Coogee Bay Road in the vicinity. Internal photos seem to be more modern, not a lot of art deco trimming. There are better examples of this architectural style.</p> <p>It is not recommended that this property be listed.</p>
12 Dudley St Randwick

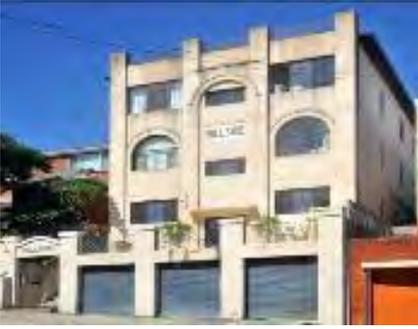
<p>Art deco/P&O style apartments 'Hillside', in a poor condition. There are better examples of this architectural style in the Randwick LGA.</p> <p>It is not recommended that this property be listed.</p>
12 George St, Randwick

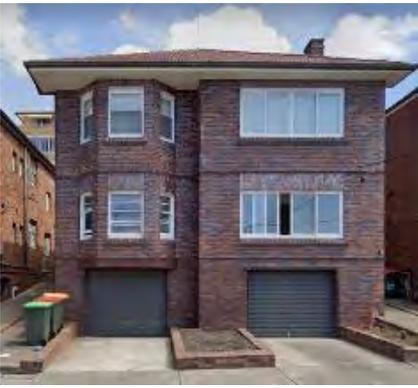
<p>A two storey Art-Deco flat building with some interesting features. Although highly intact, the house has some elements replaced. There are better examples in the Randwick LGA.</p> <p>It is not recommended that this property be listed.</p>

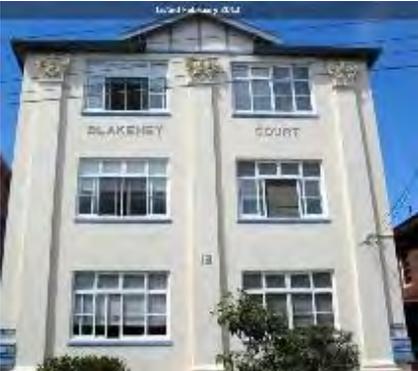
12 Kidman St, Randwick

<p>Three-storey Art Deco flat, which has interesting classical pilasters to the façade. Appears highly intact, although has been recently repainted. The item is very similar to many Art-Deco buildings in the Randwick LGA and is not an interesting example of its type.</p> <p>It is not recommended that this property be listed.</p>

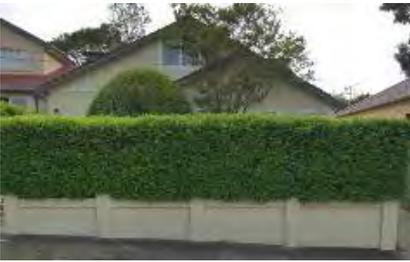
Address	Image	Reason for decision not to list
12 Marcel Ave, Randwick

<p>A highly modified Californian Bungalow with verandah infilled, and a large rear extension.</p> <p>It is not recommended that this property be listed.</p>
12 Moira Cres, Randwick

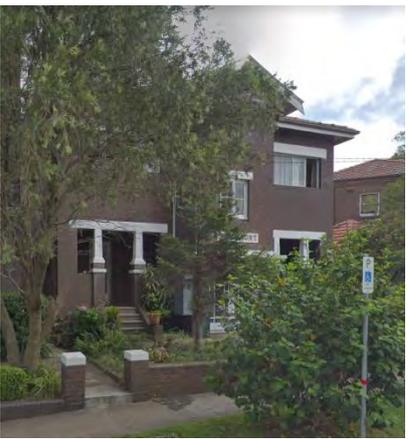
<p>A two storey Art-Deco flat building with some interesting features. While highly intact, this building is afforded adequate protection as a part of the Moira Crescent HCA.</p> <p>It is not recommended that this property be individually listed.</p>
12 St Luke St, Randwick

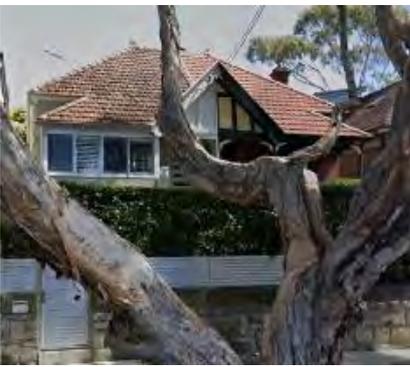
<p>One half of a semi-detached Federation house. Only No. 12 would be considered intact with No. 14 being highly modified. This would only be recommended for listing if both halves of the semi were highly intact.</p> <p>It is not recommended that this property be listed.</p>
125 Mount St, Coogee

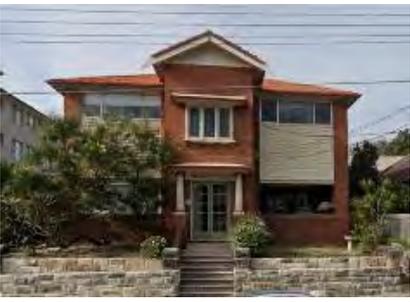
<p>Modified two-storey Federation style flat. Interesting stained glass and shingles, however, there is evidence of infilling to the balconies and verandahs.</p> <p>It is not recommended that this property be listed.</p>

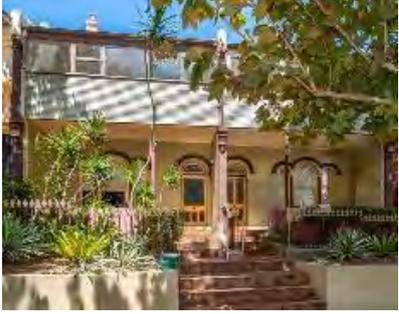
Address	Image	Reason for decision not to list
129 Alison Rd, Randwick

<p>Highly modified group of terraces. Balconies are infilled and minimal architectural features remain. Of low integrity.</p> <p>It is not recommended that this property be listed.</p>
131 Alison Rd, Randwick

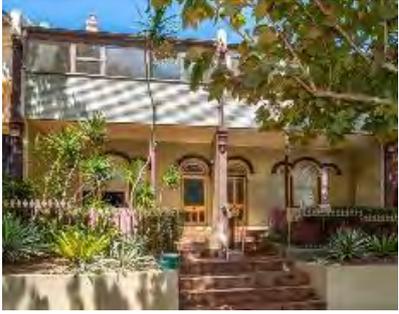
<p>Highly modified group of terraces. Balconies are infilled and minimal architectural features remain. Of low integrity.</p> <p>It is not recommended that this property be listed.</p>
14-16 Kurrawa Ave, Randwick

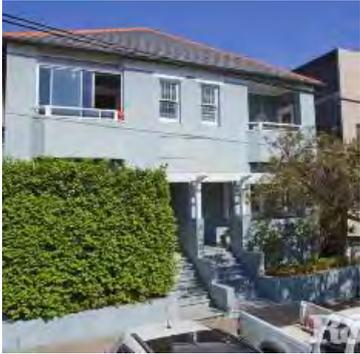
<p>A two storey Art-Deco flat building with some interesting features. Although highly intact, the house has been painted to a new colour scheme and there are better examples in the Randwick LGA.</p> <p>It is not recommended that this property be listed.</p>
14A Carr St, Randwick

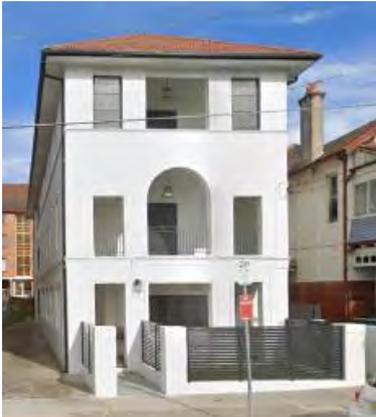
<p>Façade of this item has been rendered and all features that would contribute to this building's architectural style have been removed. It is no longer identifiable as an Art Deco building.</p> <p>It is not recommended that this property be listed.</p>

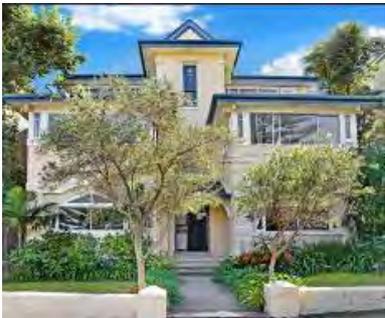
Address	Image	Reason for decision not to list
15 Baden St, Coogee

<p>Spanish mission style apartment building. Has been recently renovated internally and on the exterior, the verandahs and balconies have been infilled. Highly modified. There are better examples in the Randwick LGA.</p> <p>It is not recommended that this property be listed.</p>
15 Chatham St, Randwick

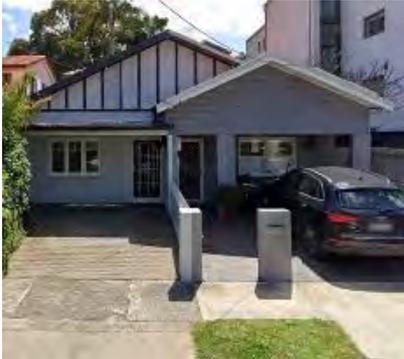
<p>A highly modified Californian bungalow that has been spilt into two residences. Repainted and has lost its integrity. There are better examples of this architectural style in the Randwick LGA.</p> <p>It is not recommended that this property be listed.</p>
15 Kurrawa Ave, Randwick

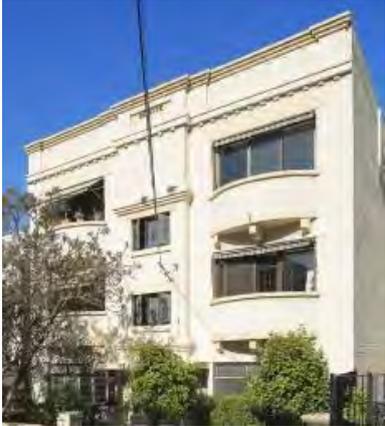
<p>Three-storey Art Deco flats. While there are some interesting features there are more impressive and better maintained art deco buildings in the area.</p> <p>It is not recommended that this property be listed.</p>
15 Waltham St, Randwick

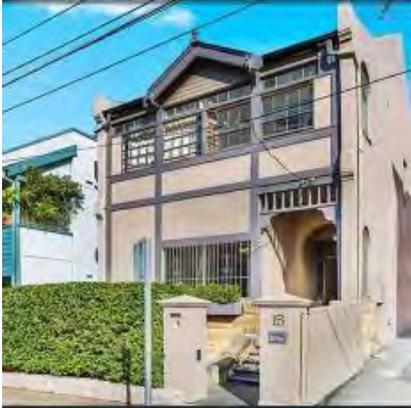
<p>Federation style terrace house repainted between 2009 and 2014. Internal fireplaces, cornices, and timber details appear to be original. The terrace has an infilled verandah and balcony and has lost the majority of details from the façade.</p> <p>It is not recommended that this property be listed.</p>

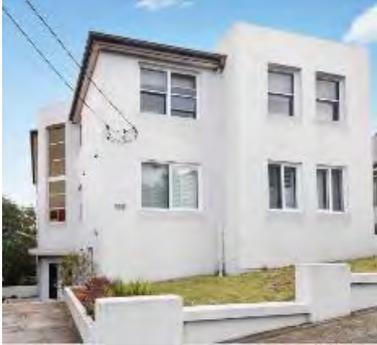
Address	Image	Reason for decision not to list
150 Arden Street, Coogee

<p>This building has no integrity as an Art Deco apartment and has a highly modified and unsympathetic exterior. Most windows have been replaced.</p> <p>It is not recommended that this property be listed.</p>
15A Vicar St, Coogee

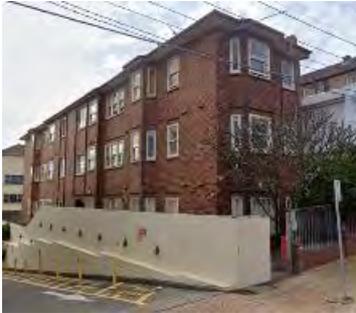
<p>Art deco apartment complex with decorative brickwork on the north elevation. Internal fireplaces are intact. Much less striking than the other art deco apartment buildings in the Randwick LGA. There are better examples in the area.</p> <p>It is not recommended that this property be listed.</p>
16A Coogee St, Randwick

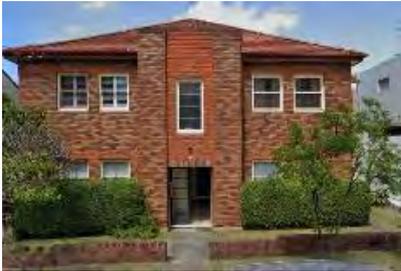
<p>An art deco apartment, built in 1946, containing only four apartments in a replication of semi-detached homes. There are better examples of this style in the Randwick LGA.</p> <p>It is not recommended that this property be listed.</p>
17 Marcel Ave, Randwick

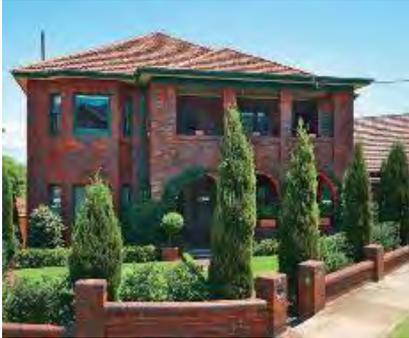
<p>Highly intact Art Deco flat on prominent corner siting. Excellent streetscape contribution within the Moira Crescent HCA. Afforded adequate protection as a part of this HCA.</p> <p>It is not recommended that this property be individually listed.</p>

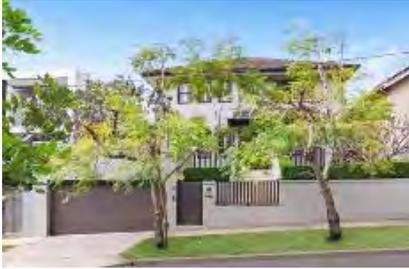
17 Wansey Rd, Randwick

<p>Highly modified 1930's house that has been expanded and renovated and no longer is identifiable in its architectural style.</p> <p>It is not recommended that this property be listed.</p>

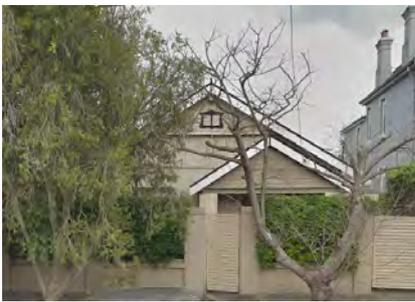
Address	Image	Reason for decision not to list
18 Bishops Avenue, Randwick

<p>No. 18 is a Californian Bungalow that has been modified with a large rear extension.</p> <p>It is not recommended that this property be listed.</p>
18 Botany St, Randwick

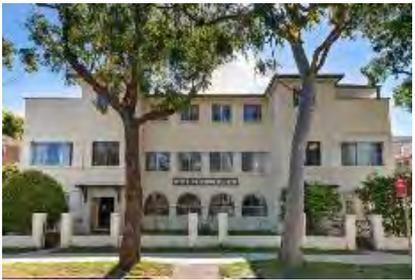
<p>Built in 1930, this is an apartment complex with a prominent streetscape contribution. Rooms have high and decorative ceiling. Some intact and original windows although many have been replaced. There are better examples in the Randwick LGA.</p> <p>It is not recommended that this property be listed.</p>
18 Glebe St, Randwick

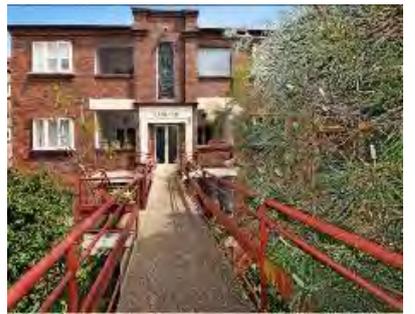
<p>Art deco apartment building with leadlight windows over front door and elaborate brickwork façade. There are better examples in the Randwick LGA.</p> <p>It is not recommended that this property be listed.</p>
19 Endeavour Avenue, La Perouse

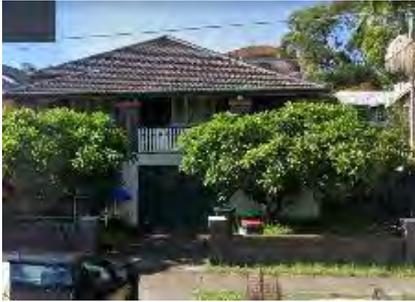
<p>1920s California style bungalow, one of only two intact remaining in this block (other is a heritage item at 27 Goorawahl)</p> <p>Internal fireplaces, ceiling decorations, windows all seem to be original, although have been painted and are disused. Modified façade with some 90s faux heritage additions. It is not recommended that this property be listed.</p>

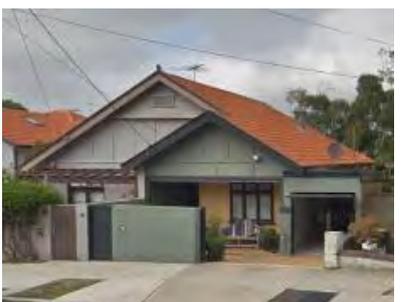
194 Clovelly Road, Randwick

<p>Modified Californian Bungalow with that has been split into two separate residences. Painted to an unsympathetic colour scheme with several unsympathetic modifications.</p> <p>It is not recommended that this property be listed.</p>

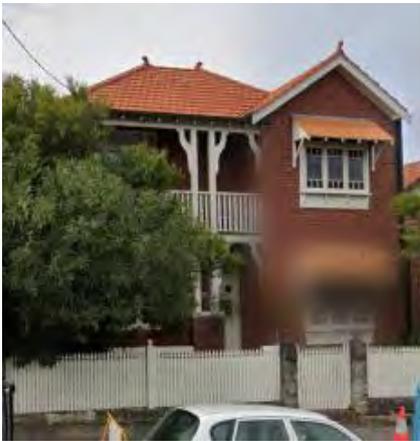
Address	Image	Reason for decision not to list
<p>47 Canberra Street, Randwick</p>

<p>Two storey residence, no internal photos available. Leadlight windows, tapered timber veranda posts. Some fabric does not seem original/ A typical example of its style that is better represented by other examples in the LGA. It is not recommended that this property be listed.</p>
<p>48 Beach St, Coogee</p>

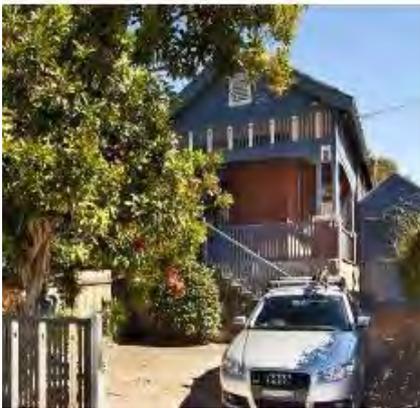
<p>Federation semi-detached cottage with high decorative ceilings, stone fireplace, transom windows. Some of the outside fabric seems new, notably the gable decorations This is a typical example of its style that is better represented by other examples in the LGA. It is not recommended that this property be listed.</p>
<p>5 Farnham Ave, Randwick</p>

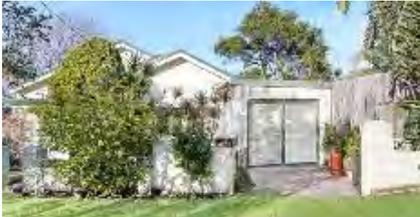
<p>A poor, modified example of an Inter-War house. This style is better represented by other examples in the LGA. It is not recommended that this property be listed.</p>

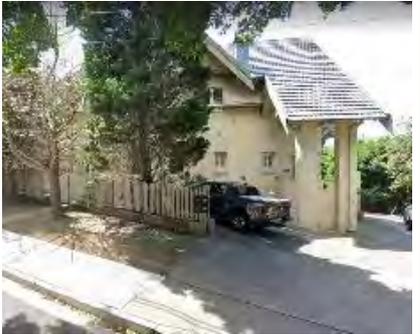
<p>5 Glebe St, Randwick</p>

<p>High ceilings and decorative cornices, timber floor, fireplaces, large distinctive archway shaped glass door. While the property is an impressive, Federation residence, it has been converted into apartments and highly modified. It is not recommended that this property be listed.</p>

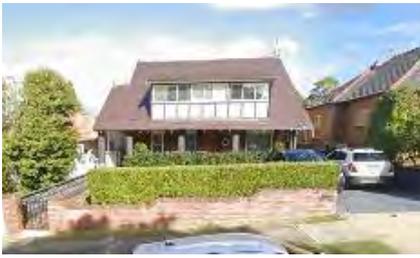
Address	Image	Reason for decision not to list
5 Roma Avenue, Kensington

<p>Highly modified Federation bungalow. Some unsympathetic features and quite modified.</p> <p>It is not recommended that this property be listed.</p>
50 Carr St, Randwick

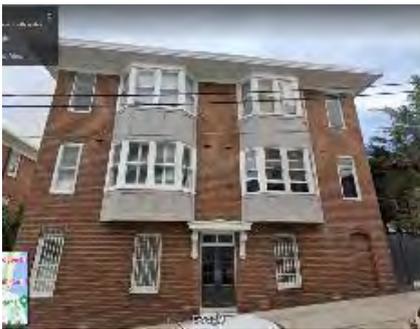
<p>Inter-War apartment - mixed residential with commercial lower ground. There are better examples in the Randwick LGA.</p> <p>It is not recommended that this property be listed.</p>
54 Bream St, Coogee

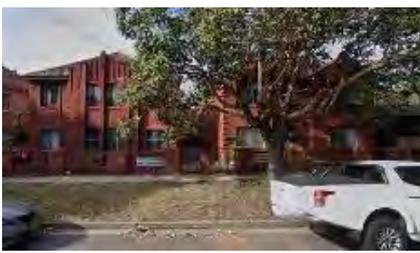
<p>Red brick art deco apartment building with decorative brickwork façade. No distinctive internal features.</p> <p>A typical example of its style that is better represented by other examples in the LGA. It is not recommended that this property be listed.</p>
55 Bream St, Coogee

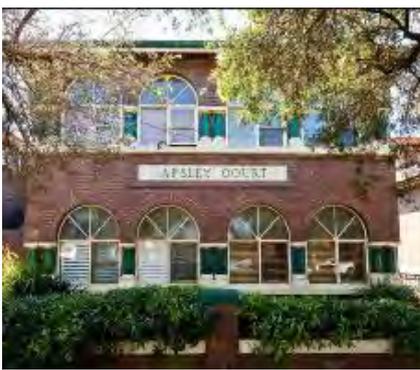
<p>Building seems to be art deco but with hints of classical revival architecture (columns, hipped roof, arch windows) Decorative high ceilings, decorative door and window frames, timber floor</p> <p>A typical example of its style that is better represented by other examples in the LGA. Original coloured, glazed windows to façade replaced.</p> <p>It is not recommended that this property be listed.</p>

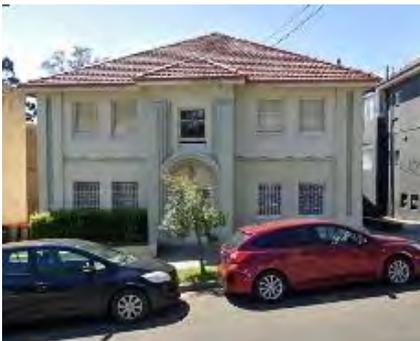
55 Clovelly Rd, Randwick

<p>Rendered art deco apartment building, façade clearly contains art deco motifs in the pillars on the walls. Internals seem to be standard</p> <p>A typical example of its style that is better represented by other examples in the LGA. It is not recommended that this property be listed.</p>

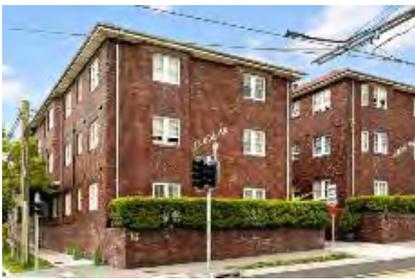
Address	Image	Reason for decision not to list
56 High St, Randwick

<p>A typical example of an Art Deco apartment block that is better represented by other examples in the LGA.</p> <p>It is not recommended that this property be listed.</p>
6 Daintrey Cres, Randwick

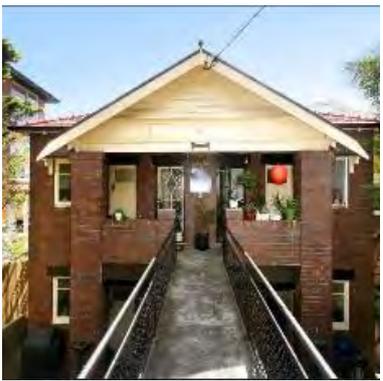
<p>Art deco apartment building, little is visible from the street. Dark brick façade, no decorative brickwork, or windows on the outside. Internally, timber floors, fireplaces, leadlight windows, decorative door frames and transom windows</p> <p>It is not recommended that this property be listed. A typical example of its style, better represented by other examples in the LGA.</p>
6 Fern St, Randwick

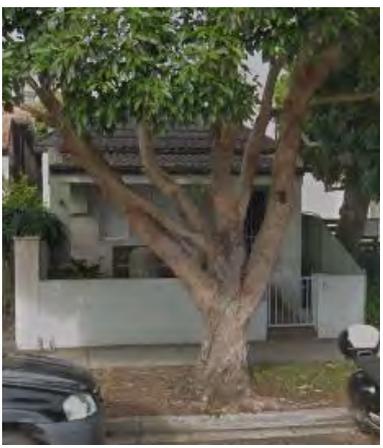
<p>Minimal original fabric remaining to warrant it being heritage. No longer identifiable as a specific architectural style.</p> <p>It is not recommended that this property be listed.</p>
63a Dudley St Randwick

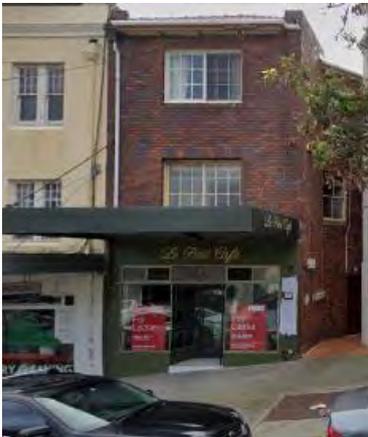
<p>A common Inter-War residential building with ground floor retail. No significant aesthetic qualities that would deem it of aesthetic significance. The interior appears to have been renovated.</p> <p>It is not recommended that this property be listed.</p>

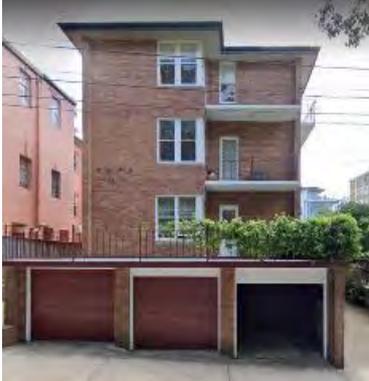
Address	Image	Reason for decision not to list
6-8 Milford Street, Randwick

<p>This property is within the High Cross HCA.</p> <p>The property is a block of mid-century four-storey walk up flats. This type of dwelling is very common in the area and does not exhibit any remarkable features.</p> <p>It is not recommended that this property be listed.</p>
7 Waltham St, Randwick

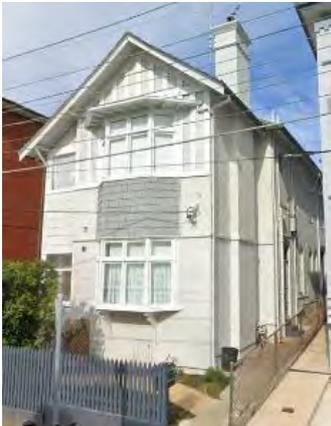
<p>This dwelling, a freestanding house, has been split into four separate apartments.</p> <p>While few original details remain, this property has been extensively altered and there are better examples of this architectural style elsewhere in the LGA.</p> <p>It is not recommended that this property be listed.</p>
72 Dolphin Street Randwick

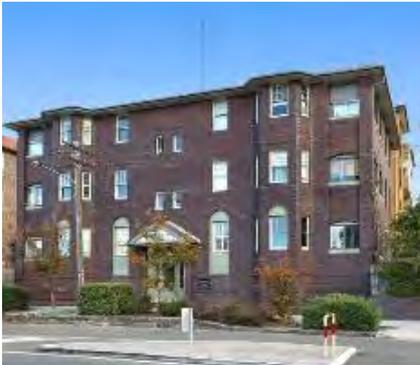
<p>This property is a dark-brick apartment building containing elements of the Art Deco style. While some original features remain and the decorative brickwork to the façade is aesthetically pleasing, there are better examples of this style elsewhere in the LGA, particularly within Moira Crescent.</p> <p>It is not recommended that this property be listed.</p>

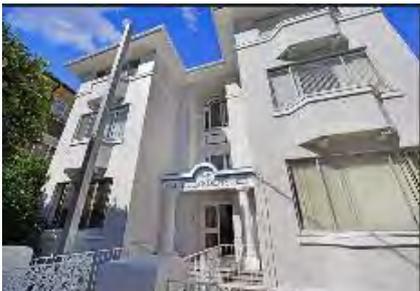
74 Bream St, Coogee

<p>Art deco apartment block, bricks painted white. High, decorative ceilings, decorative trim around the rooms. Windows replaced.</p> <p>While this property contains some original decorative elements such as decorative brickwork, this type of dwelling is common in the area and does not exhibit any remarkable features. There are better representative examples of this style in the LGA.</p> <p>It is not recommended that this property be listed.</p>

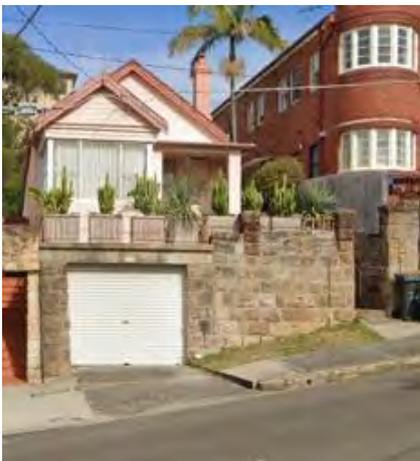
Address	Image	Reason for decision not to list
74 Dudley St Randwick

<p>Inter-War house, whitewashed walls on a sandstone elevation</p> <p>While this property contains some original decorative elements such as decorative brickwork and windows, this type of dwelling is common in the area and does not exhibit any remarkable features. There are better representative examples of this style in the LGA.</p> <p>It is not recommended that this property be listed.</p>
76 Bream St, Coogee

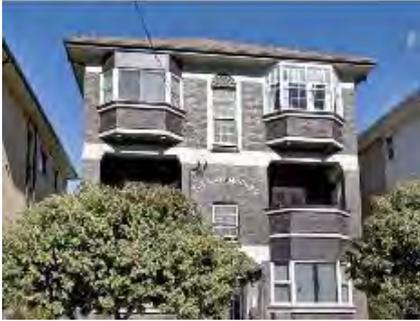
<p>Art deco building, dark brick, bay windows, decorative arch window</p> <p>High, decorative ceilings, timber floors</p> <p>While this property contains some original decorative elements such as decorative brickwork and windows, this type of dwelling is common in the area and does not exhibit any remarkable features. There are better representative examples of this style in the LGA.</p> <p>It is not recommended that this property be listed.</p>

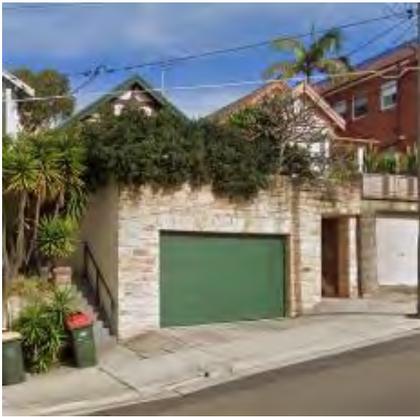
76 Dudley St Randwick

<p>Californian Bungalow that has been modified. Not overly visible from the street. While this property contains some original decorative elements such as decorative brickwork and windows, this type of dwelling is common in the area and does not exhibit any remarkable features. There are better representative examples of this style in the LGA.</p> <p>It is not recommended that this property be listed.</p>

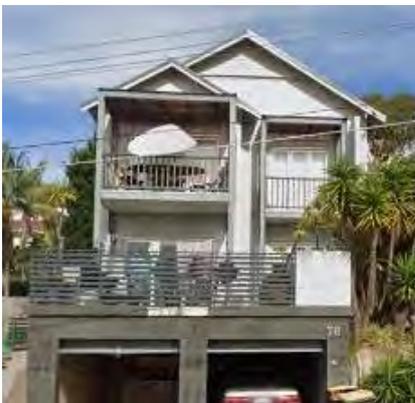
<p>This building is highly modified and no longer and contains minimal historic fabric.</p> <p>It is not recommended that this property be listed.</p>
8 Stanley St, Randwick

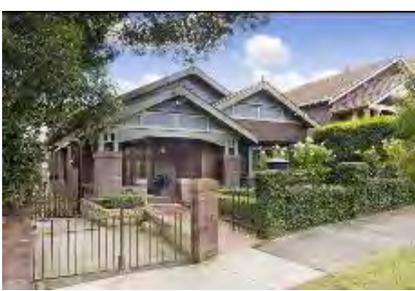
<p>While this property contains some original decorative elements such as decorative brickwork and windows, this type of dwelling is common in the area and does not exhibit any remarkable features. There are better representative examples of this style in the LGA.</p> <p>It is not recommended that this property be listed.</p>
85 Beach St, Coogee

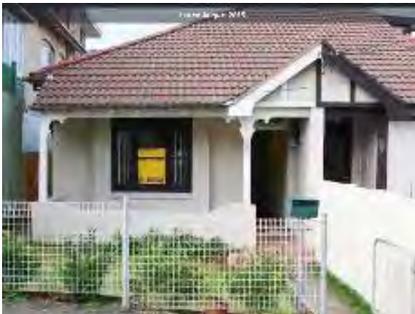
<p>This address is one half of a pair of semi-detached houses, with features differentiated from the partner house. While this address appears more intact than its counterpart at No. 87, little original timber detailing remains, and the front window appears to be a replacement.</p> <p>It is not recommended that this property be listed.</p>

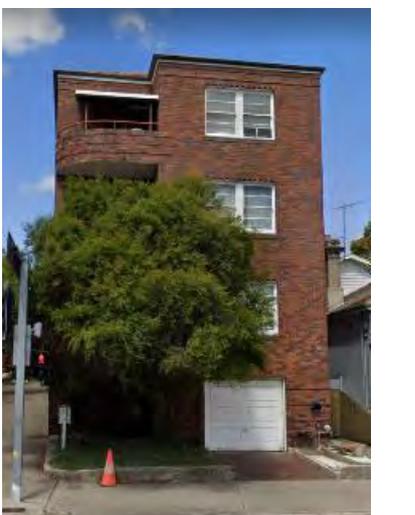
85 Coogee Bay Road, Coogee

<p>The property is a four storey walk up apartment. While this property contains some original decorative elements such as decorative brickwork and windows, this type of dwelling is common in the area and does not exhibit any remarkable features. There are better representative examples of this style in the LGA.</p> <p>It is not recommended that this property be listed.</p>
