Randwick Heritage Study Volume 1

Heritage Conservation Area Review

Heritage Study Randwick City Council

March 2021—Final

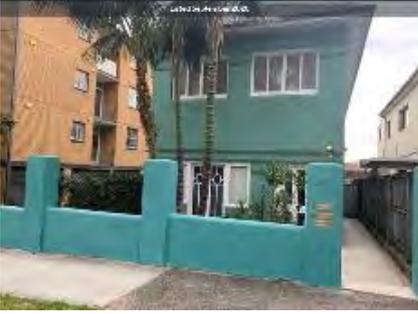
Address	Image	Reason for decision not to list
87 Gilderthorpe Ave, Randwick

<p>The property is a duplex apartment in the Art Deco style. While some elements such as leadlight glass is intact, this type of dwelling is very common in the area and does not exhibit any remarkable features.</p> <p>It is not recommended that this property be listed.</p>
9 St Paul St, Randwick

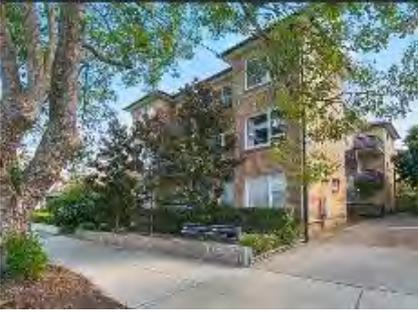
<p>An intact Post-War apartment. Not an interesting or unique example of its type. There are better, more interesting post-war apartments within the LGA. Originally submitted as '9 Paul Street' we assume this is the correct address.</p> <p>It is not recommended that this property be listed.</p>
96a Dudley St Randwick

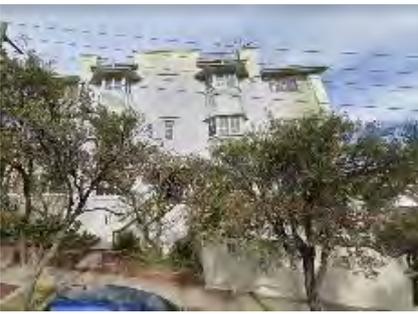
<p>While this building does contain some intact features, such as timber shingled-bay windows and wrought iron balustrades, it appears as if several unsympathetic additions have been made to the property and some original detailing has been removed.</p> <p>It is not recommended that this property be listed.</p>

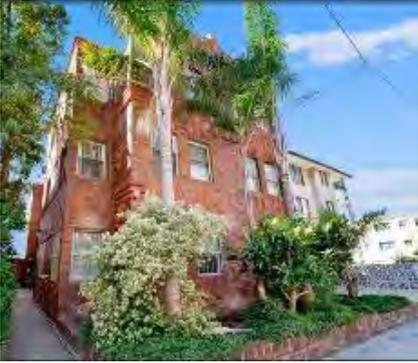
98 Coogee Bay Road, Coogee

<p>While this building does contain an intact decorative brickwork façade to the street, there are better representative and more intact examples of this style in the Randwick area.</p> <p>It is not recommended that this property be listed.</p>

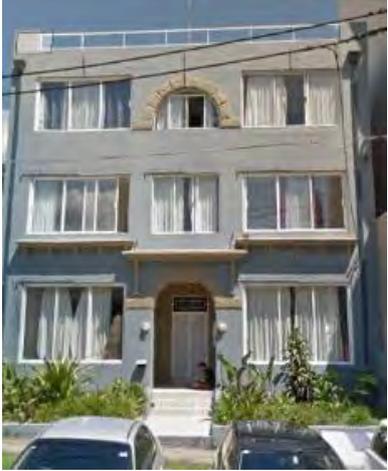
Address	Image	Reason for decision not to list
2 Kurrawa Ave, Randwick

<p>The exterior architectural features are not strongly representing the art-deco theme. They are not the strongest or most notable of art deco features. Other external modifications like replacement windows reduces its historic character further.</p> <p>It is not recommended that this property be listed.</p>
20 Glebe St, Randwick

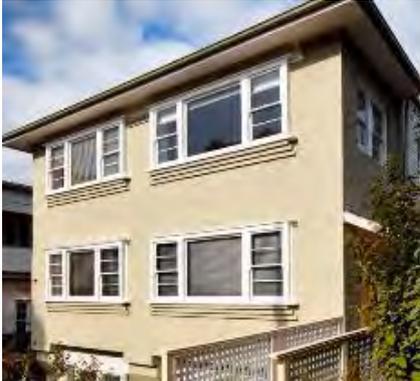
<p>The exterior architectural features are not strongly representing the art-deco theme. They are not the strongest or most notable of art deco features. Other external modifications like repainting and landscaping reduce its historic quality further.</p> <p>It is not recommended that this property be listed.</p>
20 Kurrawa Ave, Randwick

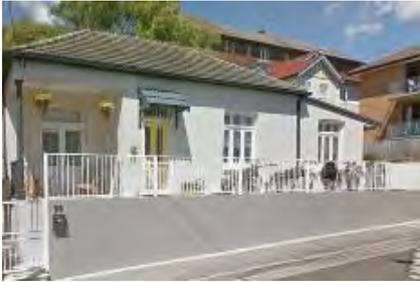
<p>The building appears heavily modified including a rear extension with internal modern fit outs. Unsure, but the rendered façade is unlikely original.</p> <p>It is not recommended that this property be listed.</p>

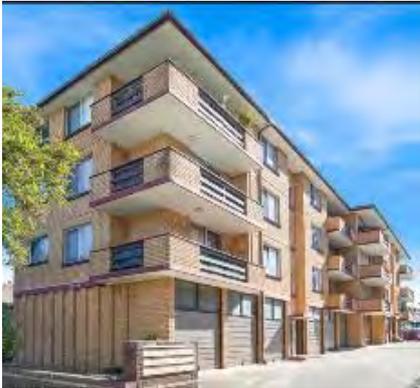
200 Carrington Road, Randwick

<p>A common type of building throughout Sydney, this example specifically does not exhibit exemplary or outstanding features.</p> <p>It is not recommended that this property be listed.</p>

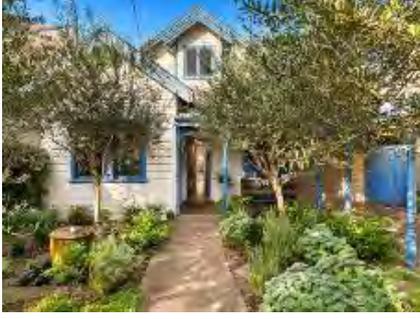
Address	Image	Reason for decision not to list
21 Avoca St, Randwick

<p>The building appears heavily modified including many internal modern fit outs and extensions. Unclear how much of the original building was retained but appears most of the current building is modern extension work.</p> <p>It is not recommended that this property be listed.</p>
21 Waratah Ave, Randwick

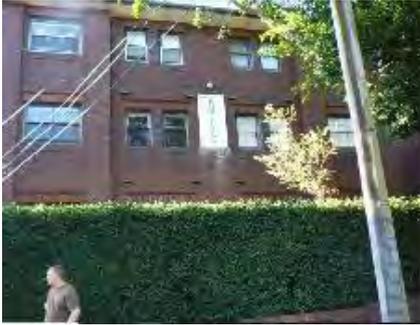
<p>Hard to see from the street, appears to be art deco. Although the building is a fine and typical example of its style, it is better represented by other examples in the LGA.</p> <p>It is not recommended that this property be listed.</p>
217 Alison Rd, Randwick

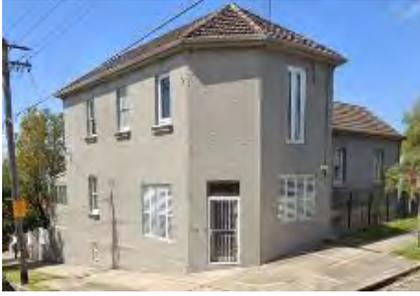
<p>An early form but not many outstanding exterior qualities that strongly expresses a period or era that this building buildings to.</p> <p>It is not recommended that this property be listed.</p>
22 Mears Ave, Randwick

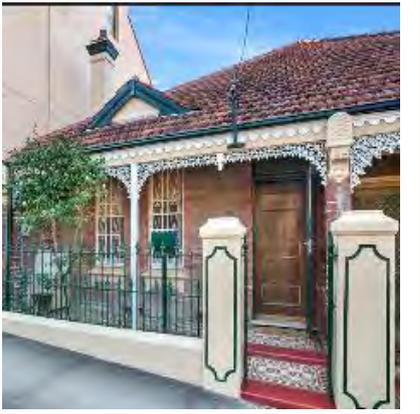
<p>One half of a semi-detached Federation cottage. The house has been somewhat modified and is not the best example of its type in the High Cross HCA. It is afforded adequate protection as a part of the High Cross HCA.</p> <p>It is not recommended that this property be listed.</p>

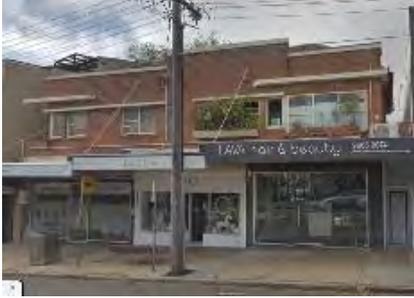
Address	Image	Reason for decision not to list
228C Clovelly Rd, Sydney

<p>Not a good, or consistent example of this style, and adjacent buildings are detracting, making this more and more obstructed.</p> <p>It is not recommended that this property be listed.</p>
2-4 Havelock Ave, Coogee

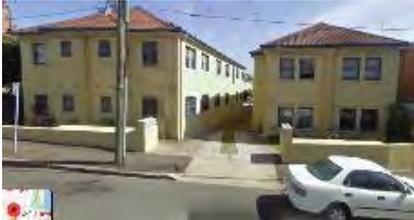
<p>Not an exemplary form of its type.</p> <p>It is not recommended that this property be listed.</p>
25 Havelock Ave, Coogee

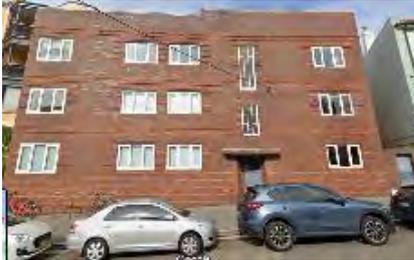
<p>A typical example of its style that is better represented by other examples in the LGA.</p> <p>It is not recommended that this property be listed.</p>
25 Marcel Ave, Randwick

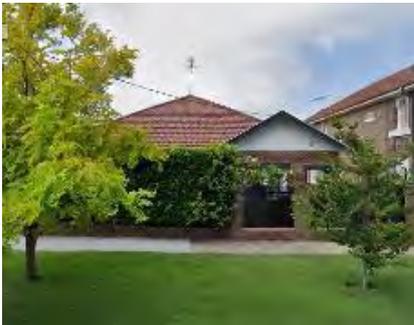
<p>A typical example of its style that is better represented by other examples in the LGA. Afforded adequate protection as a part of the Moira Crescent HCA.</p> <p>It is not recommended that this property be individually listed.</p>
25 Prince St Randwick

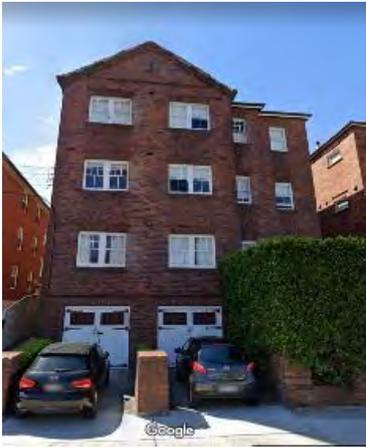
<p>A typical example of its style that is better represented by other examples in the LGA.</p> <p>It is not recommended that this property be listed.</p>

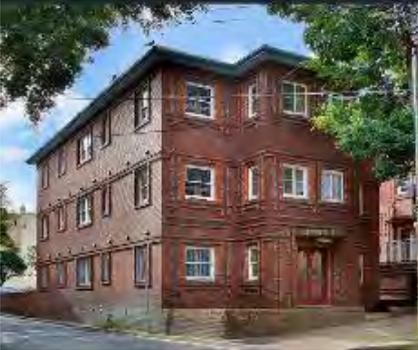
Address	Image	Reason for decision not to list
25 Waratah Ave, Randwick

<p>A typical example of its style that is better represented by other examples in the LGA. Afforded adequate protection as a part of the Gordon Square HCA.</p> <p>It is not recommended that this property be individually listed.</p>
26 Canberra Street, Randwick

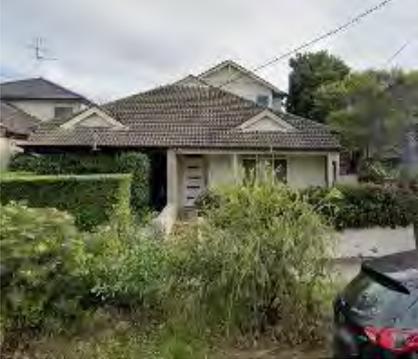
<p>Appears heavily modified.</p> <p>It is not recommended that this property be listed.</p>
26 Kidman St, Randwick

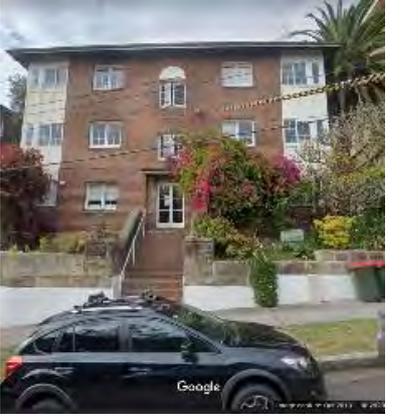
<p>A typical example of its type that is better represented by other examples in the LGA.</p> <p>It is not recommended that this property be listed.</p>
28 Bream St, Coogee

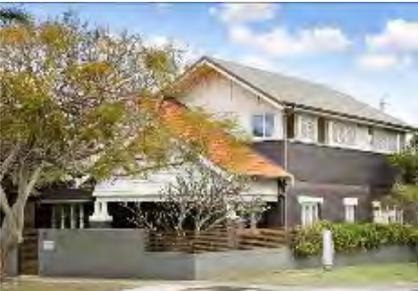
<p>Given the heavy internal modifications throughout the house, there are more intact examples of a typical Californian bungalow in the LGA.</p> <p>It is not recommended that this property be listed.</p>

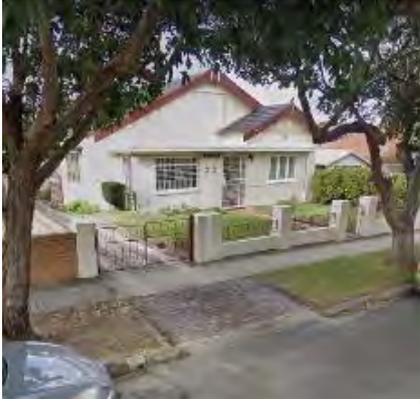
Address	Image	Reason for decision not to list
28 Cottenham Avenue, Kensington

<p>The external enclosed balcony obscures the original form of the house. For that reason, there are many better representatives of this style in the LGA.</p> <p>It is not recommended that this property be listed.</p>
32 Arcadia St, Coogee

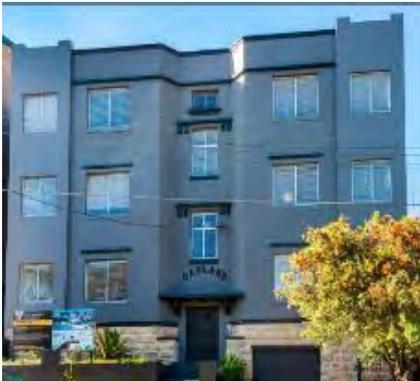
<p>Appears to have been highly modified, some better, more decorative examples of its type.</p> <p>It is not recommended that this property be listed.</p>
32 Bishops Avenue, Randwick

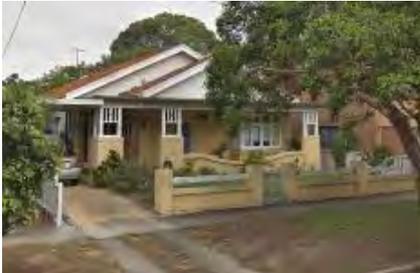
<p>Some better, more decorative examples of its type exist elsewhere in the LGA.</p> <p>It is not recommended that this property be listed.</p>
32 Marcel Ave, Randwick

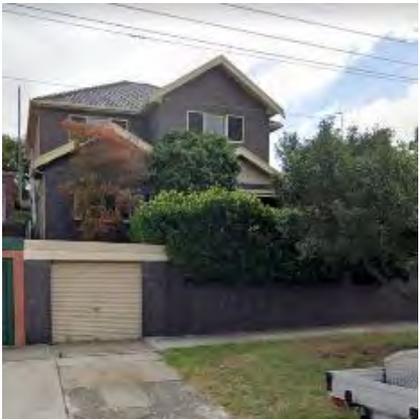
<p>Appears to have been highly modified, some better, more decorative examples of what was likely originally a more modest bungalow style.</p> <p>It is not recommended that this property be listed.</p>

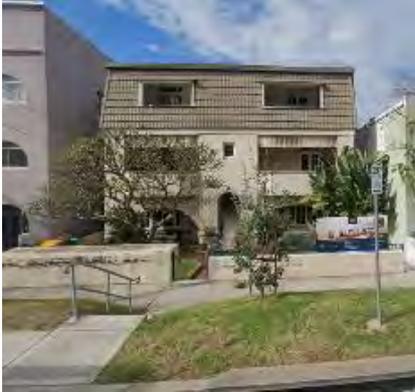
Address	Image	Reason for decision not to list
33 Arcadia St, Coogee

<p>Appears to have been highly modified, perhaps externally rendered. Some better, more decorative examples of what was likely a Federation arts and crafts style.</p> <p>It is not recommended that this property be listed.</p>
34 Bishops Avenue, Randwick

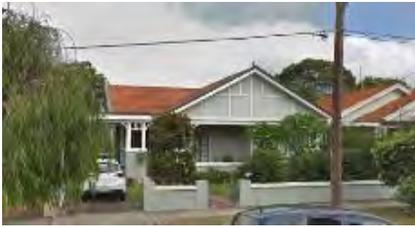
<p>Some better, more decorative examples of its type.</p> <p>It is not recommended that this property be listed.</p>
34 Day Avenue, Kensington

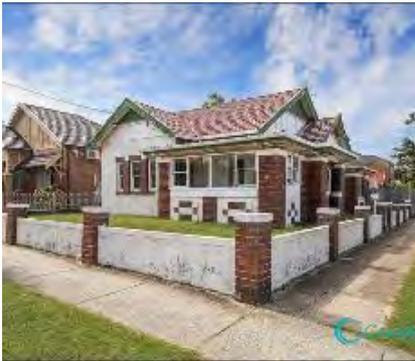
<p>Some better, more decorative examples of its type exist elsewhere in the LGA. Has some nice internal traditional finishes still intact.</p> <p>It is not recommended that this property be listed.</p>
34 French Street, Maroubra

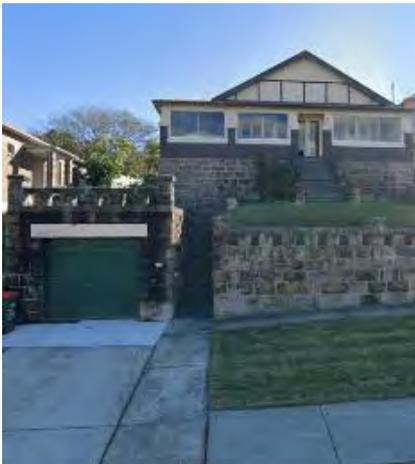
<p>Some better, more decorative examples of its type exist elsewhere in the LGA. External enclosure of the verandah detracts from the original material.</p> <p>It is not recommended that this property be listed.</p>

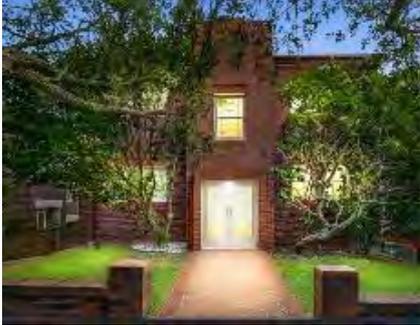
Address	Image	Reason for decision not to list
35-37 Moira Cres, Randwick

<p>Adequately protected as a part of Moira Crescent HCA. Works better as a group.</p> <p>It is not recommended that this property be individually listed.</p>
36 Bishops Avenue, Randwick

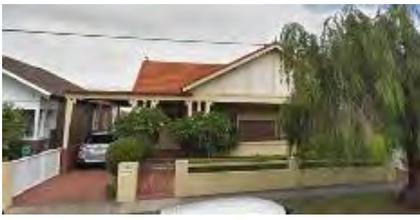
<p>Large freestanding Californian Bungalow with some additions and alterations. Not all original material present.</p> <p>It is not recommended that this property be listed.</p>
36 Canberra Street, Randwick

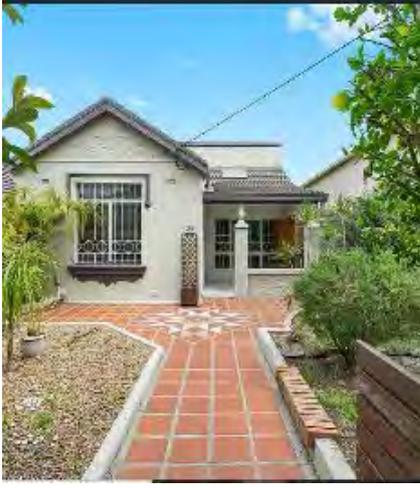
<p>Heavily modified internally with large extension to the rear.</p> <p>It is not recommended that this property be listed.</p>
36 Mooramie Avenue, Kensington

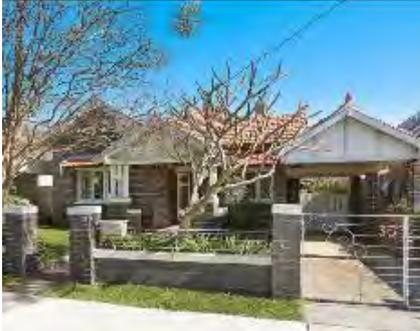
<p>1920's Californian Bungalow. Interesting balcony design, quite uncommon. Original features intact. There are better examples of this style of building in the Randwick LGA.</p> <p>It is not recommended that this property be listed.</p>

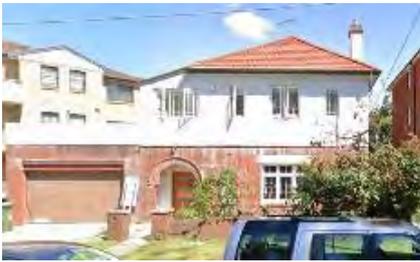
Address	Image	Reason for decision not to list
<p>36 Prince Street, Randwick</p>

<p>Highly modified Federation building. Many extensions and unidentifiable as an architectural style.</p> <p>It is not recommended that this property be listed.</p>
<p>364 Alison Rd, Randwick</p>

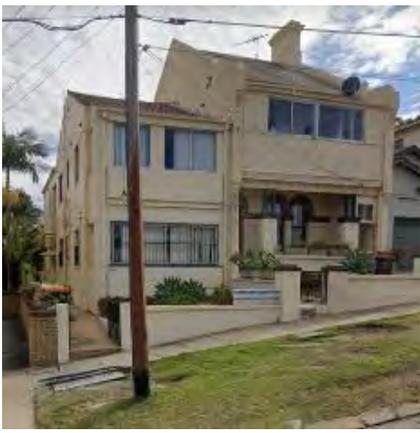
<p>Highly modified, infilled terraces that are no longer identifiable as their architectural style.</p> <p>It is not recommended that this property be listed.</p>
<p>37 Melody St, Coogee</p>

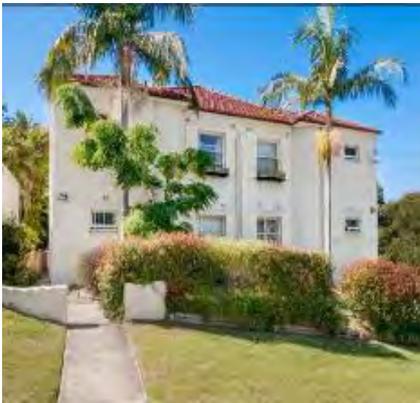
<p>Simple Spanish mission style Inter-War building. There are better examples of this type in the Randwick LGA.</p> <p>It is not recommended that this property be listed.</p>
<p>38 Bishops Avenue, Randwick</p>

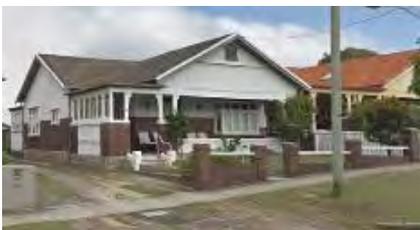
<p>Some better, more decorative examples of its type exist elsewhere in the LGA.</p> <p>It is not recommended that this property be listed.</p>

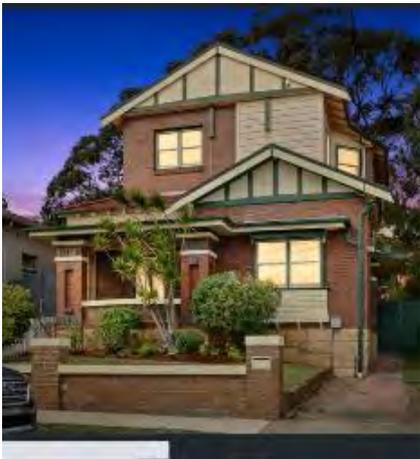
Address	Image	Reason for decision not to list
39 Helena St, Randwick

<p>Highly modified with no integrity as a Federation cottage.</p> <p>It is not recommended that this property be listed.</p>
40 Bishops Avenue, Randwick

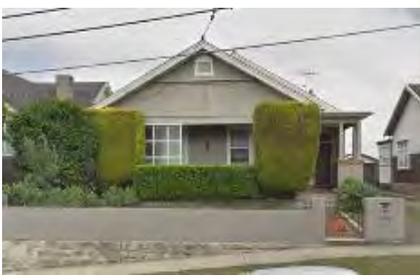
<p>Some better, more decorative examples of its type exist elsewhere in the LGA.</p> <p>It is not recommended that this property be listed.</p>
40 Marcel Ave, Randwick

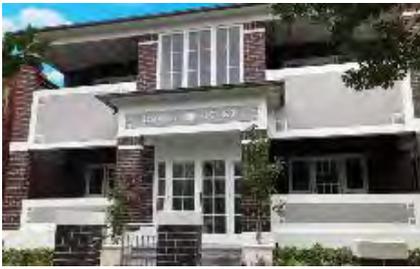
<p>Adequately protected as a part of the Moira Crescent HCA. Forms a part of an intact group in the HCA.</p> <p>It is not recommended that this property be individually listed.</p>
40 Oberon St, Randwick

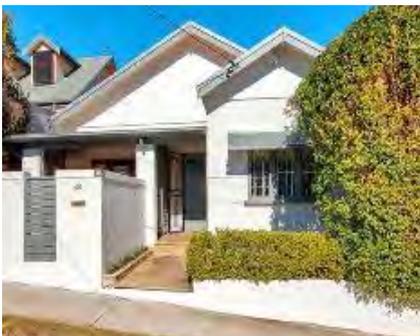
<p>Highly modified and unsympathetic modifications to the façade. No streetscape contribution.</p> <p>It is not recommended that this property be listed.</p>

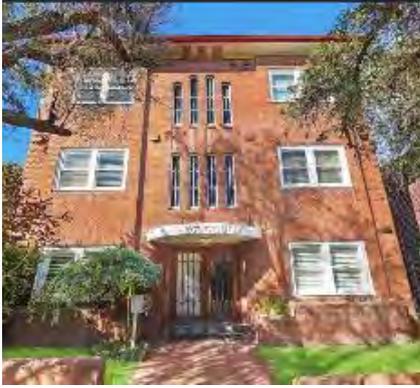
Address	Image	Reason for decision not to list
41 Moira Cres, Randwick

<p>Inter-War apartment. Adequately protected as a part of an intact group in the Moira Crescent HCA.</p> <p>It is not recommended that this property be individually listed.</p>
414 Malabar Road, Maroubra

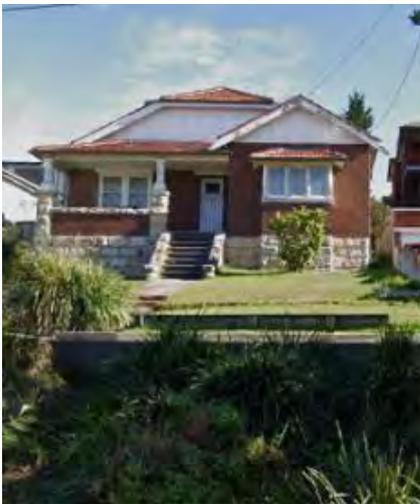
<p>Not the best example of the type.</p> <p>It is not recommended that this property be listed.</p>
3 Berwick Street, Randwick

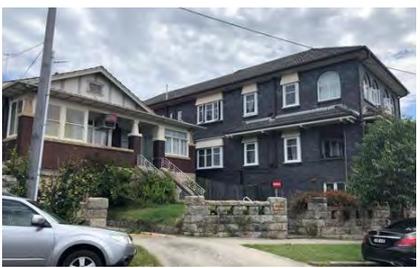
<p>Modified Inter-War Bungalow. Loss of significant fabric to interior and exterior (e.g. removal of timber trim elements, verandah enclosure) which has affected its integrity and significance.</p> <p>3 Berwick Street is not recommended for listing.</p>
