RE: Vibration Monitoring – Coral Sea Park, Maroubra NSW

1 Introduction

Sydney Environmental Group (SEG) have been engaged by Randwick City Council (hereafter referred to as ‘the client’), to advise the client on vibration generating activities undertaken during the Coral Sea Park Synthetic Sports Field Upgrade Project, located at Coral Sea Park, Maroubra NSW (hereafter referred to as the ‘site’).

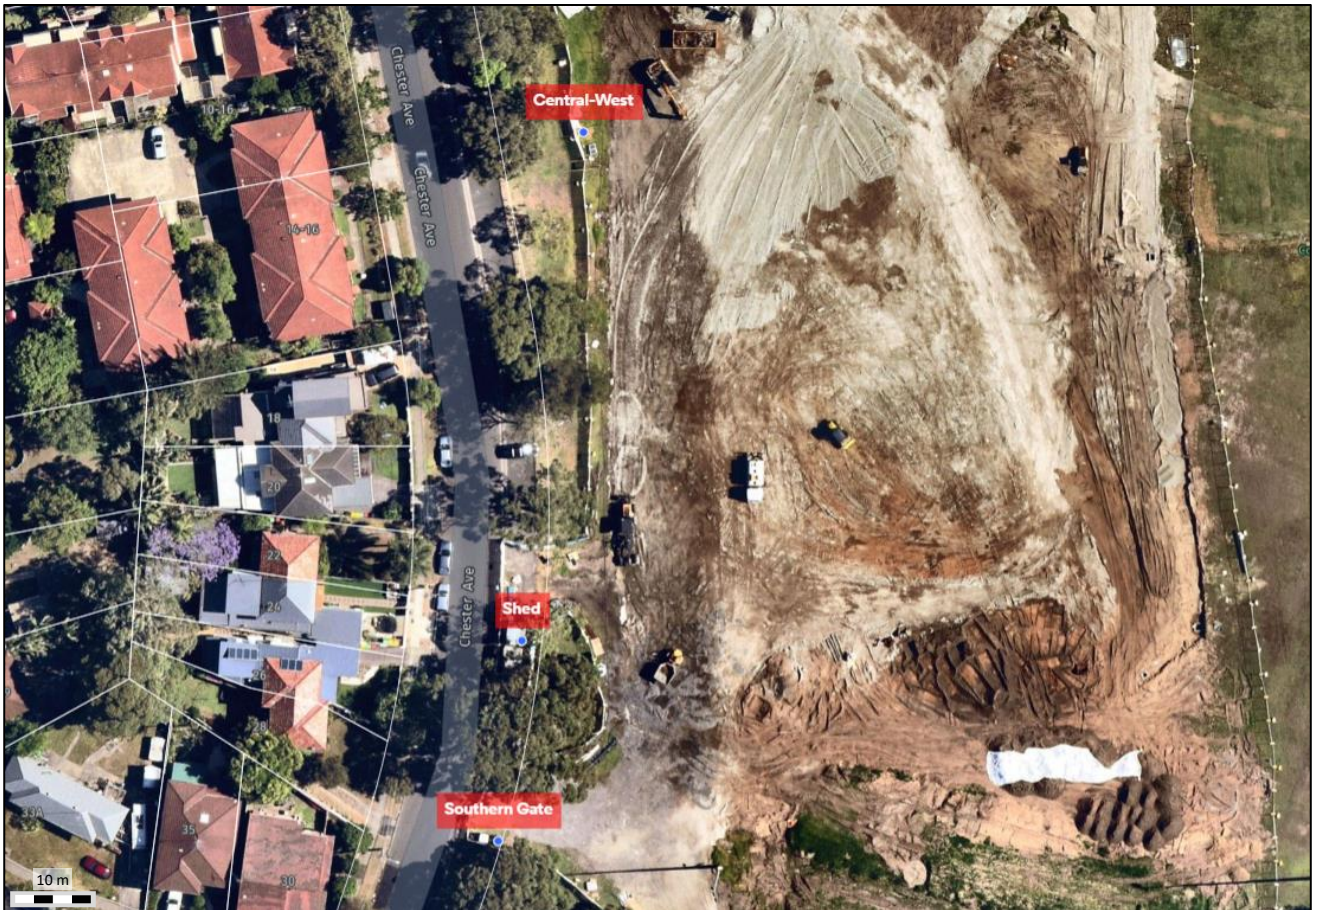
Figure 1 – Vibration Monitoring Locations

SEG installed three (3) ‘Profound Vibra’ vibration monitors fitted with tri-axis geophones on the 23rd of January 2023 along the western site boundary along Chester Avenue. The siting of monitors was selected to address particular resident concerns. Monitors were mounted to solid fixtures affixed to the ground. Refer to **Figure 1** for monitor locations.

Mounting of the monitors was undertaken in accordance with DIN 45669-2 Measurement of vibration emission – Part 2: Measuring method June 2005. Geophones were affixed using the supplied mounting bracket and screws to solid structures in contact with the ground. The location of monitors is provided in **Figure 1**.

SE note that generally vibration monitors must be affixed to the structure requiring monitoring. In this case, monitors were unable to be affixed to nearby residential structures. As there is currently no easily agreed upon calculation to accurately determine vibration attenuation through ground over short distances, all results associated with the vibration monitoring are considered to be conservative, in that results are significantly higher than if vibration had been measured at the residential receptor as is industry practice.

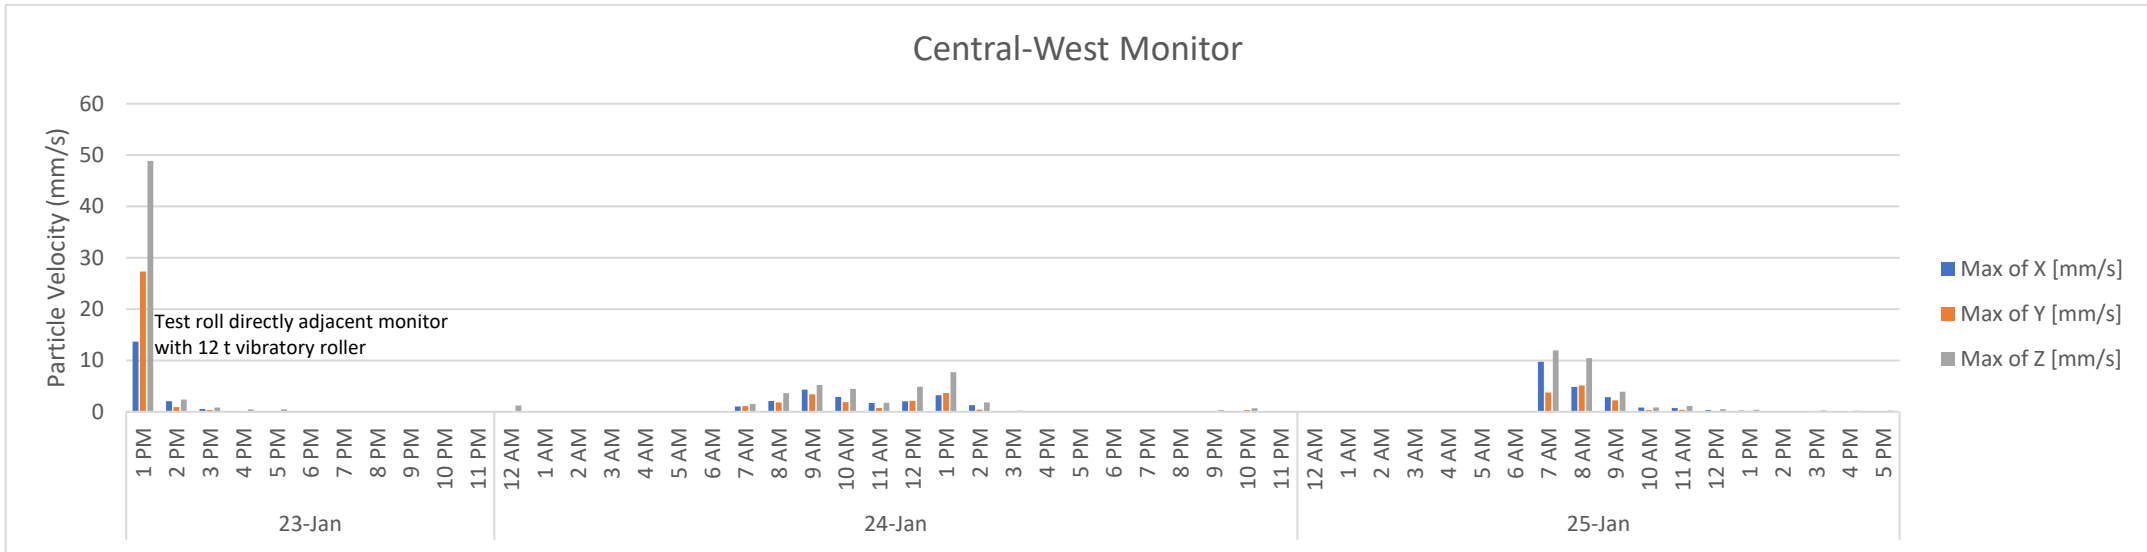
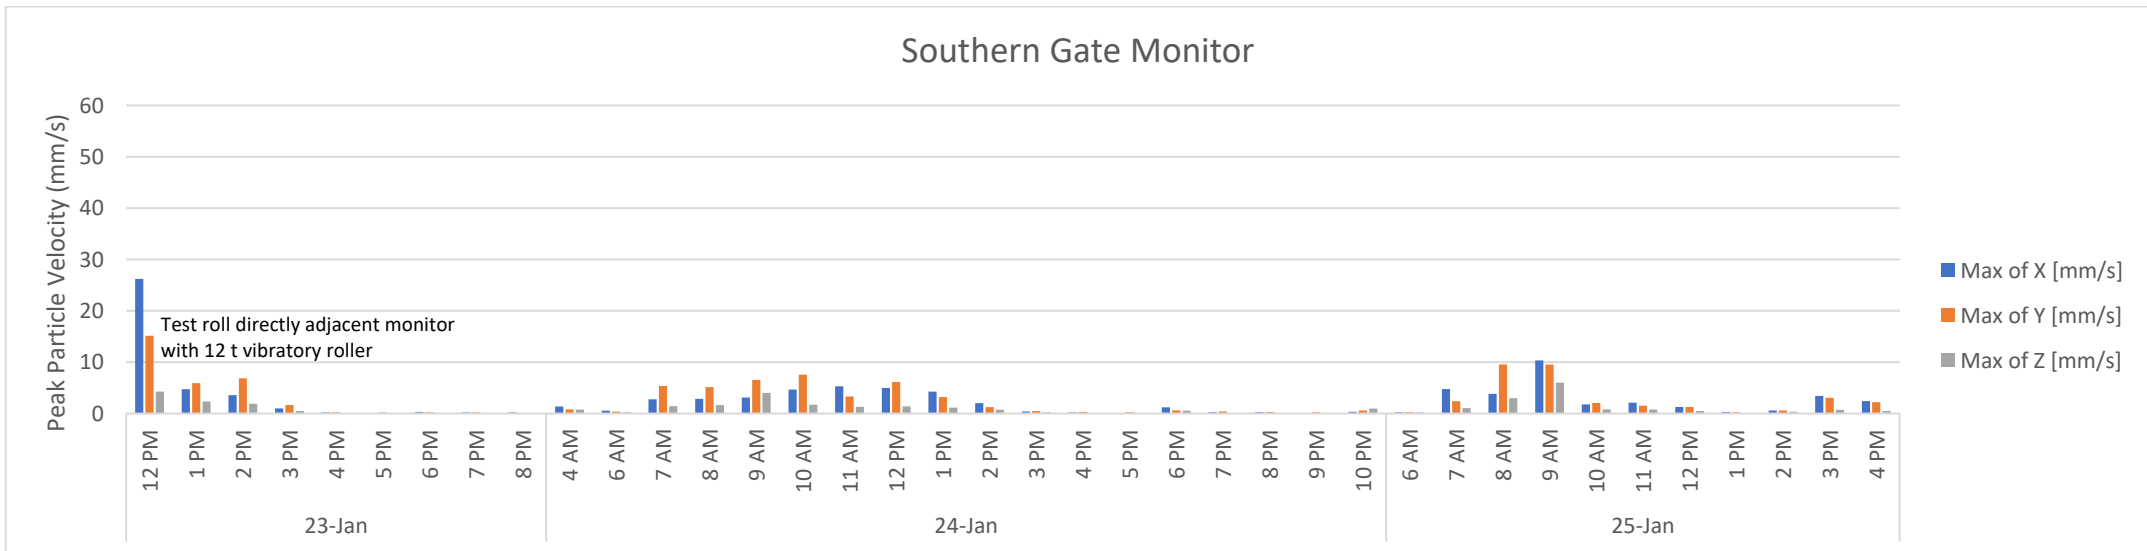
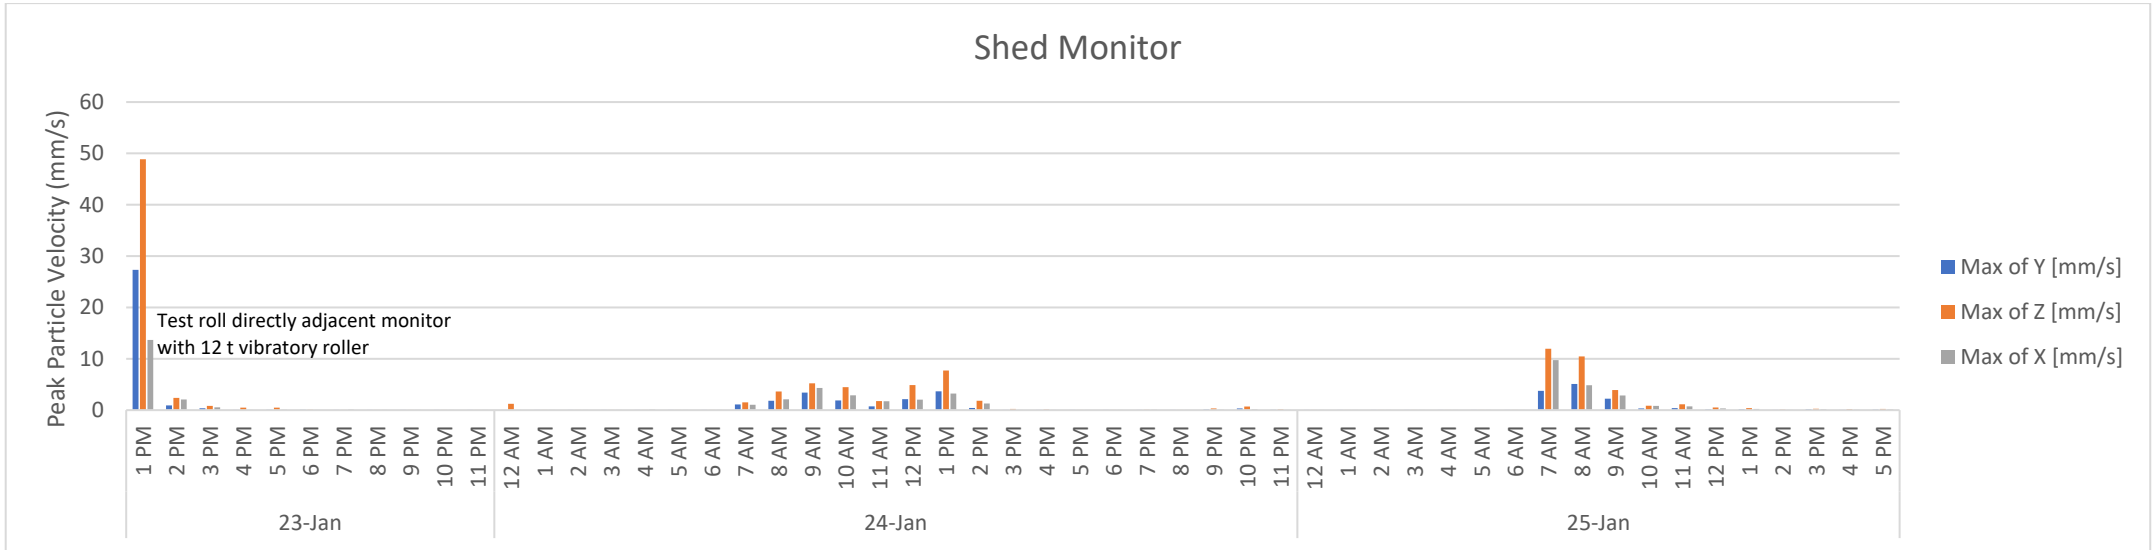
VIBRATION RESULTS SUMMARY TABLES

A summary of maximum vibration values recorded within an hour interval are presented in **Appendix A**. SE note that data recorded around 12 pm – 1 pm on the 23rd of January 2023 was a test of the 12 tonne vibratory roller at maximum vibration within 5 m of each monitor. Vibration measured and correlated to the vibratory rollers indicated a frequency of

around 20 – 30 Hz. Figures in Appendix A detail the highest Peak Particle Velocity measured noting that this is generally in the 20 – 30 Hz range where measurements are above 1 mm/s.

- Vibration levels measured at the site boundary on the 24th and 25th of January 2023 were found to be below relevant criteria, and therefore, vibration experienced in off-site receptors is assumed to be below criteria;
- The client has introduced effective vibration mitigation methodologies to reduce vibration on-site;
- Due to the constraints of monitor positioning, vibration dose parameters could not be calculated; and
- Vibration reduction methodologies implemented on-site are considered adequate and above industry best practice, and as such, no further controls are recommended.
