Asbestos Containing Material Clearance Inspection

1 September 2022

Site:	Little Bay Beach
Location:	Southern, Western and Northern Little Bay Beach

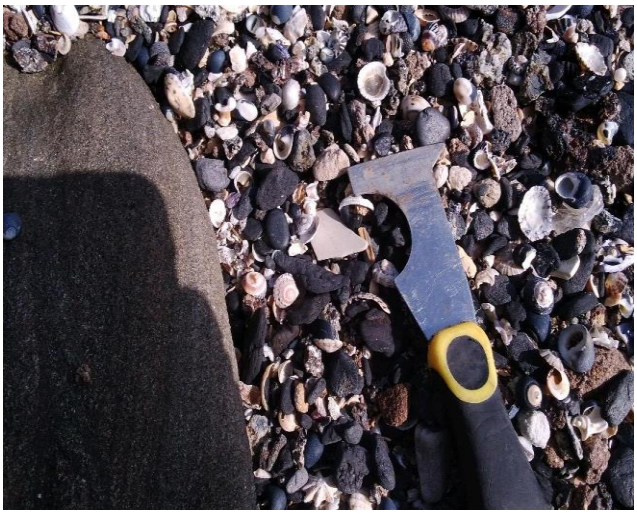
**Notes:** FC fragment identified on sand surface prior to emu pick - Northern section

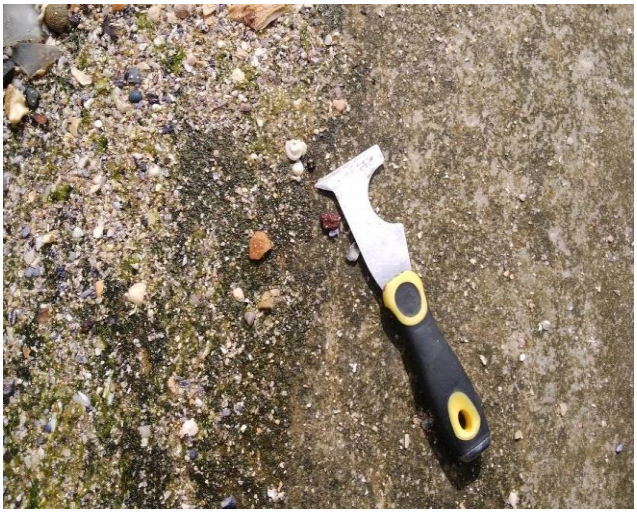
Notes: Sand surface following emu pick - Southern section

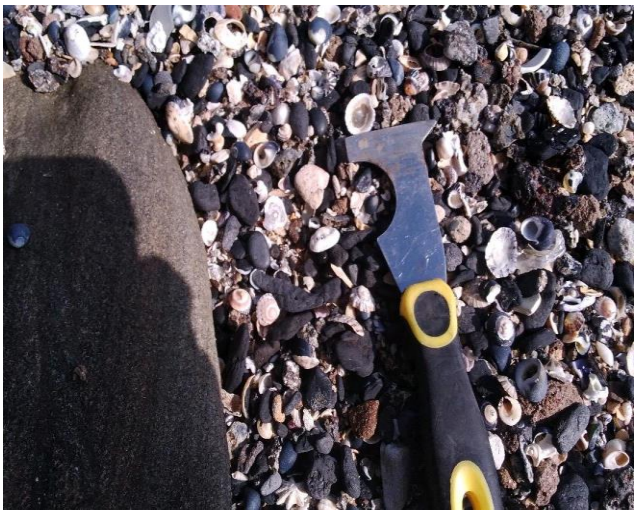
**Notes:** Sand surface following emu pick - Northern section
