RE: Asbestos Containing Material Clearance Inspection

Site:	Little Bay Beach

Asbestos Containing Material Clearance Inspection

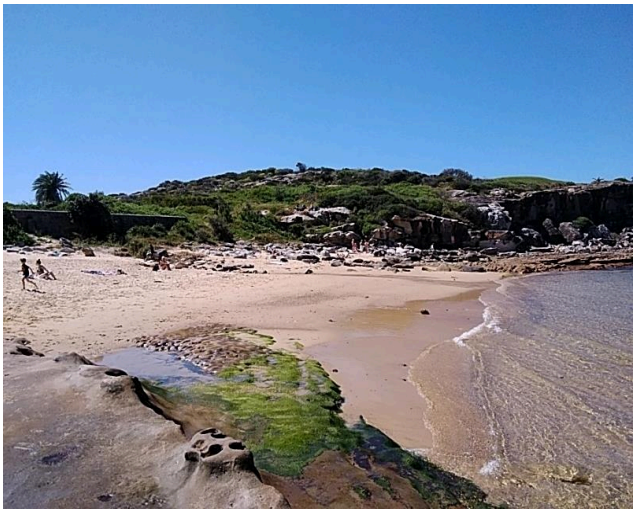
Notes: Overview of the southern beach during low tide	 **Notes:** Overview of the western beach during low tide
