RE: Asbestos Daily Air Monitoring Report

Location:	Little Bay Beach

Appendix 1: Air Monitoring Locations

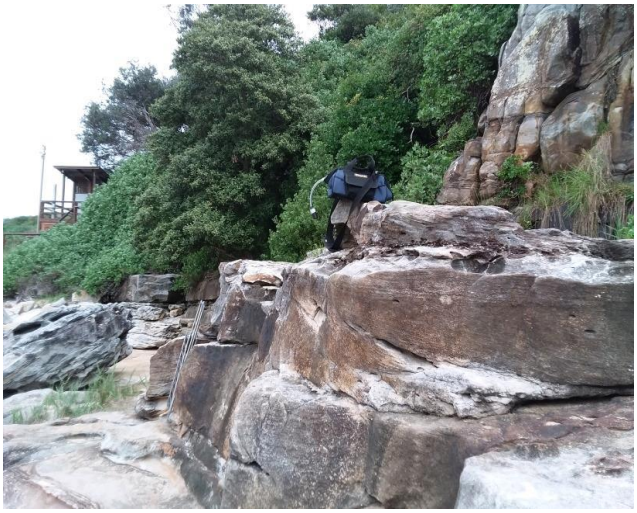
Location: Southern beach
Result: <0.01 f/ml
Image Id: 200930-111303
