Asbestos Containing Material Clearance Inspection

3 August 2022

Site:	Little Bay Beach
Location:	Southern, Western and Northern Little Bay Beach

Requested by:	
Name	Joe Santangelo
Contact	0436839760
Email	joe.santangelo@randwick.nsw.gov.au
Site Details:	
Address	2 Coast Hospital Rd, Little Bay NSW 2036
Local Government Area	Randwick City Council

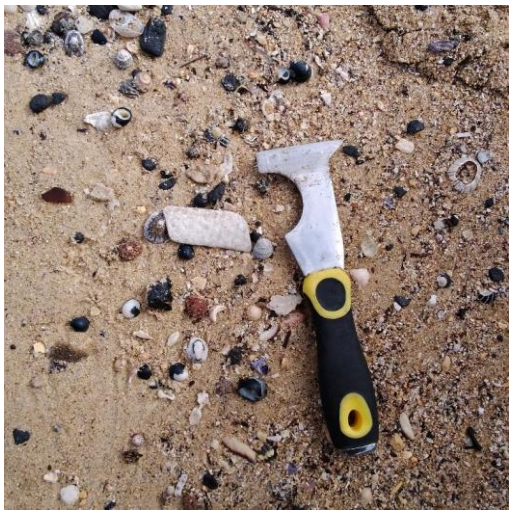
Notes: FC fragment identified on sand surface prior to emu pick - Northern section

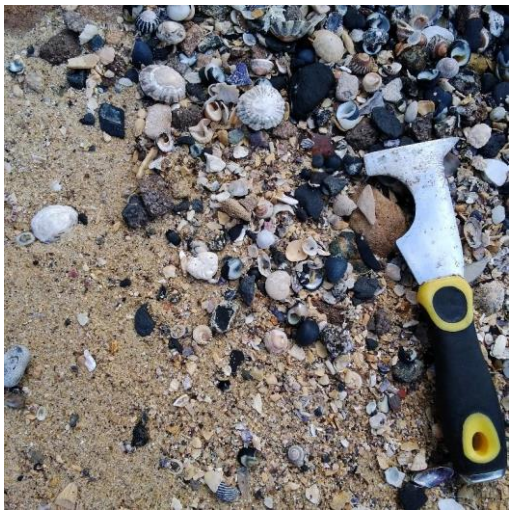
**Notes:** FC fragment identified on sand surface prior to emu pick - Northern section

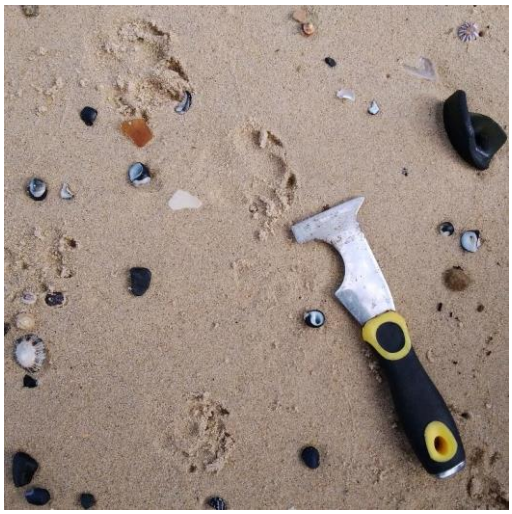
**Notes:** FC fragment identified on sand surface prior to emu pick - Southern section

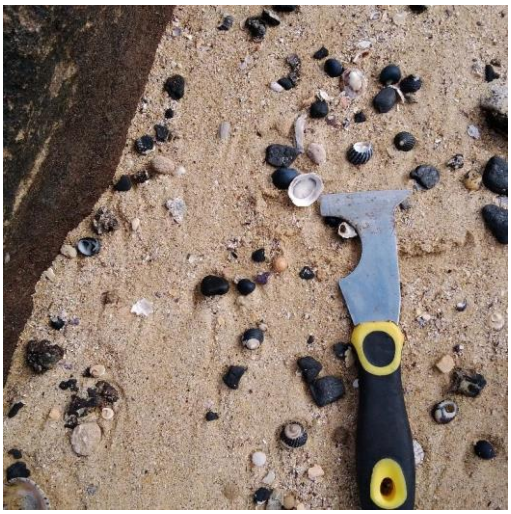
Notes: Sand surface following emu pick - Northern section	 **Notes:** Sand surface following emu pick - Northern section

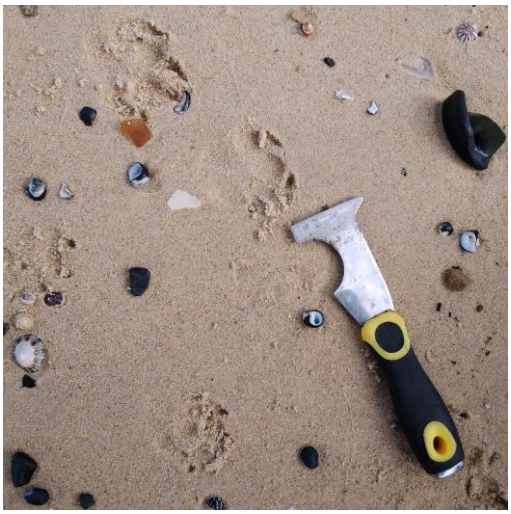
**Notes:** Sand surface following emu pick - Northern section	 **Notes:** Sand surface following emu pick - Northern section

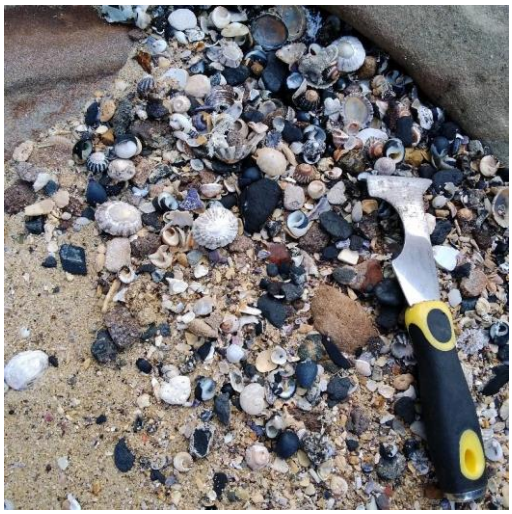
Notes: Sand surface following emu pick - Northern section	 **Notes:** Sand surface following emu pick - Northern section
 Notes: Sand surface following emu pick - Northern section

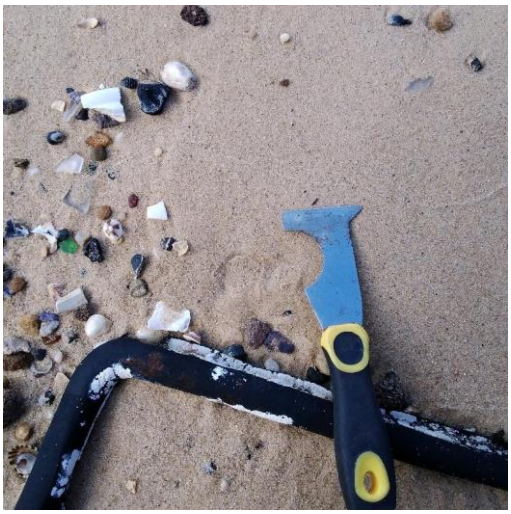
**Notes:** Sand surface following emu pick - Northern section
