Asbestos Containing Material Clearance Inspection

29 July 2021

Site:	Little Bay Beach

Requested by:	
Name	Ryan Zammit
Contact	90936744
Email	ryan.zammit@randwick.nsw.gov.au
Site Details:	
Address	2 Coast Hospital Rd, Little Bay NSW 2036
Local Government Area	Randwick City Council
Clearance Area	
Clearance Type:	
Clearance Type	Asbestos Containing Material
Application Legislation	2011 WHS Act 2017 WHS Regulations Code of Practice, How to Manage and Control Asbestos in the Workplace 2019 Code of Practice, How to Safely Remove Asbestos 2019 Guidance Note On The Membrane Filter Method For Estimating Airborne Asbestos Fibres 2nd Edition [Nohsc:3003(2005)]
Scope of Remediation Work:	
Location of Remediation Work	Northern, western and southern Little Bay Beach
Material	FC fragments
Bonded / Friable	Non-Friable
Scope of Remediation	Emu picking of suspected fragments on sand surfaces
Date of Remediation work	29/07/2021

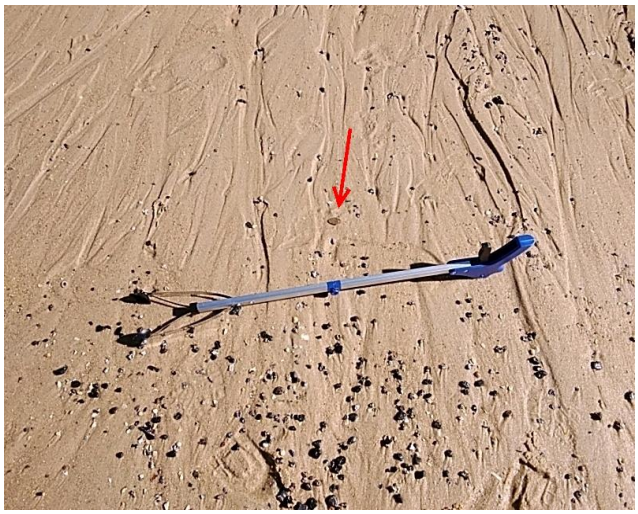
Notes: Overview of the removal item within northern beach	**Notes:** Overview of the removal item within northern beach
Notes: Overview of the removal item within northern beach	**Notes:** Overview of the removal item within northern beach
