Asbestos in Soil Clearance Inspection

4 June 2021

Site:	Little Bay Beach

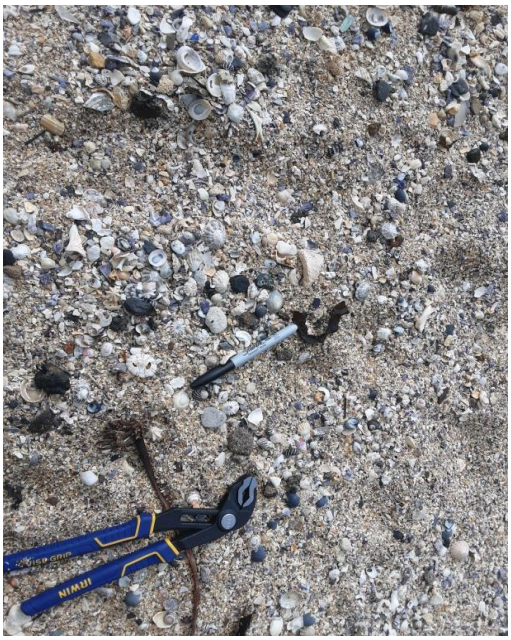
Notes: Southern beach

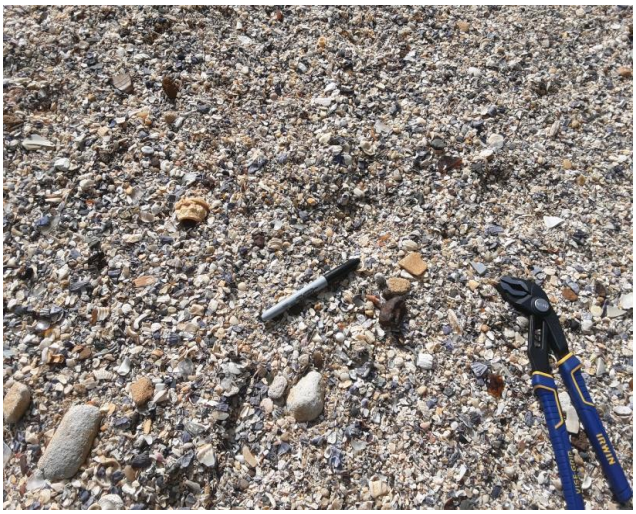
Notes: Southern beach

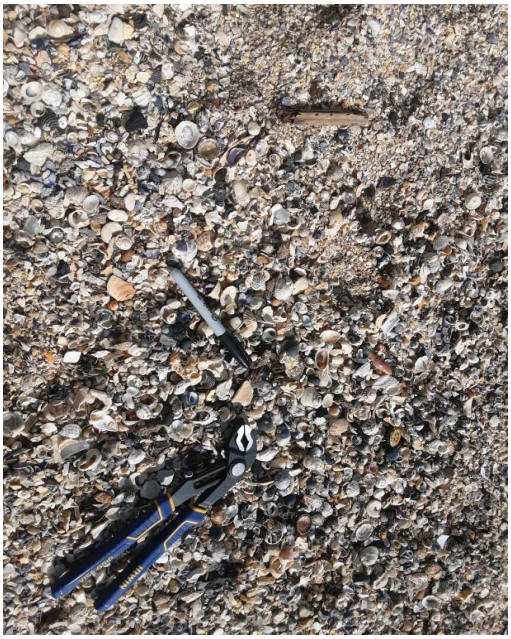
Notes: Southern beach

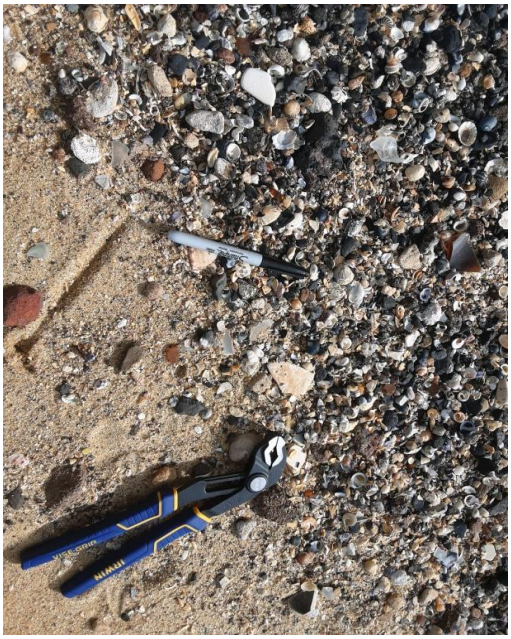
**Notes:** Middle beach

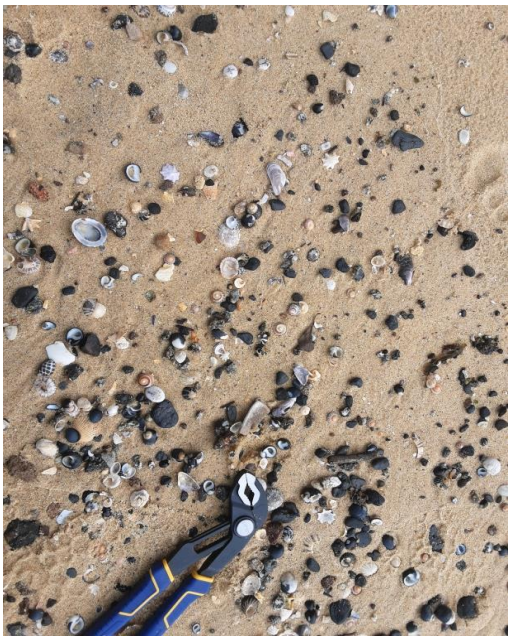
Notes: Northern beach

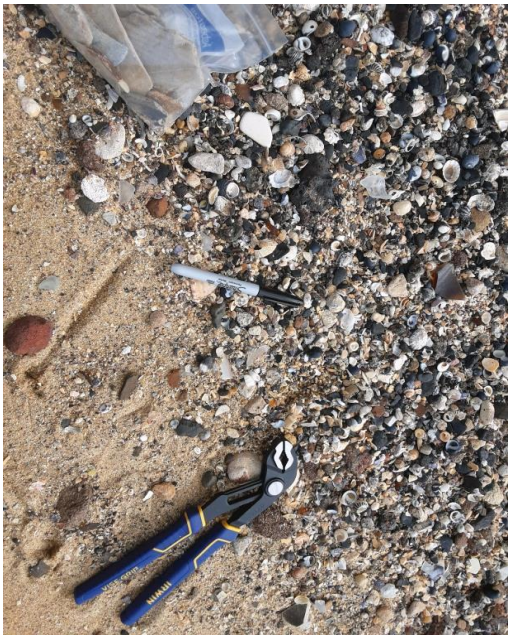
**Notes:** Middle Beach

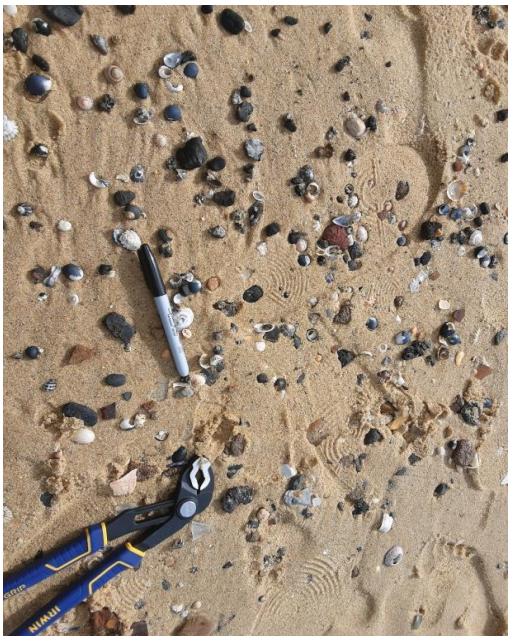
Notes: Middle Beach
