Asbestos Air Monitoring Report

8 December 2022

Site:	Little Bay Beach
Location:	Background air monitoring

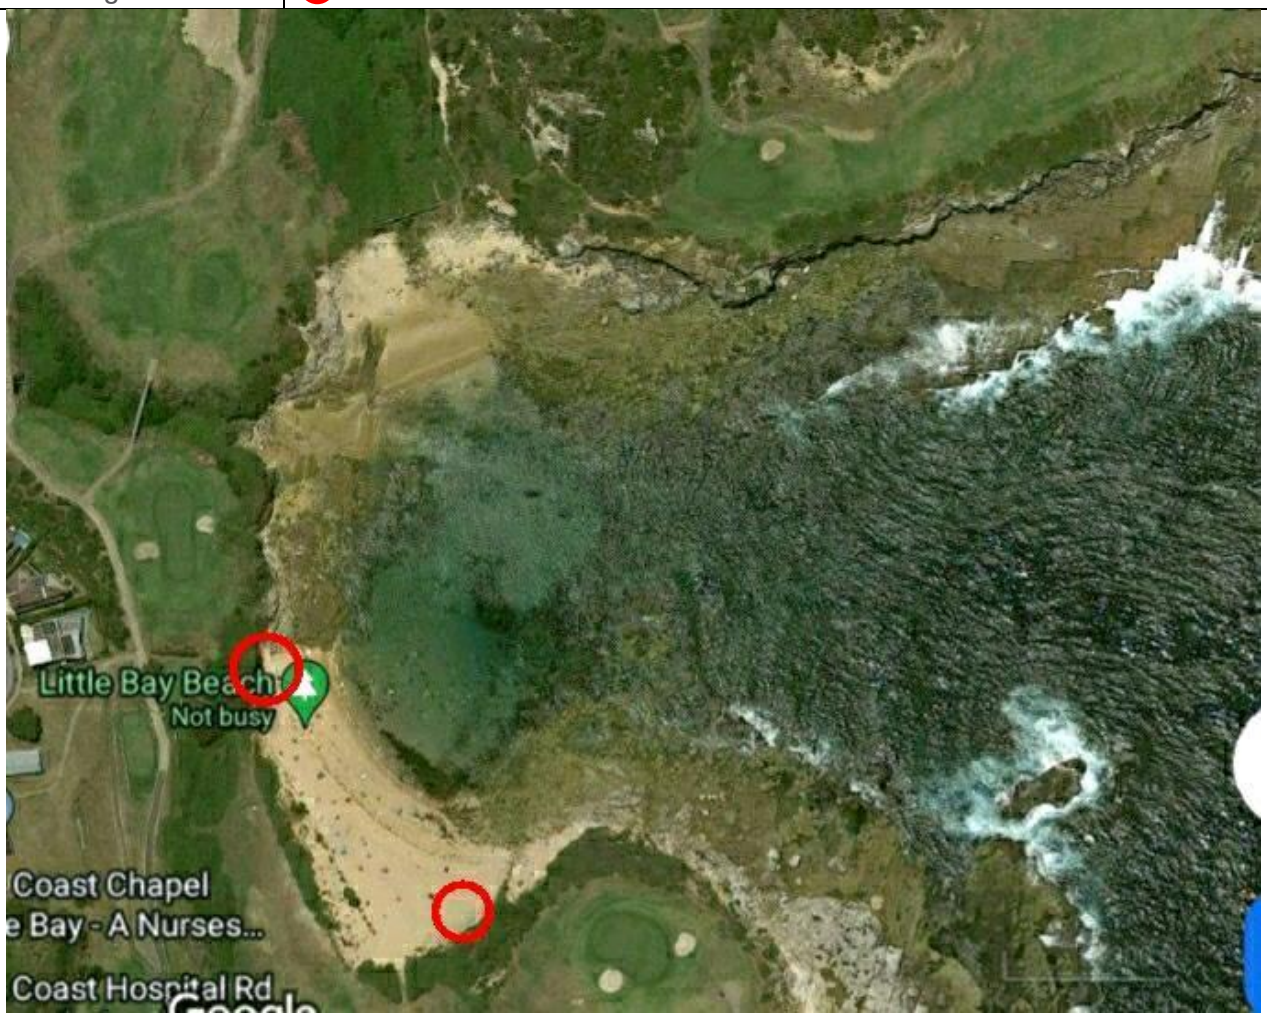
Requested by:	
Client Contact Name	Joe Santangelo
Client Contact Number	0436839760
Client Contact Email	joe.santangelo@randwick.nsw.gov.au
Site:	
Address	2 Coast Hospital Rd, Little Bay NSW 2036
Local Government Area	Randwick City Council
Site Boundary	
Air Monitoring Locations
