75 & 77 arden street  
coogee

# planning report

tree removal

# Arboricultural Report

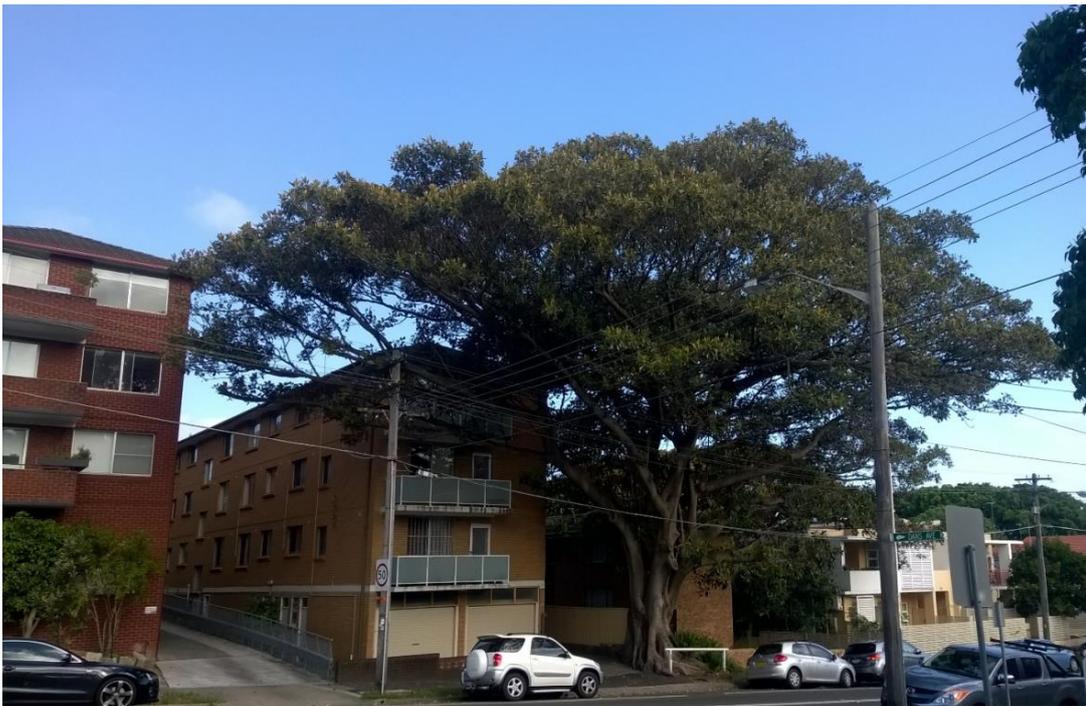
#### Photo 2.1 | The subject tree

The site 75 Arden Street is on the eastern side of Arden Street, Coogee. It contains a three storey residential flat building with ground level parking. The Moreton Bay fig is located within the front setback on the south western side of this site. It extends to encroach the common side boundary to the south, and thus the neighbouring residential property 77 Arden Street, Coogee. Vehicular access into 75 Arden Street is gained directly from Arden Street and the driveway is along the southern boundary of the Site, where the Moreton Bay fig is partially located. Other than the tree in question, there is not much vegetation or landscaping surrounding the Site.
