# Asbestos Containing Material Clearance Inspection

<b>Site:</b>	Little Bay Beach
<b>Location:</b>	Southern, Western and Northern Little Bay Beach

<b>Requested by:</b>	
Name	Joe Santangelo
Contact	0436839760
Email	joe.santangelo@randwick.nsw.gov.au
<b>Site Details:</b>	
Address	2 Coast Hospital Rd, Little Bay NSW 2036
Local Government Area	Randwick City Council

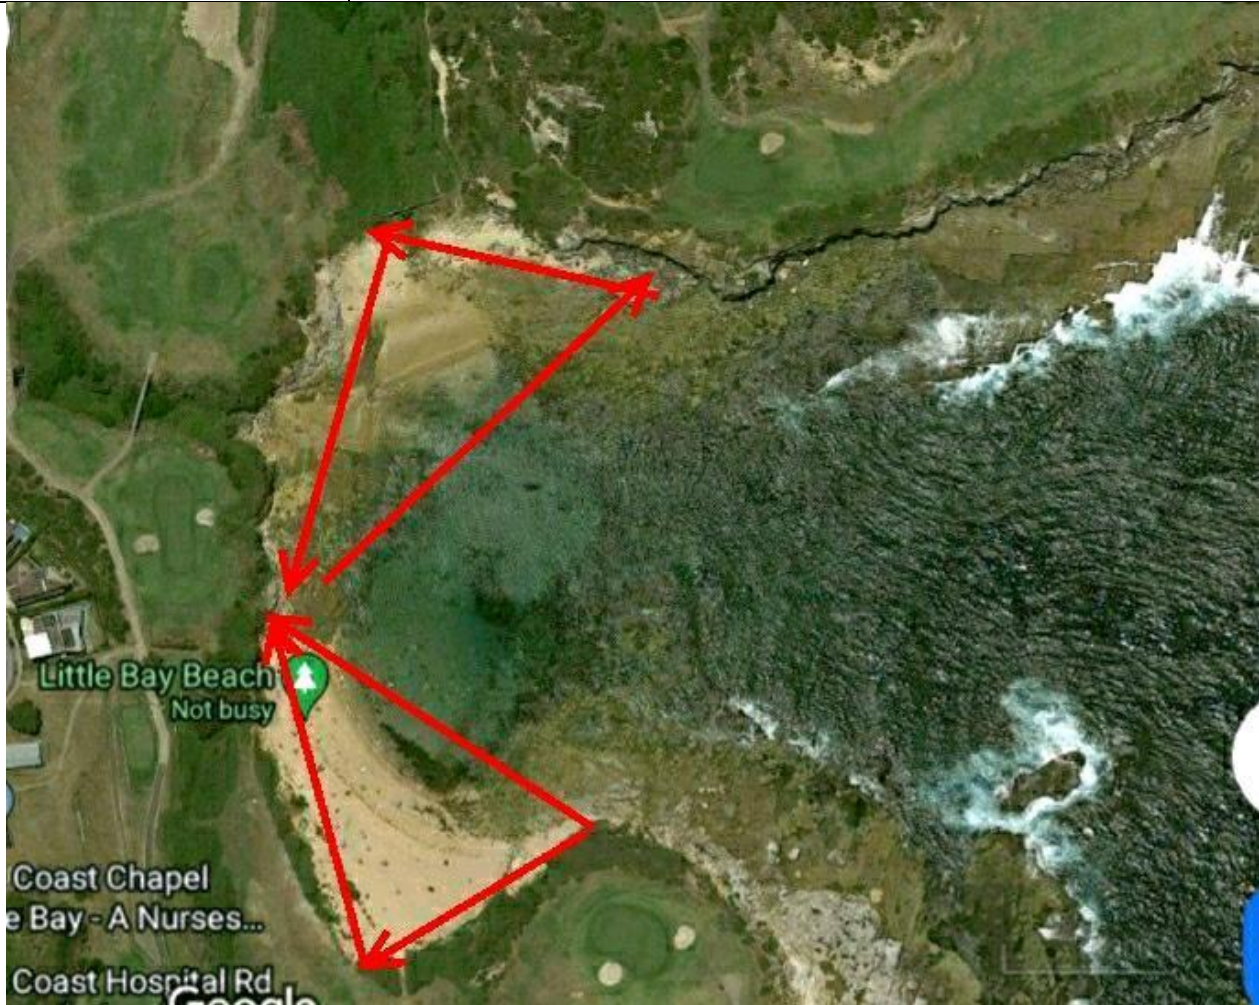
Clearance Area	
<b>Clearance Type:</b>	
Clearance Type	Asbestos Containing Material
Application Legislation	<ul style="list-style-type: none"> <li>- 2011 WHS Act</li> <li>- 2017 WHS Regulations</li> <li>- SafeWork NSW Code of Practice, How to Manage and Control Asbestos in the Workplace 2019</li> <li>- SafeWork NSW Code of Practice, How to Safely Remove Asbestos 2019</li> </ul>
