Asbestos Containing Material Clearance Inspection

11 March 2023

Site:	Little Bay Beach
Location:	Southern, Western and Northern Little Bay Beach

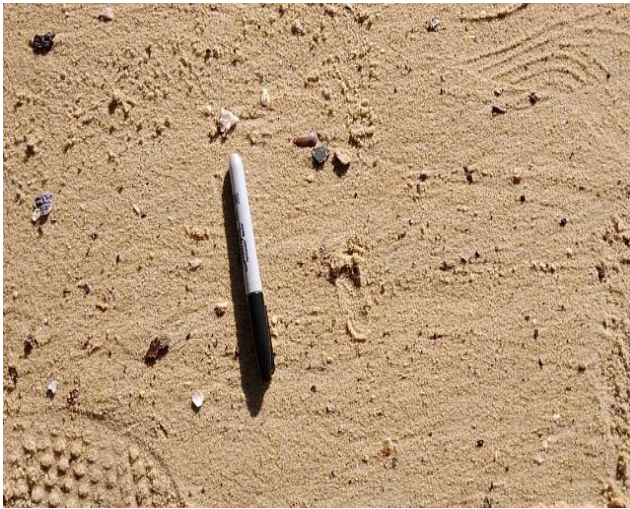
Notes: Western beach surface following fragment removal

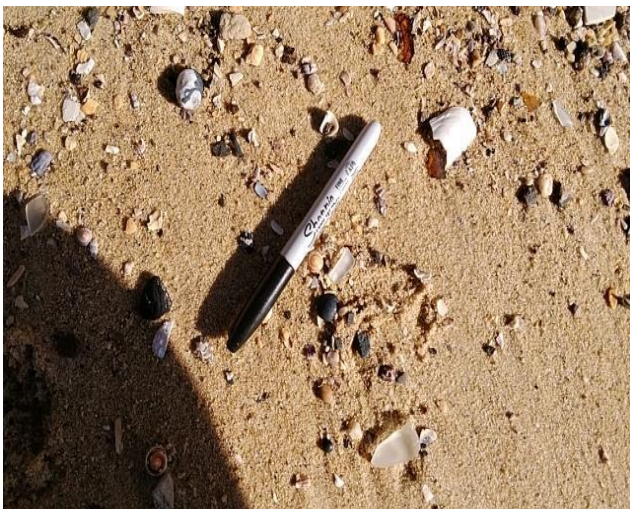
Notes: Western beach surface following fragment removal

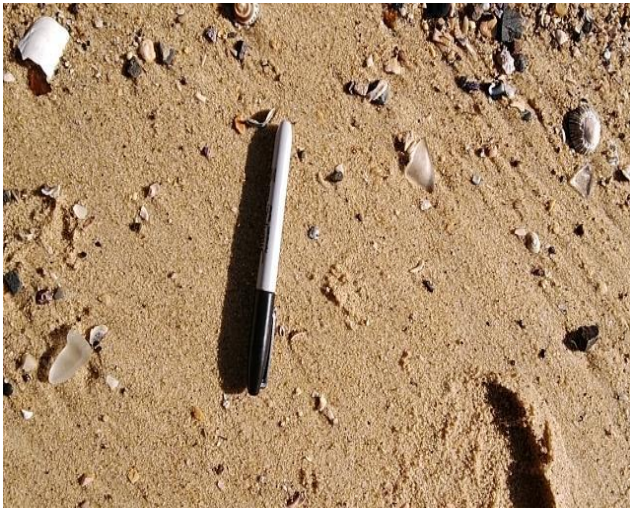
Notes: Western beach surface following fragment removal

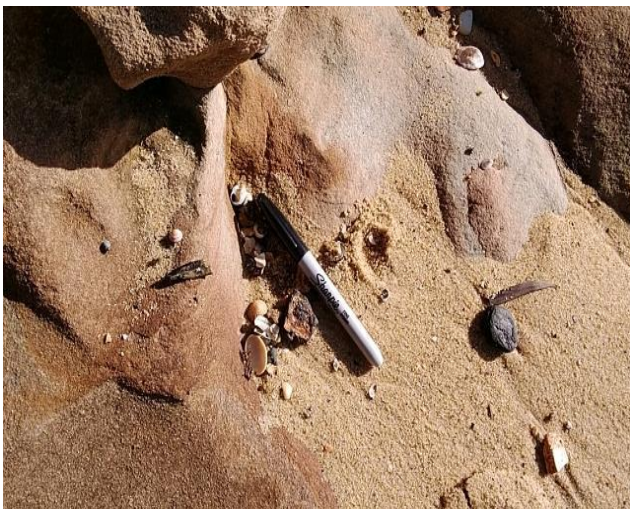
Notes: Western beach surface following fragment removal
