## **RE: Asbestos Air Monitoring Report**

Site:	Little Bay Beach
Location:	Background air monitoring

## **Appendix 1: Air Monitoring Locations**

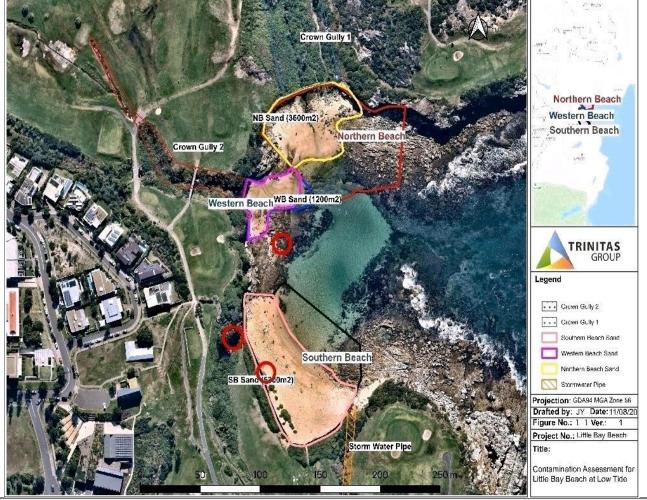
Requested by:	
Client Contact Name	Ryan Zammit
Client Contact Number	90936744
Client Contact Email	ryan.zammit@randwick.nsw.gov.au
Site:	
Address	2 Coast Hospital Rd, Little Bay NSW 2036
Local Government Area	Randwick City Council
Site Boundary	
Air Monitoring Locations	0
