Asbestos Containing Material Clearance Inspection

11 March 2023

Site:	Little Bay Beach
Location:	Southern, Western and Northern Little Bay Beach

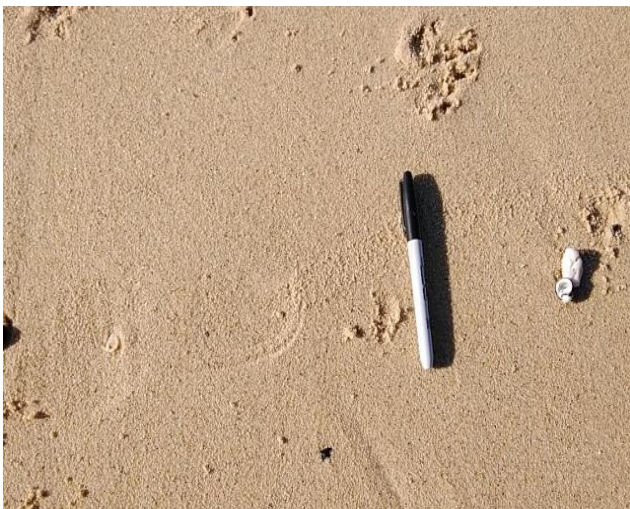
Notes: Northern beach surface following fragment removal
