Detailed Site Investigation (DSI) of Potential Asbestos Contamination at Little Bay Beach, Little Bay NSW

Prepared for:	Randwick City Council	
Site	Little Bay Beach	
Location	4R Coast Hospital Rd, Little Bay NSW	
Field Work Date	26 th – 30 th April 2021	
Report Date	17 th September 2021	
Report Version	v6 final	
	Jeffrey Yu	
Prepared by:	 Senior Environmental Consultant Licensed Asbestos Assessor (001366) PhD in Environmental Engineering PhD in Medicinal Chemistry

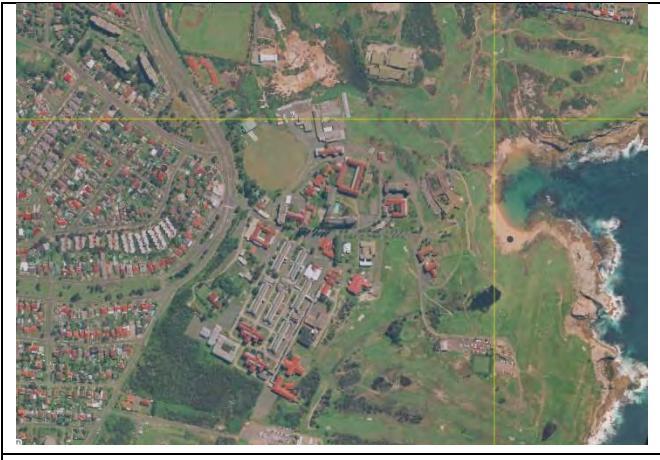
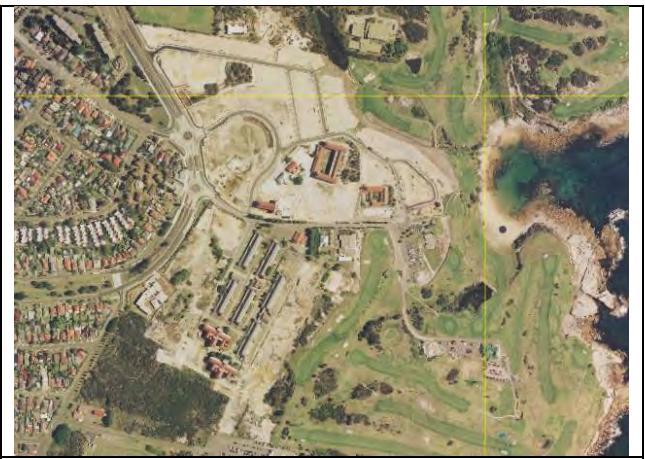
Image 3: Aerial Photograph dated 1998 (Source: NSW Spatial Services)

As observed in image 3 and image 4 in Table 2, large scale redevelopment of the areas surrounding the Site (Lot 98) was undertaken between 1998 and 2005 which involved demolition of several buildings and clearing of land. A review of 'Remediation Strategy Report & Future Site Management Principles Prince Henry Redevelopment Site – Undevelopable Area' prepared by EMS (EMS 2005) was undertaken and it is noted that the drainage channels where introduced fill was exposed were remediated via surface removal of asbestos cement fragments followed by installing a 'vegetative promoting geotextile mesh' and a layer of topsoil in addition to diverting the flow of runoff to PVC pipework. It is the opinion of Trinitas that these remediation measures failed to prove adequate as the exposed introduced fill can be observed at the surface of the drainage channels specifically within 'domain 3 – former Ambulance Corps Area' and asbestos contamination within these fill layers from Lot 98 to the sand areas within the Site (Lot 97) via natural phenomenon.

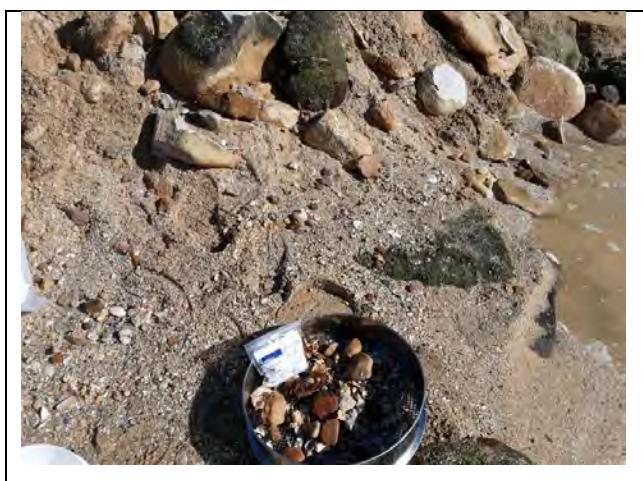
Southern beach, TP41_1.0, Sand and rock with glass, tiles and shell, ACM fragments.

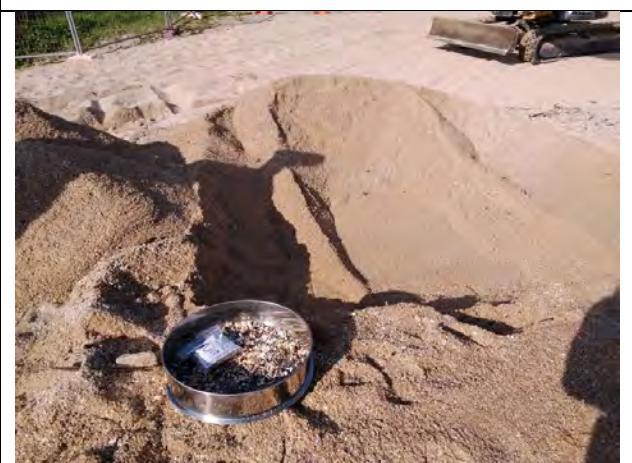
Southern beach, TP36_0.5, sand, small suspected ACM fragment 1 cmx1 cm, sandstone boulders from 0.6 m.

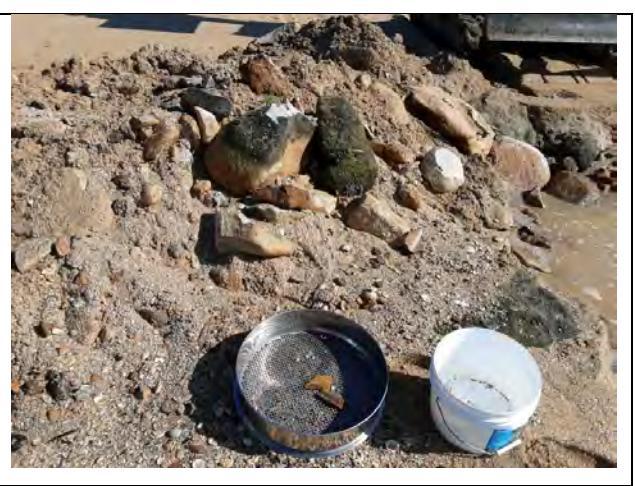
Southern beach, TP41_1.0FC02, Sand and rock with glass, tiles and shell, ACM fragments.

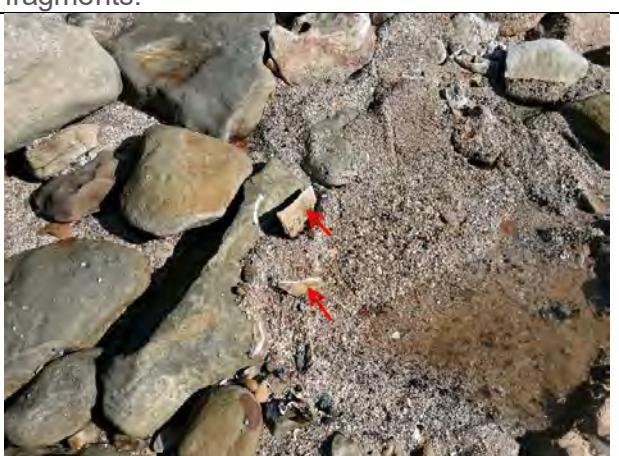
Southern beach, TP39_0.1, Rock and sand with FC sheeting fragments 1.5 kg.

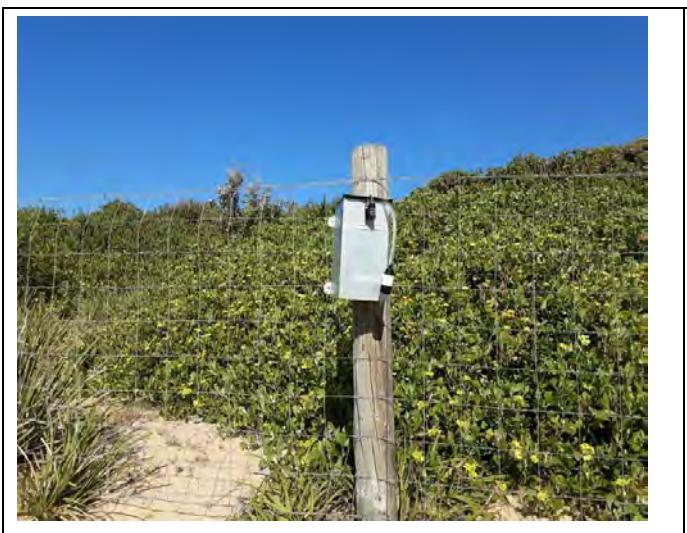
Location: Southern beach - middle Result: <0.01 f/ml Image Id: 210426-091028

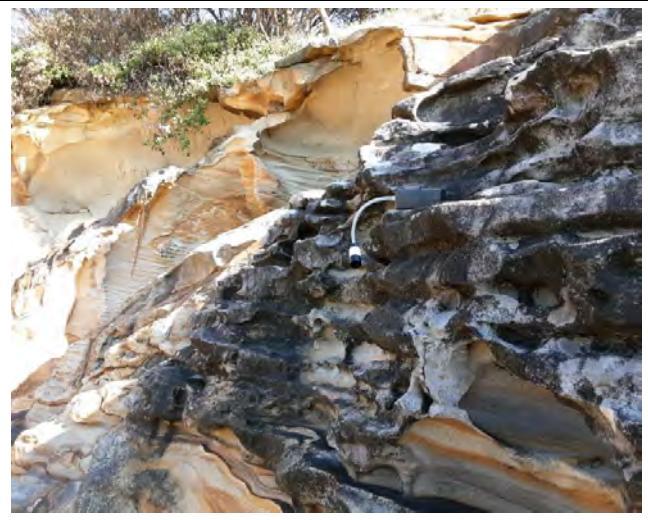
Location: Middle Beach Result: <0.01 f/ml Image Id: 210426-092040

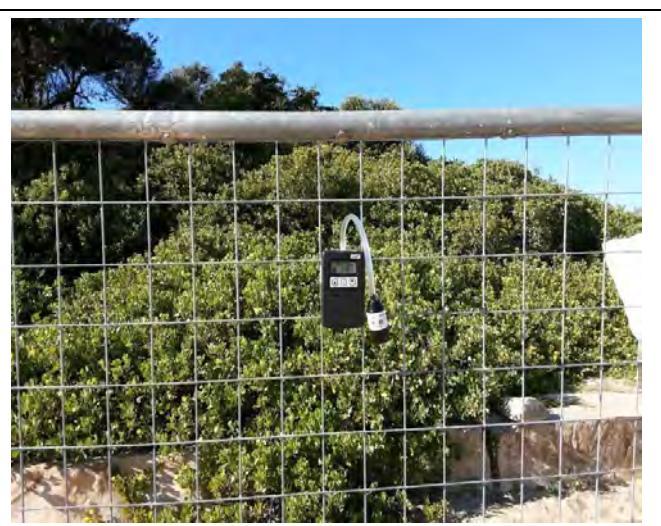
Location: Southern beach - rock area Result: <0.01 f/ml Image Id: 210426-091345

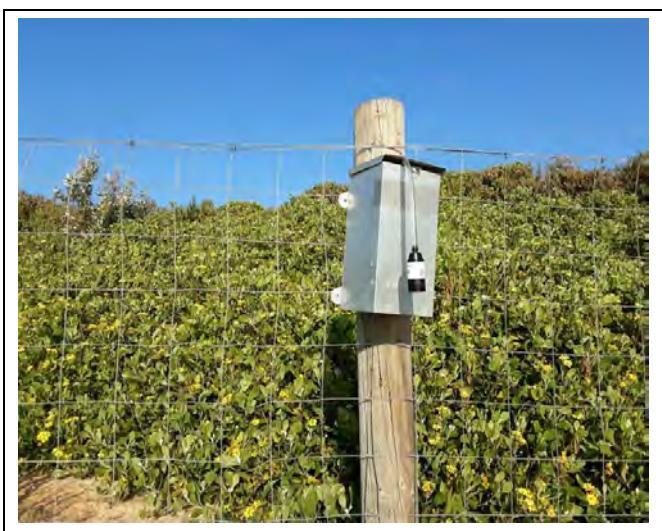
Location: Southern beach - middle Result: <0.01 f/ml Image Id: 210427-075359

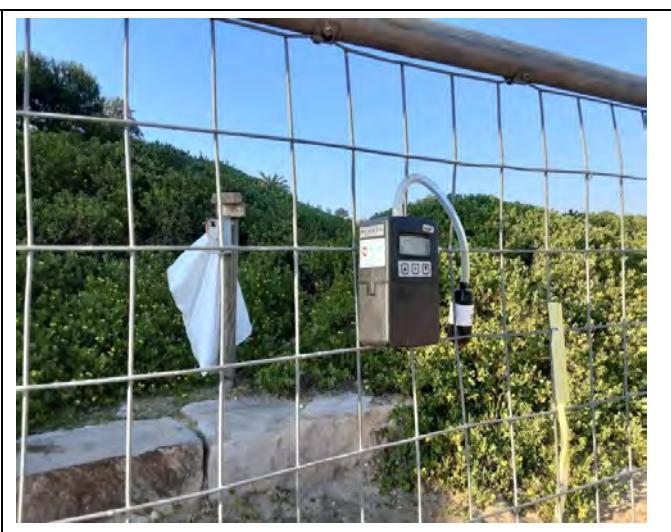
Location: Southern beach - rock area Result: <0.01 f/ml Image Id: 210427-075635

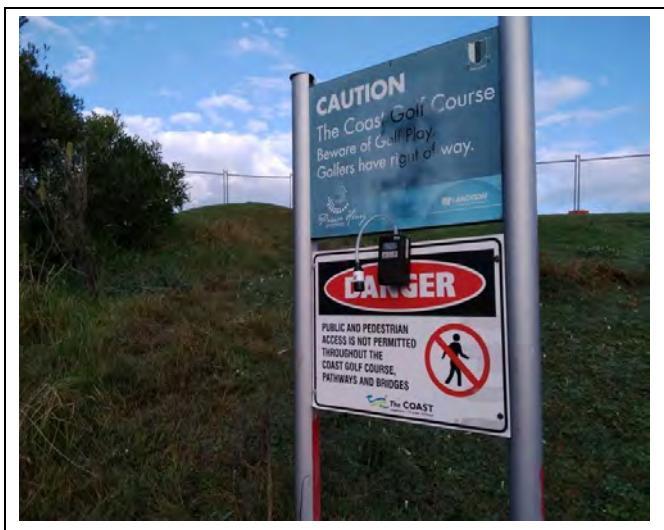
Location: Upper Northern beach Result: <0.01 f/ml Image Id: 210430-073456

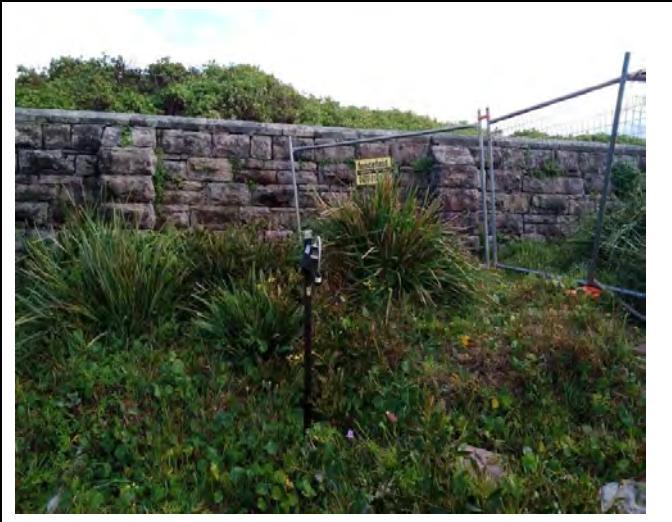
Location: Western Section at Northern beach Result: <0.01 f/ml Image Id: 210430-073705

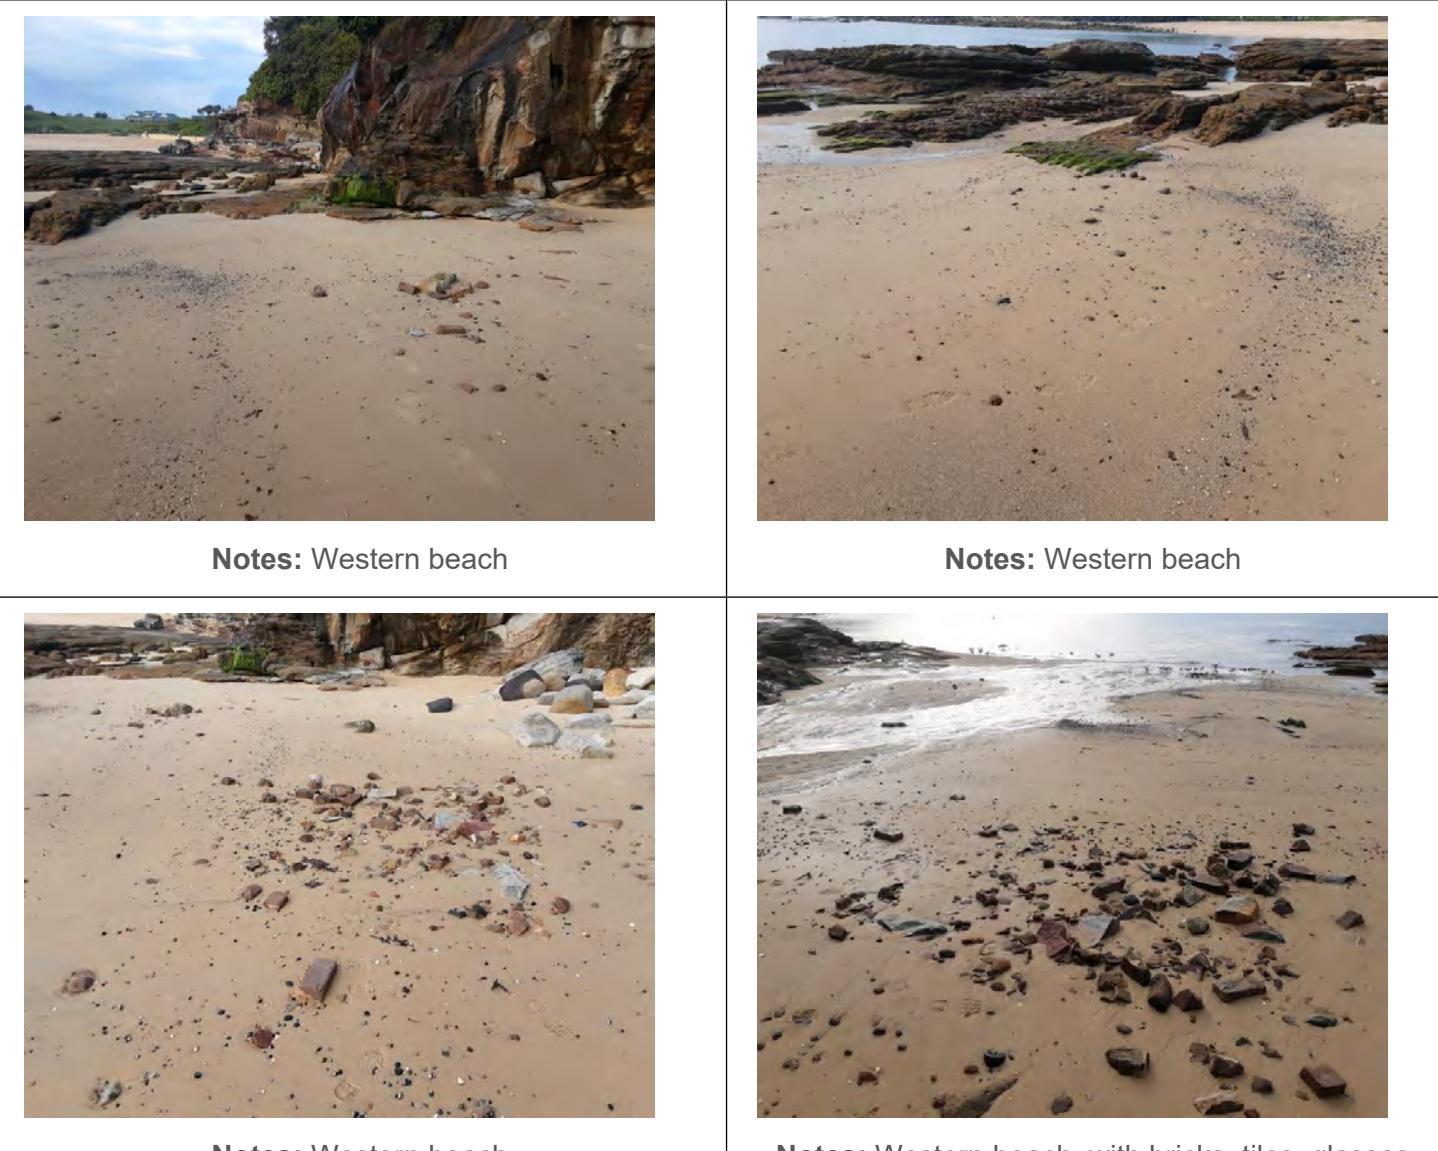
Notes: Western beach with bricks, tiles, glasses

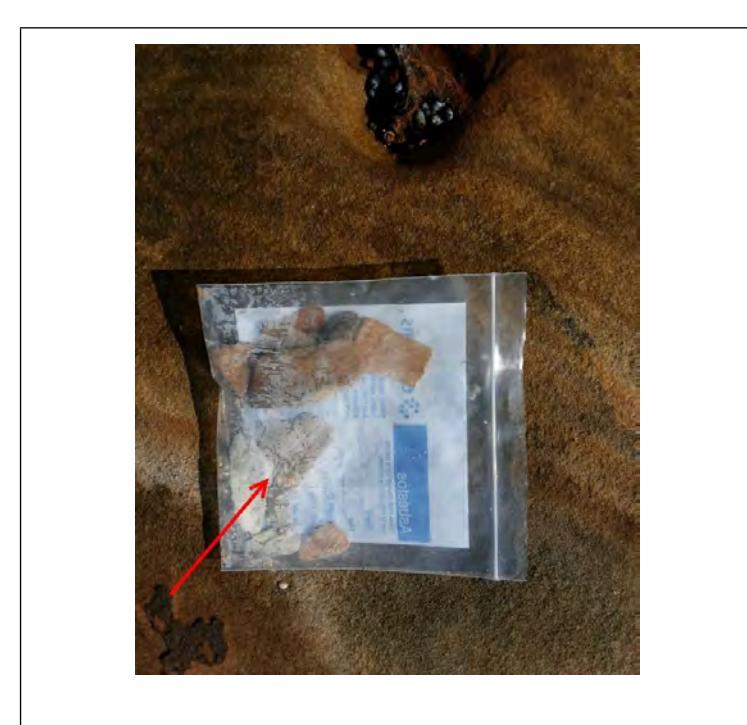
Notes: 12 ACM fragments collected
